ZAKHO MILITARY ACADEMY  
ZAKHO, IRAQ

**SIGIR PA-06-039**  
**APRIL 12, 2006**

SUBJECT: Report on the Project Assessment of the Zakho Military Academy, Zakho,  
Iraq (Report Number SIGIR-PA-06-039)

## Zakho Military Academy, Zakho, Iraq

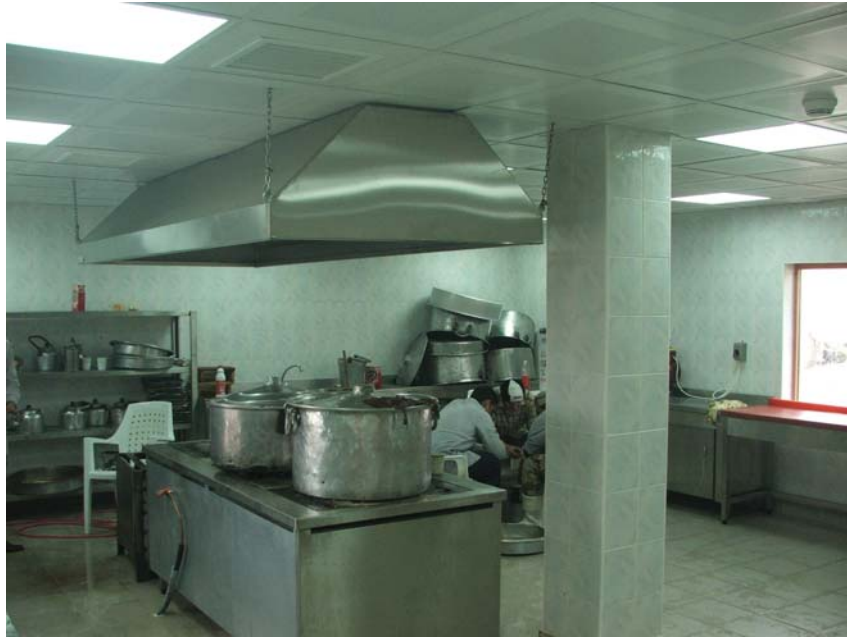
**Site Photo 2. Kitchen in Bldg. 1090**

In addition to the renovation of the kitchen area, the Task Order required the procurement and installation of 14 new items of kitchen equipment. Major items included a service counter, a stove, and an industrial refrigerator. Site Photo 2 shows the location of the stove and exhaust hood in the kitchen. We did not take an inventory of the 14 items, but the kitchen appeared to be fully functional with an oven, stove, sinks, refrigerator, food preparation and storage areas.

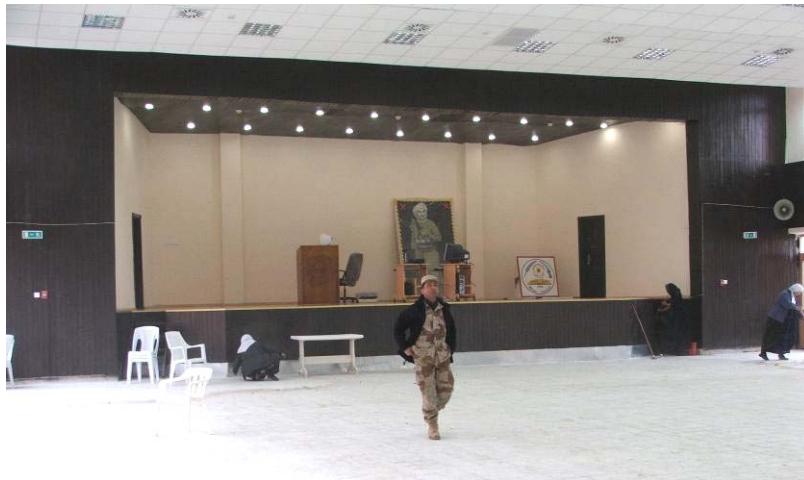
**Site Photo 5. Auditorium in the training building**

In addition to the finishes described above, the auditorium (Site Photo 5) included a new suspended acoustical tile ceiling, central air conditioning, and a stage with new wood flooring.

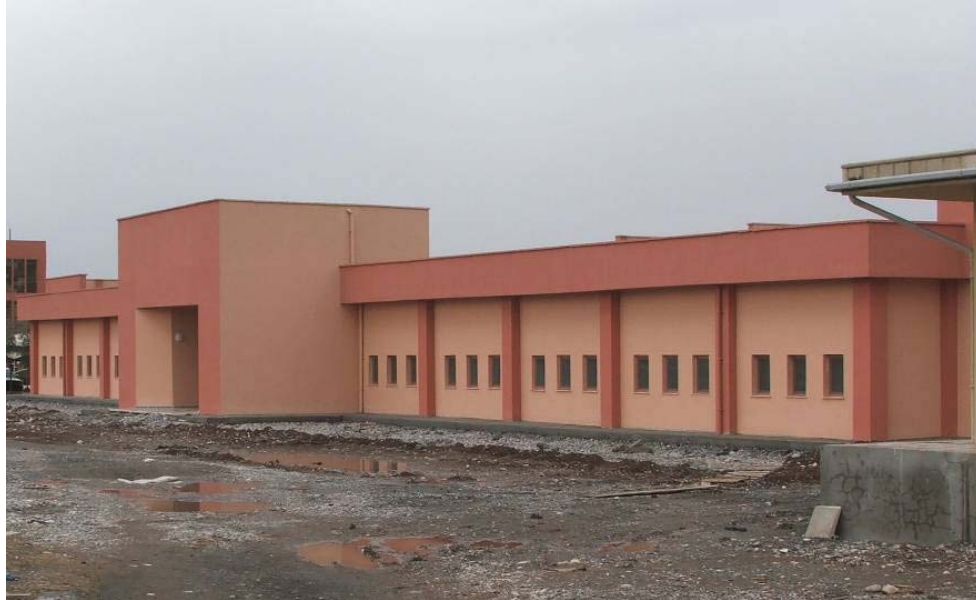
**Site Photo 12. Exterior view of the headquarters building**

The architectural style of the headquarters building is similar to the barracks. As shown in Site Photo 12, the structural concrete frame of the headquarters building was infilled with concrete block walls and covered with a painted cement-stucco finish. The color scheme of the headquarters building matched the exterior color scheme of the barracks, as well as the two dining facilities and the training building.

The completed construction of the headquarters building met the requirements of the Task Order. There were no noticeable defects in the interior finishes and with the exterior of the building, including the roof.

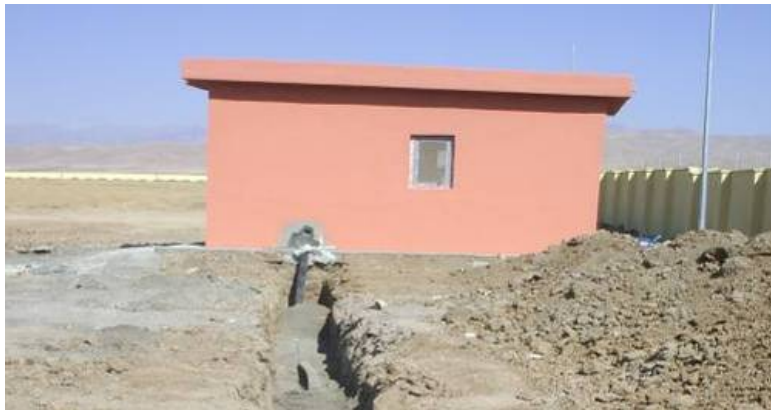
**Site Photo 18. Water main installation from new well house – Photo provided by USACE**

This facility was added by modification to the original Task Order and required the contractor to design and construct a new deep well and pump house, and to construct supply water lines to an existing elevated water storage tank adjacent to the new WTP. The well (drilled to a depth of 150 m), well house, and piping to the existing elevated water storage tank were completed in October 2005. Site Photo 18 taken during the construction, shows the well house, as well as the excavation and backfill for the water line installation.
