AL BASRAH OIL TERMINAL
BASRAH, IRAQ

SIGIR PA-06-080
APRIL 26, 2007

SUBJECT: Report on the Al Basrah Oil Terminal, Basrah, Iraq (Report Number
SIGIR PA-06-090)

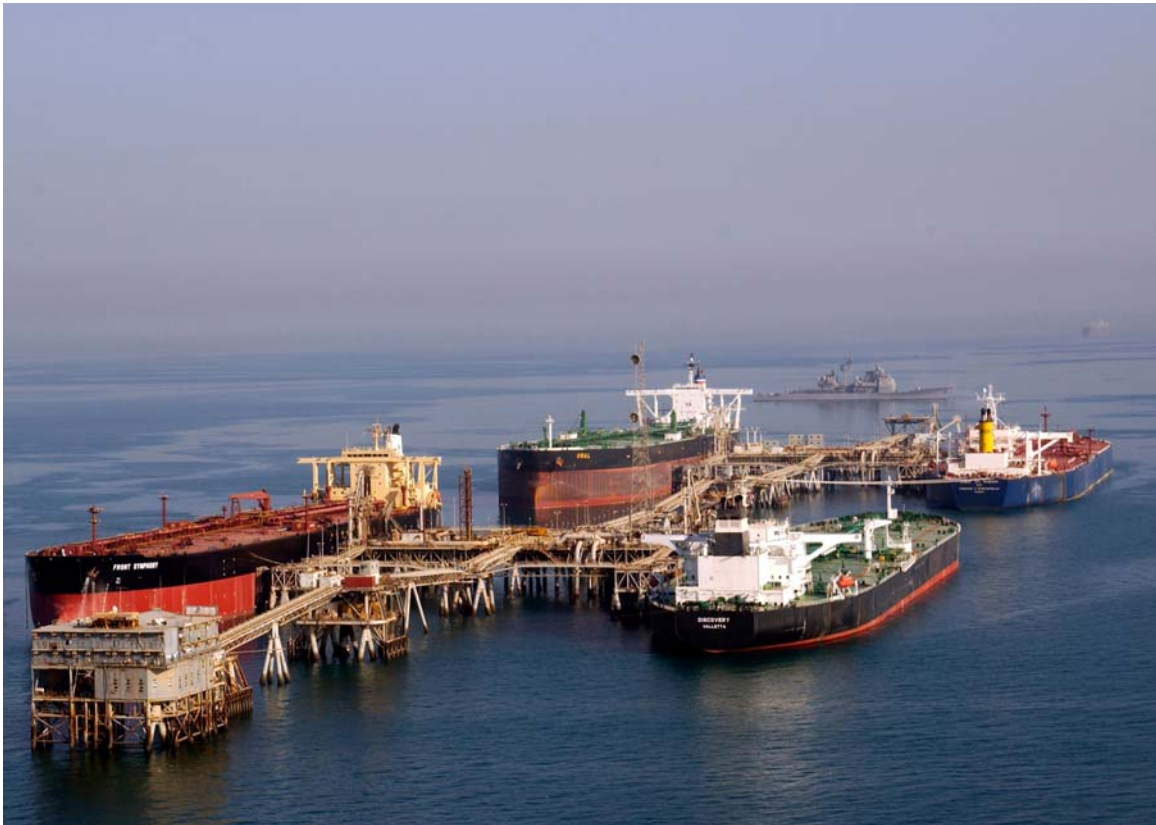
Site Photo 1. Aerial view of ABOT's four berths (Photo courtesy of USACE)

400,000 bpd per each berth (Site Photo 1). The ABOT suffered significant damage during the 1980-1988 Iran-Iraq War; however, it remained in service until 1989, when Brown and Root attempted to refurbish it in 1990 (after the conclusion of the Iraq-Iran War). Work stopped when Iraq invaded Kuwait in 1990 and the facility was inflicted with further damage during the Gulf War. In addition, the platform was operated under the Oil for Food program for several years thereafter with minimal maintenance. The terminal was later renamed ABOT. The ABOT is one of Iraq's two main export outlets – the other outlet being the KAAOT.

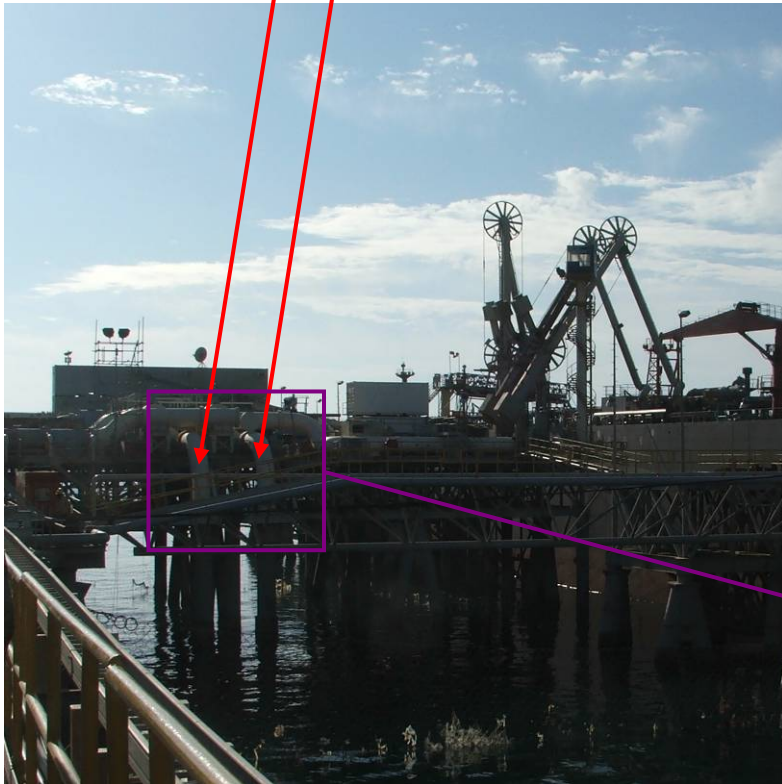
Site Photo 4. Two 48-inch incoming sea lines

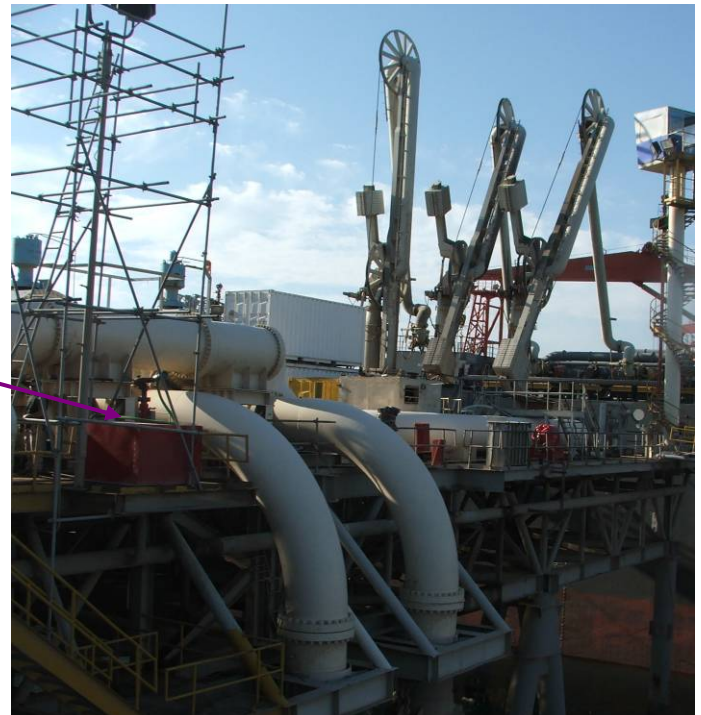
Site Photo 5. Close-up view of Site Photo 4

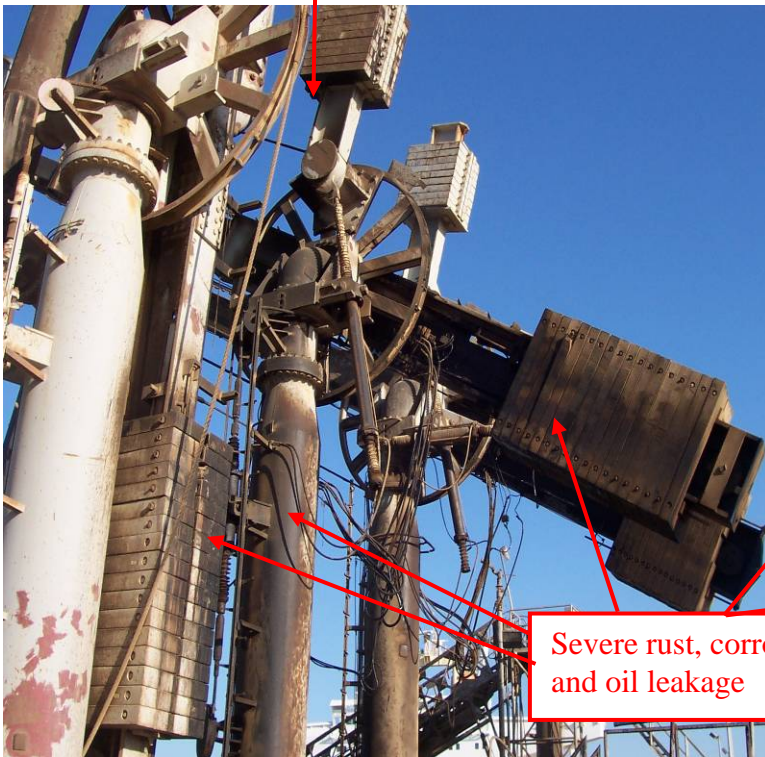
The ABOT was operating at reduced production rates because of the dilapidated condition of the crude oil loading arms and the missing and damaged ancillary equipment. The initial assessment of the loading arms on Berths 1 and 2 found severe rust, corrosion, and oil leakage (Site Photos 7, 8, and 9). According to PIJV’s site visit report, for platform B, Berths 3 and 4 loading arms were refurbished in 2003. However, they suffered operational damage and developed hydraulic leaks, which required repairs.

Site Photo 8. Previous condition of Berth 1 loading arm

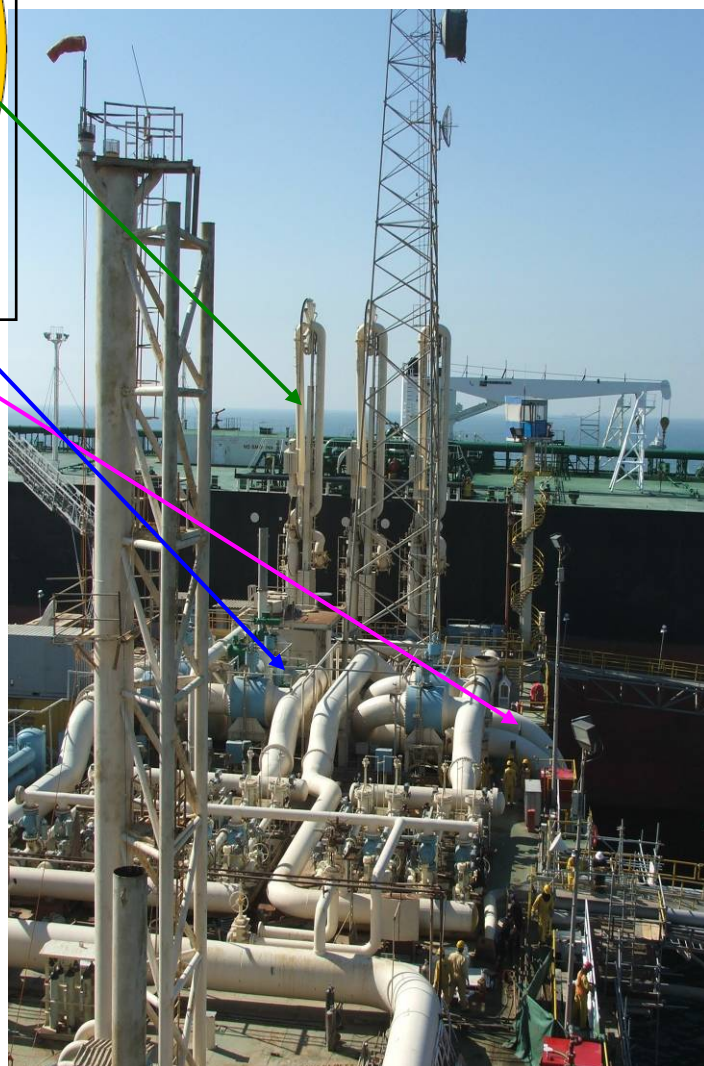
Site Photo 10. View of 48" lines, meter skid, and 24" loading arms

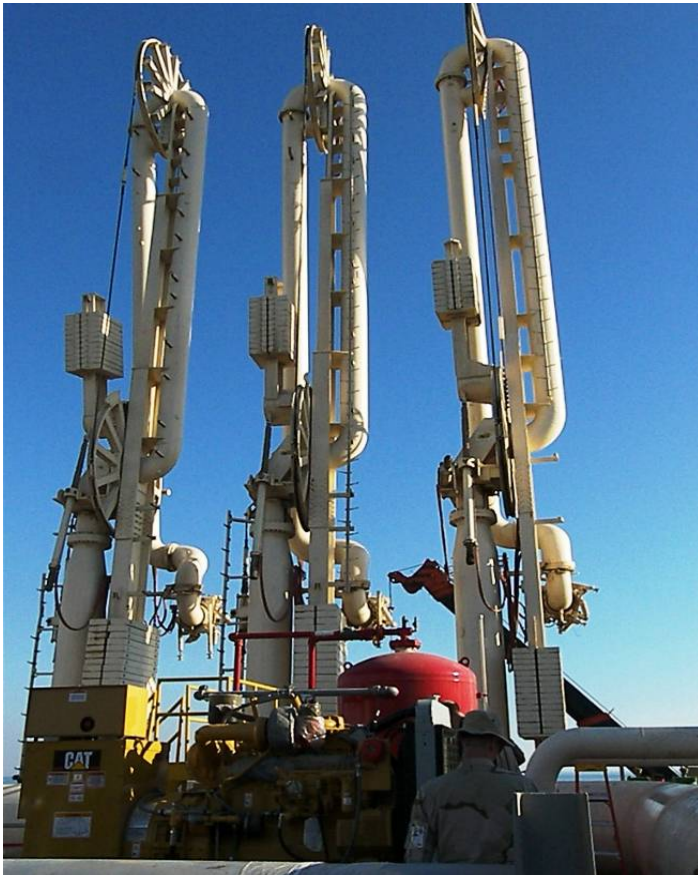
During our site visit to ABOT, we identified the 12 loading arms, which were hydraulically powered and remotely controlled to engage and disengage to the tanker. We observed the recently refurbished loading arms (Site Photos 11 and 12). The refurbished loading arms are under the operational control of the SOC, who are responsible for its usage and maintenance. This is of crucial importance for sustaining the current level of loading volume. At the time of our site visit, three large tankers were docked at ABOT; however, only two tankers were being loaded with crude oil (Site Photos 13, 14, and 15). The loading arms for Berths 3 and 4 were connected to the tankers, performing its intended function (Site Photos 16, 17, and 18). As a result, Berths 3 and 4 were being used to load crude oil onto the tankers via the repaired loading arms. However, it is important to note that because of time and security constraints we did not witness the fully automated and remotely initiated sequence of movements of the loading arm system making connection to the tanker. The function of an automated operating sequence initiated from a local control room on a berth is the following – after the loading arm makes a positive connection to the tanker and oil begins to flow through the pipes of the loading arms, sensors can detect a leak or other malfunction within the loading arm system and stop the flow of oil.

Site Photo 11. Loading arms in stand-by position

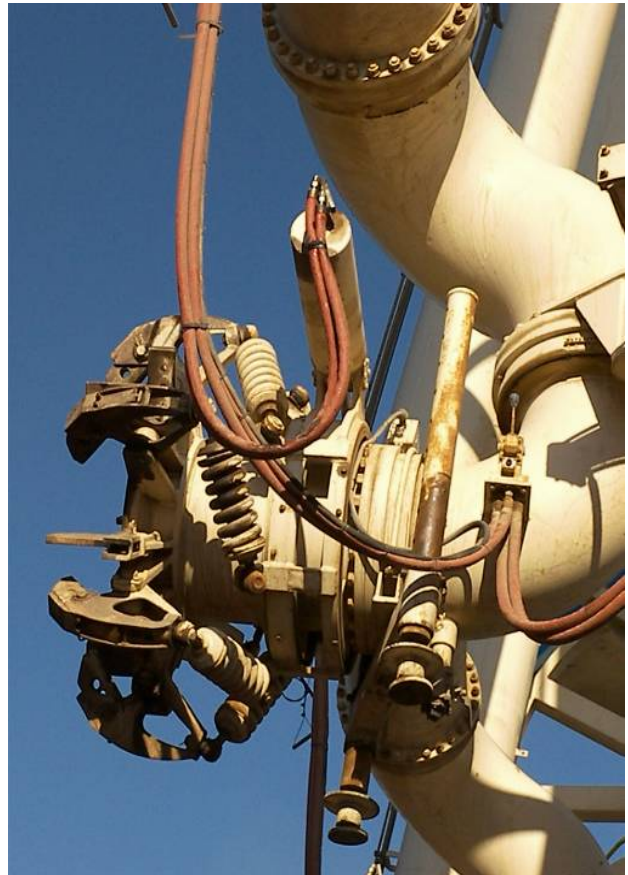
Site Photo 12. Loading arm connector for the tanker

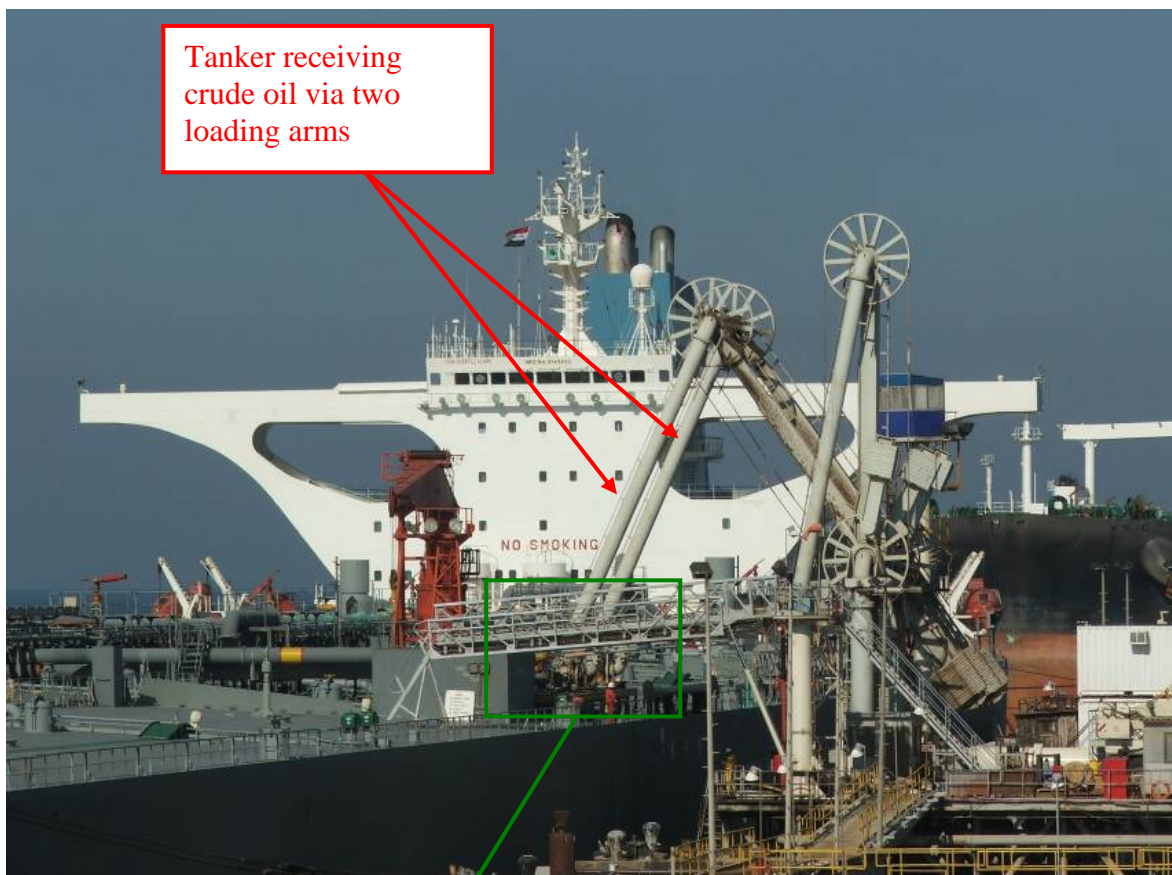
Site Photo 16. Two loading arms engaged to the receiving tanker

All actively engaged arms delivering oil to the tankers did not exhibit any malfunction during our visit. Based upon our observation, the refurbishment of Berths 1 and 2 loading arms and repair of Berths 3 and 4 loading arms appeared to improve the arms previously dilapidated and operationally damaged condition. As a result, for the first time in many years, all four berths are in operation. In addition, according to GRD representatives, this has significantly improved loading efficiency by allowing four tankers to berth at the same time.

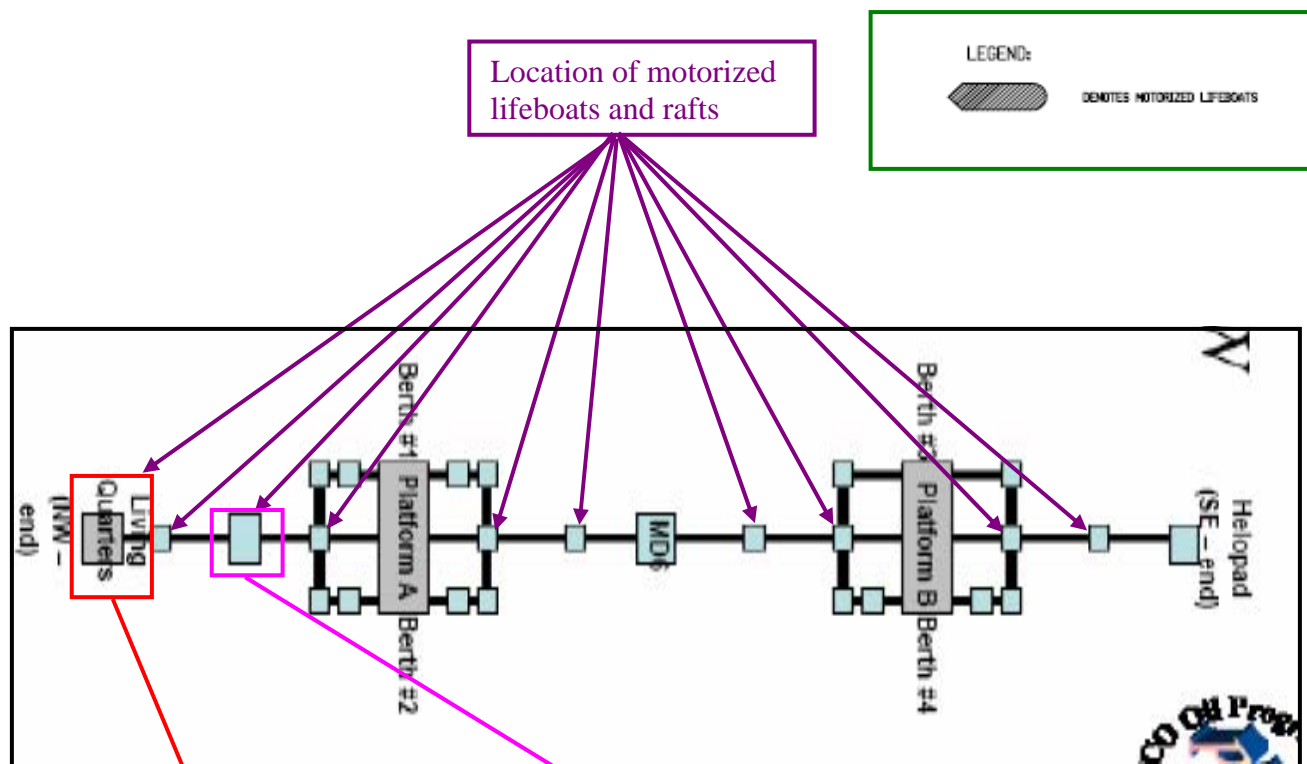
The original estimated cost for the project was approximately \$1.8 million. Figures 9, 10, and 11 show the number and location of the lifeboats and life rafts.

Figure 9. Original number and location of motorized lifeboats and life rafts on ABOT

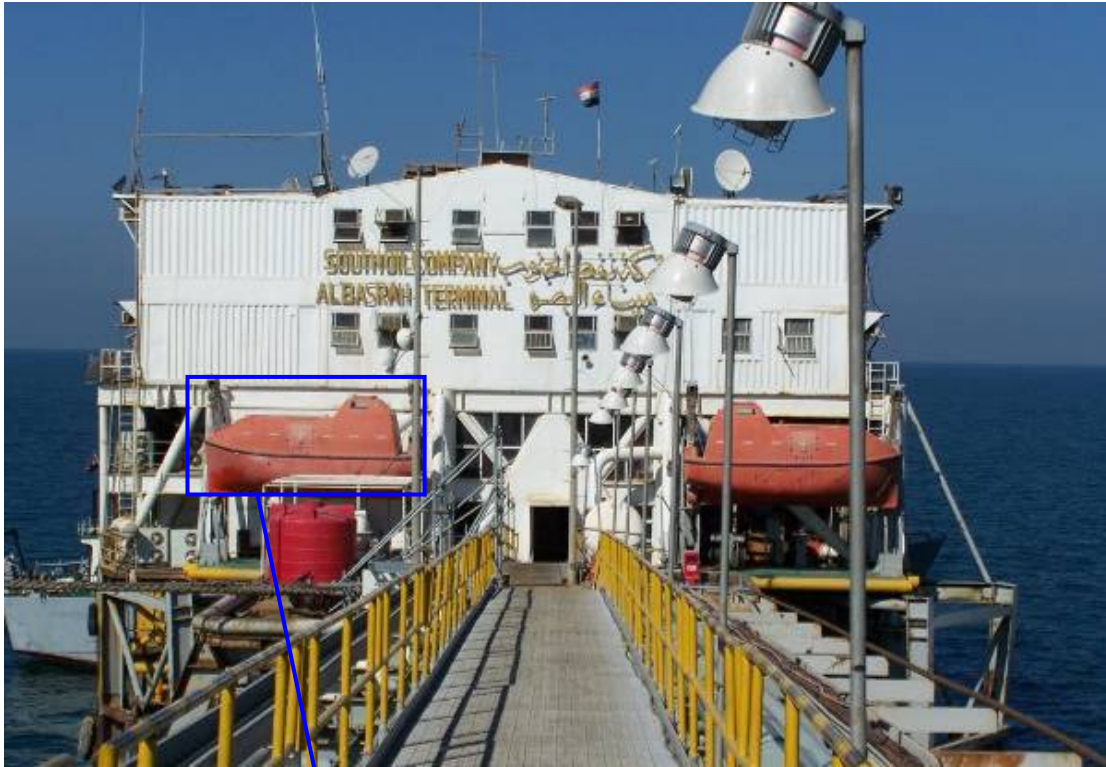
At the time of our site visit no new life rafts existed on ABOT. During our site visit, we located the two existing evacuation escape capsules previously identified by PIJV during its initial site assessment (Site Photos 20 and 21). According to GRD documentation, in March 2006, the SOC repaired the lifeboat davits for the accommodation platform and hung the two existing escape capsules.

Site Photo 20. Existing two enclosed evacuation escape capsules

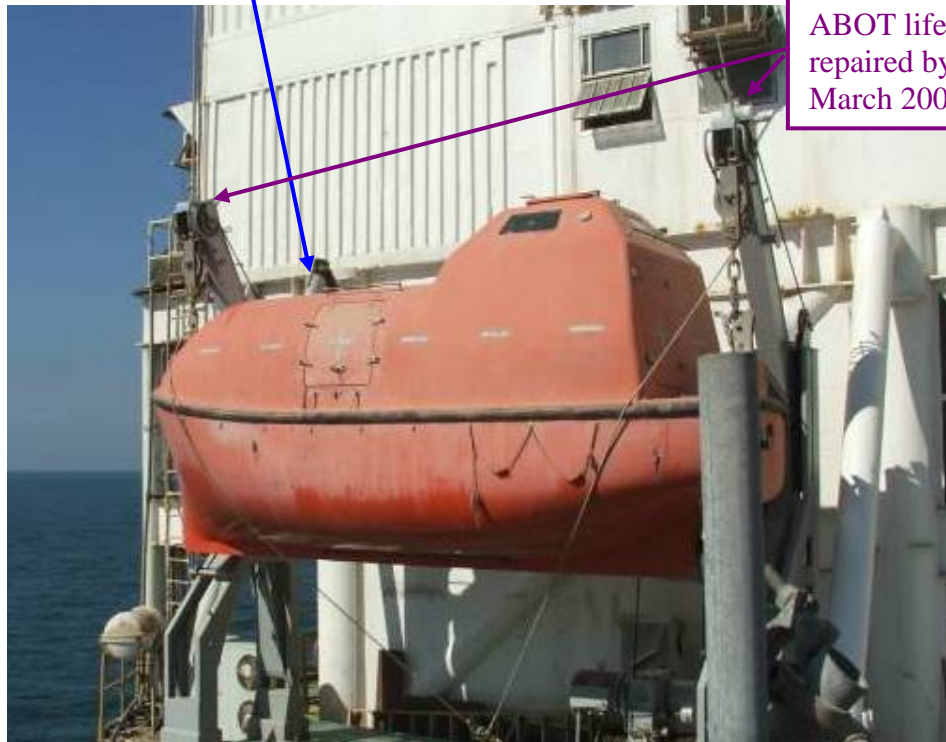
ABOT lifeboat davits –
repaired by SOC in
March 2006

Site Photo 21. Close-up of evacuation escape capsule

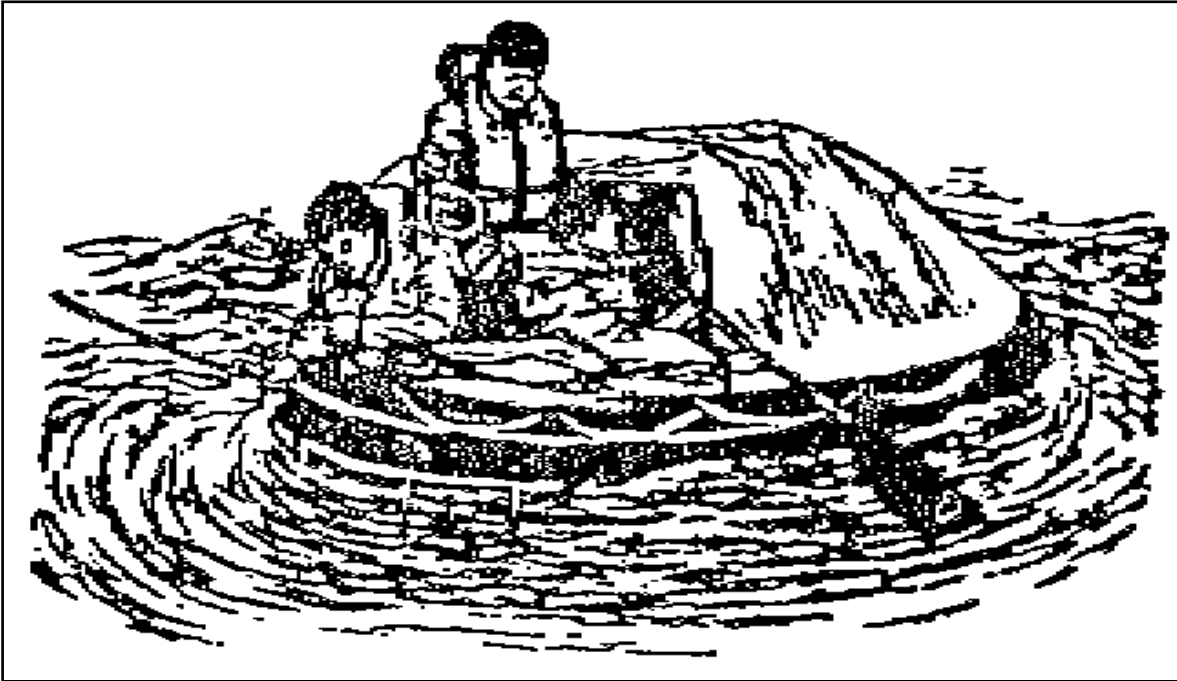
Figure 15. Illustration of a fully inflated life raft (note life raft does not appear to hold 20 occupants)

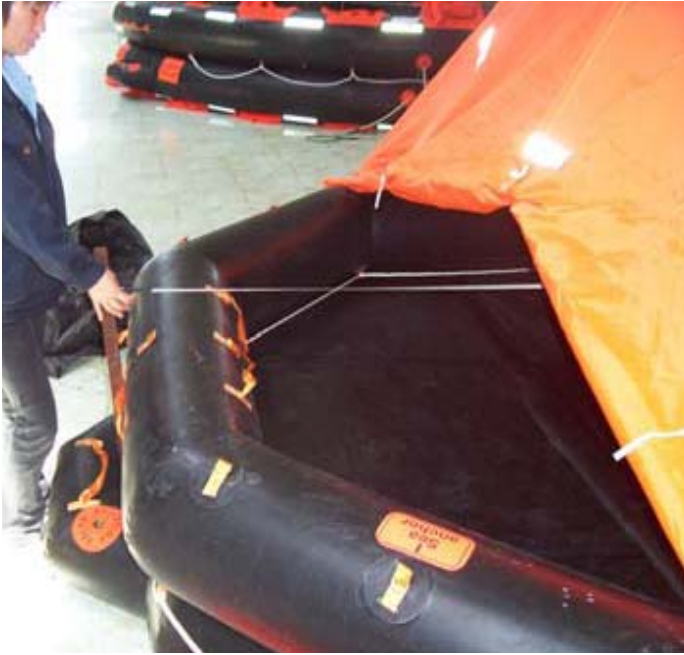
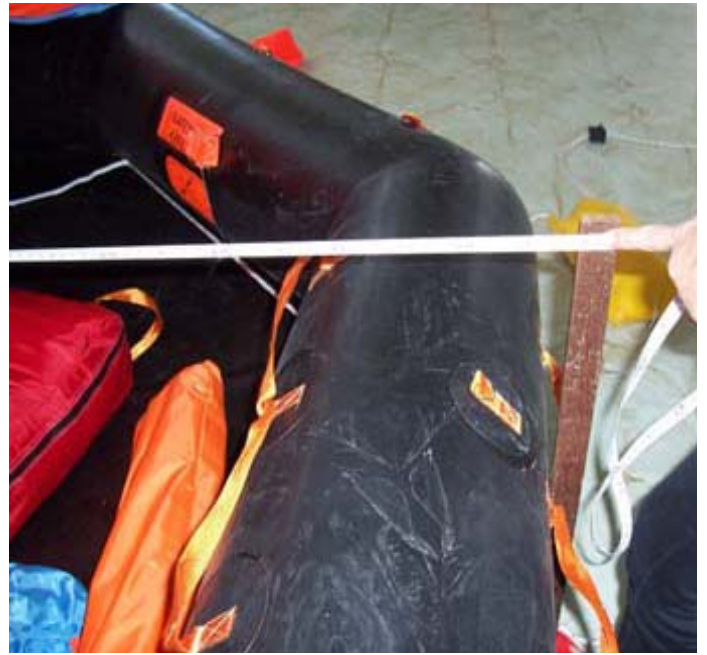
Site Photos 24 and 25. Fully inflated life raft, which is not fully enclosed

GRD Oil representatives believe the life raft material is acceptable because it "meets the standards required for SOLAS certification." Considering that the most significant safety concern for ABOT is a sizeable oil spill/explosion/fire, we believe using a life raft which the manufacturer stated is "not designed to be launched into burning oil" is ill advised. Further, because of the danger of oil spill/explosion and fire, we particularly do not believe a life raft that has not been determined to be fire retardant should be purchased and installed. The contractor and government representatives did not identify and procure a safety vehicle with the highest probability of surviving an intensive ocean fire.

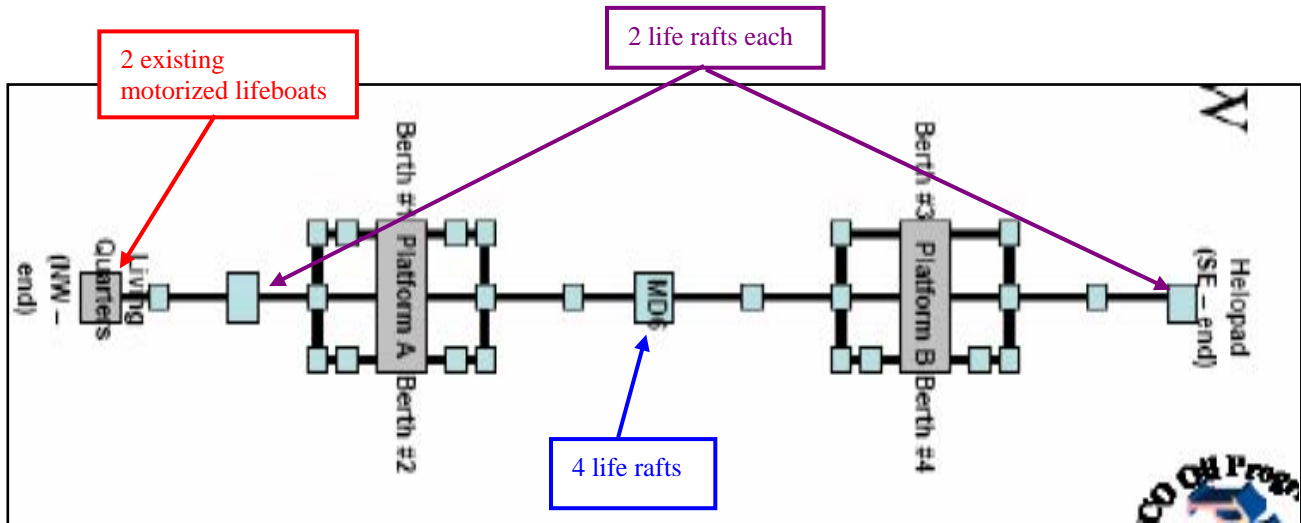
According to GRD representatives, the eight life rafts were installed at the helipad, MD6, and MD2 (Figure 16). Currently, there are no known muster points for an emergency evacuation on ABOT; therefore, we cannot determine if the life rafts were installed at the correct spots.

Figure 16. Current location of the two existing evacuation escape capsules and eight life rafts

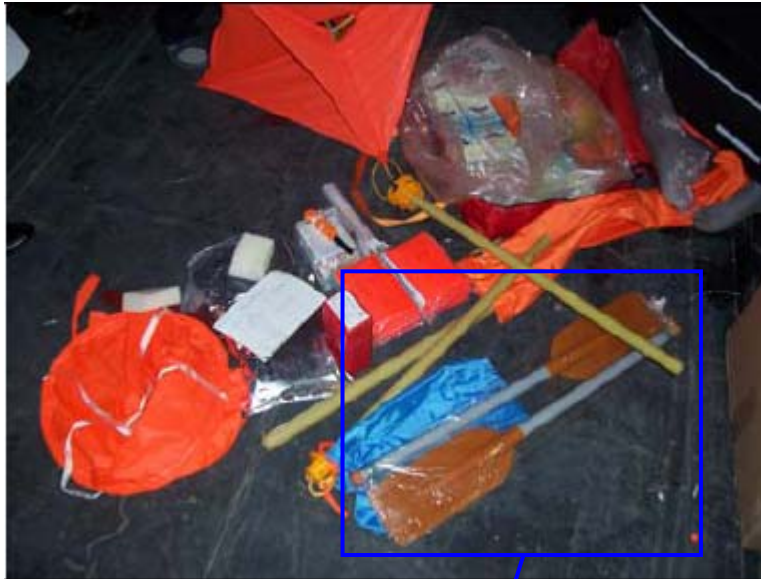
After de-scoping the motorized lifeboats, PIJV supplied and GRD Oil approved and accepted inflatable life rafts with the only source of propulsion being the manual use of two oars (Site Photos 31 and 32). The oars provided do not appear to be of a high quality material and are not appropriate for heavy sea conditions. Considering each life raft is to hold approximately 20 people, the probability of rowing at a minimum 3,000 pounds (20 people x 150 pounds/person) quickly out of the burning ocean water with only two oars is miniscule.

Site Photo 31. Two oars provided with each life raft

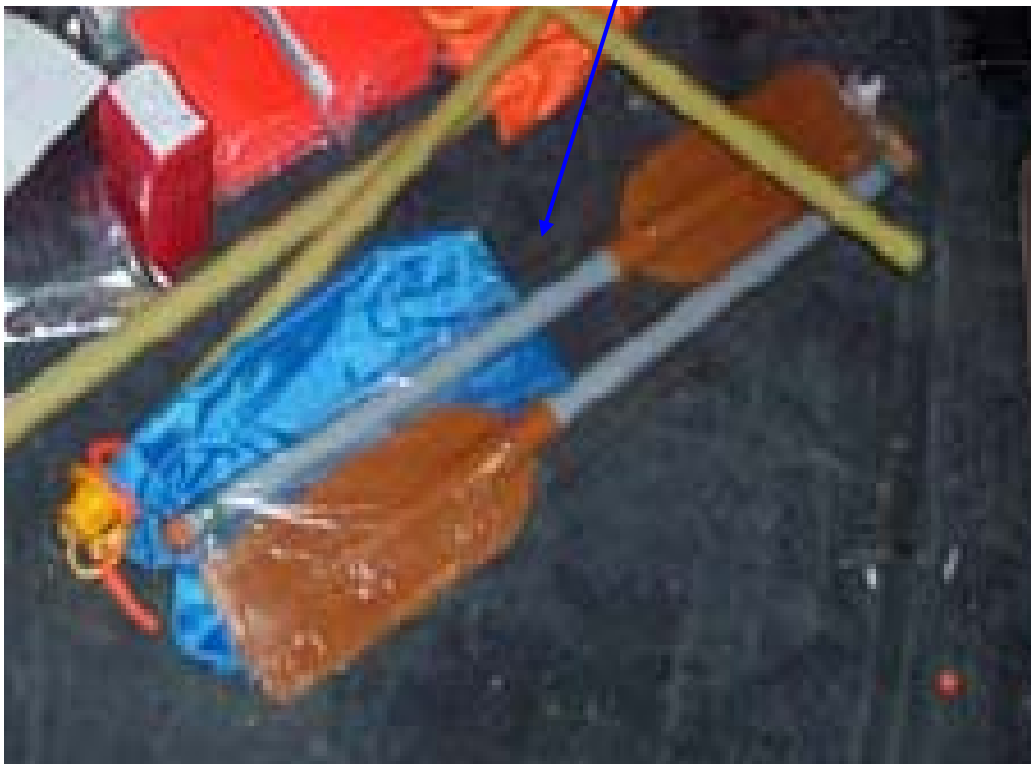
Site Photo 32. Enlarged view of the life raft oars, which appear to be made of plastic

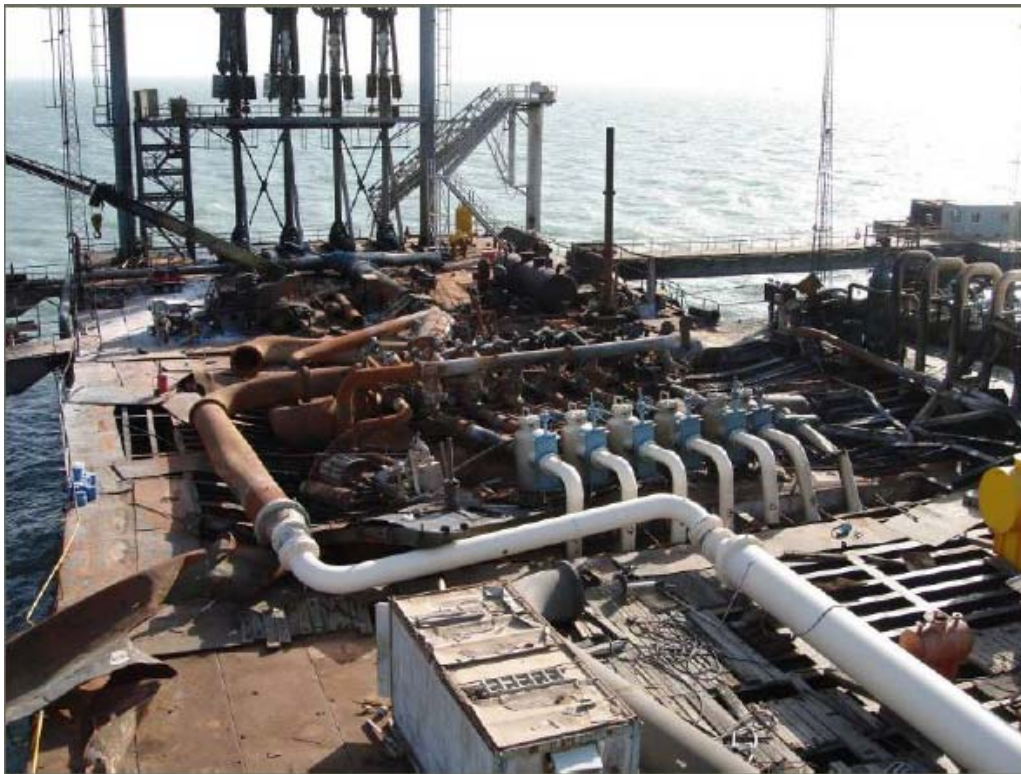
PIJV concluded that "as a result of the two blasts, all equipment, piping, and deck surfacing will require complete removal and replacement with the exception of the equipment on the north section."

Site Photo 36. KAAOT platform after the explosion

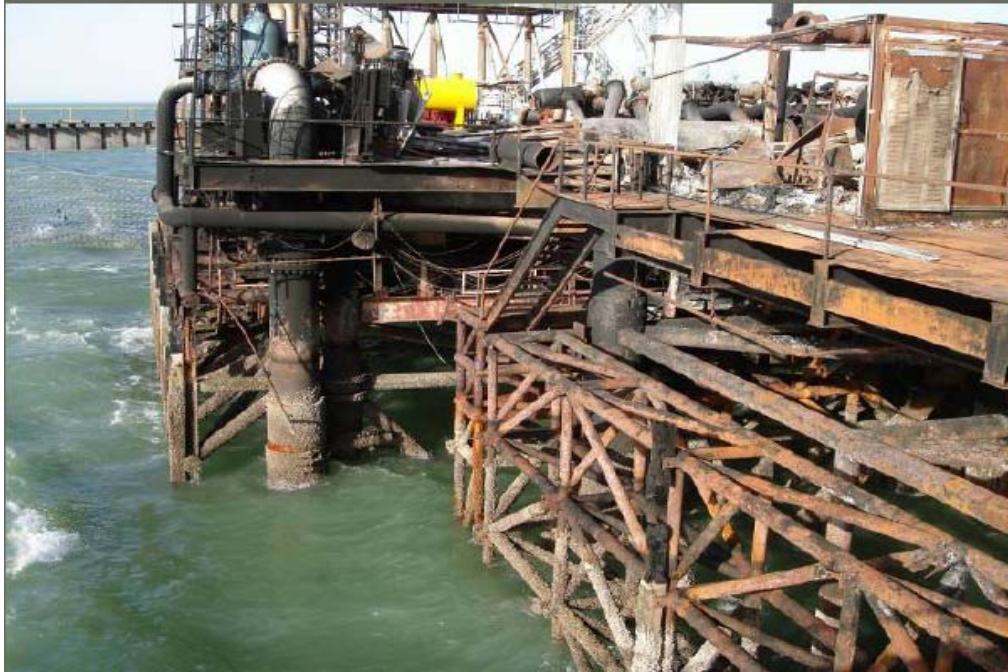
Site Photo 37. Condition of KAAOT platform after the explosion
