Long Term Hydrogen Vehicle Fleet Operational Assessment

Steven Eick, Greg Whiting, Rene Parker

TARDEC, Select Engineering Services, Select Engineering Services

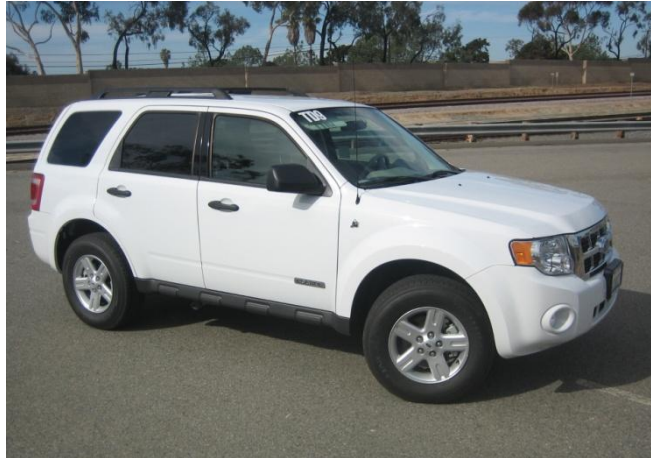
The ten H2ICE vehicles were the standard model year 2008 Hybrid Gasoline Electric Sport Utility Vehicles (SUV). Figure 1 shows one of the H2ICE vehicles. The H2ICE vehicles have a full hybrid system capable of propelling the vehicle using, electric power, engine power, or both together. The system has an engine shut-off for when the vehicle is stopped and can go full electric up to roughly 25 miles per hour (40kilometers per hour) before the internal combustion engine is started. The standard vehicles underwent a conversion process where the 15-gallon gasoline fuel systems were replaced with type-IV carbon-fiber hydrogen tanks and appropriate fuel lines. The type-IV tanks have a service pressure of 350 bar and were connected in series with check valves that locked the tanks when the vehicle loses power. The replacement hydrogen storage system can hold 3.8 kg of gaseous hydrogen at a pressure of 350 bar.

Figure 1 – A H2ICE Vehicle in Hawaii

The engines used in the H2ICE vehicles was the standard gasoline engine from the manufacturer with a few replaced parts. The standard engine is a 2.3 liter in-line four cylinder engine capable of providing 133 hp (99.1 kW). The engine had the fuel injectors and spark plugs replaced; a new air filter was required. In order to maintain vehicle power during the conversion, a turbocharger was added to make up for the lost engine power seen during the conversion to a gaseous fuel. All of these elements of the conversion were performed by during the conversion process and are protected intellectual property of the Company that performed the conversions. A supercharger on the hydrogen internal combustion engine would also have increased engine output significantly [1]. The high pressure injection of hydrogen into the engine has been investigated to find the best air-fuel ratios and nozzle geometries [2].

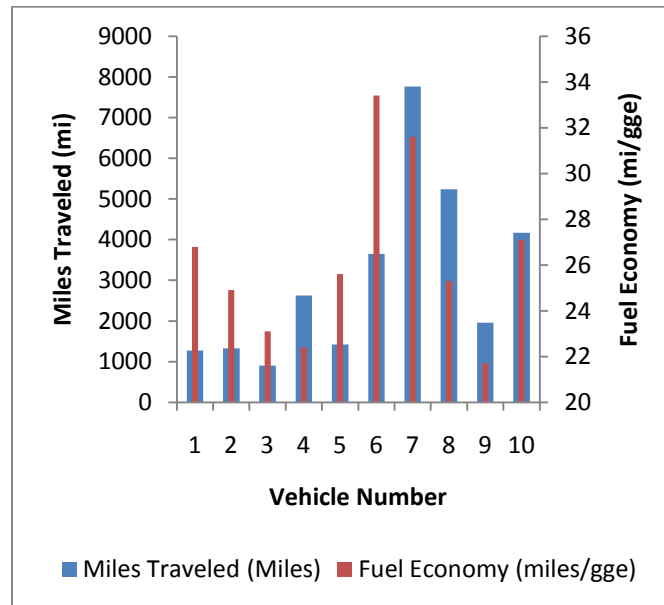
The results of the total mileage accumulated over the period of vehicle operation and the average fuel economies for each vehicle is represented in the bar chart in Figure 2.

Figure 2 – Individual Vehicle Mileage and Fuel Economy

The average fuel economies of the vehicles varied greatly between vehicles due to the differences in drive cycles of the various organizations and the variation in driving styles between the different drivers. When the ten vehicles’ average fuel economies are averaged for the fleet, the fleet fuel economy of 26.2 miles per kilogram hydrogen or 42.2 kilometers per kilogram hydrogen is found. This is comparable to fuel economies of standard hybrid electric-gasoline SUVs [5].
