# TEST AND ON-ORBIT EXPERIENCES OF FALCONSAT-3

William W. Saylor, PE<sup>(1)</sup>, Col Martin E. B. France<sup>(1)</sup>

## ABSTRACT

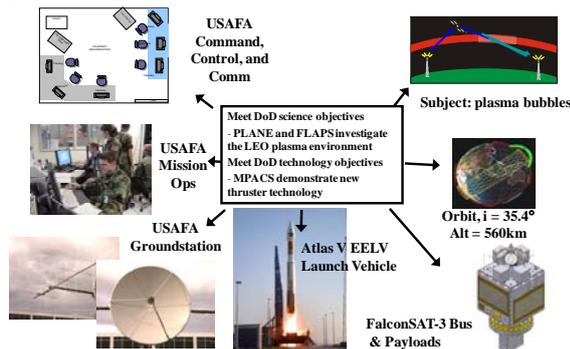
Figure 3. FalconSAT-3 Mission Architecture

The orbital requirements for the satellite were a 560 km circular orbit at a 35.4° inclination. The only ground station for this satellite is at USAFA at latitude 39° and that has made closing the link budget and successful communication difficult to manage.

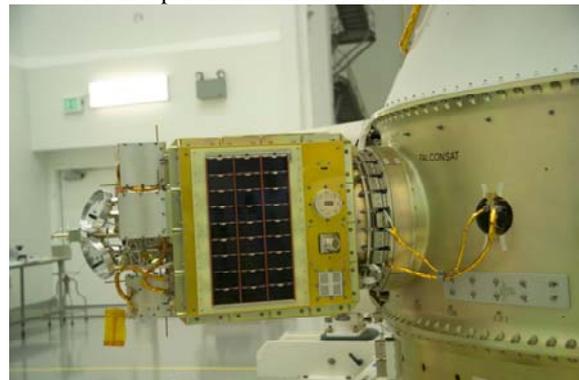
Figure 5. FalconSAT-3 mounted on ESPA Ring

The mounting ring separation system required for this mission was a 15 in (38.1 cm), 24-bolt motorized (or non-motorized for FalconSAT-3) lightband from Planetary Systems Corporation (PSC). This system eliminates the pyroshock from a pyrotechnic initiated separation system and provides a controlled, spring force-driven separation from the launch vehicle.

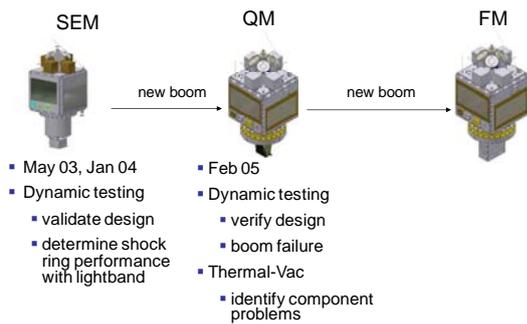
Figure 9. FalconSAT-3 test Sequence

Typically the testing approach includes four separate stages. The first stage is the construction of a physical model. The physical model can be constructed of cardboard or plywood and serves as a means to visualize what the spacecraft will look like and how payloads, avionics, and wire harness can be accommodated. This is where the initial trade-off studies and design decisions are made.

The second major item is a structural engineering model (SEM). The SEM is a duplicate of the satellite structure that will be flown and the avionics and payload components are simulated using mass dummies. The mass and volume of the SEM are the same as the flight model and are subjected to a vibration and shock environment that determines whether or not the structural design is adequate to handle the launch loads. The SEM test is also instrumented well enough to identify variations in the defined launch load environment that can be seen at various places in the structure.

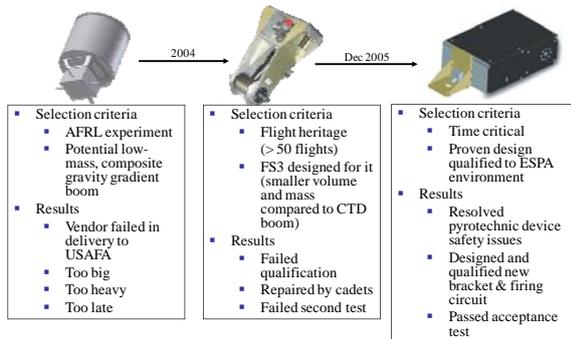
Figure 11. Gravity Gradient Boom History

The original design of the satellite included a gravity gradient boom that was a research and development endeavour of Air Force Research Laboratory (AFRL). The vendor providing a composite memory material delivered the item several months late, non-functioning, and not meeting the required mass and volume constraints. The educational value to the students in dealing with research and development activities was very significant but also caused them to pursue other alternatives. The second gravity gradient boom procured was supposed to have significant flight heritage. However, after that boom arrived and underwent testing it failed at very low levels of vibration. The cadets attempted several fixes of the boom but the design and manufacture were fundamentally flawed and after several months of effort – and launch vehicle integration rapidly approaching – the cadets were forced to initiate an emergency procurement of a more sophisticated COTS gravity gradient boom with a long heritage of successful flights. However this also required a change from an electromechanical release mechanism to one that used pyrotechnic cable cutters. While this was a standard technique in the industry it was a last minute change to all of the safety submittals to the launch vehicle integrator and range safety office. That became the definition of another learning opportunity for young engineers.

The new vendor was required to demonstrate successful deployment and the satellite team was required to develop and test a new firing circuit. This was the one exception to the general testing philosophy where the components were qualification and acceptance tested as components and bolted onto the satellite after final acceptance testing of the FM.

As FalconSAT-3 FM was completed and prepared for environment testing the previously mentioned problems with the gravity gradient boom had been identified and resolved and the testing schedule for the FM had to proceed without the boom. As a result a mass dummy of the deployable boom was used during acceptance testing of the FM. The vibration testing of the satellite was successfully completed and the satellite completed all functional testing.

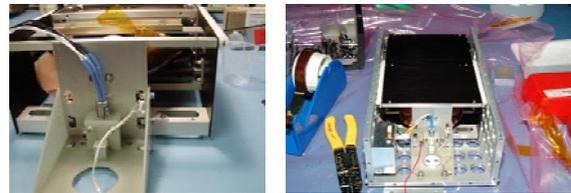
Figure 12. New Pyrotechnic Firing Circuit Added

- > NGST boom has new pyrotechnic release device
- > New firing circuit designed, built, and tested at USAFA
- > Inadvertent boom deployment and pyrotechnic safety issues resolved in Mission System Program Safety Plan (MSPSP) process

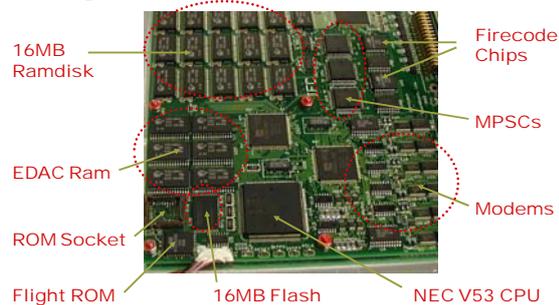
Figure 15. FalconSAT-3 IFC

cycling of the processor. This signal resets the vectors on the CPU in the IFC and clears the states to a supposedly known state.

After a firecode reset signal to the satellite the bootloader starts its initialization and flight code loading sequence. If that process can be interrupted within 30 seconds of a reset then the IFC executes just the simple bootloader commands. Since USAFA did not have access to the source code of the bootloader the vendor was enlisted to attempt communication with the satellite. The vendor was able to reset and then freeze the bootloader process so that it became possible to communicate with what is essentially the BIOS on the satellite processor.

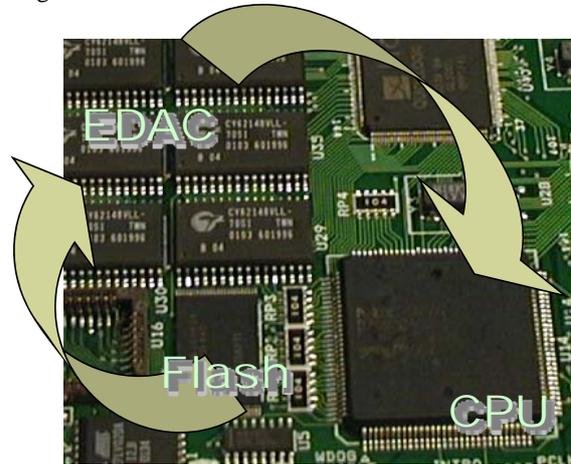
Figure 16. FalconSAT-3 Boot Sequence

When communication with the bootloader program was established it did provide limited telemetry that determined the battery voltage and temperature were normal and that there were no obvious hardware failures. The next question was to determine why the satellite could not successfully load and execute the flight code.

The next step in the anomaly resolution process was to download a memory map of the flight code in the FLASH memory. As soon as that was accomplished and the memory map examined it was clear that the FLASH memory had some how been dramatically corrupted sometime after the last functional test prior to encapsulation and before 6 hours of post-separation activity on orbit. An examination of the pattern of memory corruption made it unlikely that a radiation event had been responsible. At this point it was not clear whether or not that section of FLASH memory had been permanently damaged. It was deemed advisable to contract the vendor to provide a “crutch” modification to the bootloader code that would enable an upload of new flight code to a different part of FLASH. That crutch program was delivered to USAFA; the original flight code was uploaded to a different part of FLASH and then commissioning was able to begin 25 days after launch.
