**Demonstration/Validation for Federal Specification
MMM-A-121 Hazardous Air Pollutant-Free Adhesive
Replacement**

ARL-TR-5502

April 2011

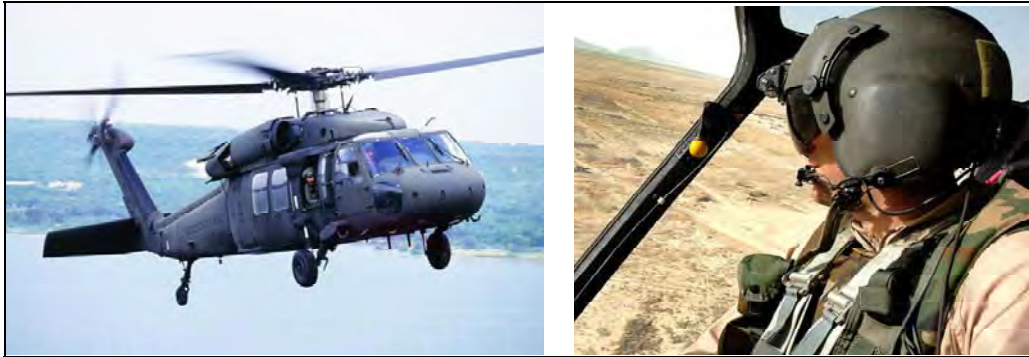
Figure 1. UH-60 Blackhawk helicopter (left) and HGU-56/P aviation helmet (right).

demonstrating and validating 3M-847 adhesive on an HGU-56/P aviation helmet and a UH-60 Blackhawk helicopter (figure 1), conducted at Lowe Army Heliport Fort Rucker, AL. Specifically, this HAP-free product was demonstrated/validated on aviation helmet model no. HGU-56/P “edge beading” preventative maintenance/repair (figure 2), a UH-60 Blackhawk helicopter “nose door seal” (NDS) (figure 3), and for general Army use. Furthermore, this report details the identification and solution of several previously undocumented issues associated with substrate materials currently used by the Army, resulting in modified adhesive application procedures and updated laboratory tests related to the MMM-A-121 specification.

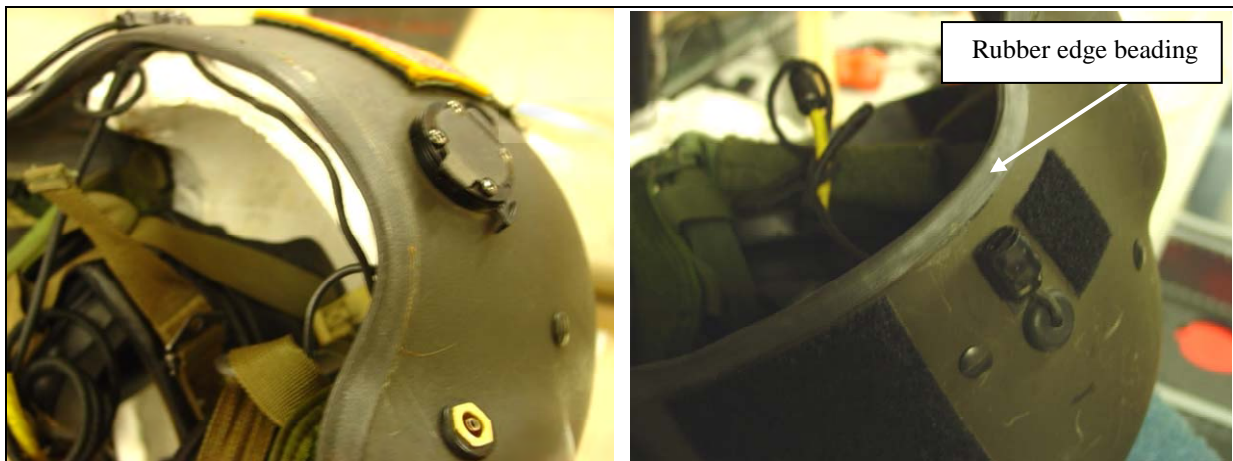
Figure 2. HGU-56/P aviation helmet without beading (left) and with beading (right).

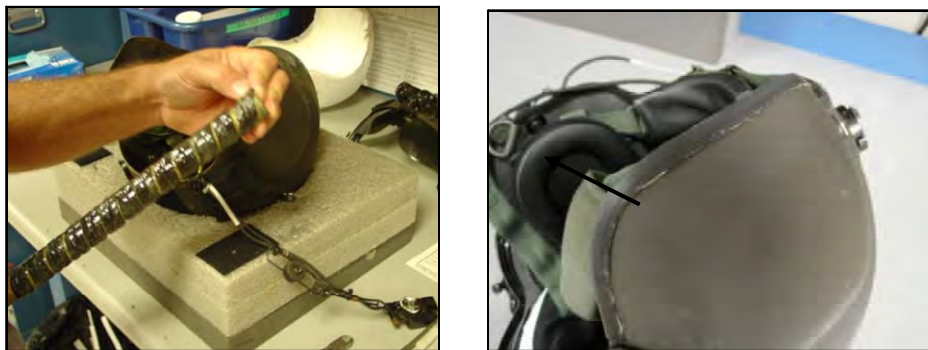
A demonstration/validation plan was written for the replacement of edge beading on aviation helmet model no. HGU/56/P to compare the baseline adhesive 3M-1357 and the HAP-free 3M-847 (appendix A). The helmet repair demonstration/validation was performed on 31 March 2009 at the U.S. Army Aviation Center Logistics Command (ACLC) Repair Shop, Lowe Army Heliport, Fort Rucker, AL. Two aviation helmets were selected for concurrent demonstration/validation. Helmet ID no. G3660 used the baseline adhesive 3M-1357, and helmet ID no. B0985 used the HAP-free adhesive 3M-847. The old adhesive and edge beading (11) were removed from the helmets. The helmet surface was wiped clean, removing any old adhesive. One coat of new adhesive was applied by brush to both the edge beading and the perimeter of the helmet shell. Figure 4 shows a photograph of the new helmet edge beading (11) wrapped around a wooden stick with one coat of freshly applied adhesive. Once aggressively tacky, the adhesive coated edge beading was then unrolled onto the perimeter of the helmet shell.

Figure 4. Adhesive application for aviation helmet.

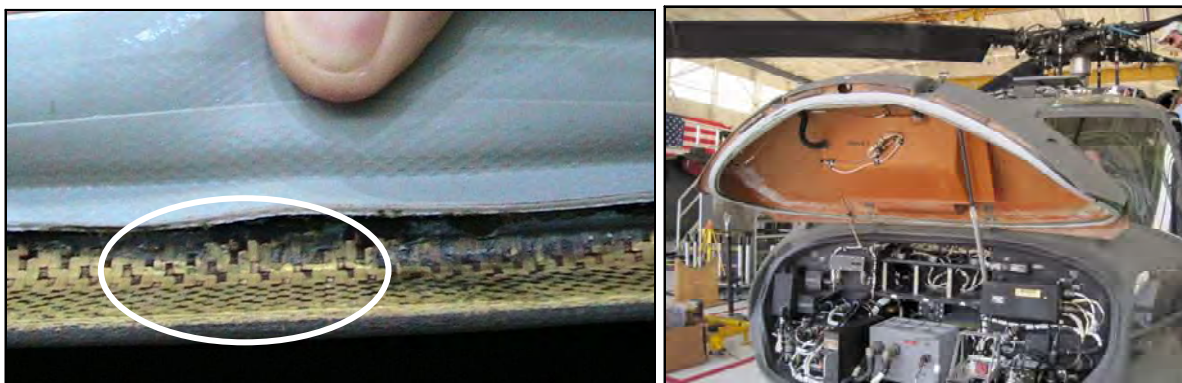
During the field trial, we discovered a number of issues with the demonstration/validation plan. First, the UH-60 helicopter NDS was made of silicone rubber (ZZ-R-765, Class 3B, and Grade 50). Class 3B was tear and flex resistant, and Grade 50 corresponded to the nominal shore-A-durometer hardness value (15). MMM-A-121 specified only three kinds of rubber substrates, consisting of neoprene, SBR, or nitrile (16). Second, the UH-60 helicopter nose door was constructed of a lightweight composite material which was highly porous, whereas MMM-A-121 specified a low-porosity metal substrate such as unpolished steel (figure 8). Furthermore, only a single layer of adhesive was applied per substrate. Higher substrate porosity could negatively affect adhesion performance if the adhesive is not applied sufficiently.

Figure 8. UH-60 composite nose door.

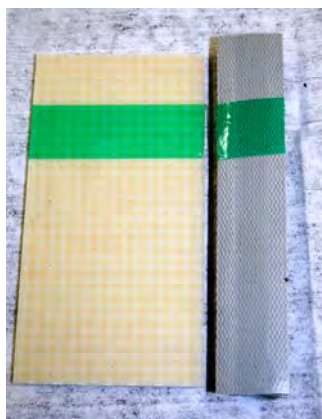
composite panel and a 1- × 6-in strip of UH-60 NDS (ZZ-R-765, Class 3B, and Grade 50). The contact surface of the NDS was hand-sanded with a course abrasive paper to roughen the bonding area and cleaned with acetone (appendix A). The rough side of the composite panel was used for bonding to simulate the rough texture of the interior of the UH-60 nose door. Release tape was placed on both substrates to create a clean edge to start the peel ~2 in from the top of the panel (figure 9). The adhesives included in this test series were 3M-1357, Clifton E-1293, and 3M-847 (table 1). Peel assemblies were prepared both with one coat of adhesive per substrate and with two coats of adhesive per substrate. Peel assemblies with two coats of adhesive per substrate were allowed to dry between coats. Adhesive was applied with a brush to achieve a thin uniform coat. Once the adhesive had dried to a tacky consistency, the two substrates were bonded together. A roller 2 inches in diameter was used to remove any trapped air between the substrates and assist with the bonding process.

Figure 9. Composite panel and UH-60 NDS.

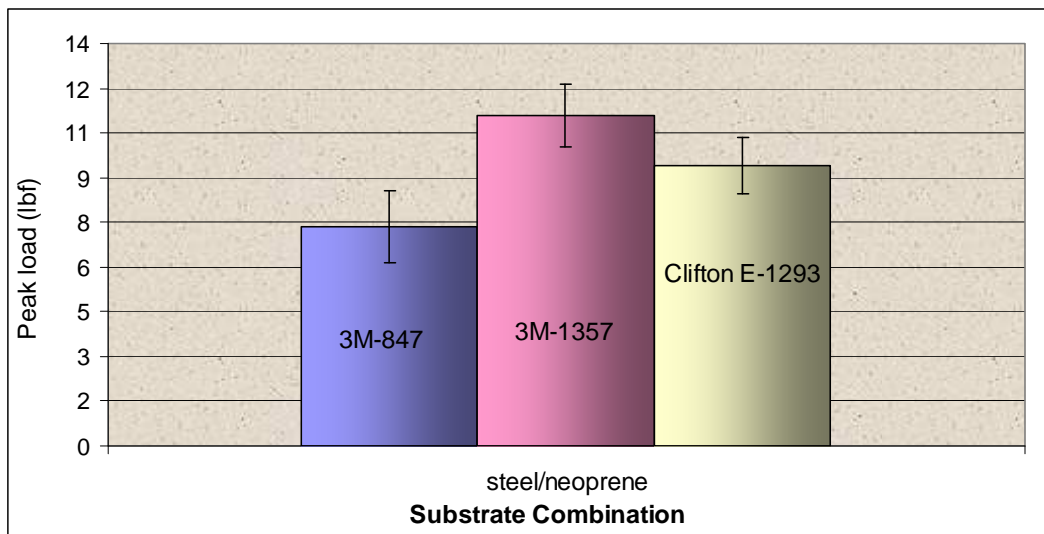
Figure 12 shows the peel strength for both baseline products and the HAP-free alternative applied to the substrate combination of unpolished steel bonded to neoprene rubber. All three adhesives met the minimum MMM-A-121 peel strength requirement of 5 lbf with the steel-to-neoprene substrate combination. The baseline 3M-1357 had the highest peel strength of ~11 lbf, followed by Clifton E-1293, with a peel strength of ~9.5 lbf, and 3M-847 had the lowest peel strength of ~7.5 lbf. Despite the slightly lower peel strength, the results suggested that HAP-free 3M-847 was a suitable alternative for MMM-A-121 if used on the traditional substrate combination of steel and rubber. The data in figure 12 also supports the original test results described in TR-4715 for 3M-1357 and 3M-847 (6).

Figure 12. Steel bonded to neoprene peel results.

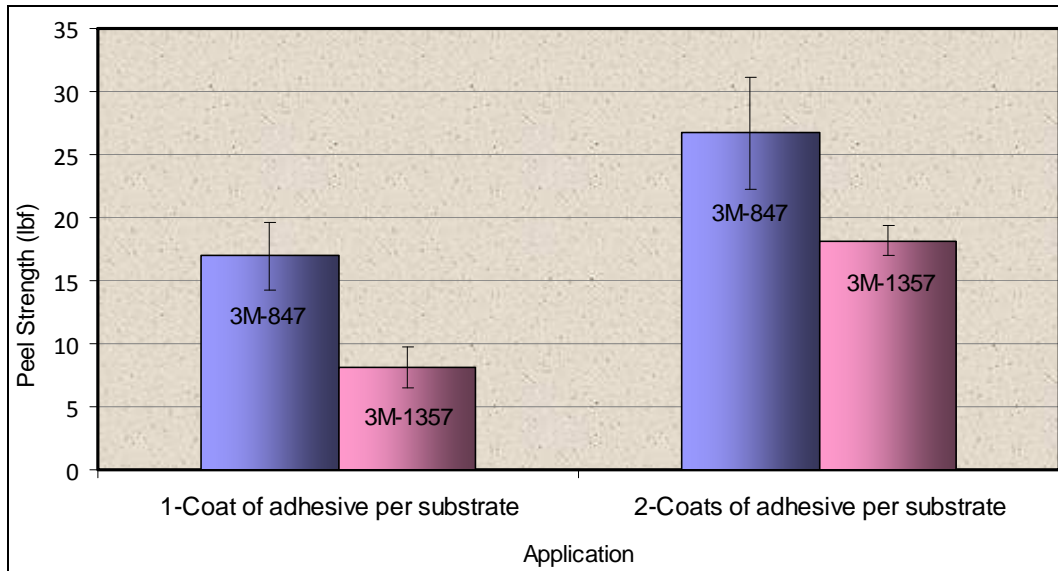
A comparison of one coat of adhesive applied to both substrates (composite/NDS) and two coats of adhesive applied to both substrates is captured in figure 13. 3M-847 had a peel strength of ~17 lbf, with one coat of adhesive per substrate compared to 3M-1357 (baseline), which had a peel strength of ~8 lbf. The peel strength for both products increased considerably with two coats of adhesive per substrate. The peel strength for HAP-free 3M-847 increased to ~27 lbf, and the baseline 3M-1357 increased to ~18 lbf. The 90° peel results for the composite/NDS substrate combination were significantly different than the steel/neoprene combination. The HAP-free 3M-847 performed better than the baseline 3M-1357 on the composite/NDS substrate combination regardless of the number of coats. The lab testing suggested that the porosity of substrate materials, composition of materials, and number of adhesive coats could affect the product's performance. The next step was to conduct another field trial to validate these laboratory findings.

Figure 13. Composite bonded to NDS peel results.

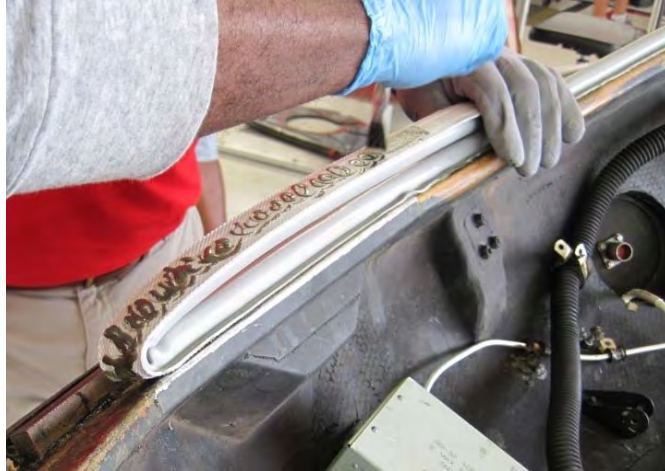
On 29 July 2009, in conjunction with the U.S. Army Research Laboratory (ARL) and AMCOM G-4 team, the ACLC Environmental Group executed the ARL “Demonstration/Validation Plan II For MMM-A-121 Federal Specification Adhesive, Bonding Vulcanized Synthetic Rubber to Steel, HAP Free Replacement” (appendix B) at Lowe Army Heliport (appendix C). The purpose of this demonstration/validation was to determine if the HAP-free rubber and gasket adhesive alternative (3M Scotch-Weld 847) could be substituted for the baseline material (3M Scotch-Weld 1357 and Clifton adhesive E-1293) for MMM-A-121 adhesive on an Army UH-60 Blackhawk helicopter nose door seal, HGU-56/P aviation helmet preventative maintenance/repair, and for general Army use. Simultaneous tests were conducted on a UH-60 helicopter nose door seal and HGU-56/P aviation helmet edge beading. A baseline was used in each test so that the HAP-free alternate (3M-847) could be assessed in real time with the adhesive used currently. The baseline for the UH-60 nose door seal was 3M-1357, and the baseline for the helmet edge beading was Clifton E-1293. Teams were used to apply the baseline and alternative on two UH-60 nose door seals, one for the baseline (tail no. 4633) and one for the alternate (tail no. 4441) (appendix B). Both teams closely followed the demonstration/validation plan (appendix B) that outlined the proper way to apply each adhesive, ensuring that two coats of adhesive per substrate were applied for each product, as the photos in figures 14 and 15 illustrate. This application directive was vital for the success of the field trial. Comments from the alternative adhesive team spoke of the tackiness of the new adhesive and the shorter drying time

Figure 14. Baseline (3M-1357) adhesive application to UH-60 NDS.

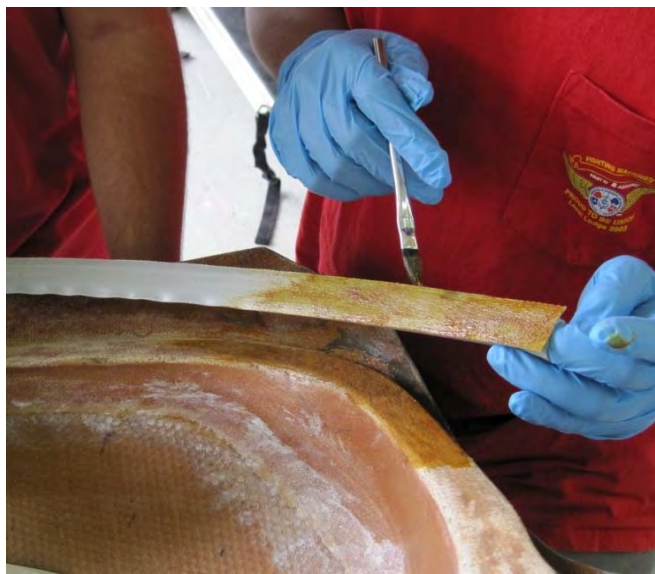
Figure 15. Alternative (3M-847) adhesive application to UH-60 NDS.

both of which contributed to the difficulty in spreading the material evenly. Overall, the team stated the alternative adhesive (3M-847) appeared to perform well but was slightly more difficult to apply than the baseline (3M-1357).

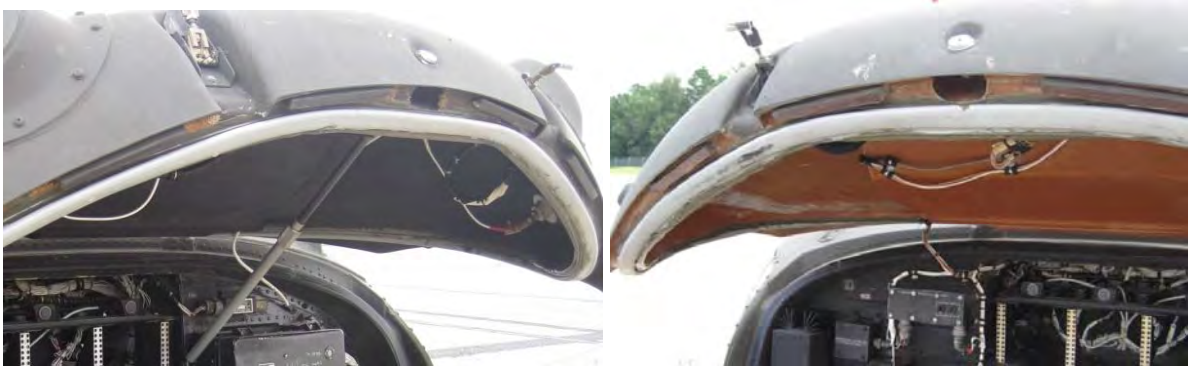
After the adhesive application, the nose doors were reinstalled on the aircraft (figure 16) and released into the field for normal operation. Inspections were conducted at 24 h, 7 days, 30 days, and 90 days after application to determine how the adhesives performed over time (appendix B). In each inspection, the alternative adhesive did not show any signs of slippage, delamination,

blistering, deterioration, or failure compared to the baseline (appendix B). The photos in figure 16 show the two UH-60 helicopters after 90 days in the field. The helicopters were photographed intentionally with the nose door open to view the condition of the NDS. At the end of the 90 day field trial, both NDS's were still properly adhered to the respective UH-60 nose door. Overall, the inspector concluded that the alternative adhesive (3M-847) performed as well as the baseline (3M-1357).

Figure 16. UH-60 NDS after 90 days in the field, baseline (left) and alternate (right).

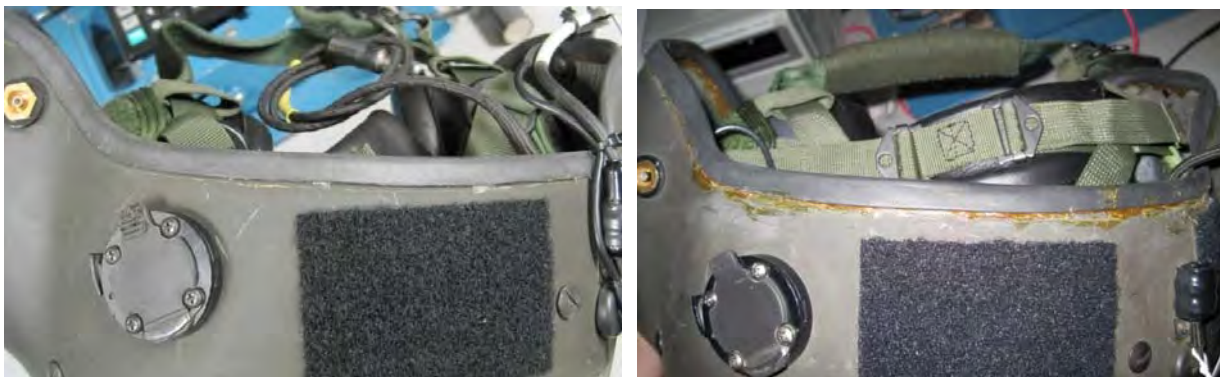
One technician applied the baseline Clifton E-1293 (helmet ID no. R20048) and the alternative 3M-847 (helmet ID no. L284) to two HGU-56/P aviation helmets to secure the edge beading (appendix B). The technician closely followed the demonstration/validation plan that outlined the proper procedure for the application of the adhesives (appendix B). Applying two coats of adhesive per substrate was a key change from the first demonstration/validation (March 2009) and the second demonstration/validation (July 2009). Comments from the technician indicated that the alternative 3M-847 dried faster than the baseline, causing the edge beading to look sloppy and pucker in the curved areas (figure 17). Overall, the technician preferred the baseline adhesive (E-1293) to the alternative (3M-847) because of the ease of application. Once the adhesive application was completed, the helmets were released to the field for normal operation.

Figure 17. Aviation helmet after adhesive application, baseline (left) and alternate (right).

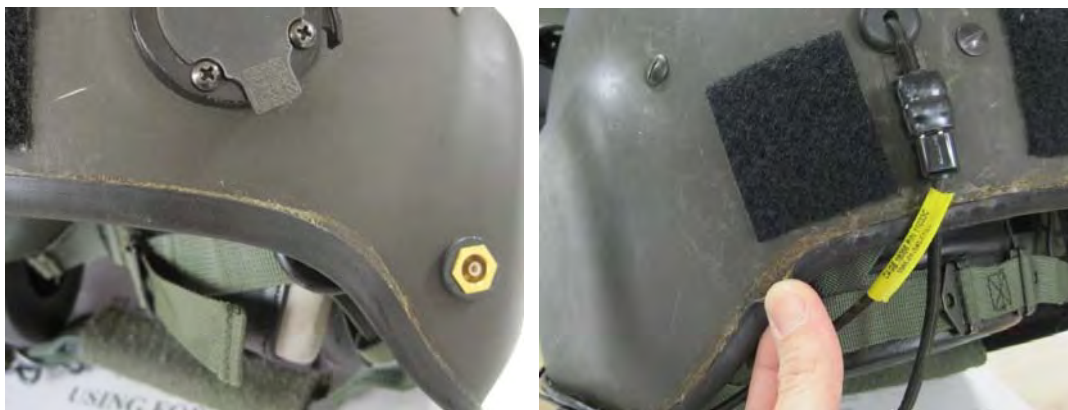
Inspections were conducted at 24 h, 90 days, and 180 days after adhesive application to determine how the products performed over time (appendix B). In each inspection, the alternative adhesive did not show any signs of slippage, delamination, blistering, deterioration, or failure, except for a slight lifting in the curved areas (appendix B). This lifting appeared to be caused by the fast drying time during application rather than failure of the adhesive over time (figure 18). Overall, the inspector concluded that the alternative adhesive (3M-847) worked as well as the baseline (E-1293) if the quick drying time was considered in the application process.

Figure 18. Aviation helmet after 180 days in the field, baseline (left) and alternate (right).
