Report No: CG-D-08-11

Water Transport during Normal Operations of Towboats and Barges in the Illinois River

January 2011

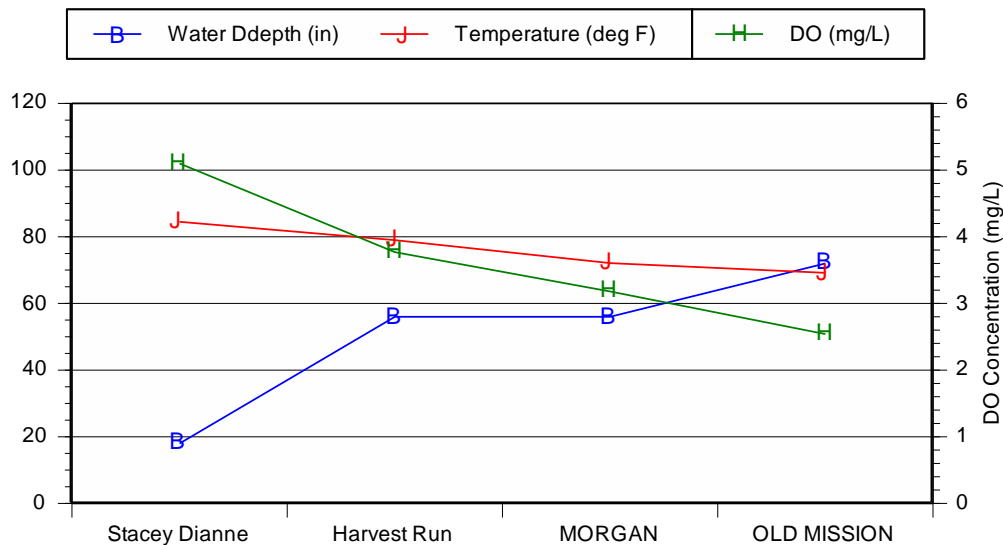
Figure 3. Water depth (inches), water temperature (°F), and DO concentration (mg/L) for towboat ballast tanks sampled in August 2010.

Of the 14 towboats inspected in August 2010, only four had measurable amounts of water in their ballast tanks. Water depths for towboats ranged from a low of 18 inches to a high of 72 inches (Figure 3). Average water depth for towboats was 50.5 inches. No information regarding the ballasting of the towboats was available. Towboat operators indicated that ballasting is not routinely conducted.

Water temperature in towboat ballast tanks ranged between 69.2 - 84.5 °F (Figure 3) with higher temperatures found in those tanks with less water. Similarly, the ballast tank with the most water (72 inches) had the lowest temperature. Average water temperature in towboat ballast tanks was 76.2 °F.

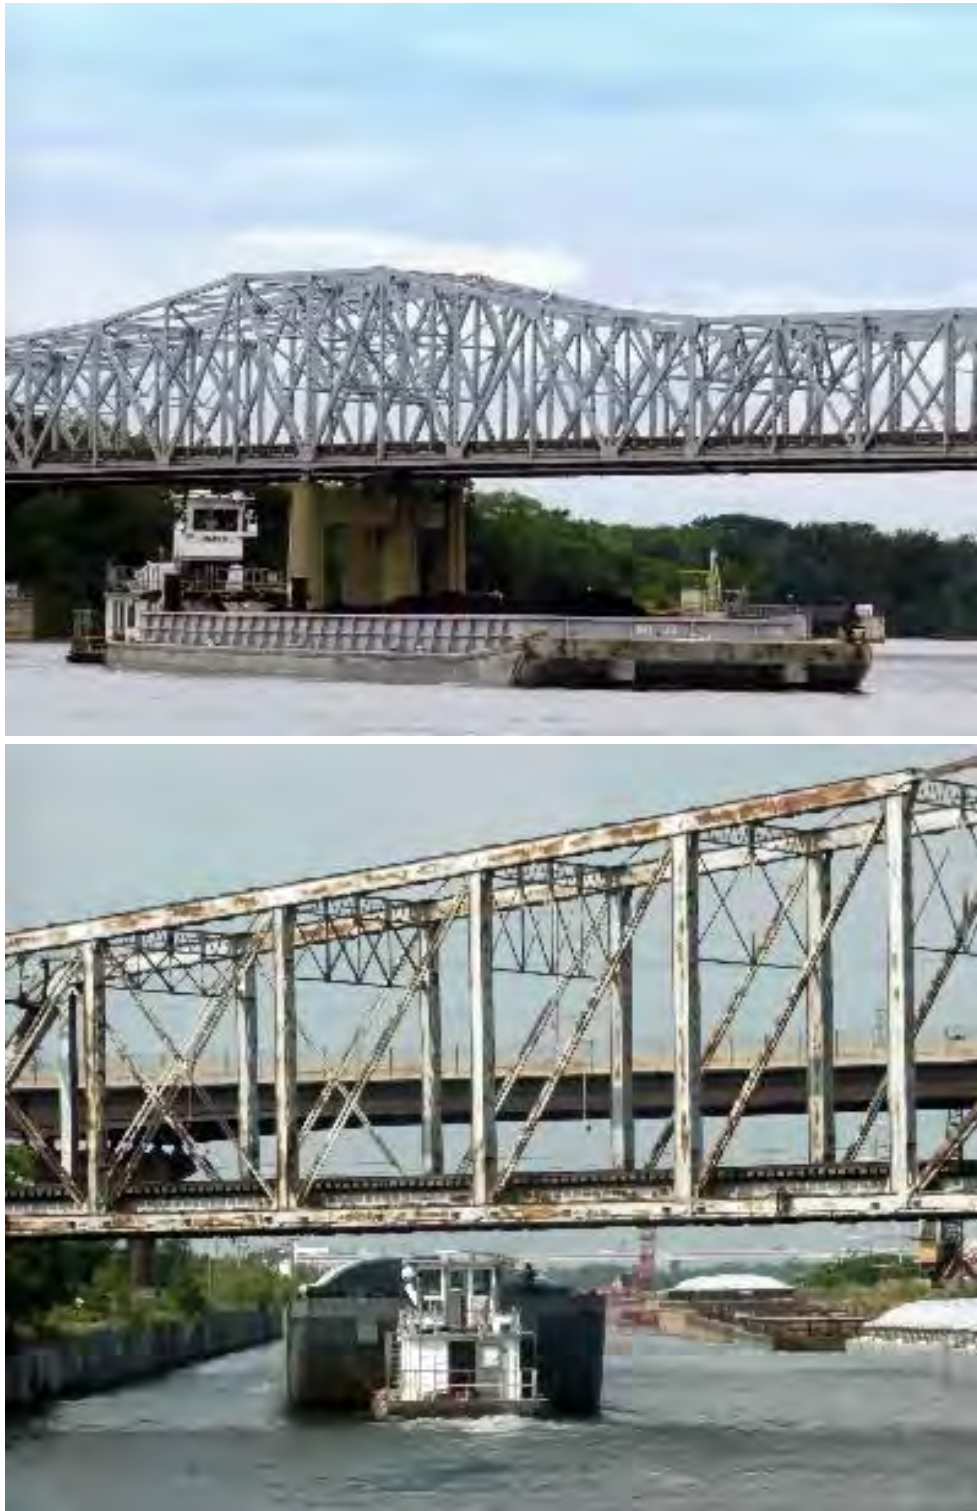
Figure B-1. Loaded (upper) and unloaded (lower) barges. Note minimal clearance under bridge.

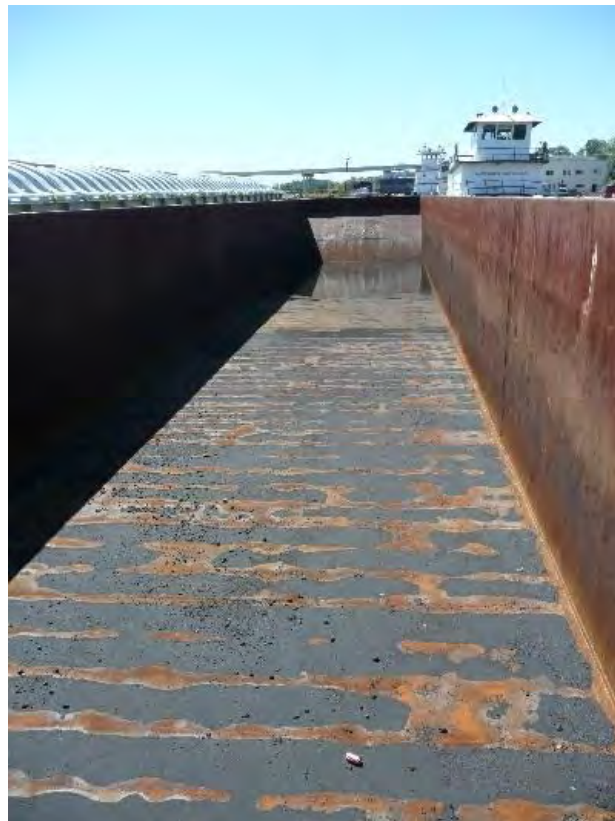
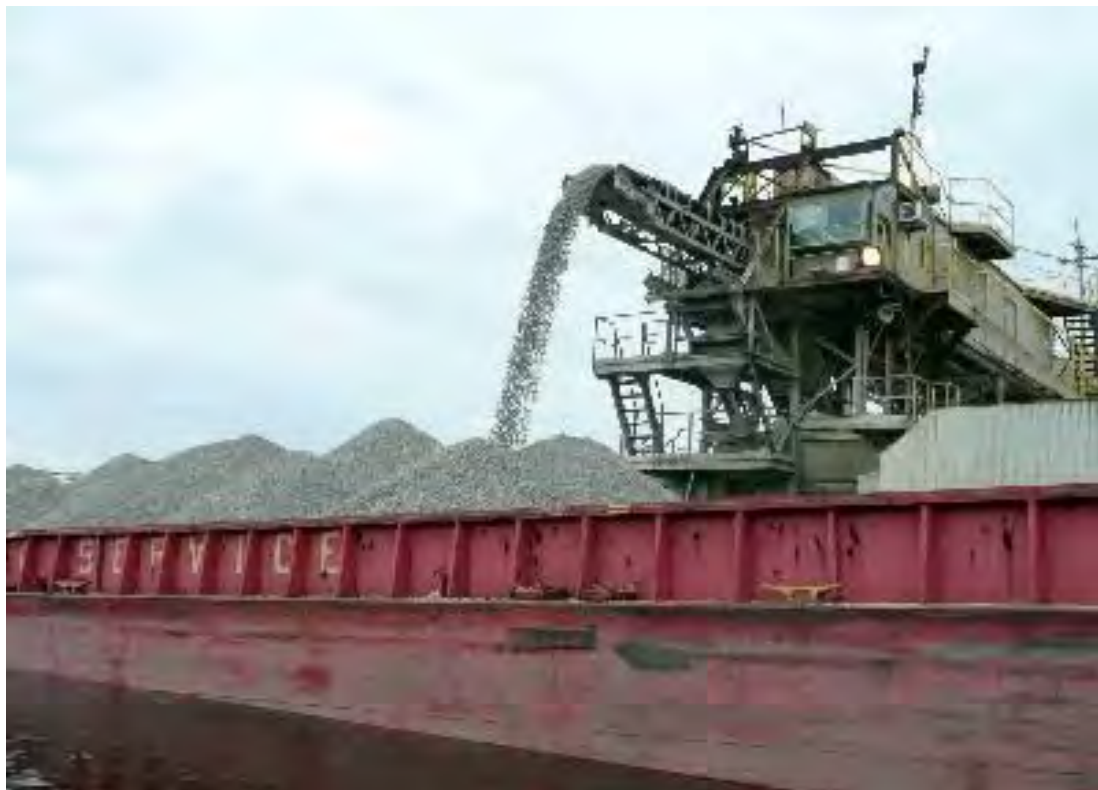
Figure B-2. Interior of empty hopper barge (upper). Loading hopper barge (lower).

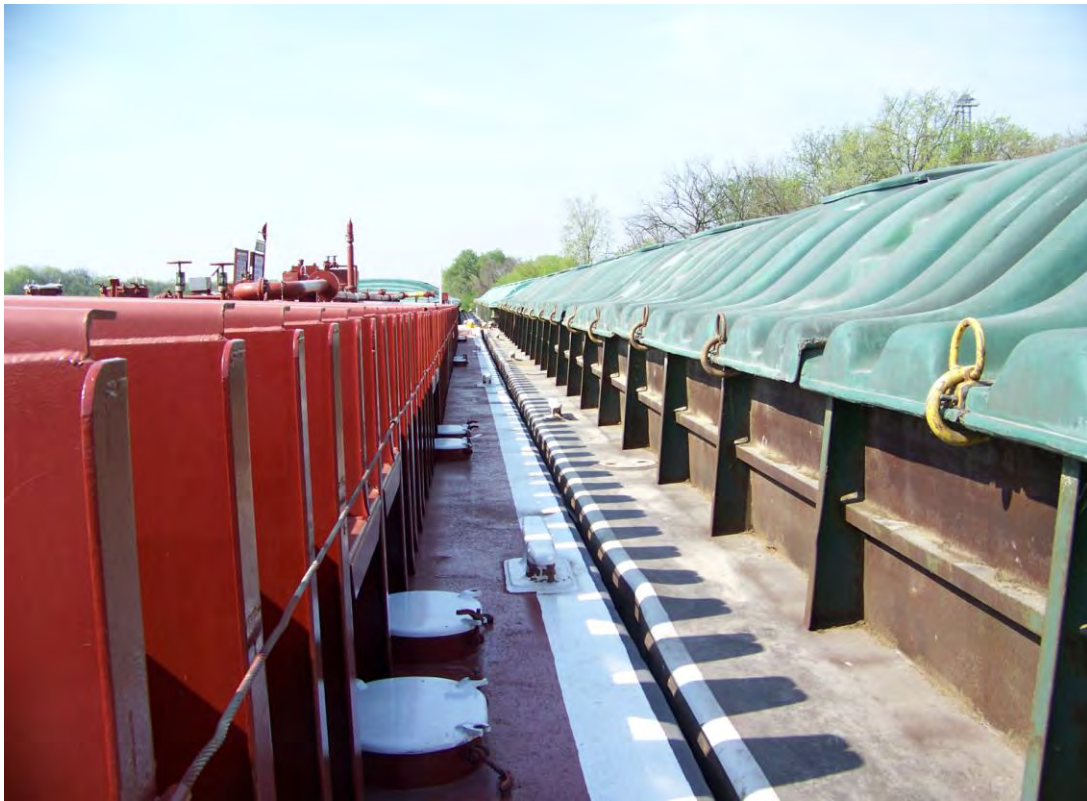
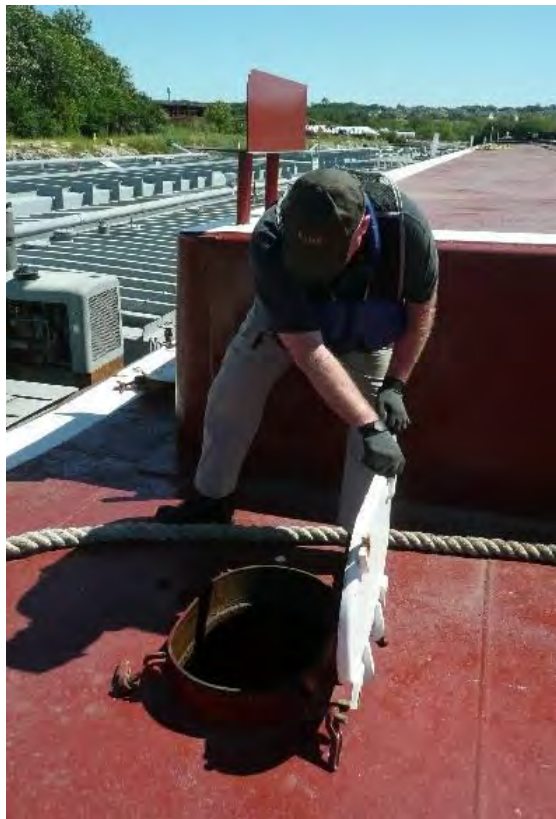
Figure B-3. Raised and flush hatch covers on rafted barges (Upper). Raised access hatch (lower).

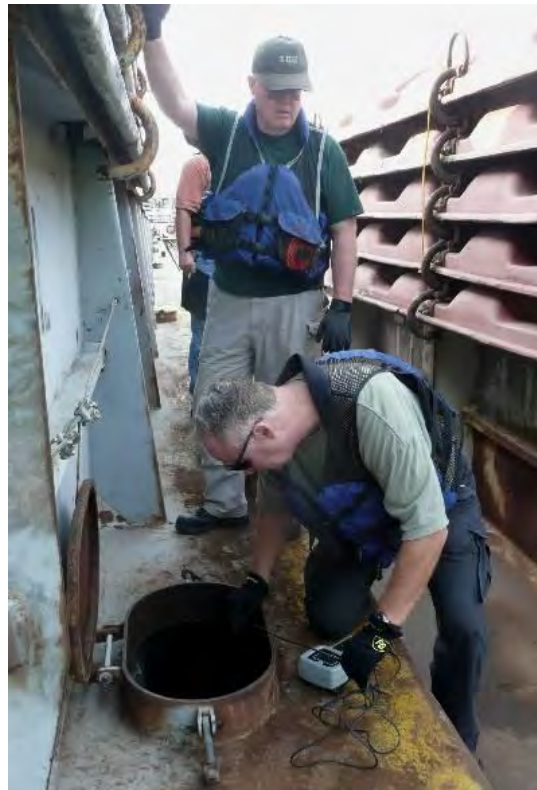
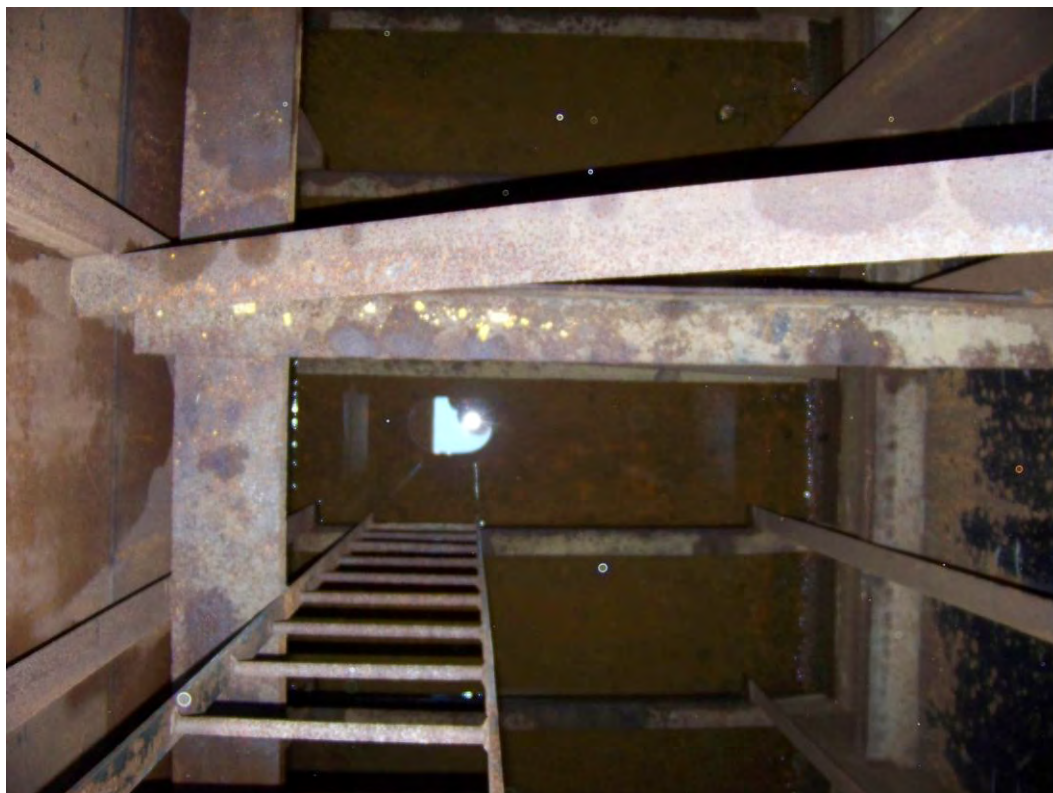
Figure B-4. Measuring temperature and dissolved oxygen on rafted barge (upper). Interior of barge void space (lower). Water depth approximately 3 inches.
