SUPPLEMENTAL REPORT

OPTIMIZED DEPOSITION PARAMETERS & COATING PROPERTIES OF COBALT PHOSPHORUS ALLOY ELECTROPLATING FOR TECHNOLOGY INSERTION RISK REDUCTION

(ESTCP Project WP-0411)

**October 2010
Final Version**

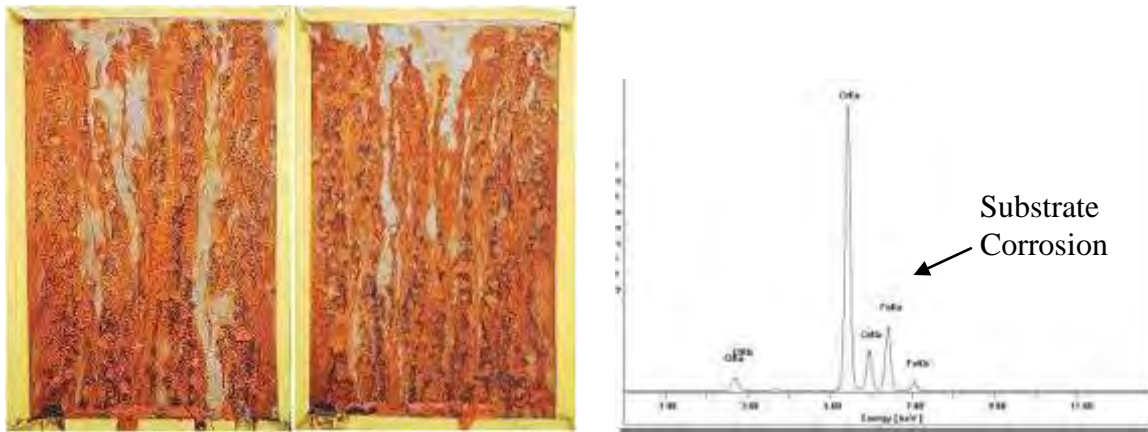
As shown in **Figure 6a**, examination of the EHC-coated panels following 165 h salt fog exposure reveals an orange/brown discoloration across the entire panel. Surface composition analysis reveals the presence of iron and chromium, as shown by the μ -EDXRF spectra in **Figure 6a** indicating that red rust has formed. By contrast, the nCoP-coated panels following salt fog exposure exhibit a golden brown discoloration. Surface composition analysis reveals the presence of cobalt, but with no iron as shown by the μ -EDXRF spectra in **Figure 6b** indicating the absence of red rust but likely a surface oxide. These results indicate that nCo-P exhibits superior corrosion resistance to EHC.

FIGURE 6. IMAGES AND μ -EDXRF SPECTRA FOR THE SURFACES OF (A) EHC-COATED AND (B) NCO-P-COATED MILD STEEL FOLLOWING 165H SALT FOG EXPOSURE.

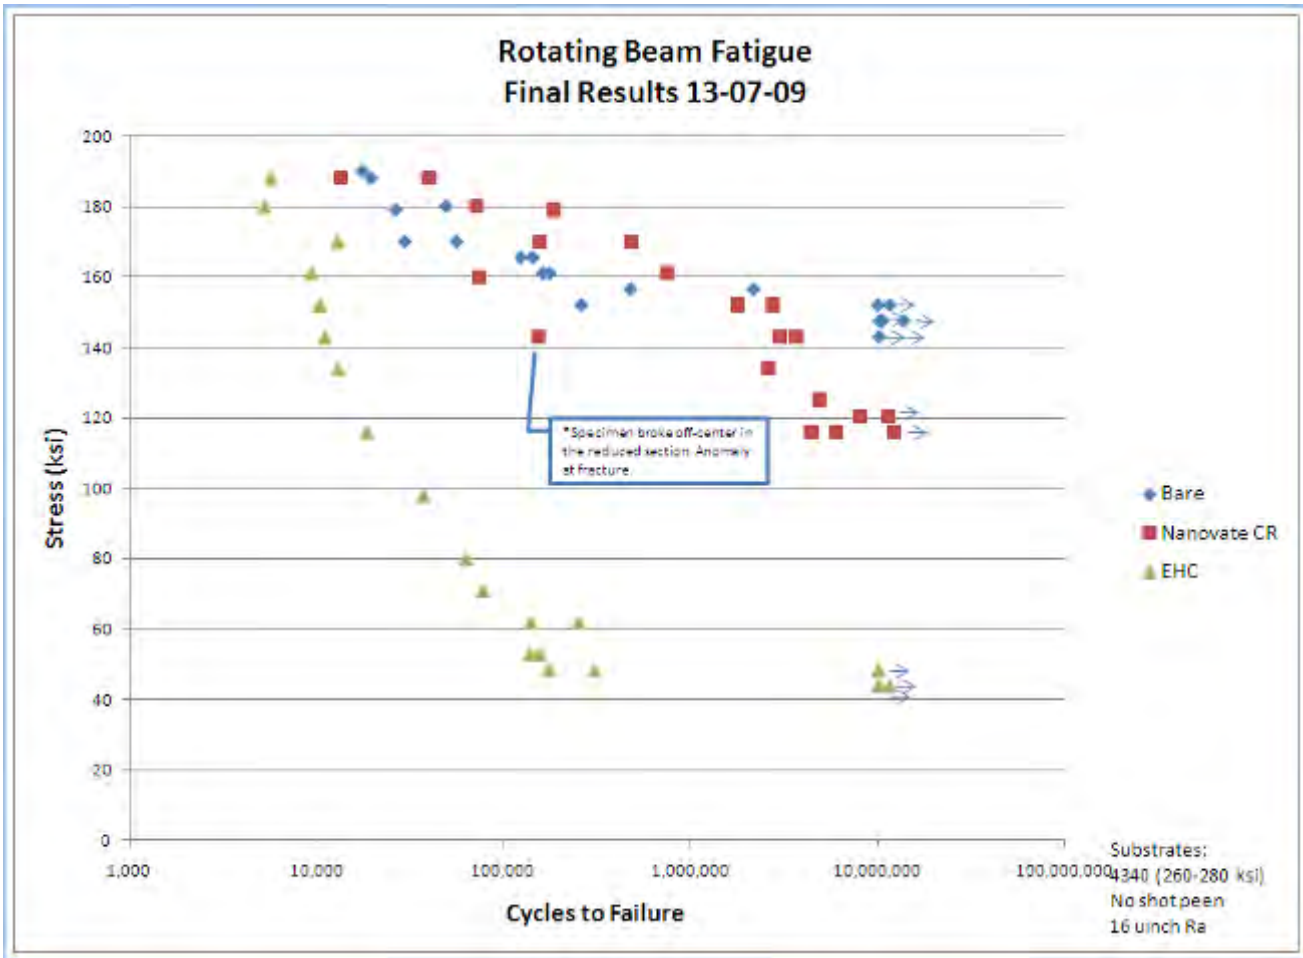
As shown in **Figure 7** below, fatigue data shows a significant fatigue debit for EHC coating compared to bare material. In comparison, the nCo-P coating shows a fatigue life similar to the bare material at lower loads. At lower applied loads there appears to be a debit compared to bare, however, this is not nearly as severe as the debit exhibited by the EHC coated material. Therefore, nCo-P exhibits significantly enhanced fatigue performance compared to EHC.

FIGURE 7. ROTATING BEAM FATIGUE RESULTS SHOWN AS AN S-N CURVE.

Rotating beam fatigue testing was conducted in laboratory air at ambient temperature. Loads were spread between 85% of tensile yield strength (F_{ty}) and the runout load (10^7 cycles), with no more than four points per load. Load and cycles to failure were used to generate S-N curves for bare, nCo-P-coated and EHC-coated specimens.

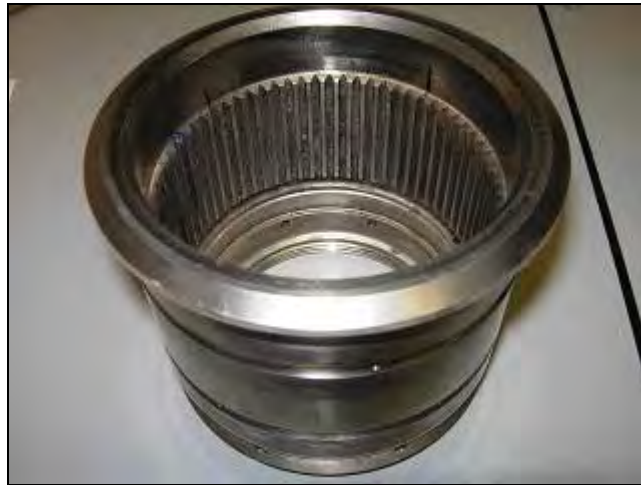
The demonstration piece for internal diameter plating was a J52 coupling, as shown in **Figure 8**. This part was 4340 steel and required plating on a small 1" wide band on the inner diameter of the part.

FIGURE 8. J52 COUPLING USED FOR THE INNER DIAMETER PLATING DEMONSTRATION.

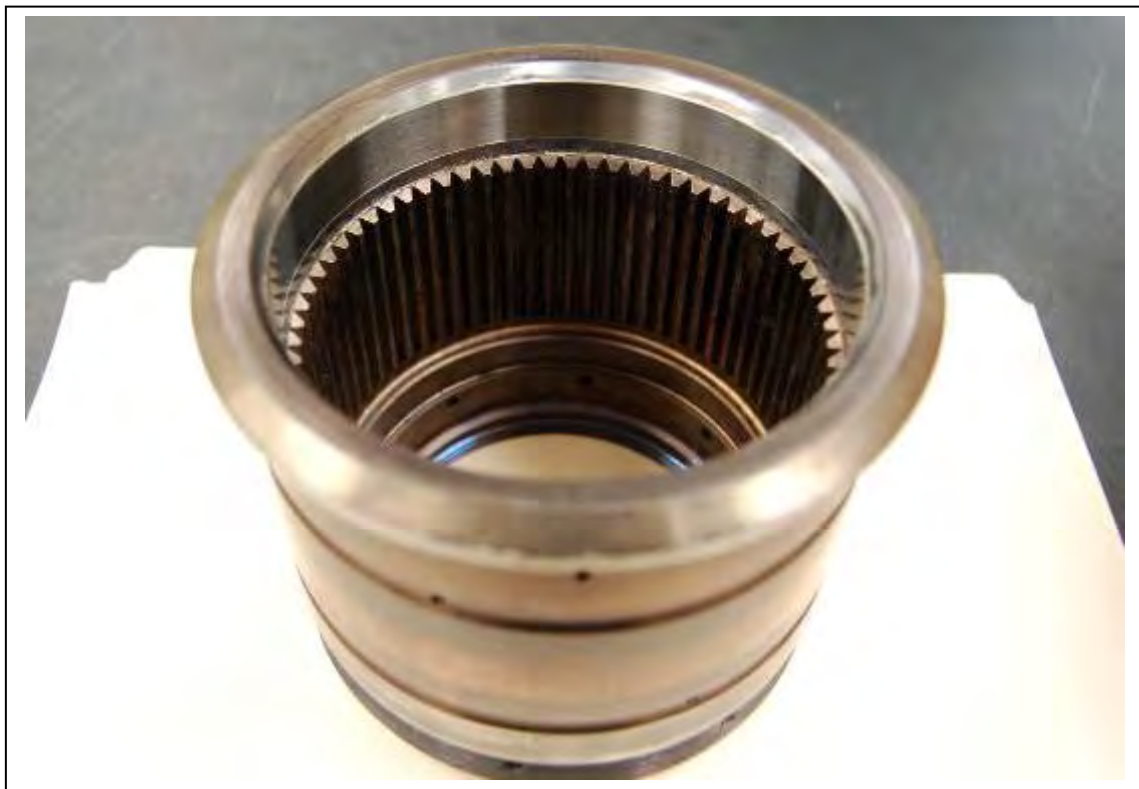
The as-deposited electroplate on the J52 coupling was smooth and shiny. No pits or cracks were observed. A few isolated nodules including some small dendrites were present along the plated edge of the ID which is not uncommon in areas where higher current densities are expected. Some imperfections were noted, consistent with how the part was received. The average as-deposit thickness was $0.011'' \pm 0.00076''$. Following plating, the part was machine ground to a surface finish of 16 microinches Ra or better. The aim of grinding the plated part was to evaluate machinability characteristics. A runout of the edges was not performed as this was not required for the evaluation.

J52 COUPLING FOLLOWING FRC-SE MACHINING OF ID PLATED AREA

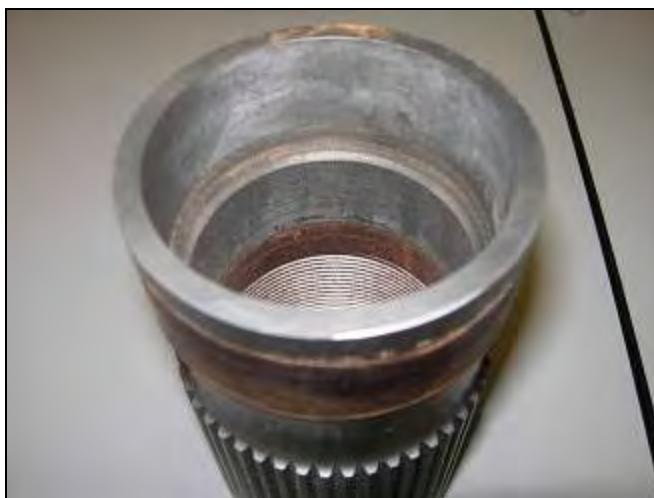
The demonstration piece for outer diameter plating was a J52 shaft (section), as shown in **Figure 10**. This part was 4340 steel and required plating on a small 2" wide band on the outer diameter of the part.

FIGURE 10. J52 SHAFT (SECTION) USED FOR THE OUTER DIAMETER PLATING DEMONSTRATION.

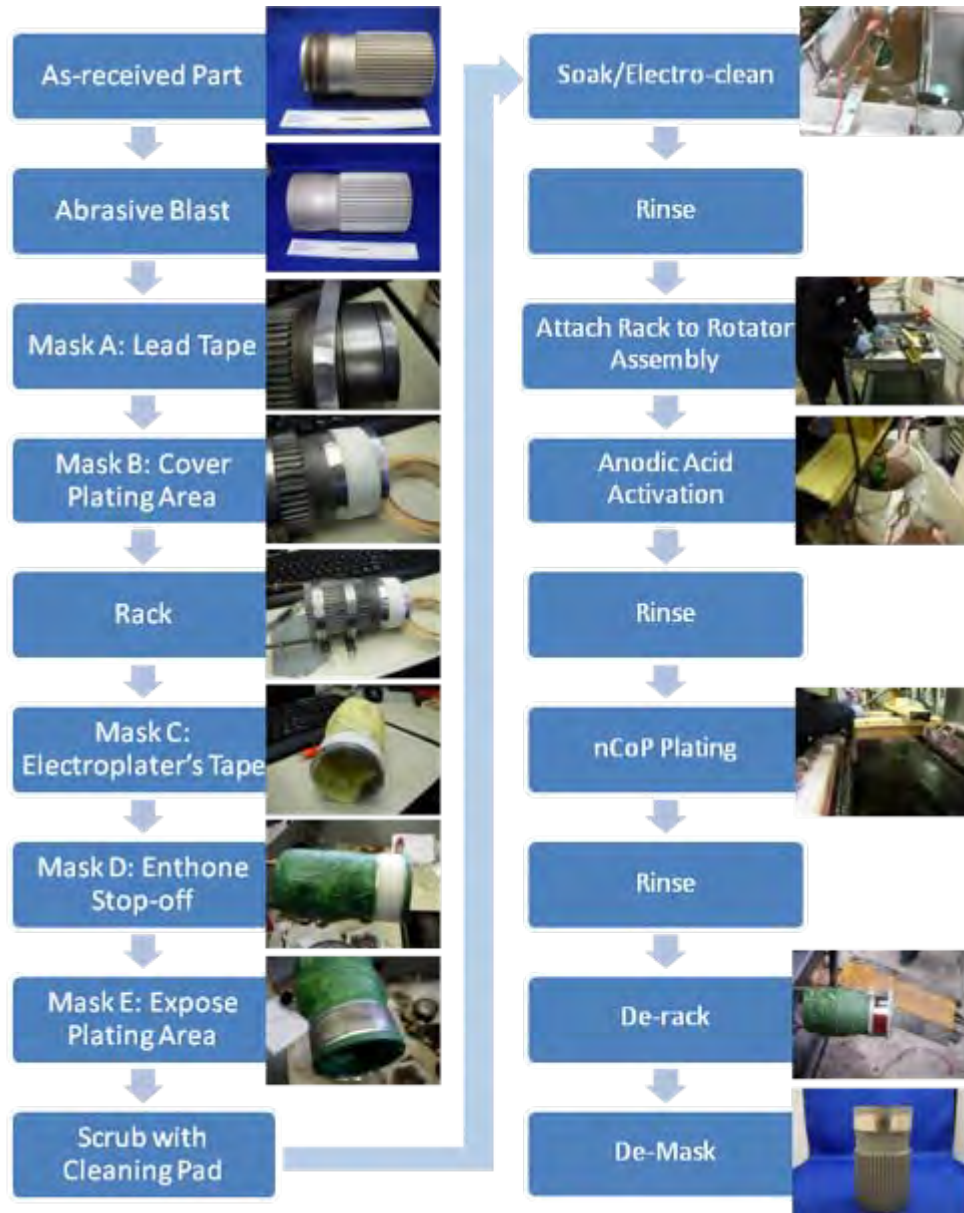
FIGURE 11. PROCESS FLOW CHART FOR J52 SHAFT OD PLATING.

The area to be plated was scrubbed with a cleaning pad. Use of higher mesh pads is recommended in order to reduce appearance of scratches in the final deposit. Next the

part was immersed in the alkaline cleaning solution. It was electrocleaned for 3 minutes at a current density of 50 mA/cm². The part was rinsed and then attached to a rotator assembly. The part was activated using a mineral acid (5% HF/30% Sulfuric Acid) for 1 minute at an anodic current density of 300 mA/cm² (live entry). The part was rinsed and then plated with nCo-P with the optimized pulse condition Section 2.0. A flow eductor is attached in order to facilitate flow at the plating area. Once plating was complete, the rotation was stopped, the part was removed and was rinsed. Finally, the part was de-racked and manually de-masked.

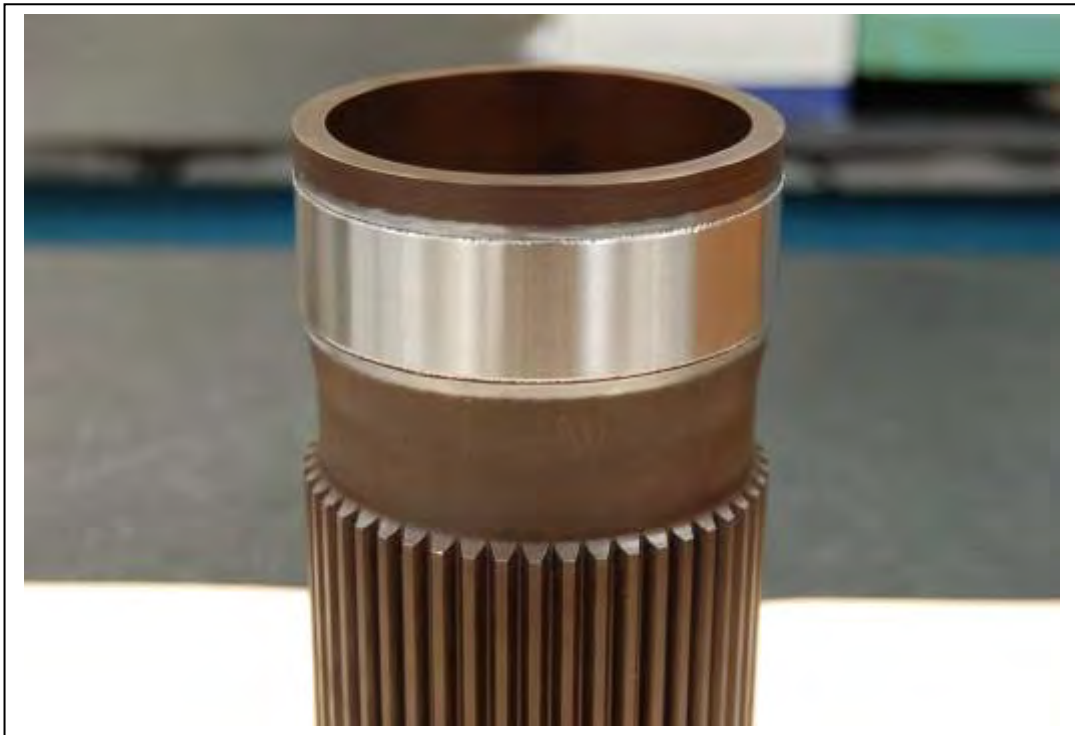
Many small nodules were scattered along the surface of the plated J52 Shaft. This is consistent with electroplating of thick coatings. Some small dendrites were seen along the plated edges which is typical in high current density areas. Some imperfections were noted, consistent with how the part was received. The average deposit thickness prior to machining was $0.014'' \pm 0.0001''$. Following plating, the part was machine ground to a surface finish of 16 microinches Ra or better. The aim of grinding the plated part was to evaluate machinability characteristics. A runout of the edges was not performed as this was not required for the evaluation.

J52 SHAFT SECTION FOLLOWING FRC-SE MACHINING OF OD PLATED AREA

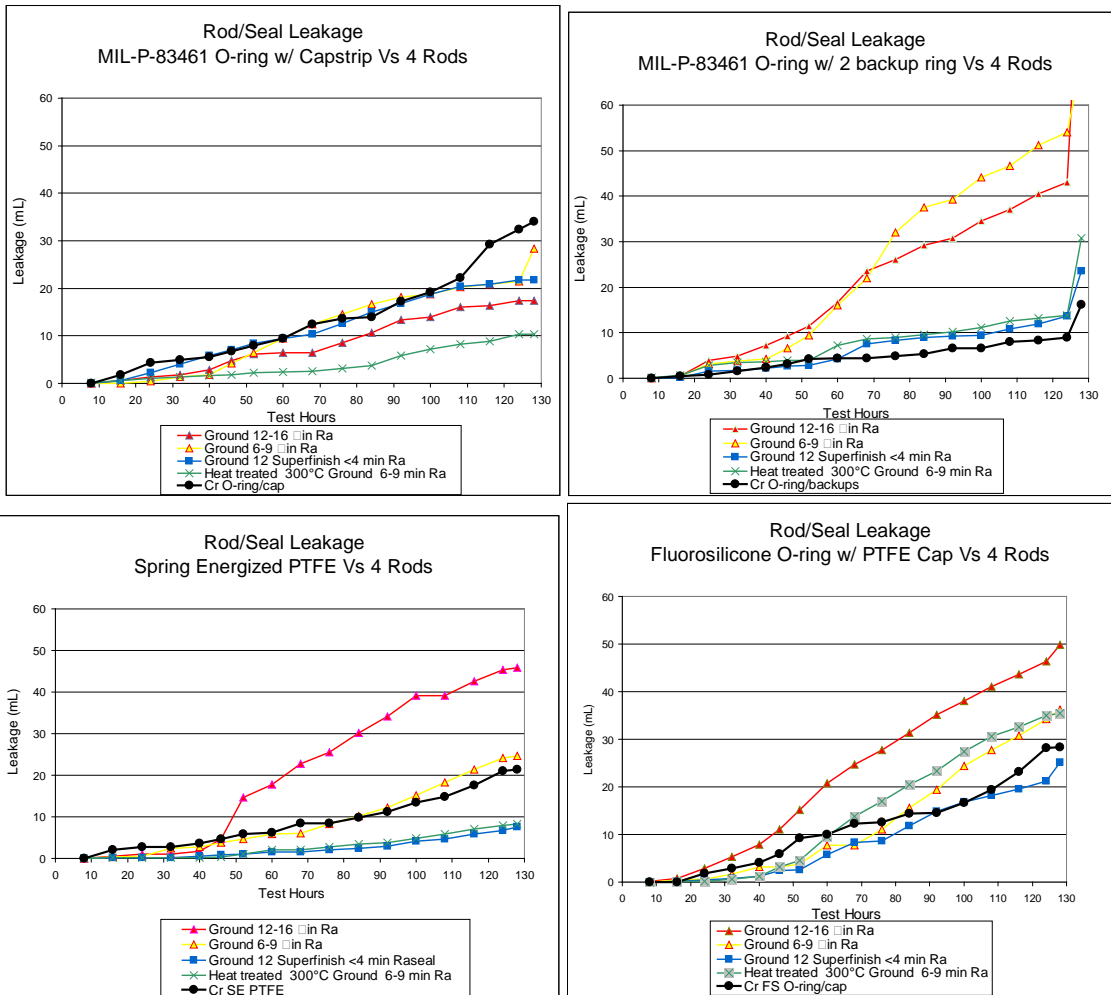
Leakage rates for all coating finishes are shown in **Figure 17**. For comparison, EHC data from prior testing (not done in the same test as nCo-P) are also included. Leakage rates for all nCo-P coating finishes were acceptable for the duration of the test. Failure criterion is a leakage rate exceeding 1 drop for 25 full strokes, although this is different than the combination with the dither strokes. The superfinished nCo-P rod resulted in the least accumulated leakage over the test duration, followed by the heat treated rod, while the rougher ground finishes resulted in the highest leakage (6-9 and 12-16 min Ra finishes). For one seal configuration during 1 hour near the end of the test very slightly exceeded this rate (24.4 cycles per drop), however, this configuration leaks by design at cold temperatures so it wasn't considered significant.

FIGURE 17. LEAKAGE RATES FOR NCO-P COATINGS WITH VARIOUS SURFACE FINISHES AND DIFFERENT SEAL CONFIGURATIONS. FOR REFERENCE, EHC DATA FROM PRIOR TESTS ARE INCLUDED.
