TECHNICAL REPORT
TR-2361-ENV Revision 1

ESTCP COST AND PERFORMANCE REPORT: RC-200610
Application of a Bimetallic Treatment System
(BTS) for PCB Removal from Older
Structures on DoD Facilities

**Naval Facilities Engineering Command
Engineering Service Center (NAFAC ESC)
RC-200610**

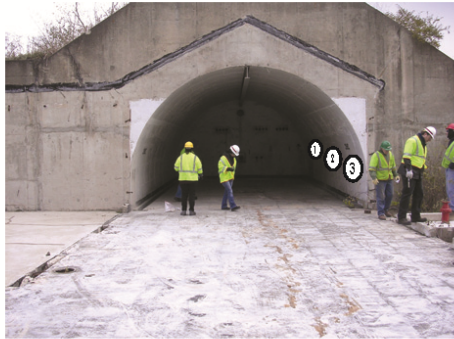
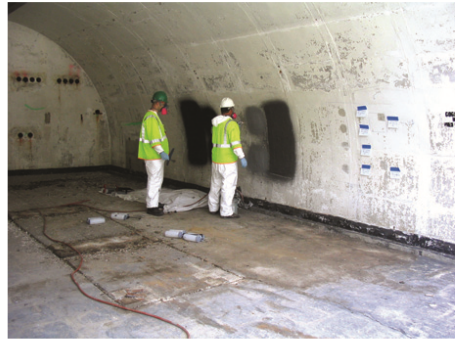
Figure 5.2

Bunker/Press House 6810-11 BTS Paste Application	
Guelph	February 2010

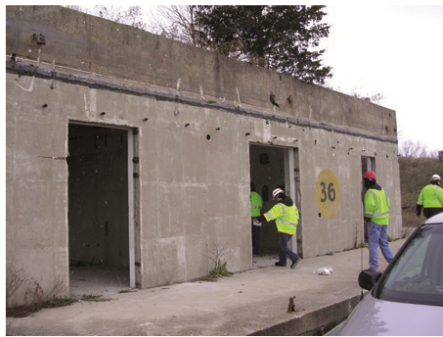
Press Building 6810-36 BTS Paste Application		Figure 5.3
Guelph	February 2010

① 68 10-36
NM
VP

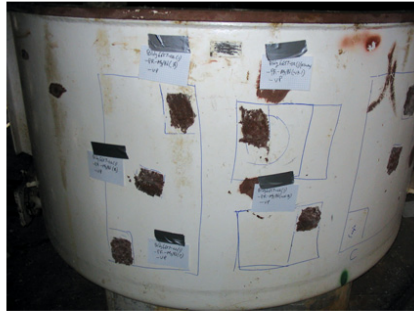
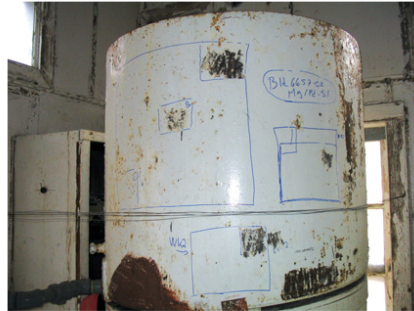
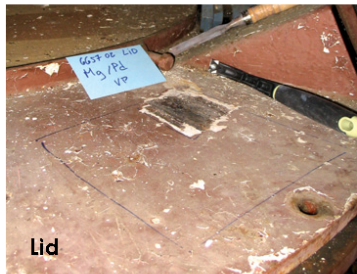
Figure 5.4

Large Tank
Mg/Pd and NM-VP

Small Tank
Mg/Pd Sil

Nitrating House 6657-02 BTS Paste Application	
Guelph	February 2010

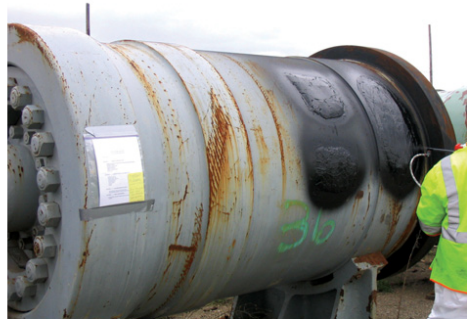
BTS Paste applied to various spots on press #4, 12, 14, 15, 36

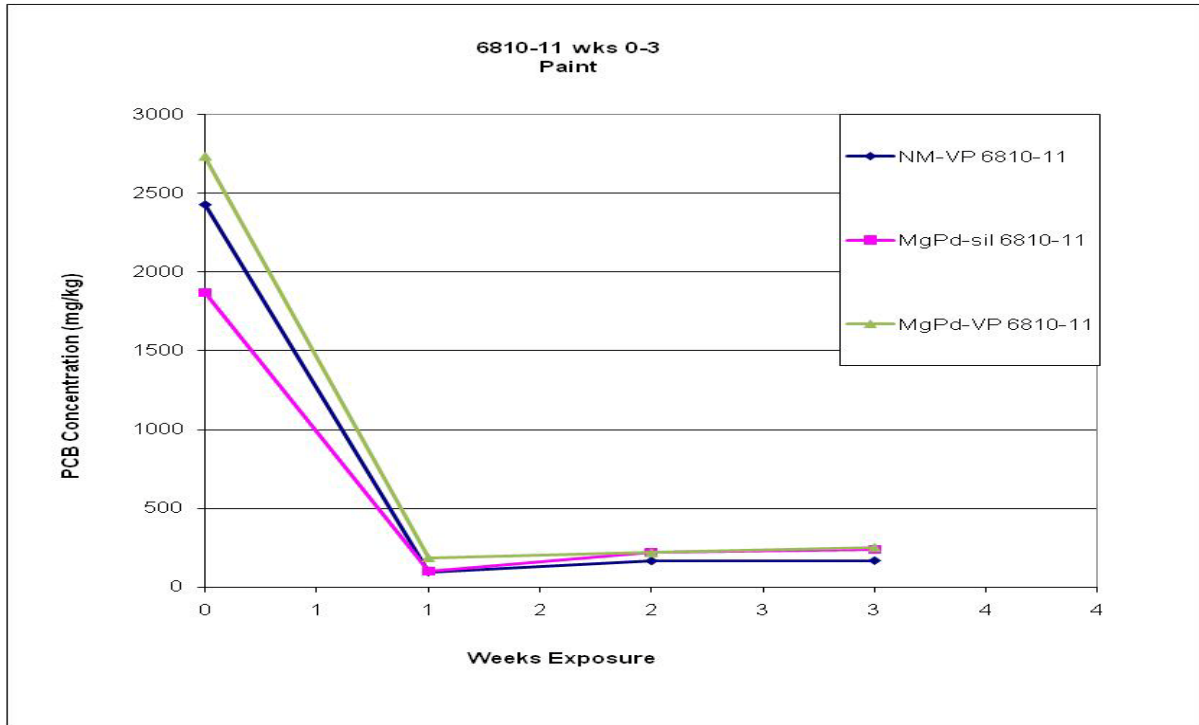
Figure 5-8. Average Concentrations of PCBs in paint during treatment times of 0-3 weeks.

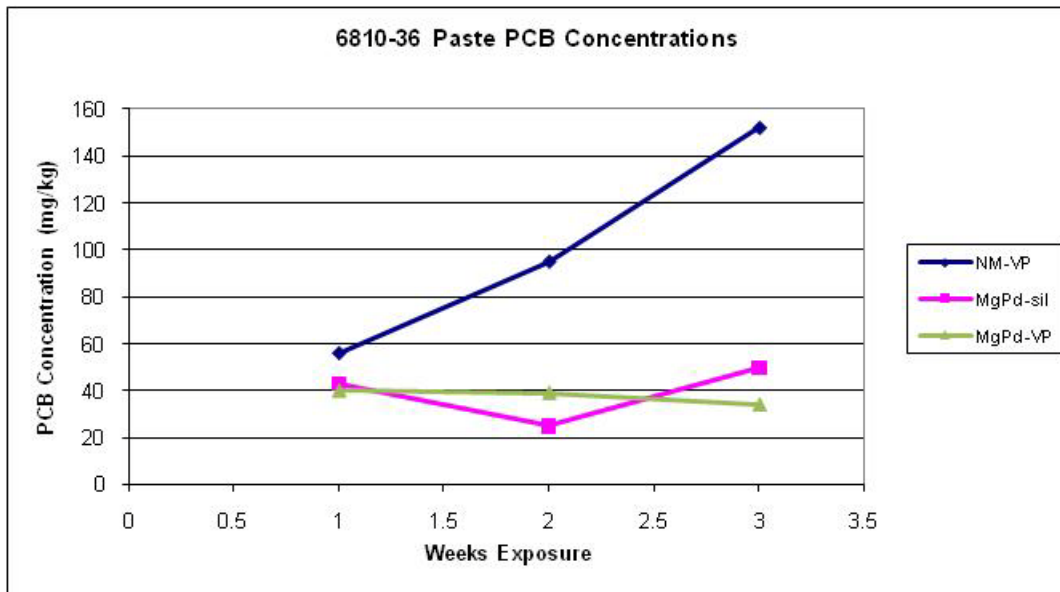
Figure 5-13. Average PCB concentrations in paste sampled at 1-3 weeks after BTS application,

paint samples were collected. The data from these analyses is plotted in Figures 5-12, 5-13, 5-14, and 5-15.
