COMPOSITE CERAMIC ARMOR DEFECT DETECTION ANALYSIS USING PHASED ARRAY ULTRASOUND

J. S. Steckenrider
Illinois College
Jacksonville, IL

T.J. Meitzler and Lisa Prokurat Franks
US Army, TARDEC
Warren, MI

W. A. Ellingson
Argonne National Laboratory
Argonne, Illinois USA

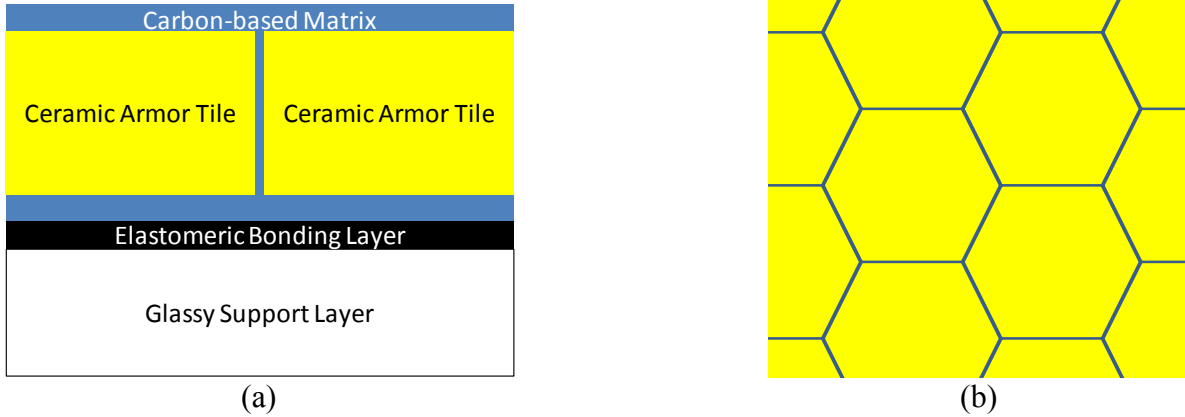
Figure 1. Schematic diagram of composite layered armor panel: a) cross-section and b) top view.

PA-UT has also demonstrated its performance with regard to the actual implementation of ceramic armor that incorporates these monolithic tiles into a thick, multi-layered ceramic composite structure⁸. In the current and previous work, a layered structure is used in the assembly of composite armor panels. The panels were made up of tessellated hexagonal high-toughness monolithic ceramic tiles, a carbon-based matrix to encase these tiles, an elastomeric layer to distribute and attenuate mechanical stresses transmitted by the ballistic impact, and a glassy layer which provides a monolithic substrate to support the composite armor. These were arranged as shown in the cross-section and topography of Figure 1. To evaluate defect detectability, planar inclusions of a range of sizes (0.5”, 1.5” and 2.5” diameters) were intentionally inserted at the two most critical boundaries (i.e., on either side of the elastomeric bonding layer) to simulate a “disbond” at the locations where it would have the

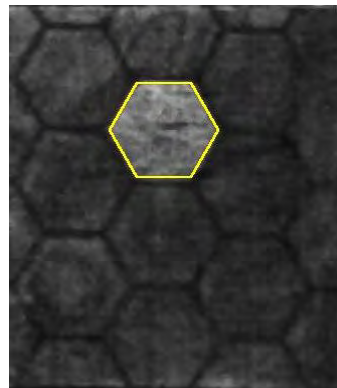
Figure 4. Selection of Region-of-interest (ROI) definition: a) support-side inspection, b) ceramic-side inspection with a single high-performance tile and c) ceramic-side inspection with three such tiles.

The second accommodation that must be made for these test panels derives from the fact that only a central portion of the panel, where ballistic impact would ultimately be applied, was constructed according to the actual in-service armor design. The remainder of the panel was built with “filler” material of a lesser quality and cost. Thus, for the feasibility study, a smaller region-of-interest (ROI) in the center of each panel where the ultimate armor materials were used was examined. Because the location of this region varied from panel to panel, the ROI had to be manually selected for each panel. However, the shape of the ROI was known, so only three different selections were used, and these are shown in Figure 4 for inspections from a) the support side (where the 190 mm x 220 mm ROI was limited by the overlapping encapsulating overwrap around the edges), b) the ceramic side (in the cases where a single high-value 102 mm height hexagonal tile was used, for a 7613 mm² ROI) and c) the ceramic side (in the cases where three high-value hexagonal tiles were used, for a 25,308 mm² ROI).

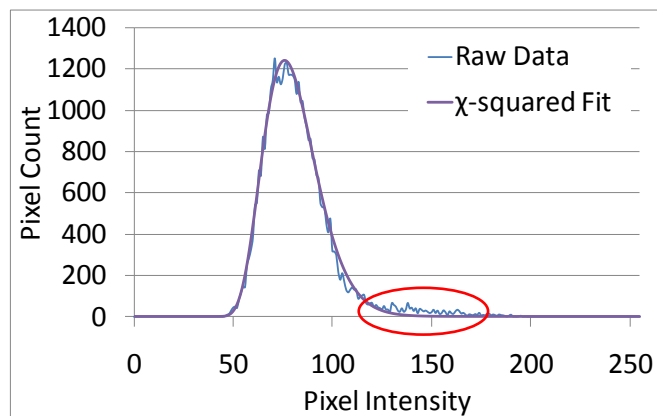
Figure 9. Histogram plot for panel N1, showing both the raw histogram and the χ^2 fit.

Figure 8 shows the log probability maps for the N-series of panels. In this series, a 38mm (1.5”) -diameter inclusion was located between the support and elastomer layers during manufacturing. This inclusion is located directly beneath the intersection of three hexagonal ceramic tiles (again on the opposite side of the panel), and is located on the left of the ROI for panels N1 and N2, and on the right of the ROI for panels N3 – N6. Note that the outline of the hexagonal tiles in N4 – N6 was the result of surface contamination, which altered the ultrasonic coupling efficiency (i.e., an ink outline of the underlying tiles applied by one of the other inspection facilities) and is not the result of acoustic interaction with these tiles. Again, the SNR for each tile was greater than 1:1, as shown in Table 3. However, in this case, because the area of the defect was larger than in the J-series panels, the defects in all six panels differ from the background by a statistically significant amount. In other words, the maximum area meeting or exceeding the average defect intensity, as predicted from the random variation of the background, is smaller than the actual defect size in all panels. This is also demonstrated in the histogram analysis of Figure 9, where the background variation is well aligned with the χ^2 fit, but the defect manifests a significant deviation from that fit at pixel values centered around 152 (the defect’s mean intensity) as encircled by the ellipse in the figure.
