U.S. Army Engineer Research and Development Center: Rapid Repair of Levee Breaches

**U.S. ARMY ENGINEER RESEARCH AND DEVELOPMENT CENTER:
RAPID REPAIR OF LEVEE BREACHES**

Donald Resio, Stanley Boc, Donald Ward, Andrew Kleinman, and Jimmy Fowler
U.S. Army Engineer Research and Development Center

June 2011

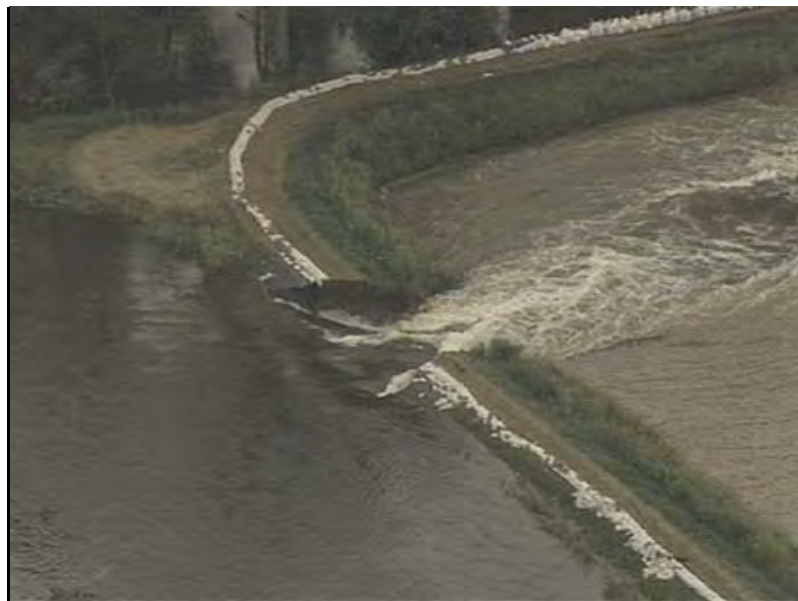
Figure 2.3. Failure of the Pin Oak levee in the Midwest. Note sand bags atop levee used to fight rising water levels.

Both natural and man-made levees have a long history of breaching in nature. Natural levees, built from sediment deposition when rivers overflow their banks, occasionally breach in what is termed a crevasse. Throughout the United States, failures of natural and man-made levees have resulted in lives lost, destroyed infrastructure, and huge economic losses. One example is the part of the Midwest containing the upper Mississippi River, Missouri River, and their tributaries. This area frequently experiences flood events that result in levee failures. Figure 2.3 shows a levee failure on the Pin Oak levee in the Midwest. Figure 2.4 shows the Elm Point levee break, also in the Midwest.

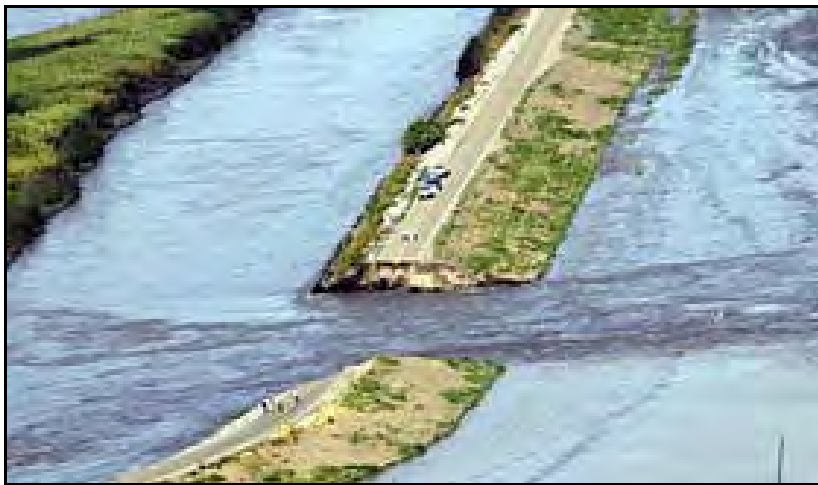
Figure 2.5. Upper Jones Tract levee breach in the Sacramento-San Joaquin River Delta.

Another area where levee failures are of great concern is the Sacramento-San Joaquin River Delta area. Major flood events occurred there in 1950, 1955, 1964, 1986, and 1997. Mount and Twiss (2004) report that the projected subsidence of the delta indicates that it will “become increasingly difficult and expensive to maintain the delta levee system.” Some areas of the delta are more than 8 m below sea level. This large amount of subsidence greatly increases the chance of piping-related levee failures, which will be discussed subsequently. Piping-related failures are the major concern in these levees. Figure 2.5 shows the 2004 breach in the levee at the Upper Jones tract in the Sacramento-San Joaquin River Delta.

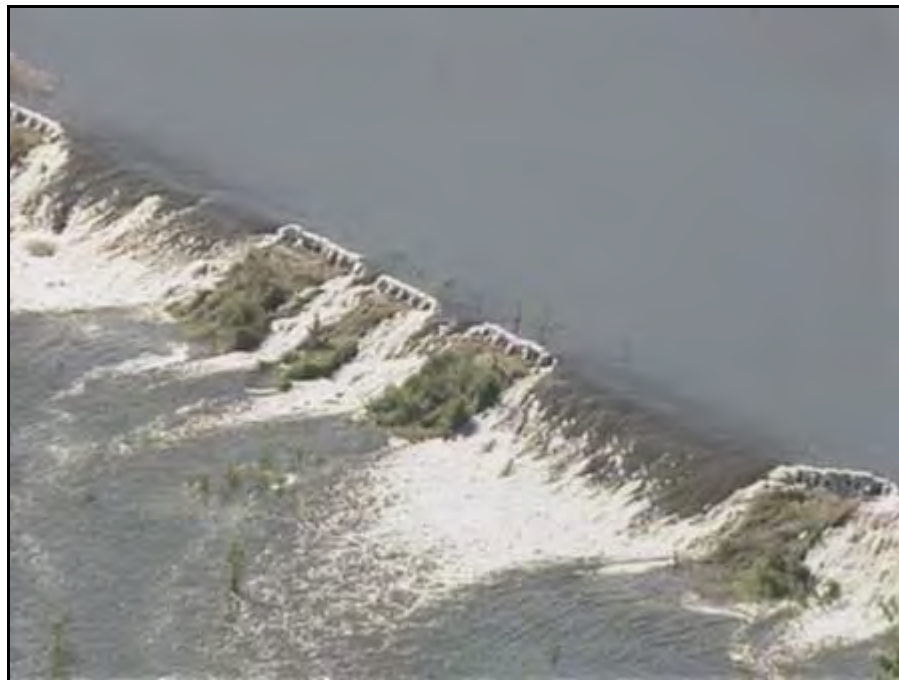
Figure 2.12. Overtopping of the Foley levee in the Midwest.

Overtopping- Overtopping occurs when the water level in the river exceeds the crest of the levee or waves spill over the levee. Because of the relatively steep landside slopes of many levees, such as those shown in the previous levee cross sections, once they are overtopped, the water moves rapidly down the land side of the levee. If the height and duration of overtopping is small and the slope is covered by a good layer of grass or other protective material, the levee can survive overtopping. For large heights and durations of overtopping and no landside slope protection, a breach is likely to occur. The overtopping flow will find a locally low or locally weak spot at which erosion is initiated. Once erosion has been initiated, the flow tends to concentrate the erosive forces and the breaching process accelerates. The stages of breach formation will be discussed subsequently. The Scientific Assessment and Strategy Team (SAST) reported that eyewitness accounts indicate that the majority of levee breaches during the 1993 flood on the Missouri River were caused by overtopping (SAST 2007). Wave overtopping and breaching of the levee is similar to overtopping from excessive river water level except that an RRLB technique may have to be placed in waves and withstand wave forces. Figures 2.11 and 2.12 show overtopping over a wide area of a levee along a river.

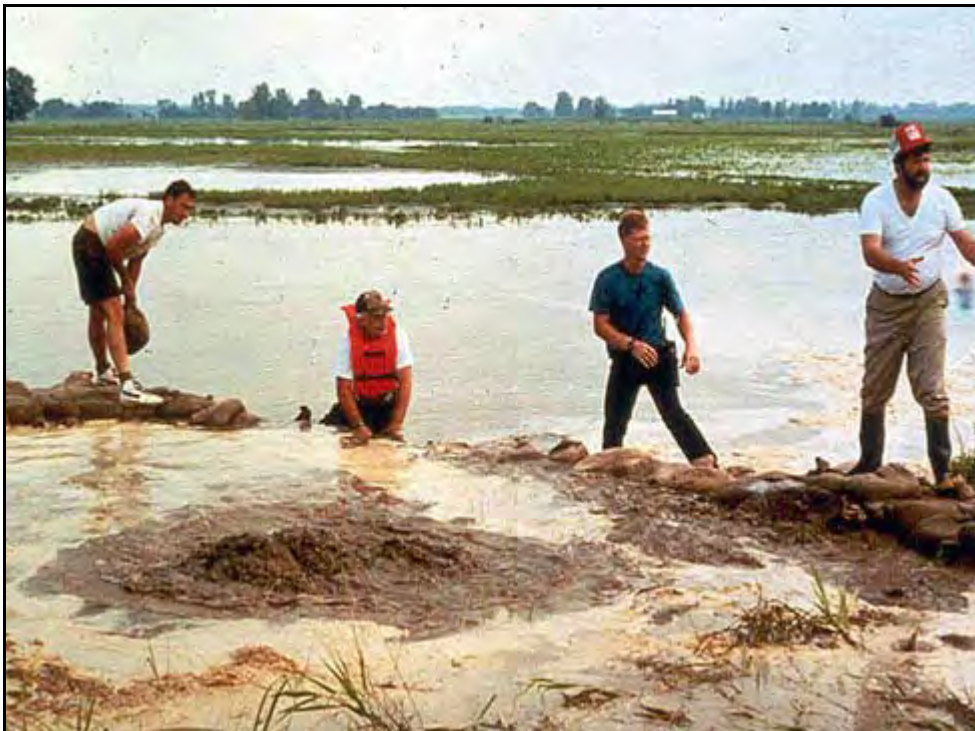
Figure 2.13. Sand bag levee around sand boil on Kaskaskia River.

Figure 2.13 shows a ring levee of sand bags around a sand boil on the Kaskaskia River levee. Ring levees are one of the existing rapid repair techniques that have been used for many years with great success. Ring levees are placed only to the level that stops movement of sediment with the water. If placed to a greater height to stop flow, the increased head will likely result in the piping connection blowing out somewhere else. Before this picture was taken, the ring levee had reduced the flow and stopped the movement of solid material. Suddenly the levee foundation material started moving again as shown in the figure. Efforts to further raise the sand bag levee and stop the material movement were unsuccessful and the full breach formed as shown in Figure 2.14.

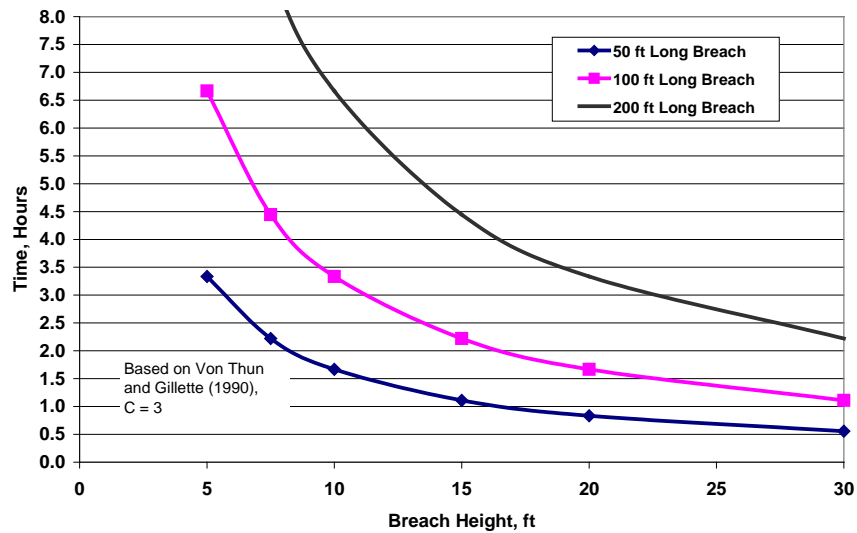
Figure 2.15. Breach time for erosion resistant embankments.

example, a 100 ft wide breach in a 15 ft high levee will form in less than 0.5 h in a highly erodible levee (Figure 2.15) and possibly as long as 3.2 h in an erosion resistant levee (Figure 2.16).

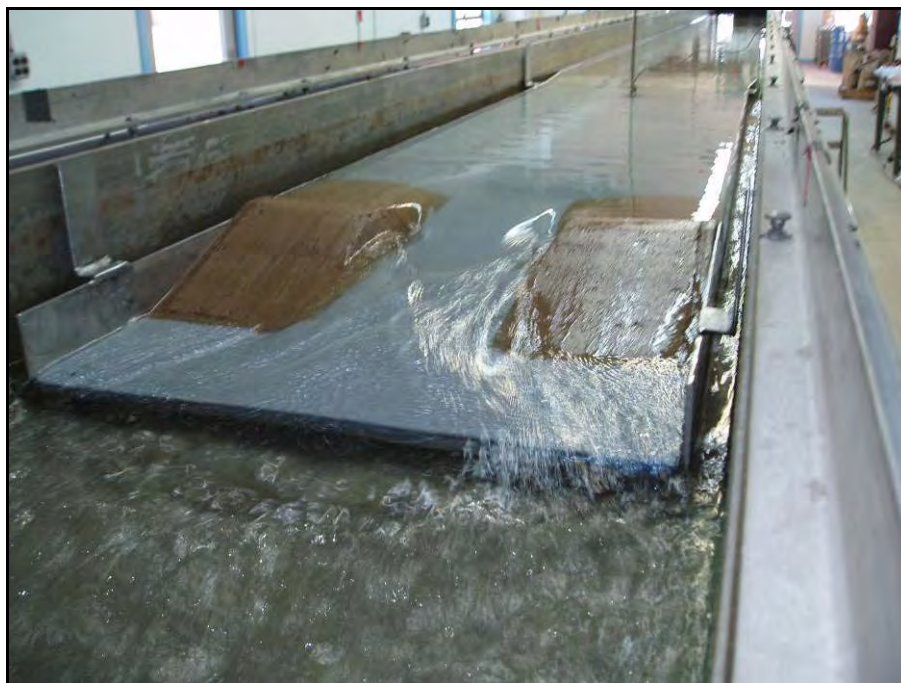
Figure 2.25. Photo of flow through small-scale (1 : 50) breach.

An 80 ft long tilting flume was used to provide a simulated levee breach and flow for testing the various closure methods discussed above. The flume cross section is 3 ft wide and 1 ft deep. The facility has pumps that can supply up to 5.5 ft³/s of flow capacity. To maintain a constant water level during the closure tests, a special side-weir-overflow device was constructed to fit within the flume. A simulated levee was constructed separately but made to fit exactly within the confines of this overflow device. The flume, overflow device, and simulated levee are all shown in Figure 2.25.

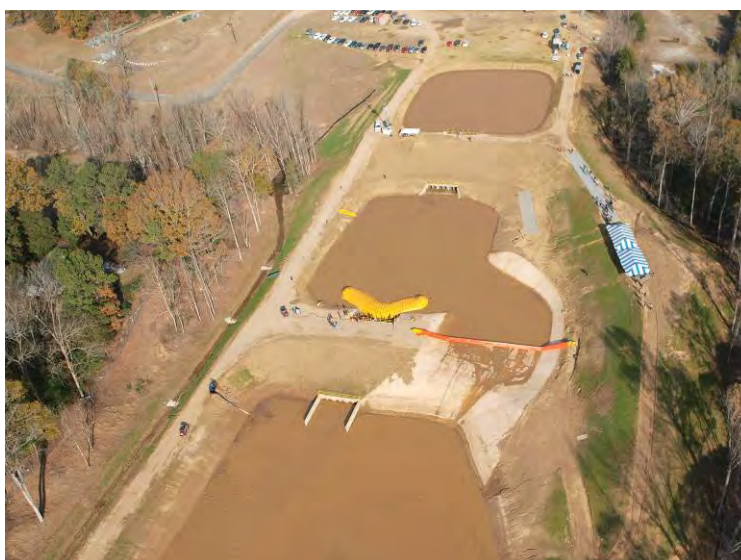
Figure 4.2. Aerial photograph of full-scale test basin, December 15, 2010.
