A Method and Device for Health Monitoring of Glass Armor

By Thomas J. Meitzler^{*}, Thomas Reynolds⁺ and Samuel Ebenstein⁺

ABSTRACT

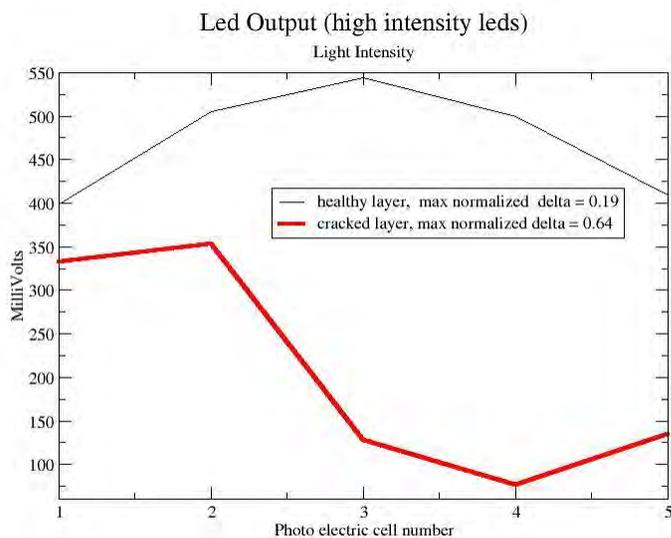
Figure 2 LED output per layer of the glass cube

Figure 2 shows the change in light intensity in moving from each photo transistor to the next one. Based on the sharp change in photo intensity in layer 2 as compared with layer 1, we

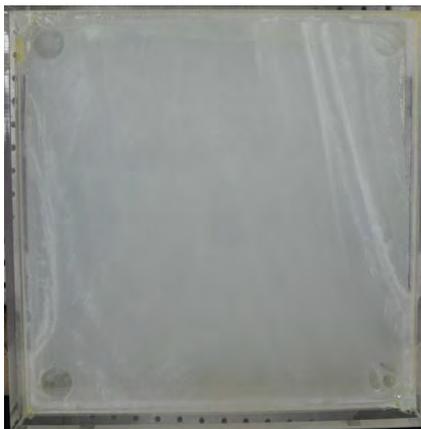
Figure 3 a Top View of a healthy Armor Sample

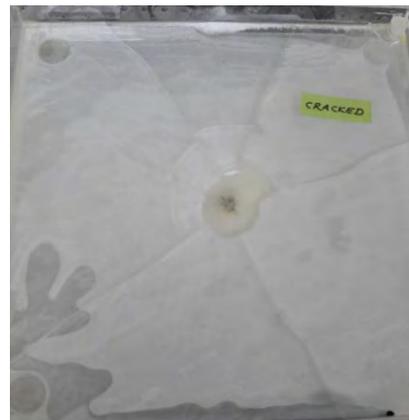
3b Top View of a damaged Armor Sample

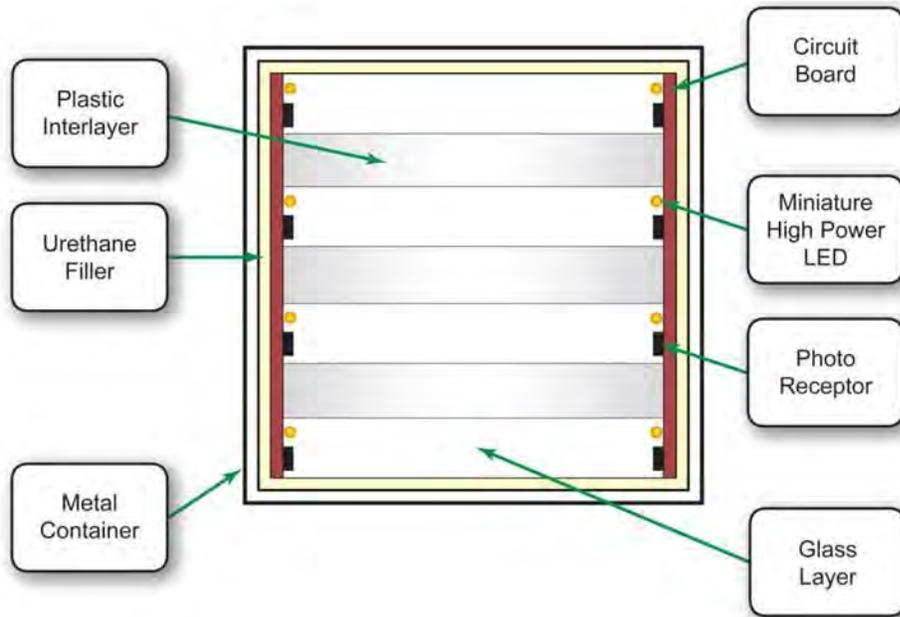
Figure 4 Hardware configuration of the inspection system

As shown in Figure 4 the cube has 4 glass layers, and these glass layers are separated from each other by plastic inner layers. The entire cube is encased in a plastic box. A Urethane filler is used to prevent the glass layers from movement in the box. The plastic container is then encased in a steel container. The circuit board needs to fit in the 6 mm space between the glass plates and the plastic box.

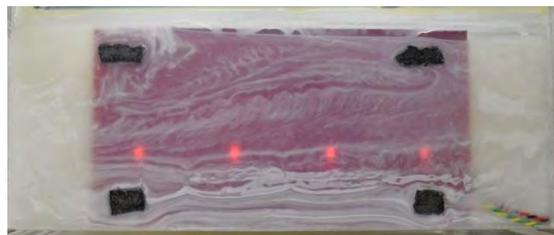
Figure 5 Image of the circuit board (side view)

Figure 5 shows a side view of the circuit board which is only a few millimeters thick and has been inserted inside the cube. Four LED's in one layer are lit, and they are clearly visible in this view.

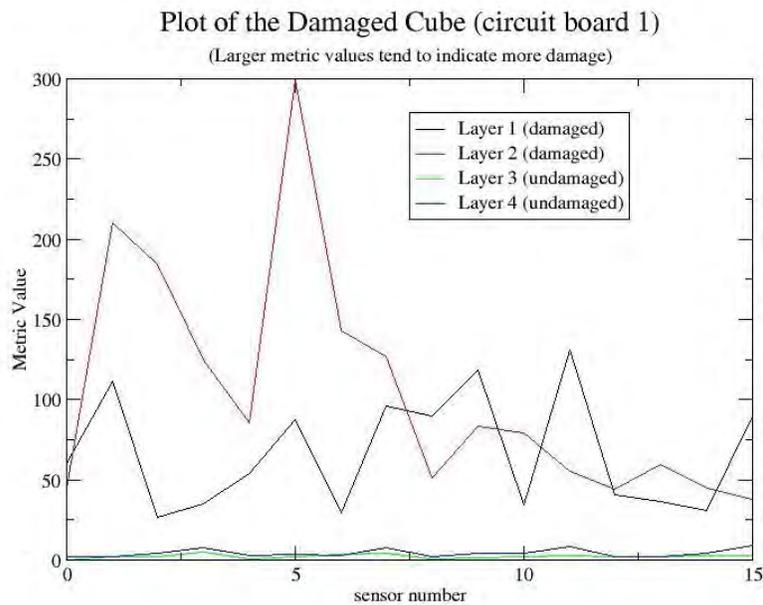
Figure 6 Plot of the Damaged Cube

Figure 6 shows the metric values for the damaged cube. Since there are 4 LED's per layer and 4 photo transistors we have a total of 16 readings per layer. Layers 1 and 2 have significantly high readings than layers 3 and 4. This is due to the fact that the cube was hit with a ballistic round which penetrated the top two layers, but had little effect on the bottom two layers. Figure 7 looks somewhat similar to Figure 6 in terms of variability, but there is more than two orders of magnitude difference in the scales on the two graphs. (Figure 6 has a scale of 0 300, while Figure 7 has a scale of 0 to 2). A comparison of Figures 7 and 8 shows that the values from circuit board 1 and 2 are quite similar. The scores from circuit board 1 and 2 are not identical because of slight differences in the positions of the LED's and phototransistors on the two boards.

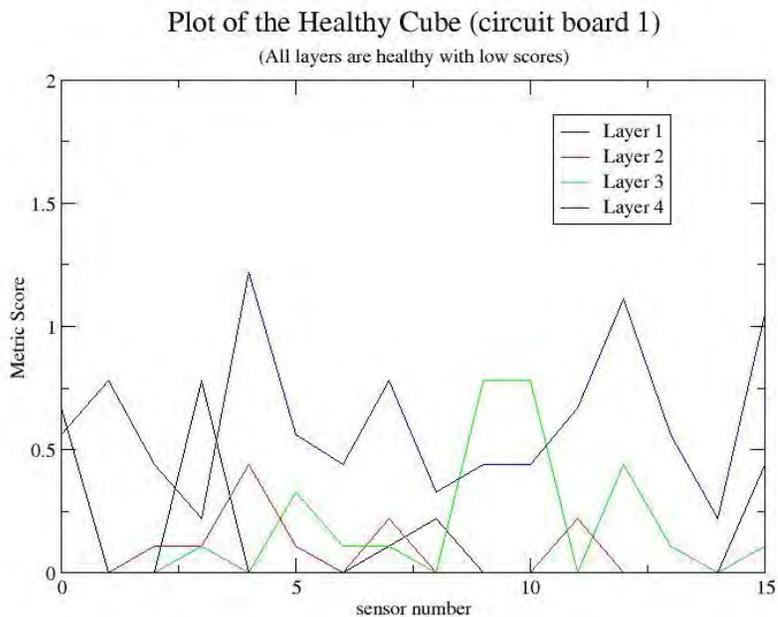
Figure 7 Plot of the Healthy Cube (circuit board 1)

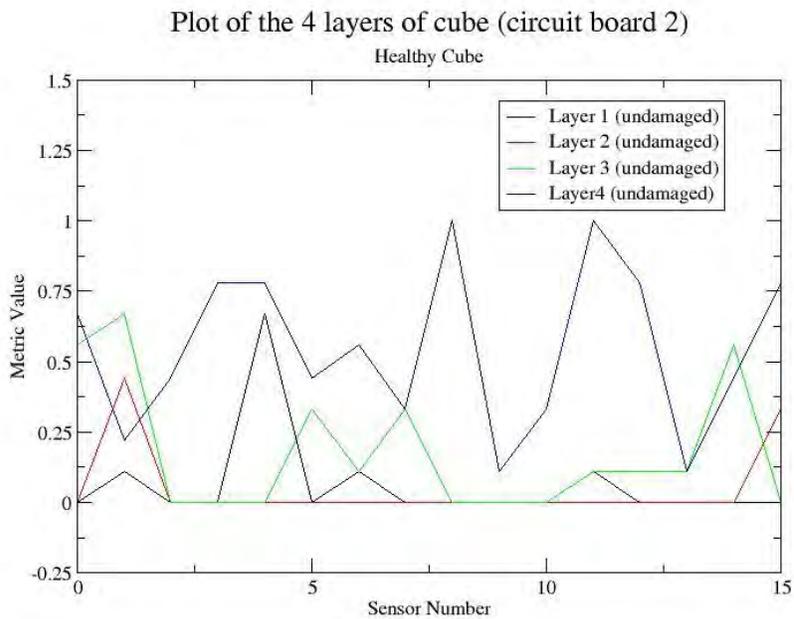
Figure 8 Plot of the Healthy Cube (circuit board 2)

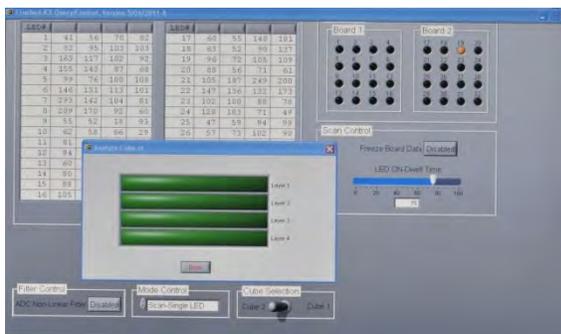
Figure 10a System Output from a Healthy Armor Cube

Figure 9 shows that the system is quite repeatable for the healthy cube. It also shows that the damage to the upper two layers of the damaged cube has caused some change in the values of the lower two layers that weren't damaged. Figures 10a and 10 b show the difference between a healthy and a damaged cube. In Figure 10a all four layers of the cube are green which indicates that the entire cube is healthy. In Figure 10b the top two layers are red which indicates they have been damaged. The bottom two layers are green so they are considered healthy.

Based on the threshold of 30.5, it is clear that Cube 2 is healthy, and Cube 1 is damaged. In addition, only the first two layers of Cube1 are damaged based on the layer scores. One of the design requirements for our system was that the output should be easy to interpret. To achieve that goal a graphical interface was designed for the system so that it would be quick and easy to determine the health of each cube layer.

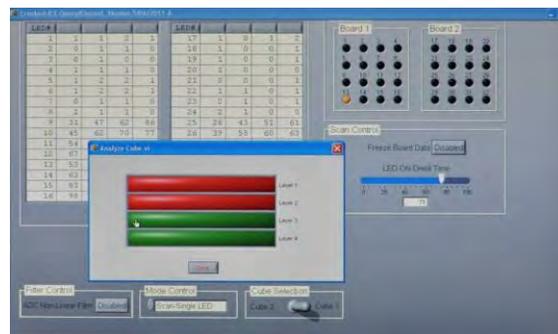
Figure 10b System Output from a Damaged Armor Cube
