Phase Zero Final Report

Recommendations on Composite Socket
Fabrication based upon Experimental Results

Christopher William Norfolk, PhD, and Jon Osborn, MS, MBA
SCRA / ARDI
20 June 2009

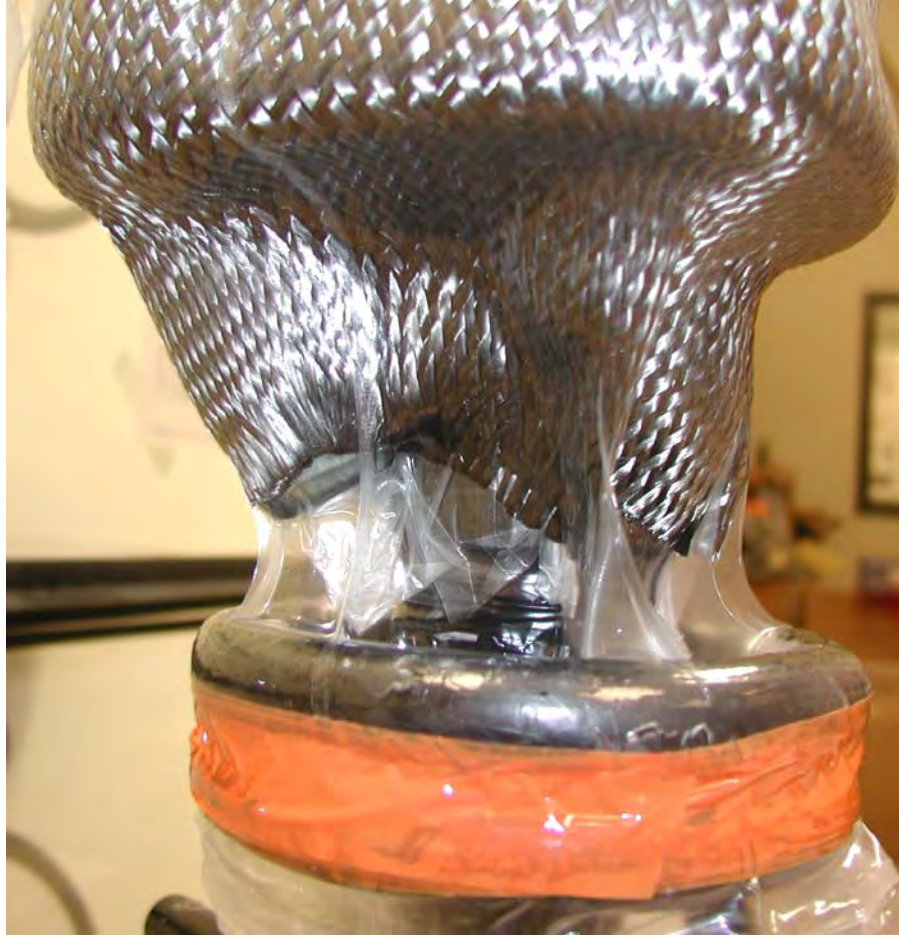
is secured in place at the bottom, and stretched tightly at the top, this collapsing effect under vacuum pressure can cause the bag to stretch and pop. This has resulted in the use of very small vacuum pressures during socket manufacturing, when compared to more traditional VARTM processing. A picture of the bag collapsing at toward the mounting pipe is shown below.

Figure 2: Illustration of the collapse of the vacuum bag

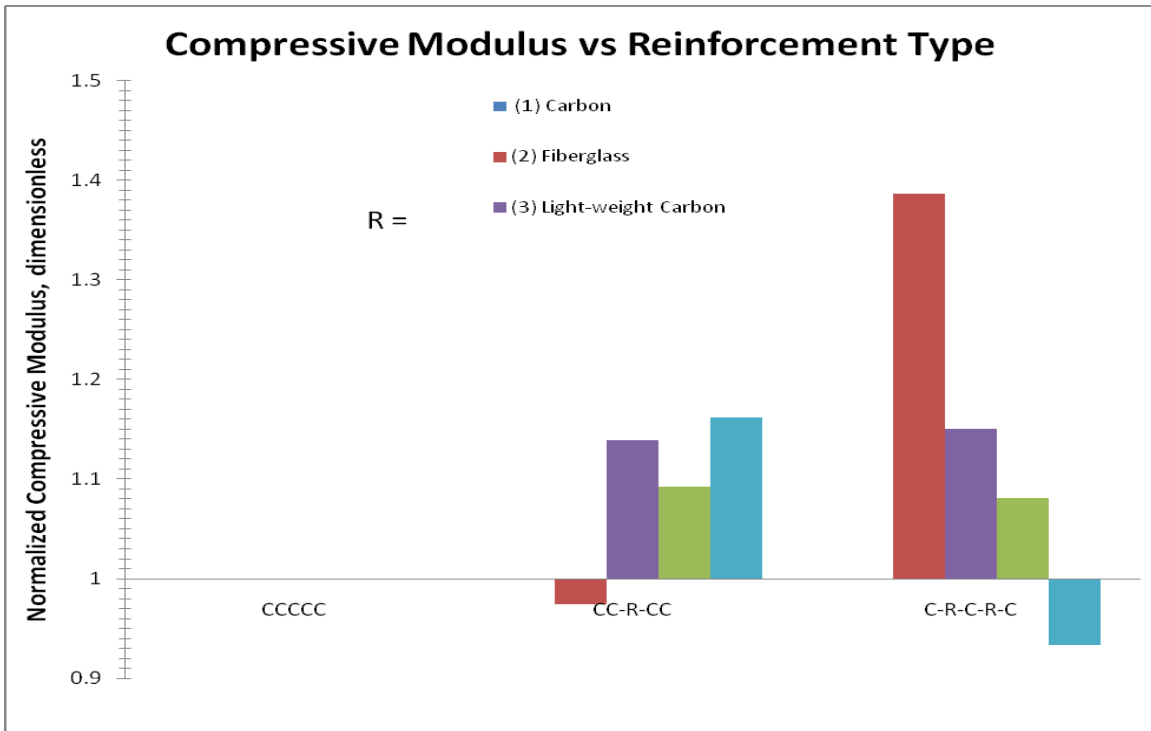
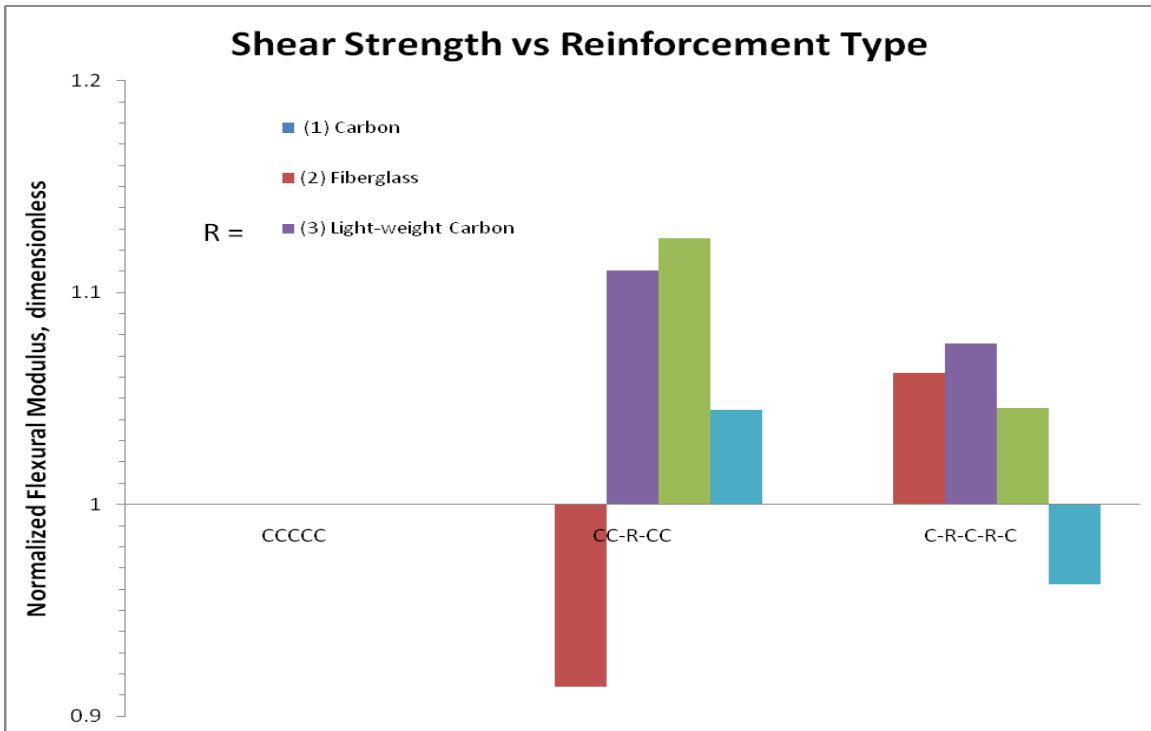
Figure 4: Comparison of Tensile Modulus for varying reinforcements in CMRK resin

Figure 5: Comparison of Compressive Modulus for varying reinforcements in CMRK resin

Figure 6: Comparison of Flexural Modulus for varying reinforcements in CMRK resin

Figure 7: Comparison of Shear Strength for varying reinforcements in CMRK resin

The results are somewhat surprising. Compared to a pure carbon structure (the baseline at the left of each graph), many of the mechanical properties are increased when fiberglass is added to the structure. This can be easily observed in Figures 4 - 6 by watching the maroon line representing the fiberglass reinforcement. This fiberglass should have mechanical properties much less than the carbon used; the carbon filament's tensile strength is approximately 4,400 MPa, whereas the fiberglass would be 2,000 MPa, and the carbon's Young's Modulus is approximately 234 GPa, whereas the fiberglass would be 80 GPa. Where the five layer structure has two layers replaced with the weaker fiberglass, we find 30% increase in tensile modulus, 40% increase in compressive modulus, and 20% increase in flexural modulus. Although the carbon is lighter weight (density of carbon will be approximately 1.80 g/cm³ versus the density of fiberglass of 2.55 g/cm³), the cost is substantially more for the carbon fabric. Comparing the fabric on an area basis, the carbon fabric is approximately 25% more than the fiberglass fabric.

Of note is the reproduction of the results from Figures 4-7 on the far left of the graph. Figures 4-7 have results for CMRK resin, and for the three structures shown in Figures 8-11, and so there is an overlap to the data displayed.

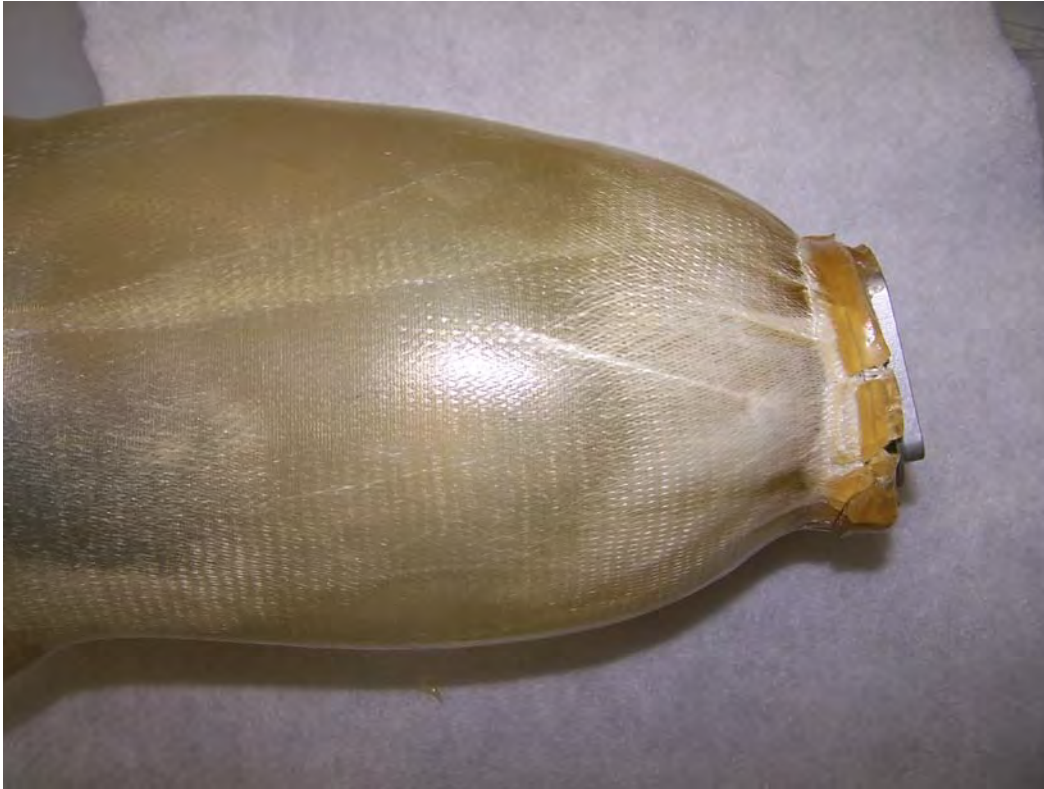
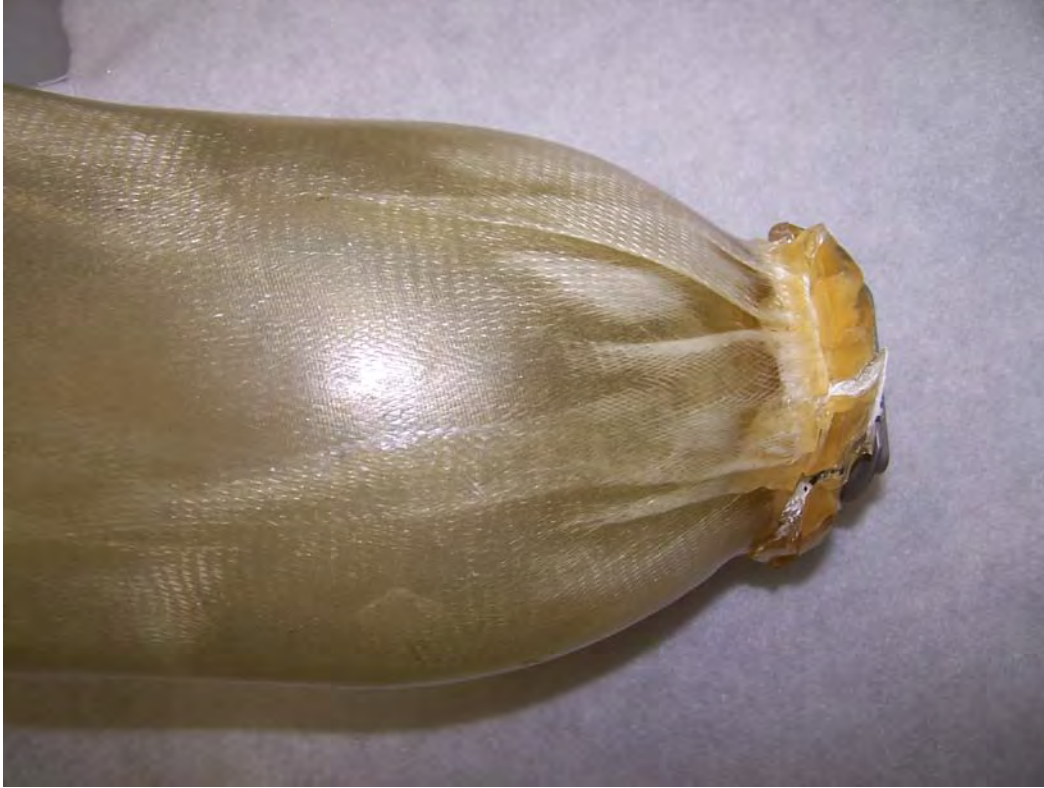
The fourth socket was fabricated from a single infusion of CMRK resin; two layers of fiberglass were placed under the attachment plate, and a single layer of fiberglass was tied into the attachment plate. The purpose of this socket was to explore the lower limit of socket strength, as this socket was envisioned to be the lowest strength socket which would ever be used clinically, and indeed is thinner than any socket I have observed. However, it was important to determine if the testing apparatus would be capable of applying loads which would fail any sockets. The ultimate strength of this socket was -8,197.7 N, which is 125% more than the P4 requirement of -3,623 N. The failure occurred at the

distal end, in the layers which were tied into the attachment plate. Note the appearance of large cracks and pulled fibers at the distal side of the attachment plate.

Figure 12: Medial close up of the failure of Socket #4

Figure 13: Posterior close up of failure of Socket #4

The series represented by sockets #4 and 5 explore the relative strength gained by using carbon over fiberglass. Their ultimate strength is very similar for the same number of layers arranged in the same configuration, and using the same resin. The carbon has only a slight advantage. However, the fiberglass fabric used has a much smaller tow size, and as a consequence, three fiberglass layers represent much less total material than three carbon layers. The advantage of the carbon over the fiberglass appears to be extremely small, with respect to the static strength.

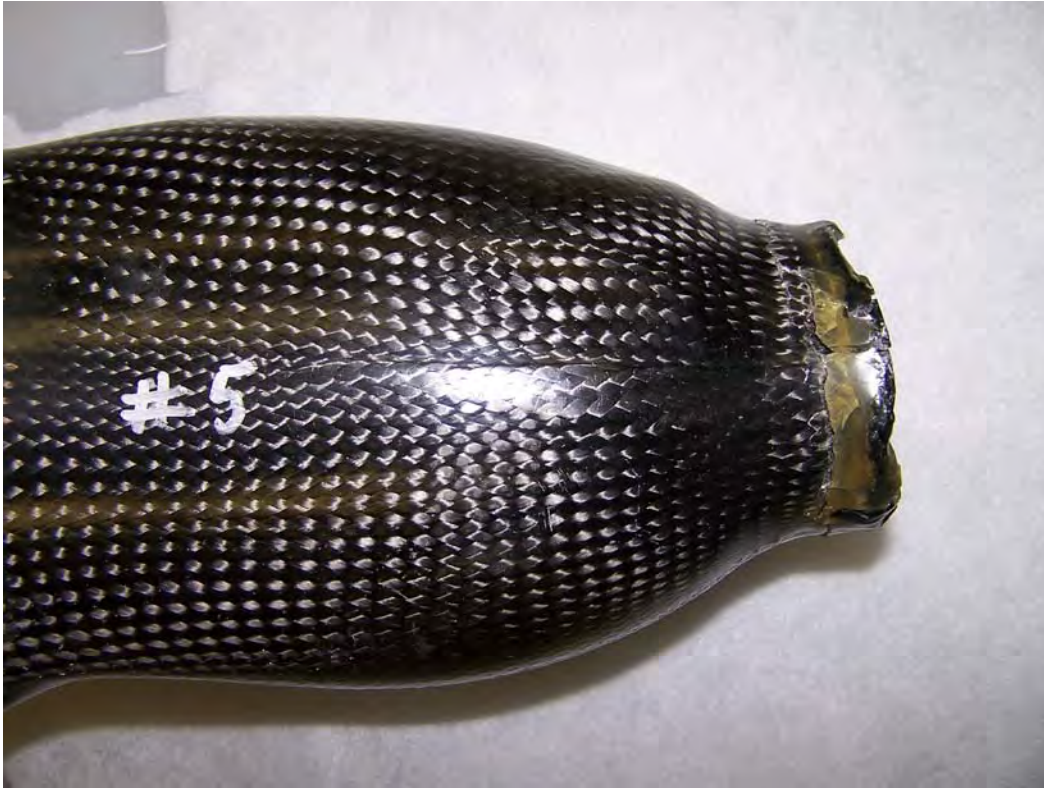
The fifth socket was fabricated using a single infusion of the CMRK resin. The reinforcement fabric used was the baseline carbon sleeve which has a tow size of 12k. Two layers were placed under the attachment plate, and a single layer was tied into the plate. It was also projected that this socket would be relatively weaker than socket #1, as there would be less carbon used in the fabrication. The socket's ultimate strength was -8,706.7 N, which is 140% more than the P4 loading required, and was indeed less than the ultimate strength of socket #1. The failure mode was again at the distal end where the attachment point was secured to the composite structure. The figure below shows a concentration of damage at the posterior near the attachment point.

Figure 14: Medial close up of the failure of Socket #5

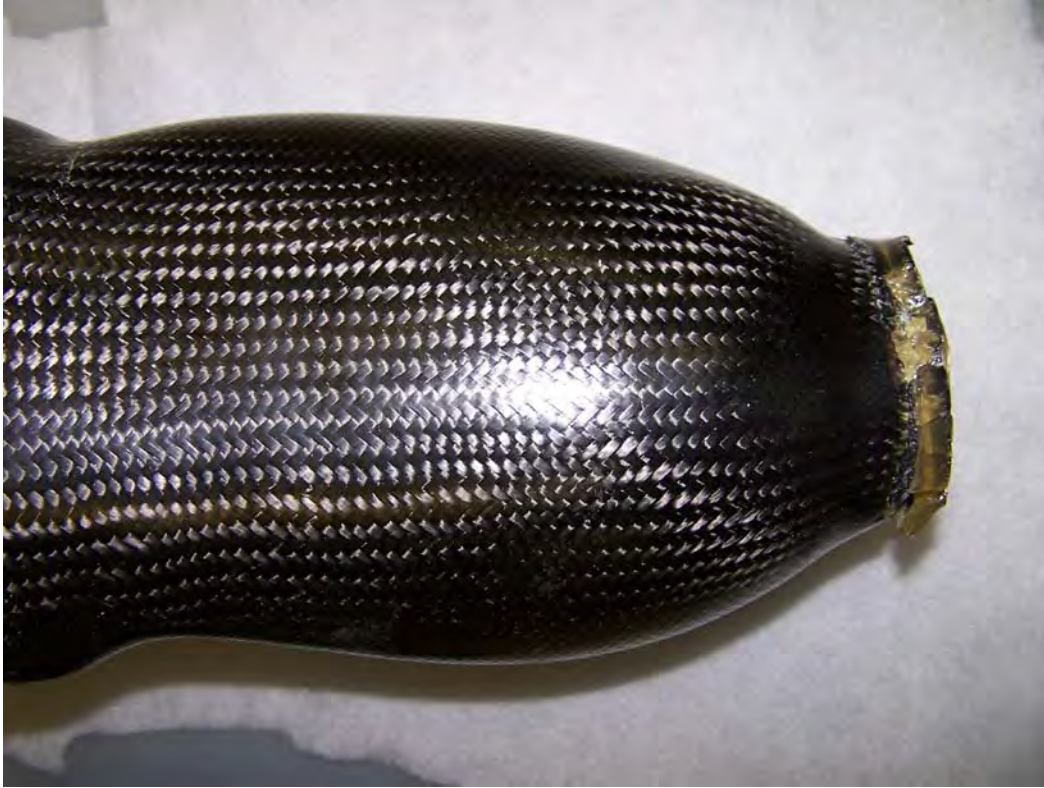
The sixth socket was fabricated using a single infusion of the CMRK resin. The reinforcement fabric used was a lightweight carbon sleeve which has a tow size of 6k. Two layers were placed under the attachment plate and a single layer was tied into the plate. It was also projected that this socket would be relatively weaker than both socket #1 and socket #5, as there would be less carbon used in the fabrication. The socket's ultimate strength was -6,279.7 N, which is 70% more than the P4 loading required. The failure mode was again at the distal end where the attachment point was secured to the composite structure. Note the concentration of damage at the posterior.

Figure 15: Medial close up of the failure of Socket #6

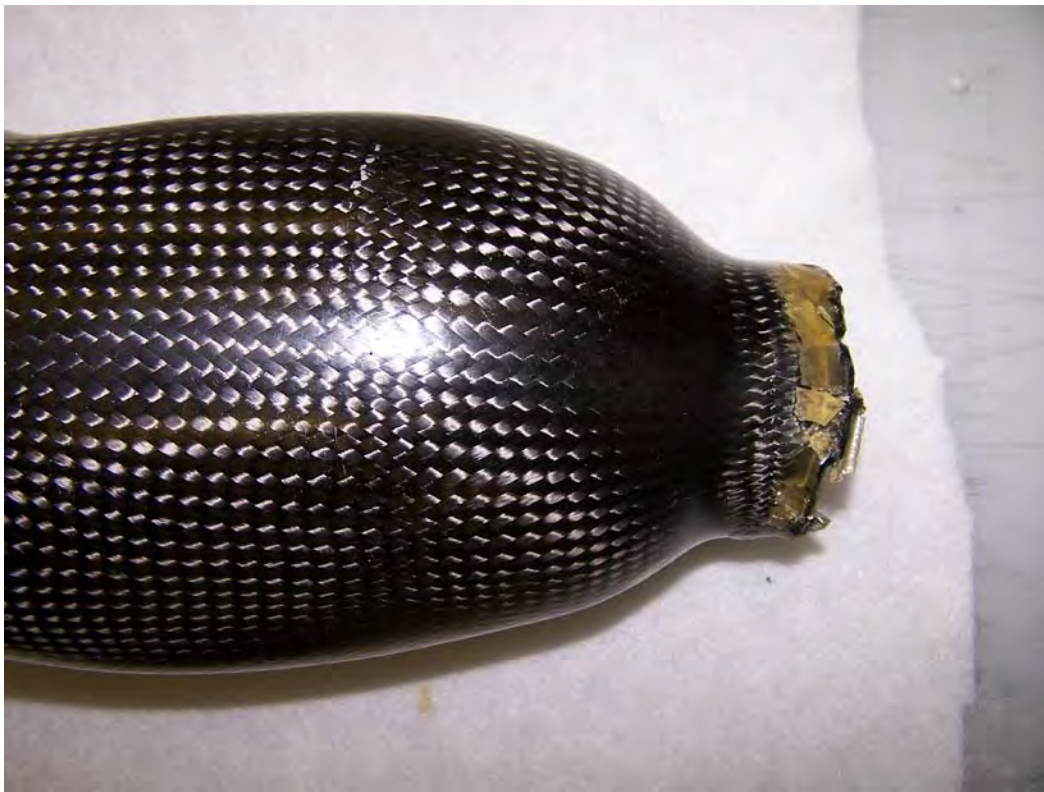
The ninth socket was fabricated using a double infusion of the CMRK resin. Two layers of carbon were placed under the attachment plate and infused in the first infusion. An additional layer of carbon was tied into the attachment plate and infused in a second infusion. The ultimate strength was -8,682.2 N, which is 140 % of more than the P4 loading required and statistically indistinguishable from socket #5. The failure mode was again at the distal end where the attachment point was secured to the composite structure. Note the concentration of damage at the distal end.

Figure 16: Lateral close up of failure of Socket #9

The series represented by sockets #4 and #9 explores the effect on the static strength of a single infusion versus a double infusion fabrication mode. At the interface between two infusions, the bond

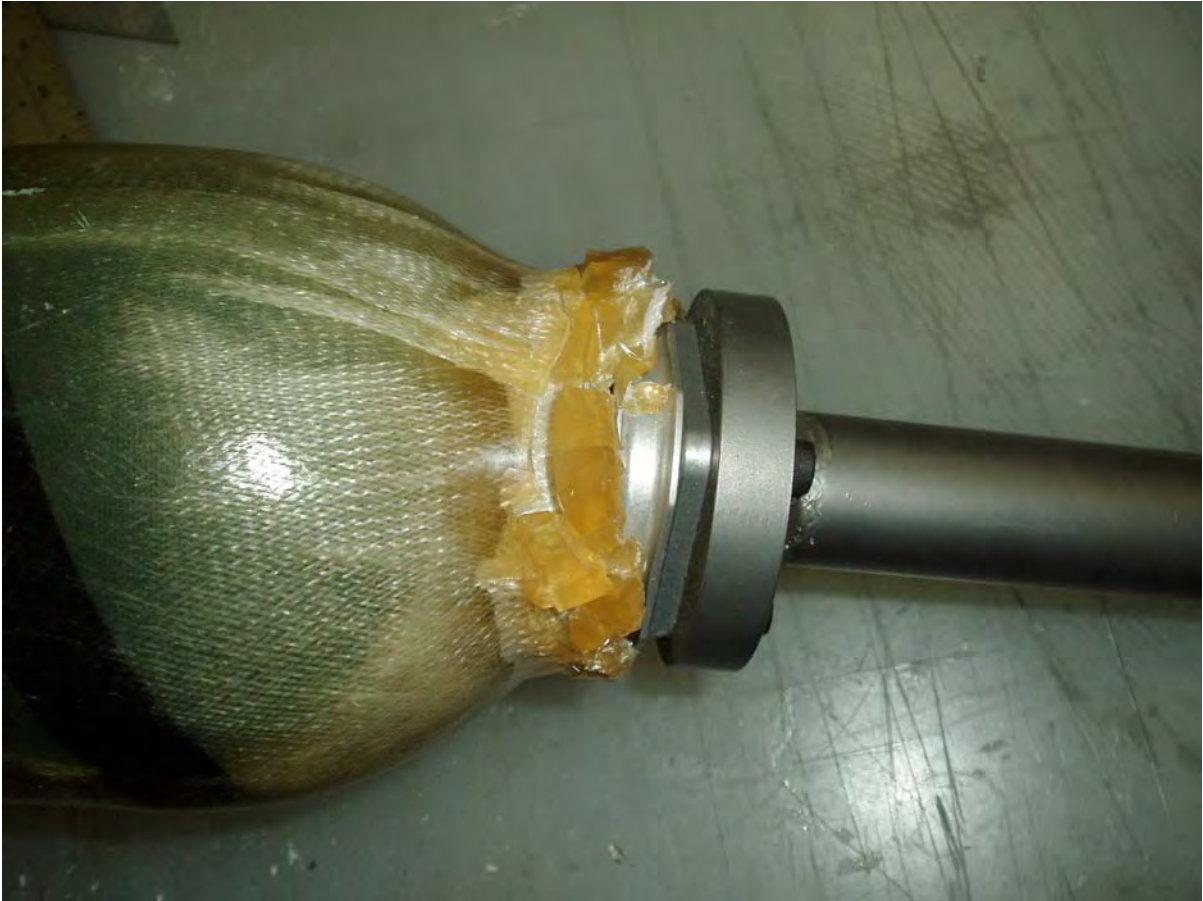
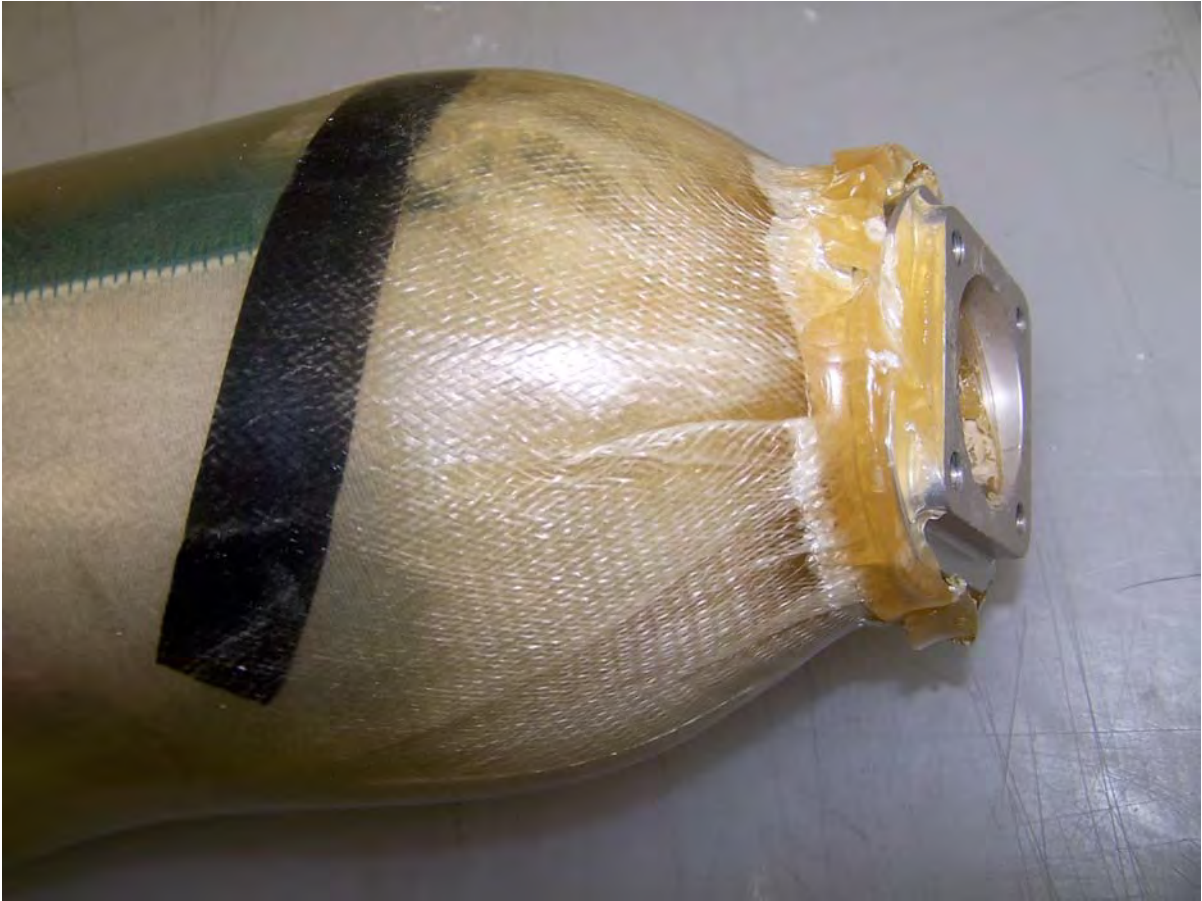
Figure 10. Failure region close-up view for socket #4.

Figure 11. Failure region close-up view for socket #4.
