**Demonstration of a Cylinder-fill System Based on Solid
Electrolyte Oxygen Separator (SEOS) Technology: One Year
Early Field Assessment at a USAF Maintenance Facility**

David Studer

Air Products and Chemicals, Inc.

Interim Report

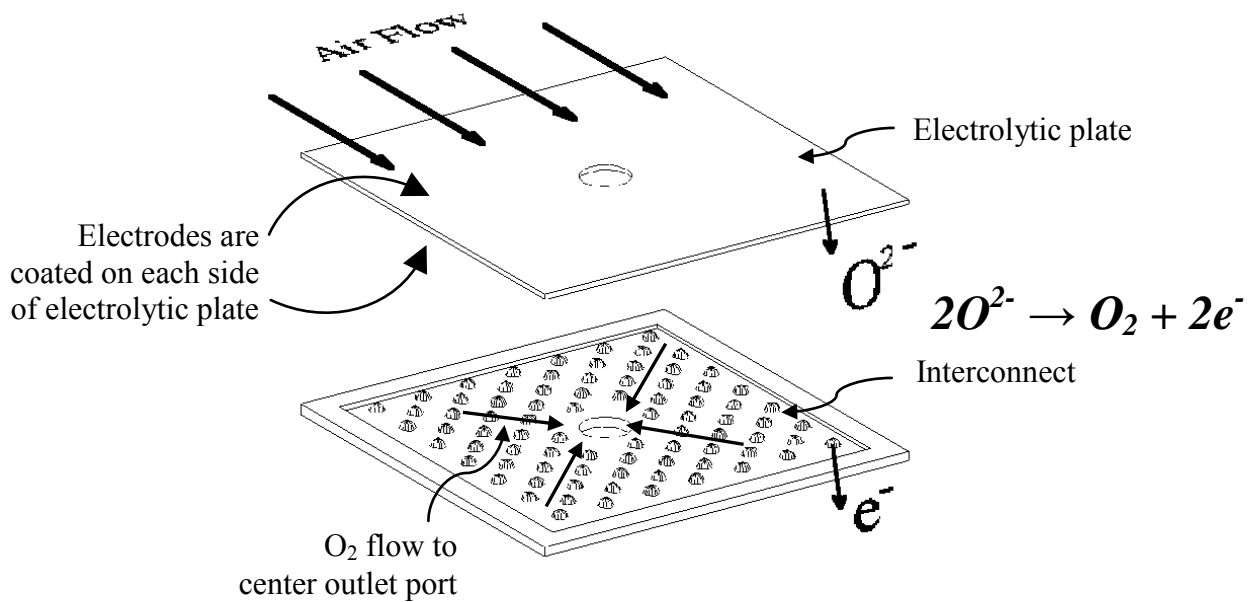
Figure 1. In this "exploded" view of a SEOS oxygen-generating couplet, air flows across the electrolyte. Oxygen is ionized on the cathode (not shown) and is transported through the electrolyte as oxygen ions due to an applied electric potential.

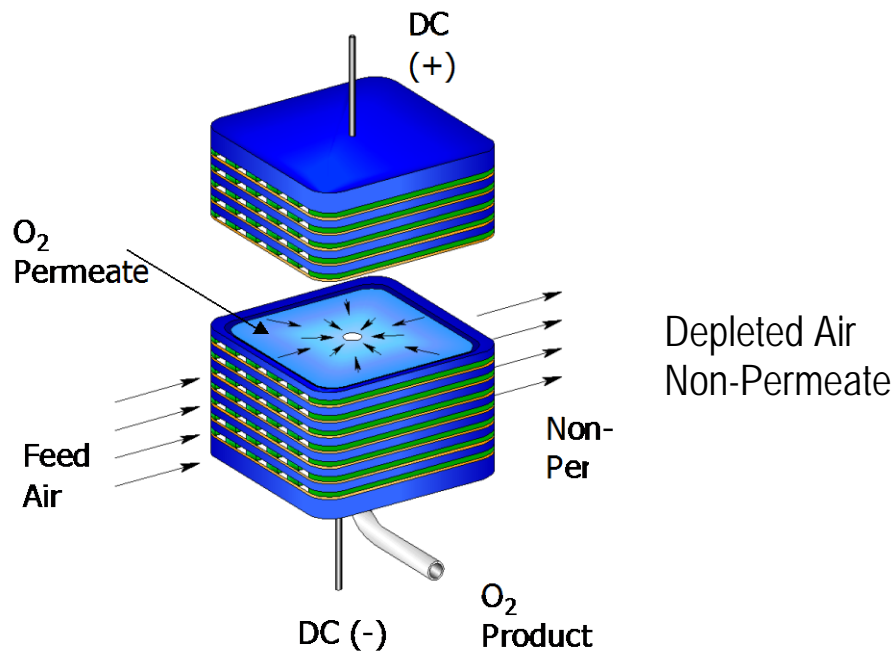
Figure 2. In this "exploded" view of an ITM SEOS stack, air flows in parallel through channels in the stack face and across the electrolyte. The oxygen product is isolated by a seal between the rim of the interconnecting plate and the electrolyte, collected in the central manifold, and exits from the stack through the centrally-positioned oxygen piping.

The ITM SEOS stack (Figure 2) consists of several SEOS membranes arranged in a planar fashion, such that they are in series electrically and are in parallel with respect to the flow of the feed gas. Additional details on general SEOS technology are included as Appendix A.

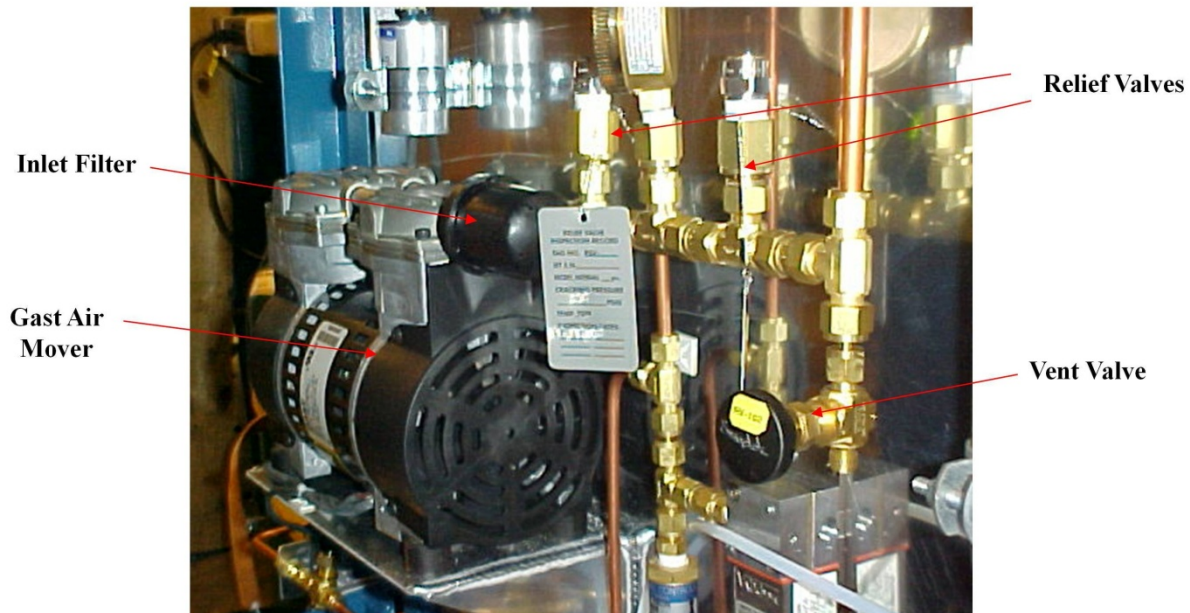
Photograph #1. SEOS 6 slpm cylinder fill breadboard air manifold system.

A mobile Advanced SEOS Breadboard cylinder fill system was designed, assembled and tested. The design and assembly activities included development of the piping and instrumentation diagram (PI&D), safety hazard review, component pre-testing and assembly, air mover testing, TMS assembly, final unit assembly and system start-up. The configuration of the air manifold system that delivers fresh air to the SEOS stacks is shown in Photograph #1.

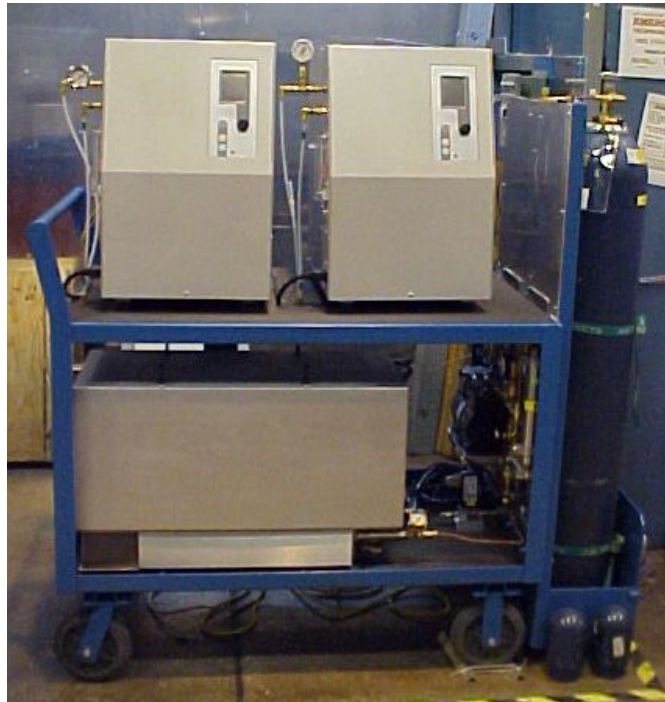
Photograph #2. SEOS 6 slpm cylinder fill breadboard as originally configured and tested at Air Products.

Facility demand for high pressure oxygen varied. In order to deliver high pressure oxygen at variable rates, the oxygen generators were designed to operate continuously and a Rix Microboost compressor compressed the low pressure oxygen from the generators to high pressure. The unit was designed to produce a steady flow of 6 slpm of SEOS oxygen at 2200 psig to two high pressure oxygen cylinders. The system was programmed to shut off the compressor when the pressure in the cylinders reached ~2200 psig and restart when the cylinder pressure fell to ~1800 psig. The cylinder fill system is shown in Photograph #2.

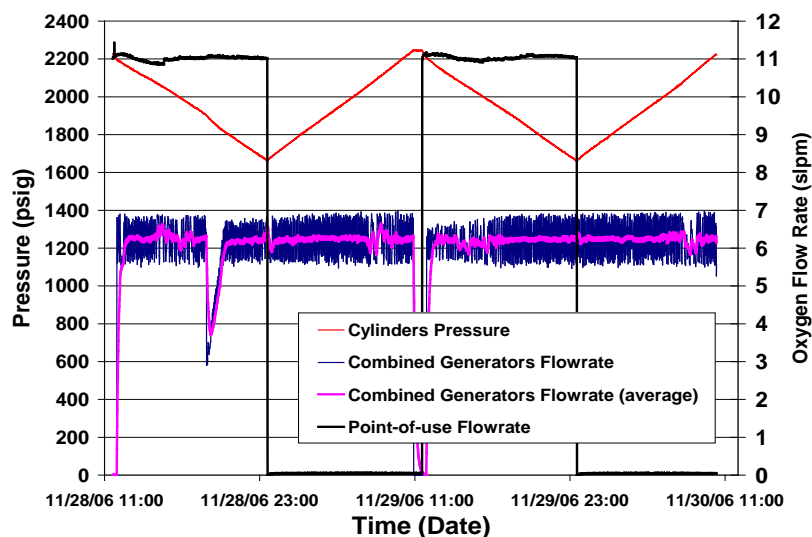
Figure 3. Laboratory testing of the cylinder filling system with varying oxygen demand rates.

Previously, the breadboard was demonstrated in 2006. During the demonstration a small medical oxygen cylinder was filled to 2000 psig, and product oxygen demand was varied between zero and 11 slpm to demonstrate a typical operating installation (Figure 3). Oxygen purity during the demonstration was measured as 99.999% oxygen and continued to improve over time as impurities were purged from the delivery system. Oxygen purity increased to 99.9997% in four days after the start of the demonstration (Figure 4).

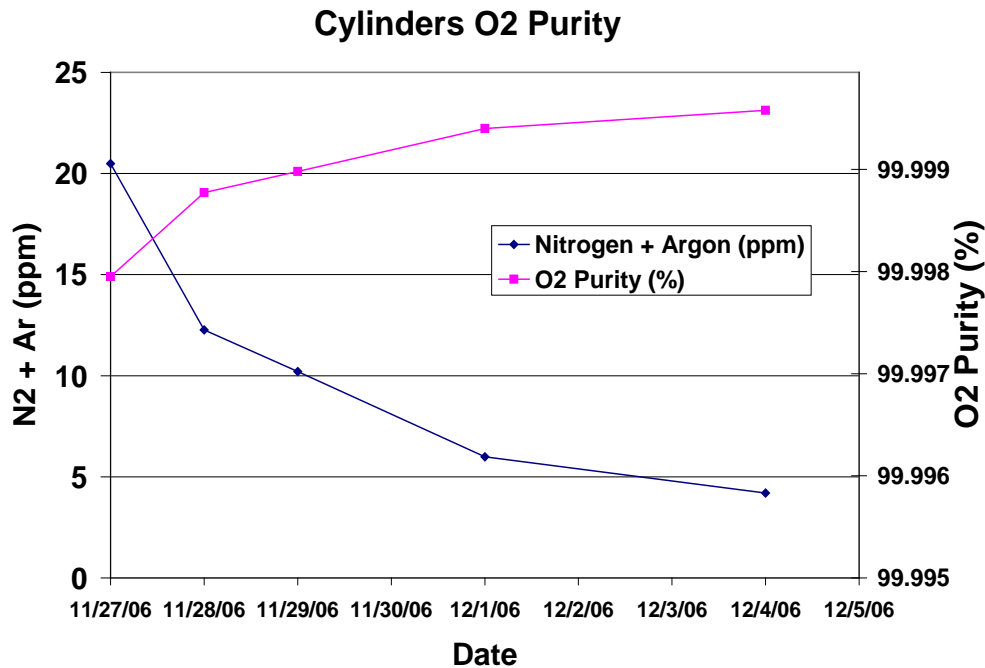
Figure 4. Laboratory demonstration of oxygen product purity of the cylinder filling system.

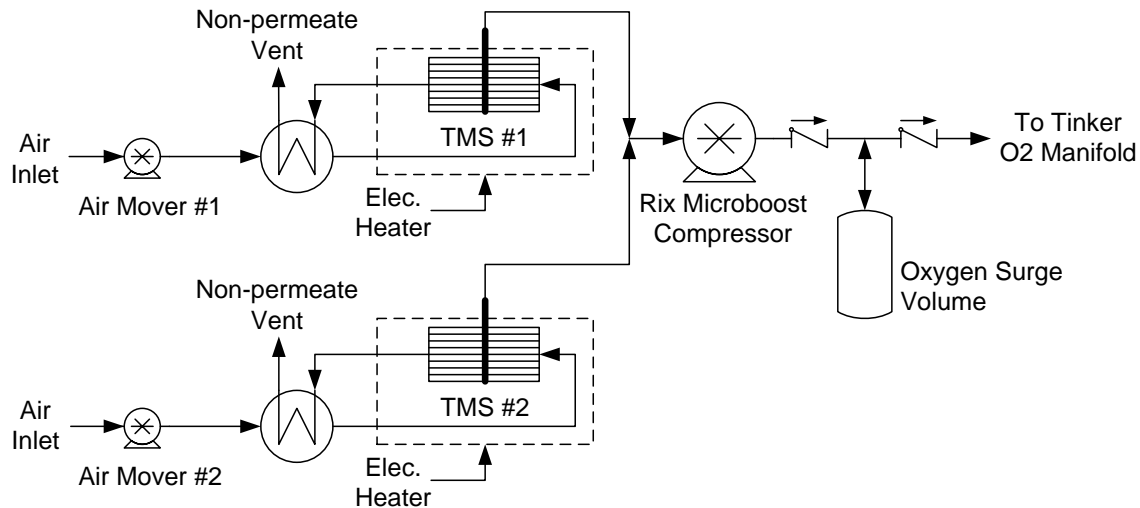
Figure 5. Simplified schematic of 6 slpm cylinder fill breadboard

adding independent air manifolds for each of the two 3 slpm generators. Air Products also improved the general safety features of the breadboard installation, such as adding a locking mechanism on the cart to prevent rolling and securely mounting the generators to the cart. A simplified schematic of the modified breadboard is shown in Figure 5.

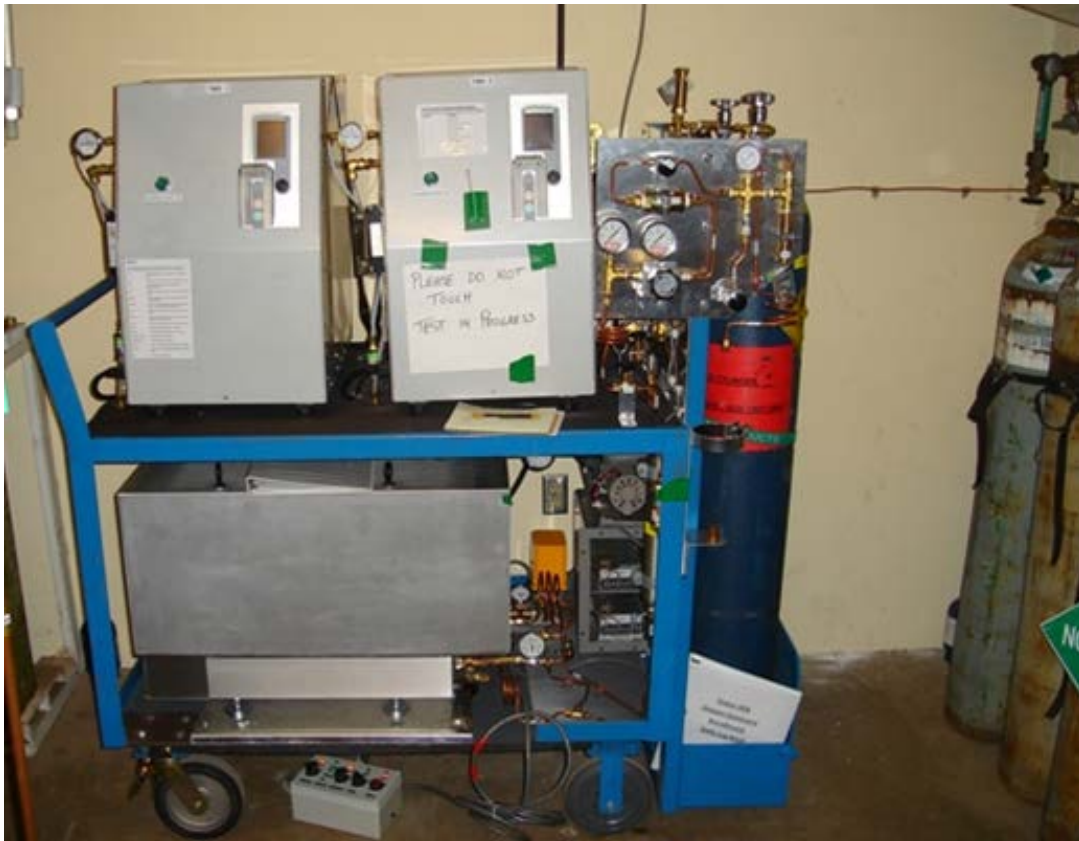
Photograph #3. SEOS breadboard installed at OC-ALC maintenance facility.

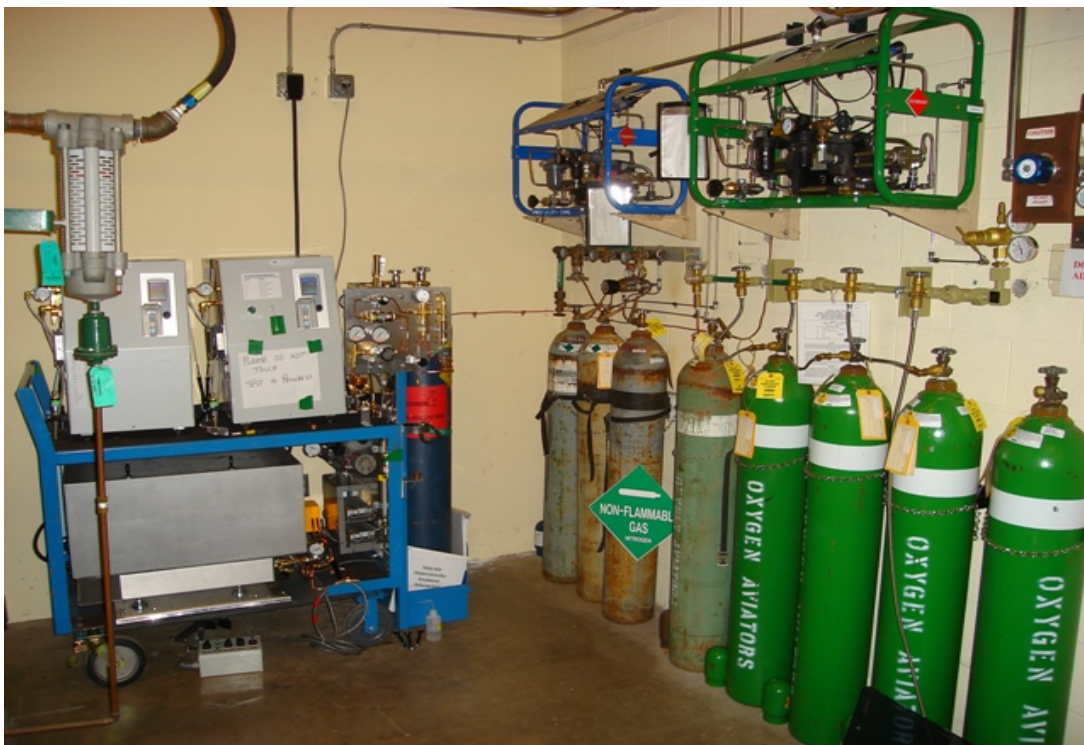
Photograph #4. SEOS breadboard shown with facility high pressure oxygen supply system.

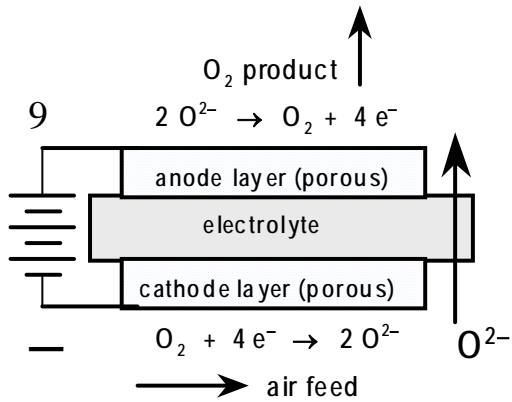
Figure 1

Operation of a SEOS electrochemical cell

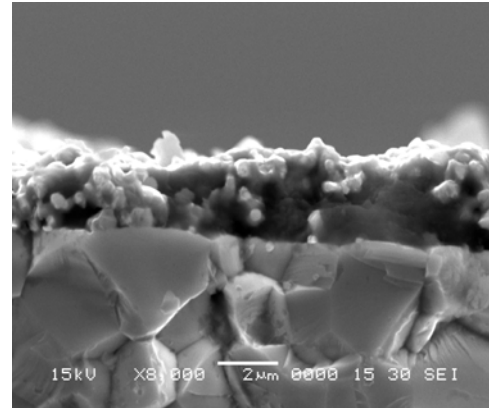
Figure 2

SEM image of porous electrode layer deposited on dense ceria-based electrolyte in an ITM SEOS electrochemical cell

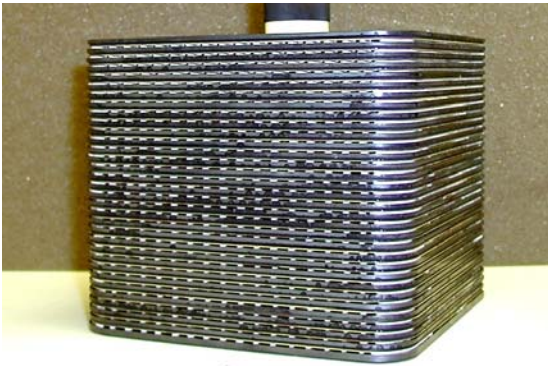
Figure 3

A 32-cell ITM SEOS stack

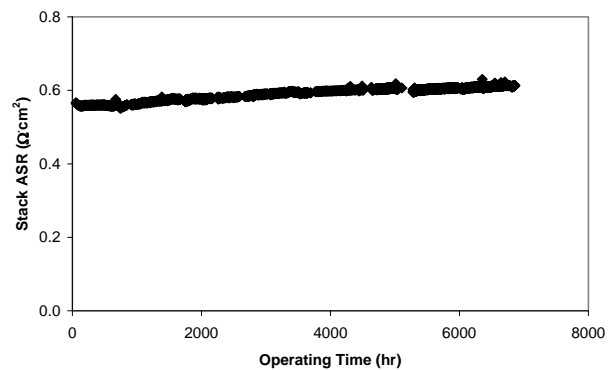
Figure 4

Area specific resistance (ASR) of a 3-cell test stack during operation

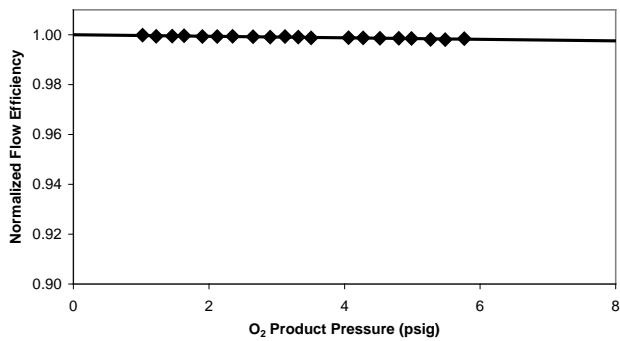
Figure 5
Flow efficiency data for the stack
represented in Figure 4

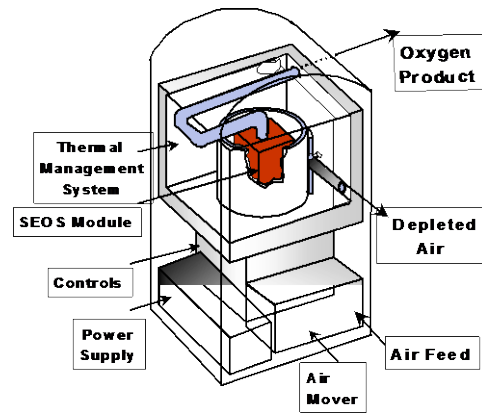
Figure 6
Schematic of a typical ITM
SEOS generator system

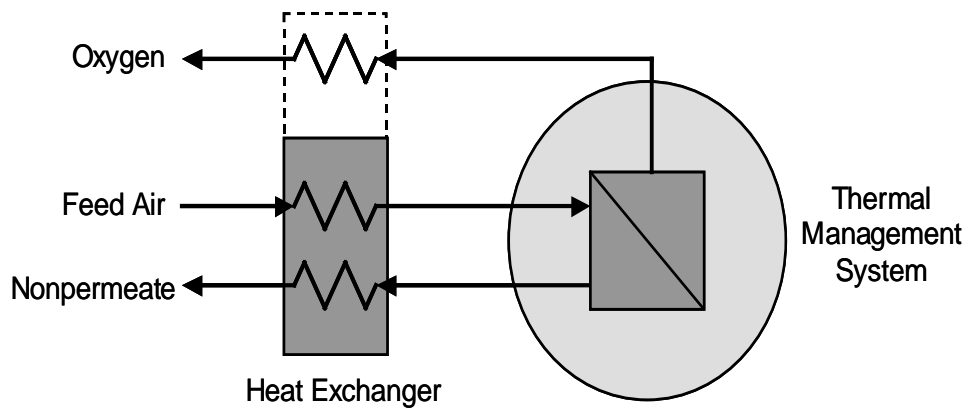
Figure 7
Schematic illustrating heating of the feed air stream via gas-to-gas heat exchange

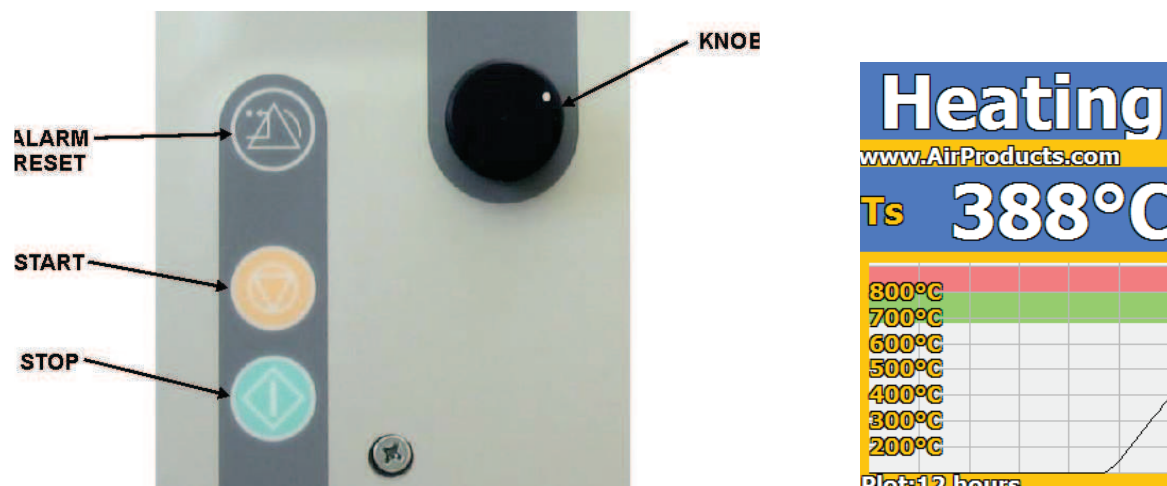
2. Press the **Start button** on the control panel. The touch-screen will display "Heating" and the oxygen generator will heat the stack to the stand-by temperature. This will take approximately 10 hours from room temperature and less time from an elevated generator temperature. (The generators heat-up at a rate of approximately 1°C/minute).

Upon reaching the stand-by temperature (e.g. 680C) the top most part of the screen will turn red and show a "PAL" alarm. (Incoming air pressure went below the minimum limit)
