Defence Science and
Technology Organisation

Improvements to Filter Debris Analysis in Aviation Propulsion Systems

Andrew Becker and Peter Stanhope

DSTO-TR-2773

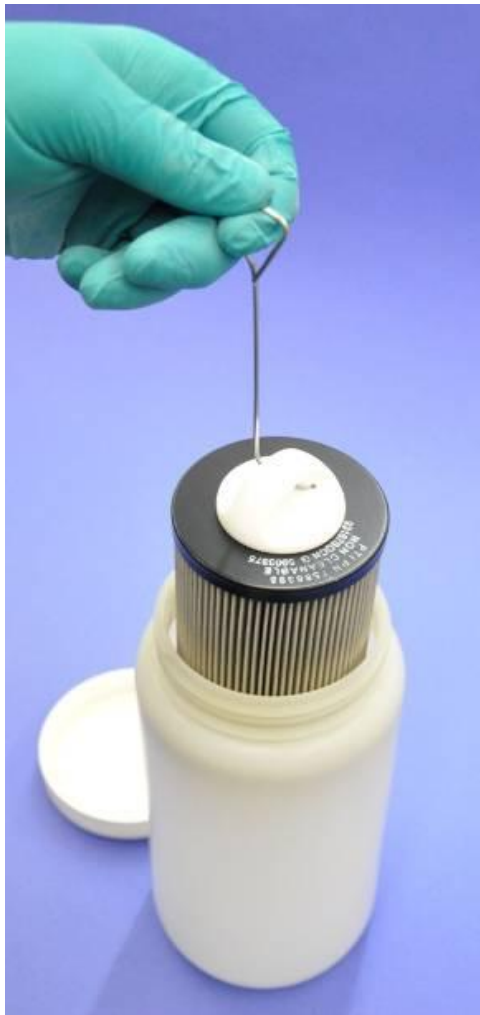
Figure 5: Plugged filter element being lowered into the cylindrical extraction container.

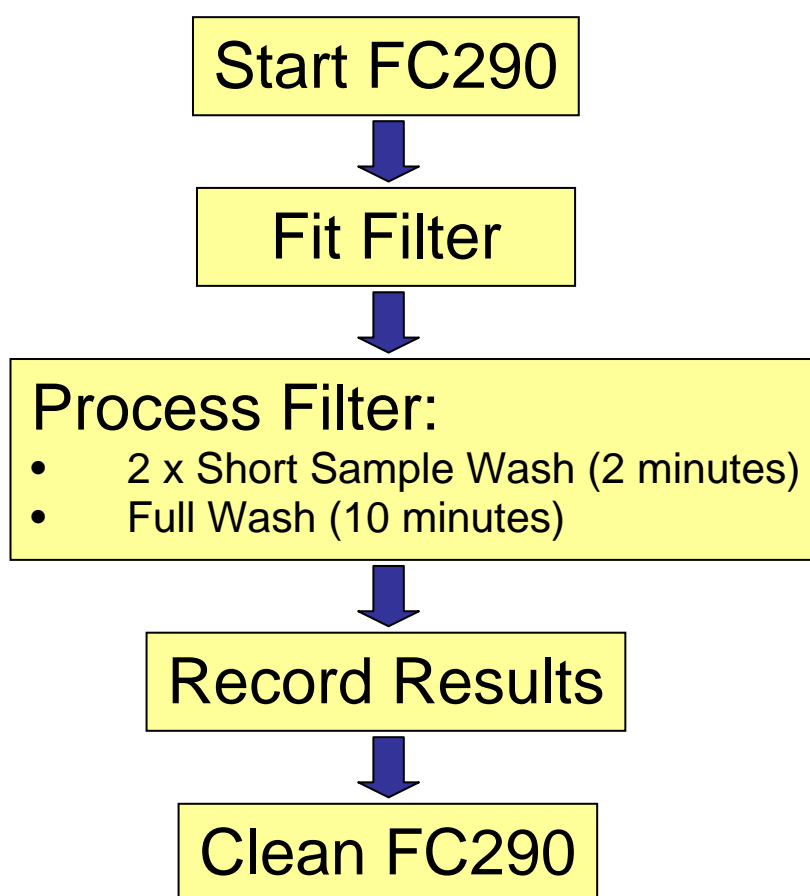
An overview of the complete cycle used for RAAF filter elements is shown in Figure 22. Once the slurry has passed through the sensor it returns to the wash fluid reservoir. The fluid is then pumped through a 3 micron filter before returning to the filter element. The specifications for the FC290 instrument are contained in Appendix D.

Figure 22: Overview of complete filter debris extraction cycle used by RAAF

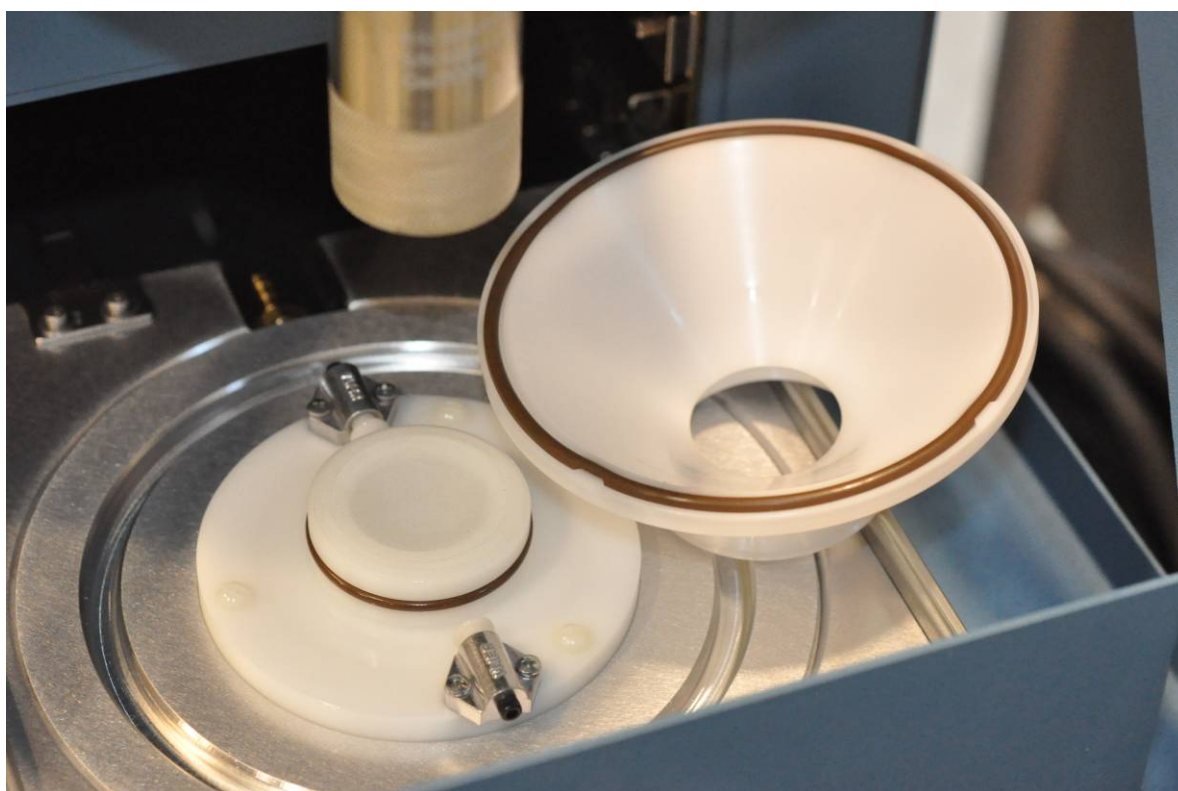
press fit over the base and this was assessed to be insufficiently robust for the expected RAAF usage. Additionally, the filter patch support gauze was considered to be too light-weight for repeated usage. DSTO incorporated a stainless steel filter patch holder manufactured by Millipore that uses a simple cam-lock method of attaching the funnel to the base. This provides a better mechanism for securing the filter patch that is both easier to use and more robust. It is important to note that the use of stainless steel prevents the FC290 models currently owned by ALSPO being upgraded to include the XRF capability, however this upgrade is not anticipated and DSTO recommends the use of external XRF units should that be desired in the future.

Figure 24: Sample filter patch holder as delivered.

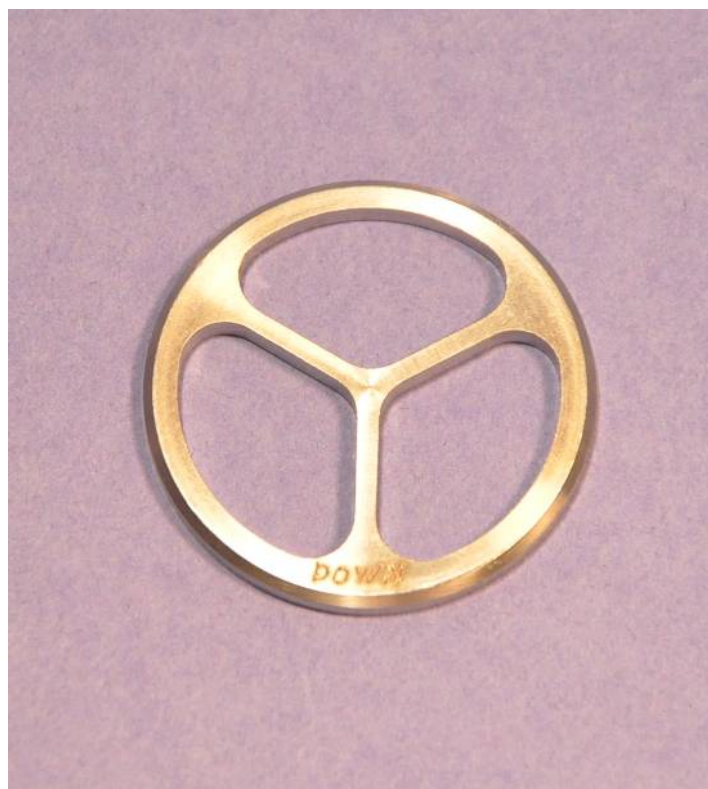
A thin gauze disc is supplied with the FC290 in order to support the filter patch during the sample phase. This item was also assessed as being sufficiently robust to meet the RAAF expected usage and a replacement was made from stainless steel (Figure 26). The cam-locking mechanism of the Millipore funnel enables the nylon filter patch to be locked in place around the periphery of the filter patch. This also allows the supporting ring to be a simple design that minimises resistance to flow of the slurry. The support ring has the word "DOWN" engraved on one side to ensure it is inserted with the bevelled edge facing down and hence allows it and the filter patch to be locked in securely. Appendix F contains details of the support ring.

Figure 26: Stainless steel replacement filter patch support

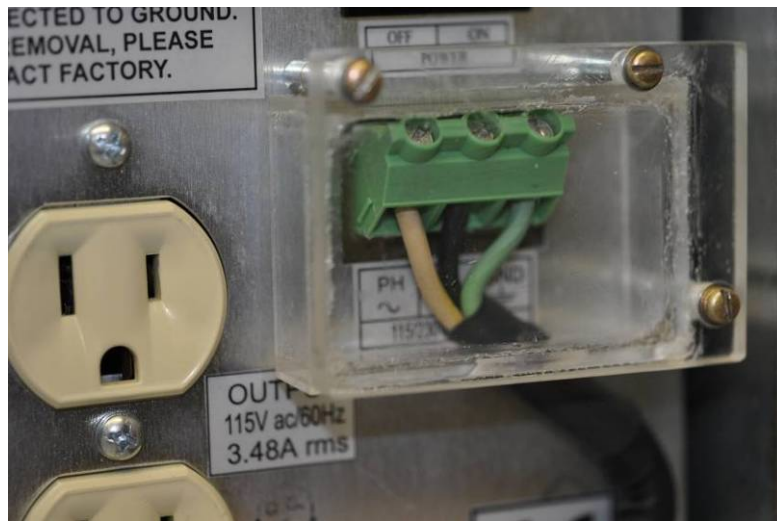
The FC290 is supplied with a power conditioning unit where the unit is used in countries that do not have 115 VAC 60 Hz mains power available. The power conditioning unit comes with a terminal block for the phase, neutral and earth wires to be connected to. This terminal block does not meet the Australian wiring standard as it is exposed and could be inadvertently accessed. To rectify this and still allow the three wire connections to be visible, a Perspex cover plate was mounted over the terminal block. This allowed the power cable from the mains connection to enter the terminal block and removed the possibility of inadvertent contact of the terminal block screws (Figure 27).

Figure 27: Perspex cover for terminal block

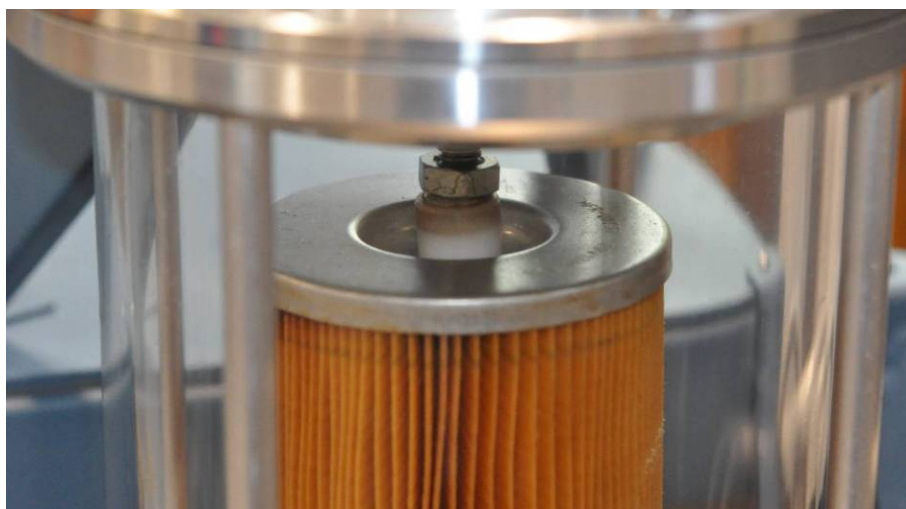
Adapters are required to secure the filter element to the wash housing connection (see Figure 21). Most modern filter elements have an open clean oil exit port at the top and bottom; these type of filters require an upper and lower adapter to ensure the slurry does not re-enter the filter element and result in particles not being detected. The top adapter is completely solid and the lower adapter has an opening to allow it to fit onto the Wash Housing hub and allow the wash fluid and compressed air to enter the bore of the filter element. The T56 external scavenge filter is different to most conventional filter elements in that the bore of the element is only open at one end. This means that the upper adapter is not required for the T56 ESF and the wash housing lid simply bears down on the solid end of the filter element (see Figure 28).

Figure 28: Top of T56 ESF in the FC290 showing the Wash Housing plunger bearing directly onto the solid top of the filter element.

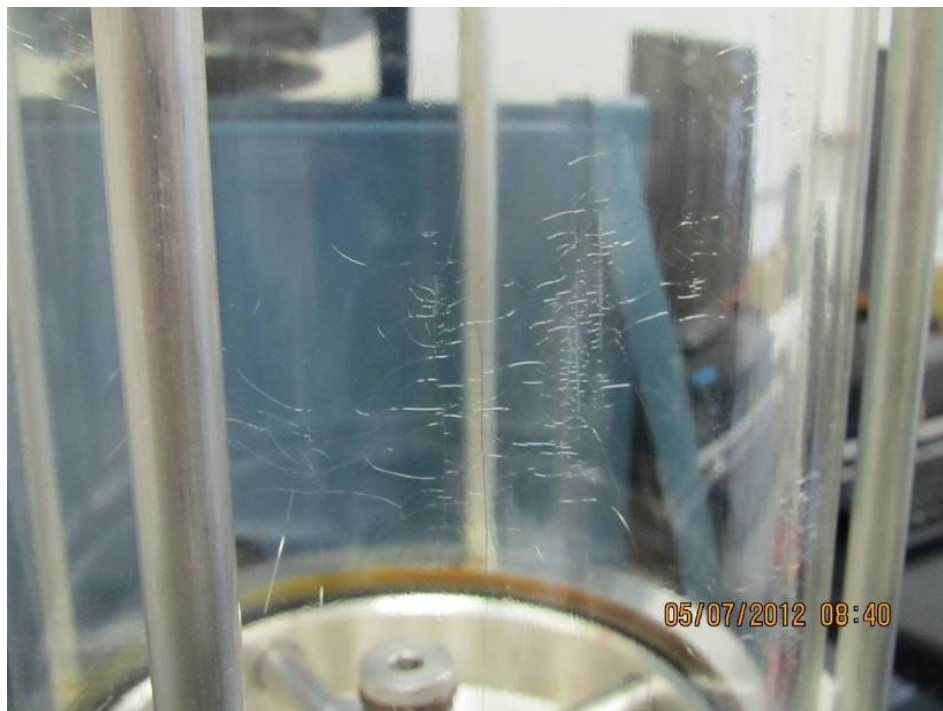
Figure 34: Wash Housing showing crazing

During the trial of the FC290 crazing of the wash housing was identified by operators along with an abnormally low level of wash fluid in the wash housing during the processing of filters (Figure 32). A further symptom was the pooling of wash fluid on top of the mist filter which is fitted to the wash housing lid assembly (Figure 33). After initial troubleshooting by the operators and discussions with the OEM, it was determined that the mist filter had become blocked and subsequently caused an artificially high pressure in the wash housing; this had also caused the low wash fluid level. The blocking of the mist filter with wash fluid was not categorically determined, however it was likely to have been caused by the regulated air pressure which had initially been set at 60 psi (420 kPa). The regulated air pressure was subsequently reviewed and was lowered to 40 psi (280 kPa) following testing by RAAF operators. Initially crazing observed on the wash housing wall (Figure 34) was thought to be related, however further advice from the OEM suggested it was benign wear and tear. The mist filters will be replaced on condition (based on observed pooling of fluid on the mist filter) to avoid further issues.

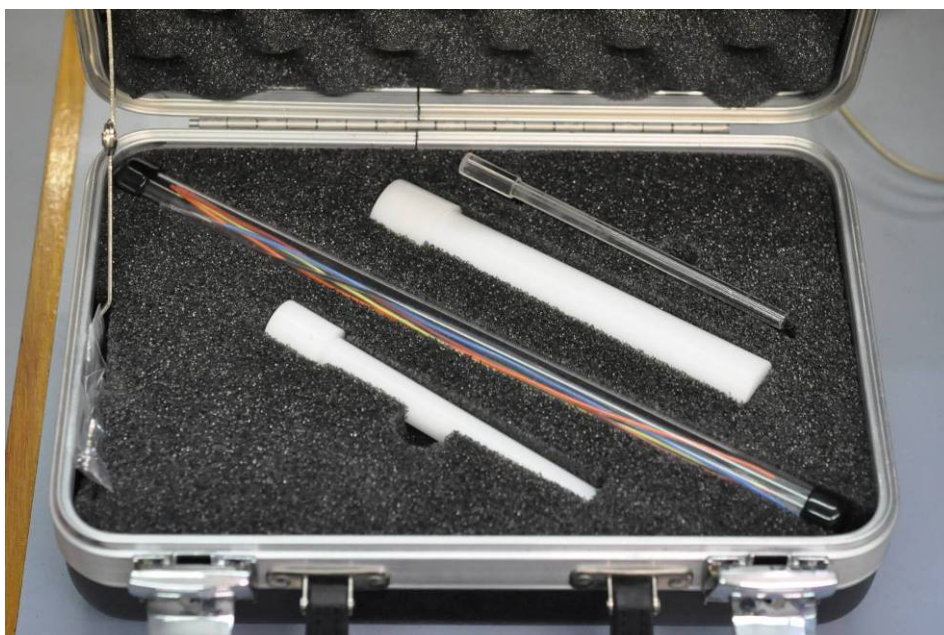
The FC290 manual does not specify any routine calibration of the FC290 [15] and this was specifically confirmed with the OEM. However, DSTO recommend that the performance of the FC290 sensor be routinely checked to ensure accurate operation. This can be easily achieved in-situ using the MetalSCAN Performance Test kit (Figure 36) that has been provided by DSTO with both RAAF FC290 instruments. MetalSCAN is the name of the sensor used in the FC 290. The test kit contains five colour-coded test straws each containing a spherical particle of known size and composition (Table 11, Figure 37). Each straw is passed through the sensor (Figure 38) to confirm that the sensor identifies the particle and that the particle is recorded in the appropriate size bin. The straw must be inserted and retrieved from the lower sensor port due to lack of access to the upper port; this means that for every insertion two particles should register (one for the upward pass and one for the retrieval pass). The sensor is sensitive to the velocity of the particle and several attempts are usually required to ascertain a suitable straw velocity. As the size bins are not specifically used in the RAAF T56 application, the particle detection (i.e. count) is all that is required. If the instrument fails the in-situ performance check then the OEM must be notified for corrective action (note that there is currently no agent for this equipment in Australia). Appendix L contains a pro-forma developed to aid the performance check process.

Figure 36: MetalSCAN Performance Test Kit
