**US Army Corps  
of Engineers®**  
Engineer Research and  
Development Center

## **Brick Paving Systems in Expeditionary Environments: Field Testing**

Final report

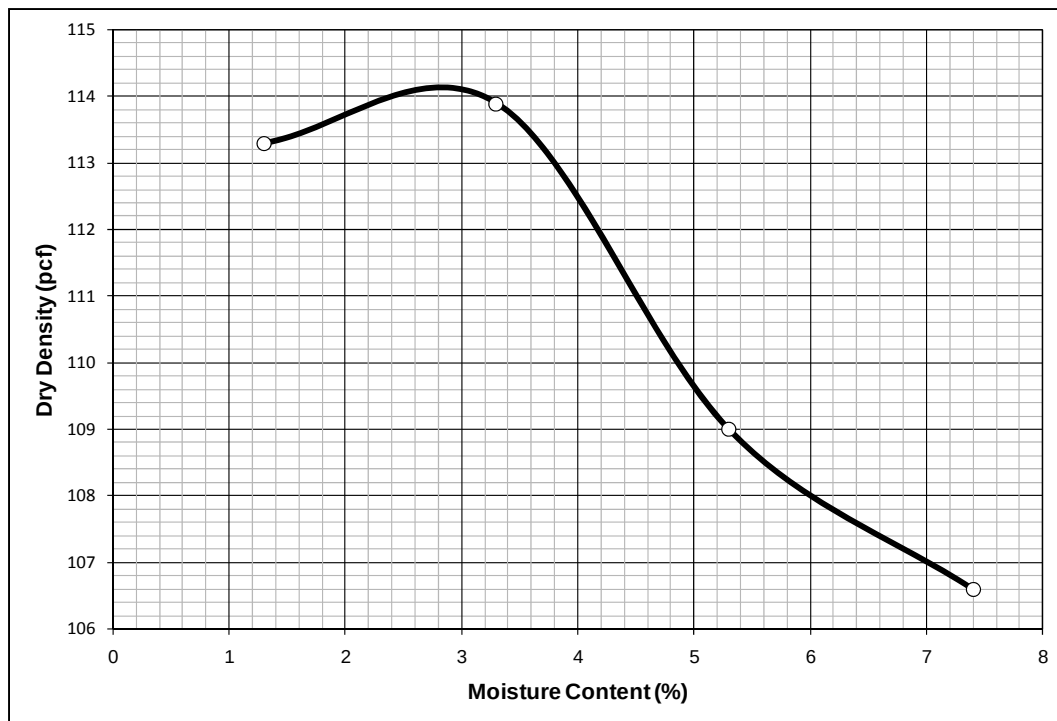
Figure 5. Dry density versus moisture content for blended GM base course.

Laboratory results indicate that the GM blend has an estimated specific gravity of 2.7, optimum moisture content of 2.6 percent, and a maximum dry density of 114.2 pcf. Figure 5 shows the Proctor curve developed by the MTC for the GM blend. The MTC followed ASTM D 698-07 Method C (ASTM 2007b) and ASTM D 1883-07 specifications for the testing (ASTM 2007a).

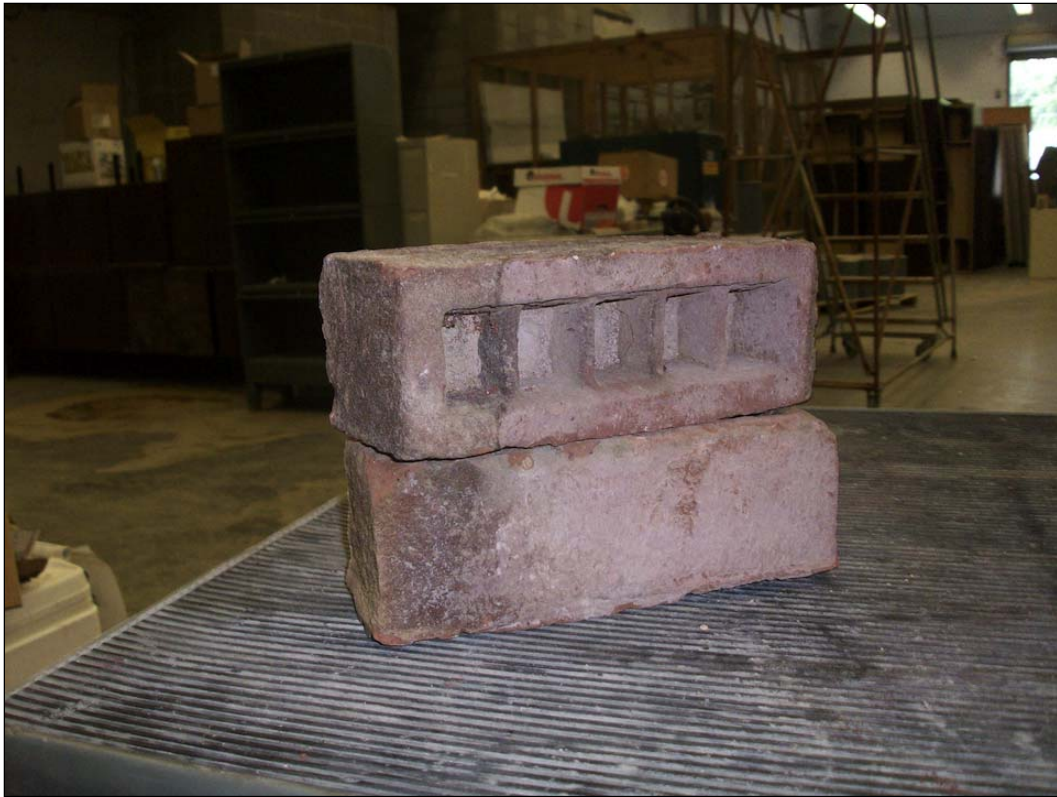
Figure 7. Queen brick.

The brick distributor noted that the queen bricks are most likely what is used in areas such as Afghanistan. This was confirmed with employees of the U.S. Army Corps of Engineers, Afghanistan Engineer District (Reed Freeman, e-mail and telephone interviews, November 5, 2010; Gregory Hales, e-mail interview, November 9 and 10, 2010; John P. Heard, e-mail interview, November 8, 2010). These particular bricks were cast in a wood mold and fired in a kiln. This type of process and brick appearance likely are indicative of the type of bricks used in more primitive parts of the world. Figure 7 shows the queen brick used in the test section.

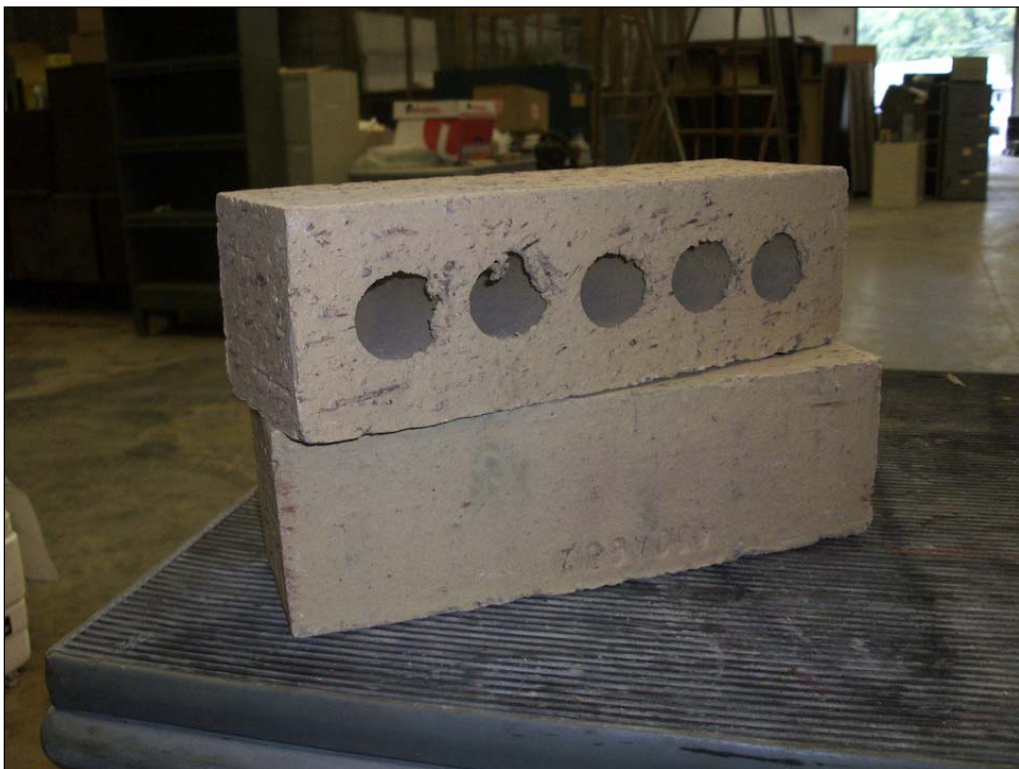
Figure 8. Utility brick.

The utility brick types are commonly used for commercial buildings because their larger size allows for a more efficient laying practice (Figure 8). The reclaimed bricks were gathered from an old burned building in Chicago (Figure 9). Reclaimed bricks are not as durable as other face bricks because of their worn edges and irregular shapes.

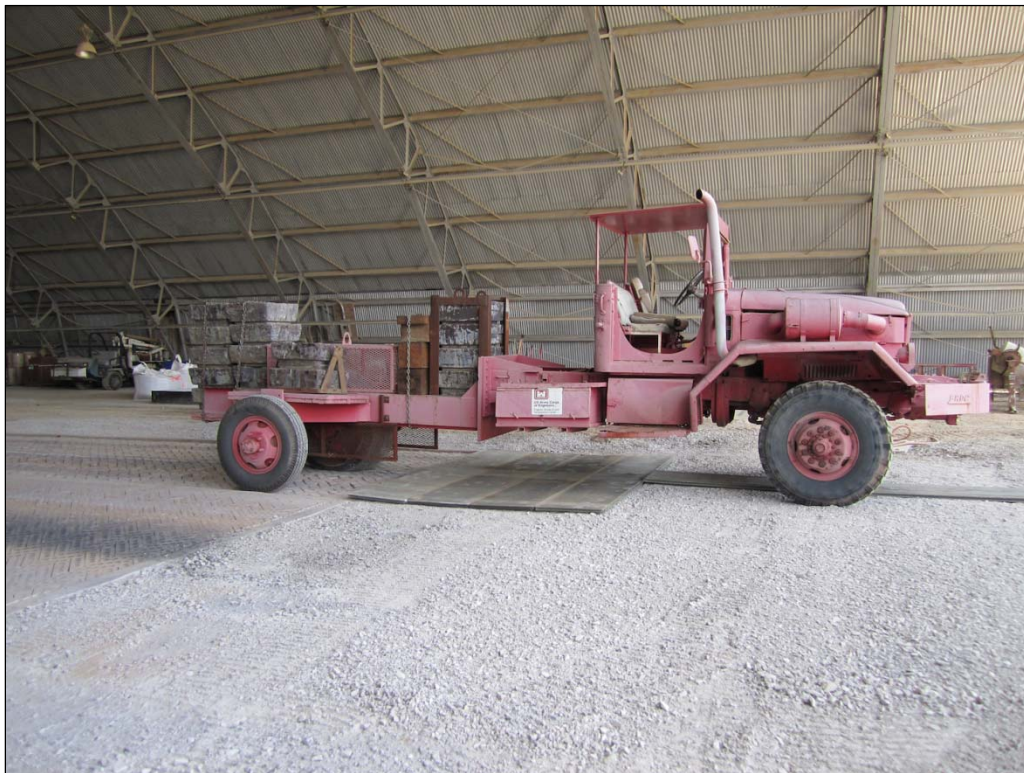
Figure 29. Single-wheel C-17 load cart.

approximately 42,000 lb and a tire pressure of 142 psi, was trafficked down the center of each item in a channelized pattern. Trafficking was to conclude at 1,000 passes or shortly after the test item failed. The failure criterion for military aircraft traffic on flexible pavements typically is based upon 1 in. of surface rutting. Figures 29 and 30 show the single-wheel C-17 load cart on the test section.

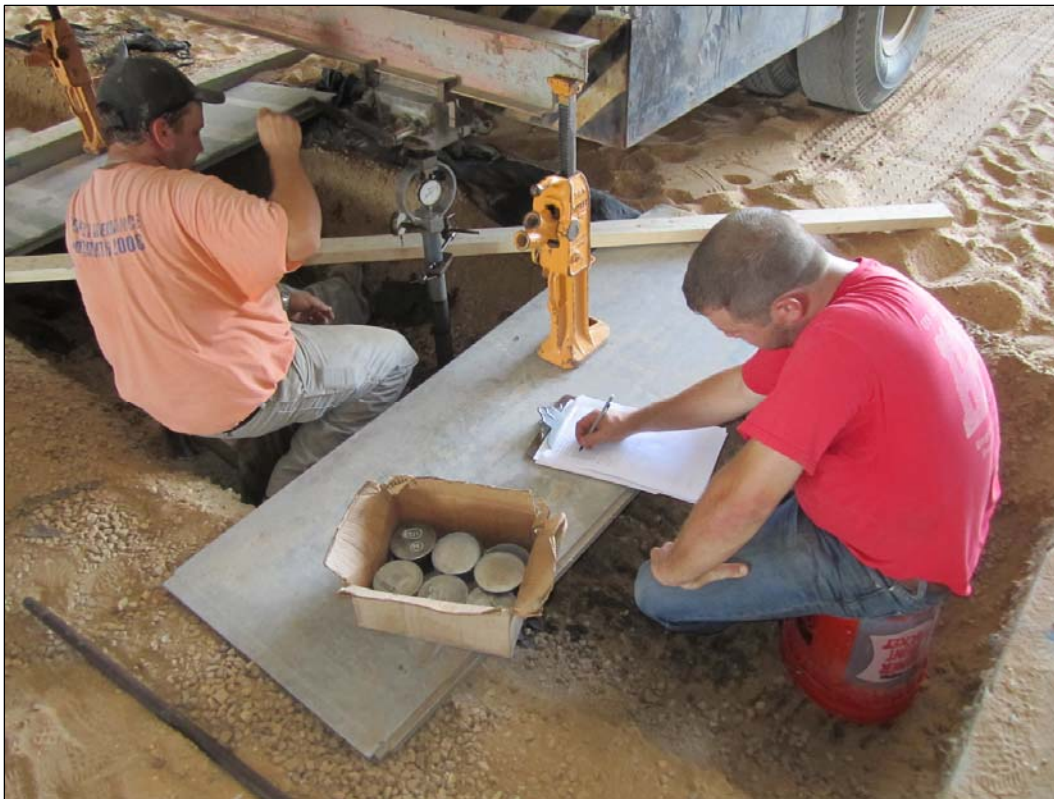
Figure 34. Subgrade CBR testing in trenched test item.

After all trafficking of the test section was completed, a 3-ft-wide trench was excavated across the center (Station 20) of each test item for forensic investigation. Each layer of the pavement structure at the center of the C-17 wheel path rut and in areas outside of the rut was removed and assessed. DCP tests, CBR tests, and oven moisture tests were completed at each location on each foundation layer (Figure 34). Furthermore, rod and level cross-section profile measurements (6-in. increments) were performed on the surface of each layer to aid in determining where failure occurred.

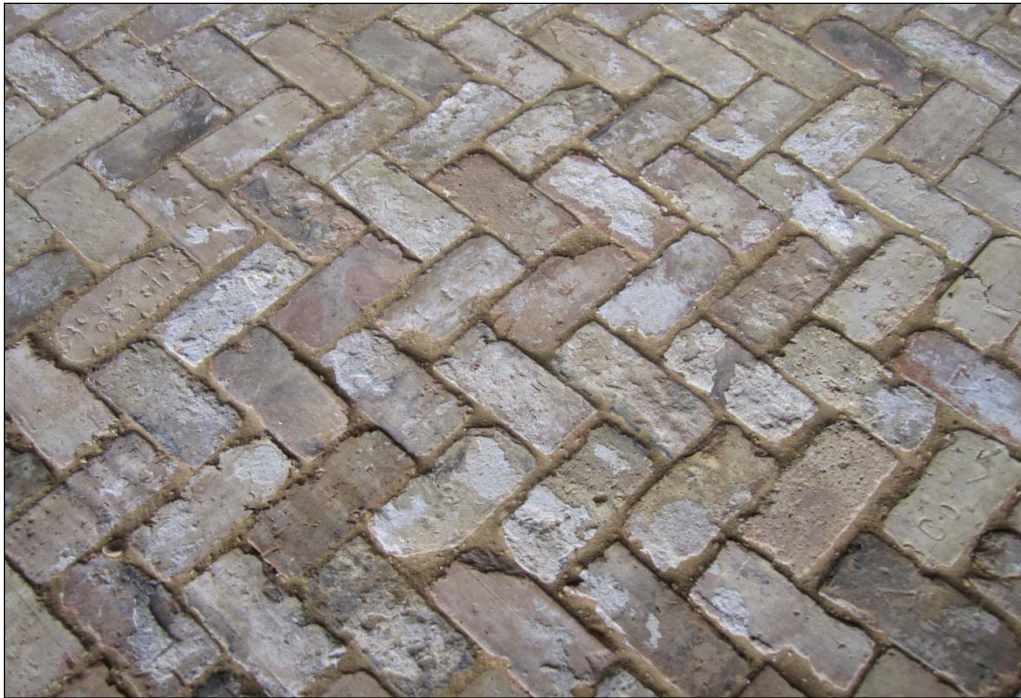
Figure 41. Reclaimed bricks before truck traffic.

Item 2 consisted of recycled bricks. Figure 41 shows the bricks before trafficking. The recycled bricks performed adequately to 10,010 passes without failure. Note that the laboratory tests revealed an average compressive strength of only 3,500 psi and a 44 percent loss in material measured with the LAA tests.

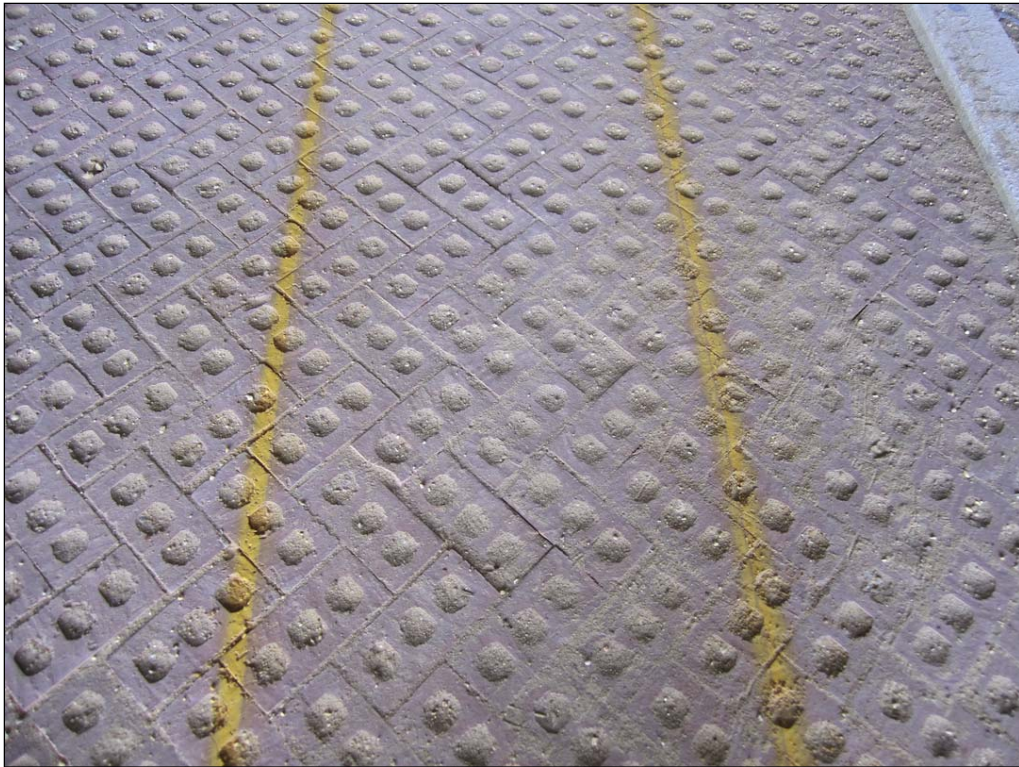
Figure 48. Item 3 wheel path before truck traffic.

Figure 48 shows the bricks in the wheel path before the truck trafficking began. After the 10,010 pass cap, there was only slight upheaval outside of the wheel paths (approximately 0.25 in.). Figure 49 shows the area where the most upheaval was observed following traffic completion. There also were a few broken bricks within the test item beginning with about pass 1,200; most were broken in half.

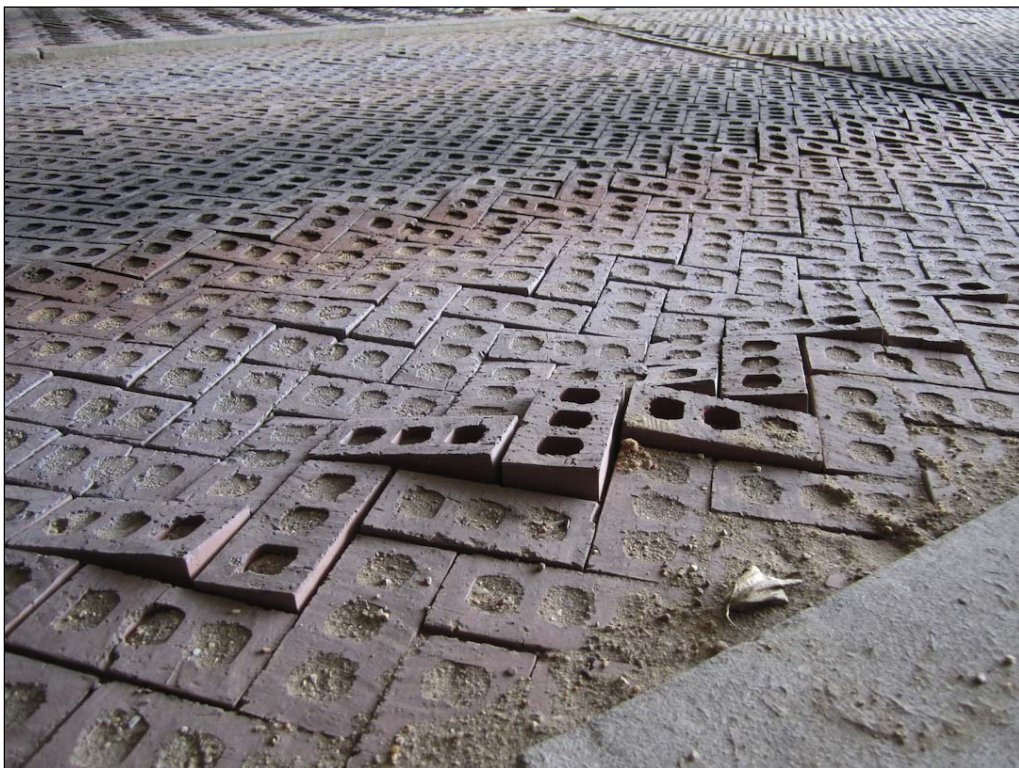
Figure 49. Item 3 wheel path at 10,010 passes of truck traffic.

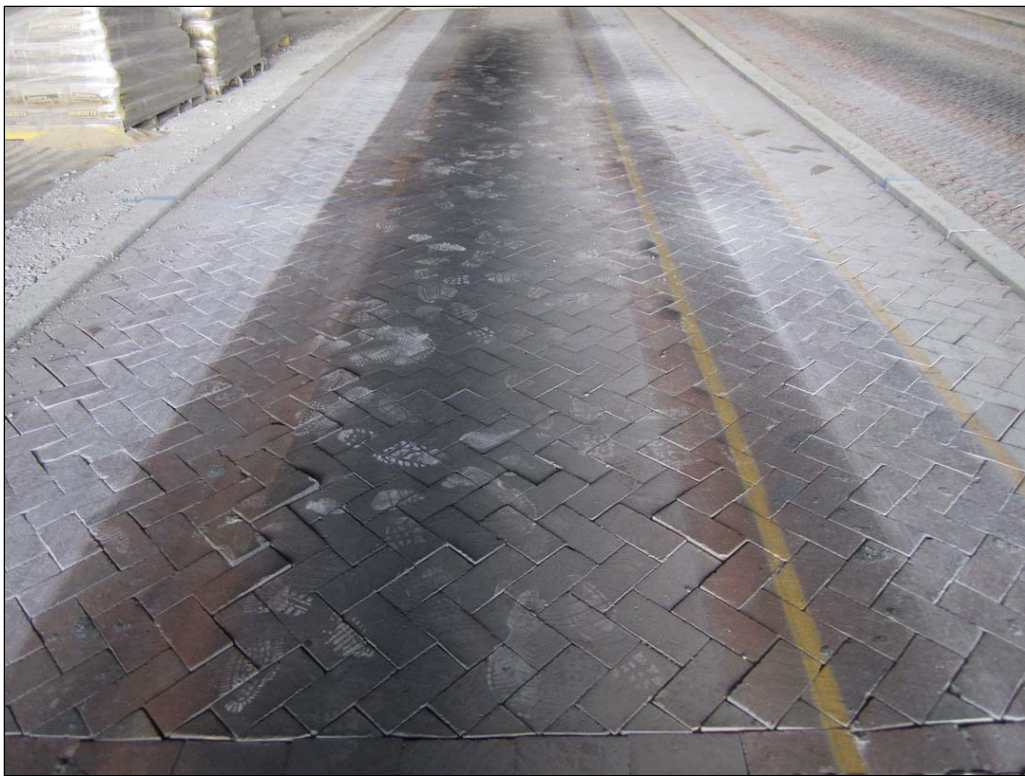
Figure 63. Item 5 overall view at 10,010 passes of truck traffic.

Item 5 was trafficked to 10,010 passes without being close to the 3-in.-deep rut failure point. The brick pavers were observed to begin shifting upward at the corners outside of the wheel paths around 2,400 passes. Almost no brick pavers were broken during the truck trafficking. Figure 63 shows the brick pavers at 10,010 passes.

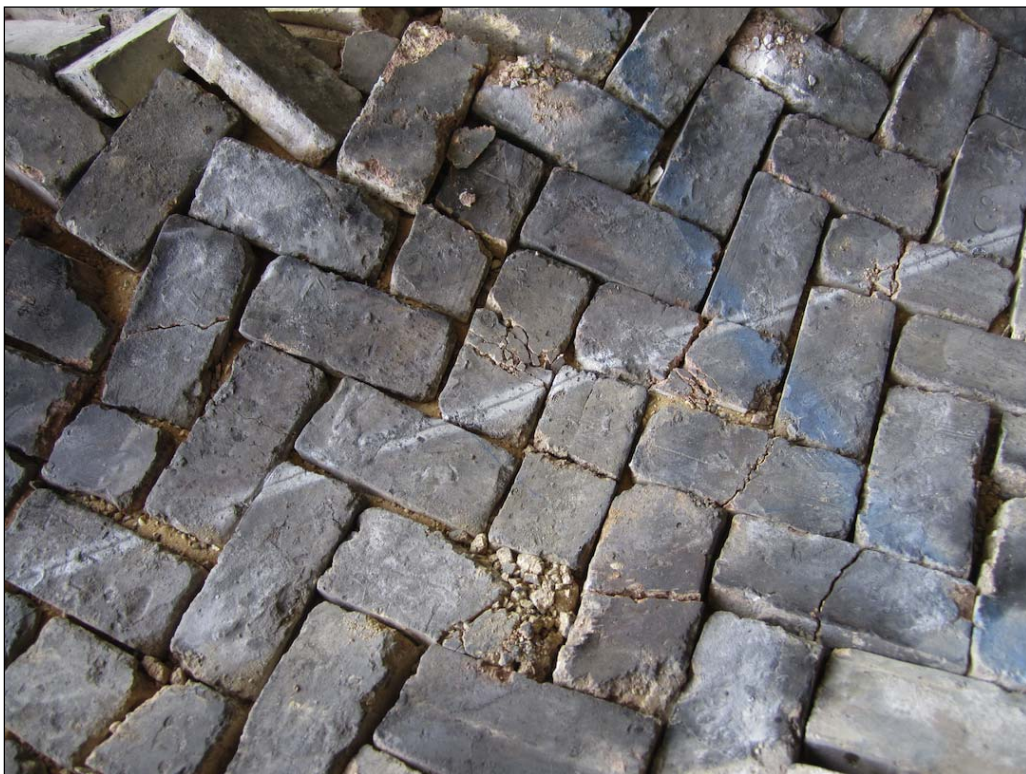
Figure 82. Center of wheel path of Item 2 at 44 passes of C-17 traffic.

Item 2 consisted of the reclaimed bricks. Measureable rutting was observed with the first pass of the C-17 load cart. Traffic was completed at 44 passes with average surface rutting beyond the failure point of 1 in. The reclaimed bricks were not able to handle the C-17 aircraft load. Figure 81 shows the rutting in the test item at 16 passes. Many of the bricks were broken or had crushed corners during trafficking. Figure 82 shows the bricks in the center of the wheel path at 44 passes.
