Role of NDI in ABDR Assessment, Equipment & Logistics

Italian Air Force – Flight Test Center – Chemistry Department
“M. De Bernardi” AFB
00040 Pomezia (Rome)
Italy

This paper deals with NDT techniques applicable for battle damage assessment, particularly focusing on composite airframe inspections, showing advantages/disadvantages of each method in ABDR context.

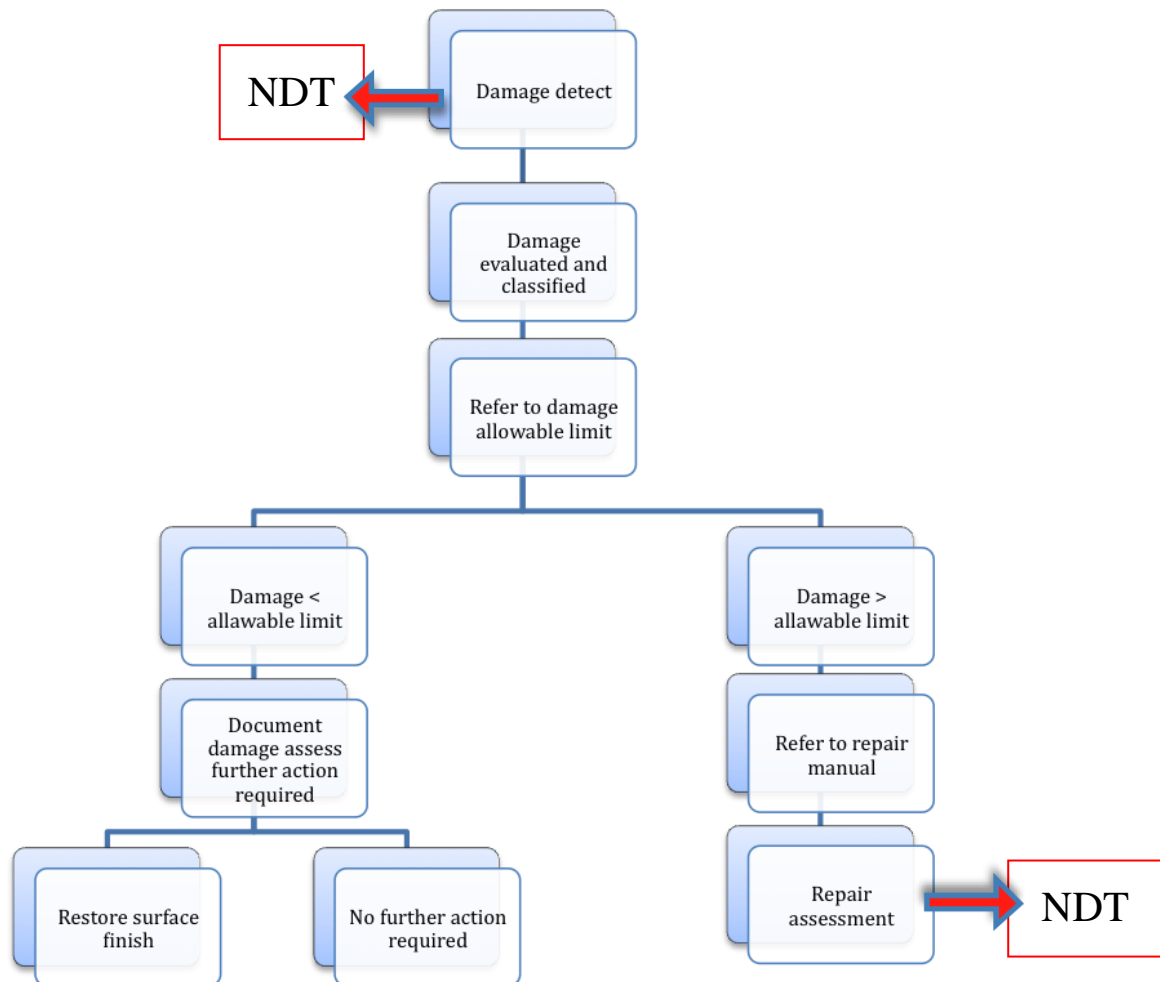
Figure 1

Damage assessment is one of the most important step during ABDR procedures application. Although ABDR/ABDAR manuals do not generally provide description of how performing damage assessment, this phase is critical and naked eyes inspections are usually not enough accurate to correctly define damage extension and depth. Hence NDT can be a useful tool to improve inspection capability, playing a key role also during repair assessment especially in the case of bonded patches, adhesive tape or co-cured laminates applications (figure 1).

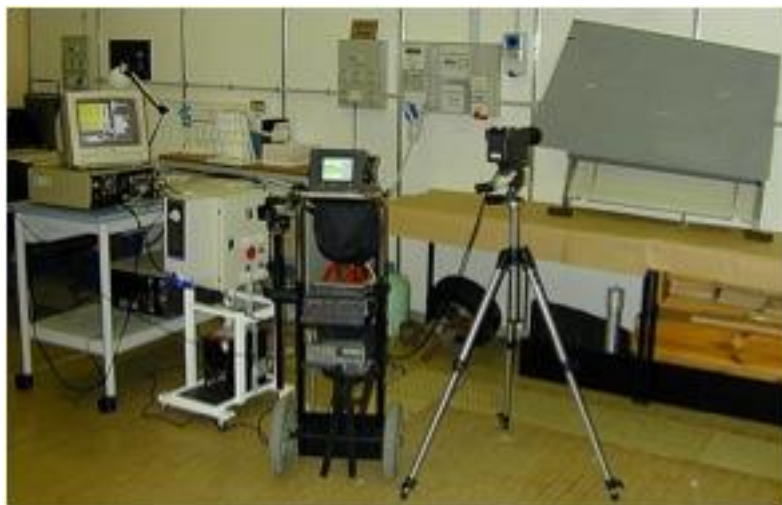
Figure 5

This technique is based on a thermo-camera that measures materials infrared emission when they are heated with a proper artificial light (figure 5).

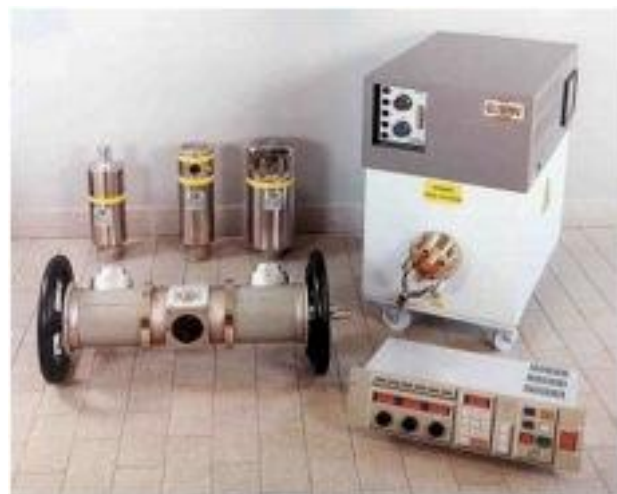
Figure 7

In figure 7 is shown X-rays equipment made of Coolidge X-rays tube, a transformer and a control panel.

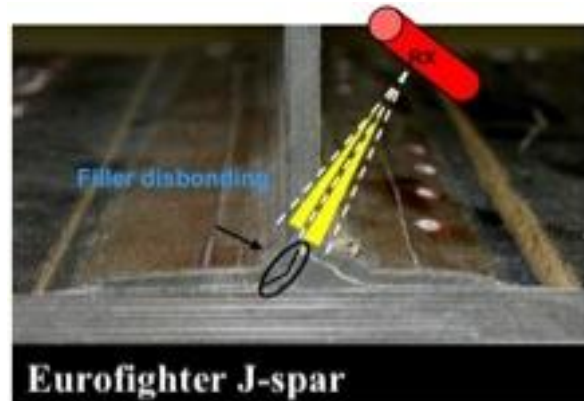
Figure 9

In general, this technique does not detect damages, such as delamination or disbonding of composite materials, which are parallel to the external surfaces. On the other hand, it is very efficient to assess J-spar (figure 8) items integrity. On this kind of structures US probes are not able

to follow the J-stiffener curvature while X-rays can be easily applied (figure 9). RX technique is very reliable also to assess the presence of water into honeycomb structures.

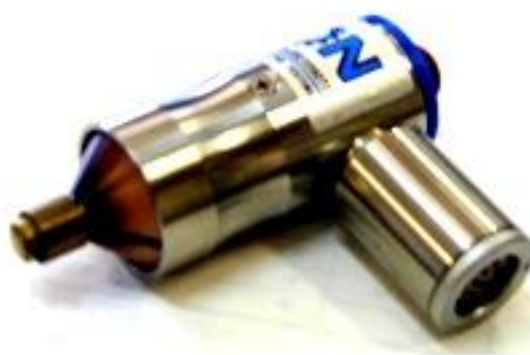
Figure 13

MIA is mainly used to investigate bonded structures and it is based on stiffness variations. This method can be considered as an “advanced” Tap Testing because it is basically based on the same physical principles. Although this technique can be applied with every kind of material, it is usually used for composite laminate and honeycomb structures to detect respectively disbonding and core crushing. It is independent on material nature, does not require a coupling medium like US and uses a single transducer for all the applications (figure 12). MIA probes (figure 13) need a little contact surface and they can hence work also on very curved components.

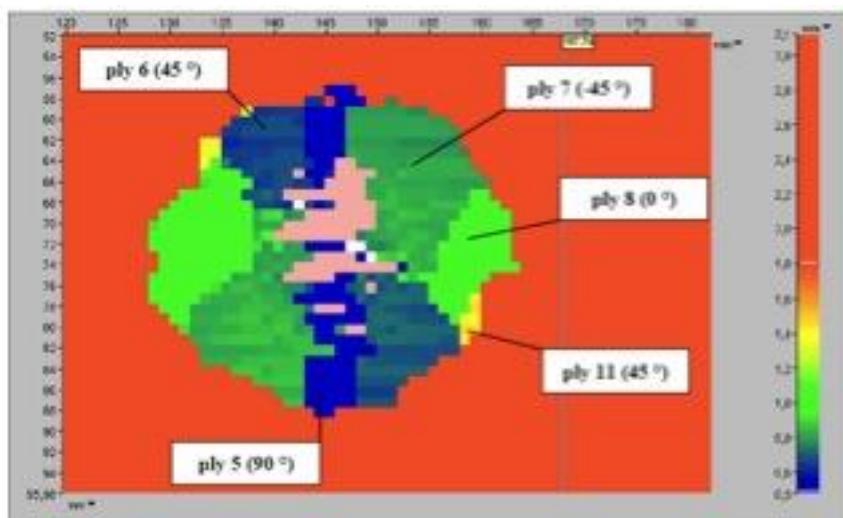
Figure 20

Visual inspection did not generate any results hence the low velocity impact does not produce damage clearly observable at naked eye, while detection of each delamination occurred between the plies through the specimen thickness is possible by improving the resolution of the thermal map and of ultrasonic C-scan and by focusing the inspection on the impact area (figure 20).

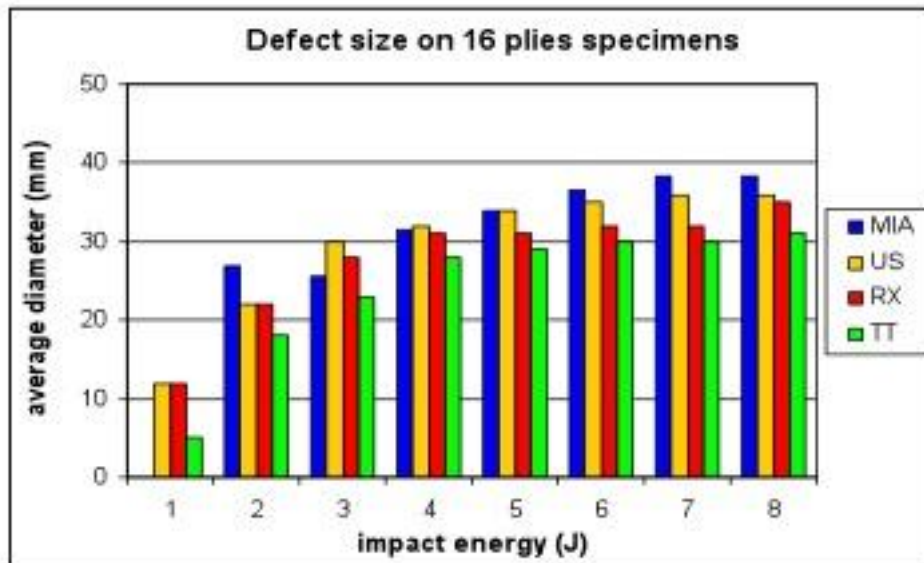
Figure 21

About damage detection, as shown by the histograms in figure 21, all applied methods detected the defects, even if in the case of small defects only US and RX techniques exhibited a good sensitivity and reliability. However, TR technique showed good results and the shortest time analysis while, on the contrary, RX resulted the most elaborated and the worst time-consuming approach.

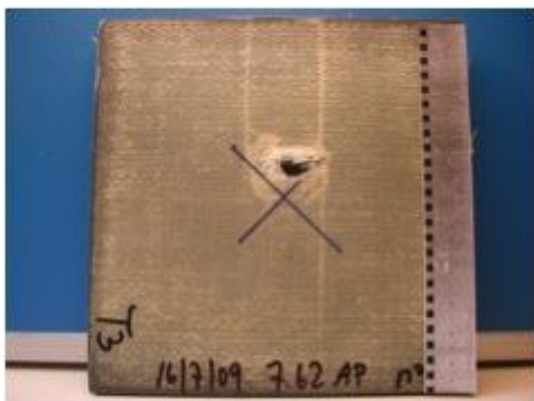
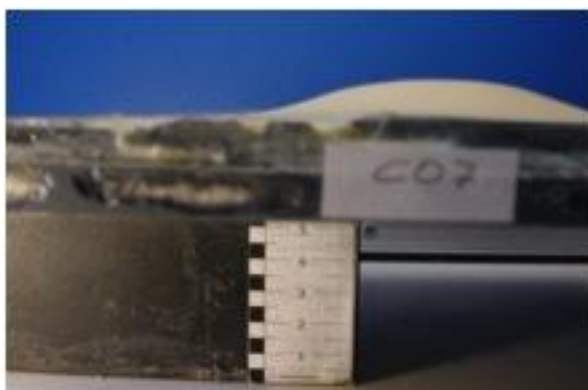
The damages occurred on the panels are showed in figures 25 and 26.

Bulging damage

Figure 26: ceramic/Kevlar panel (T3 configuration)

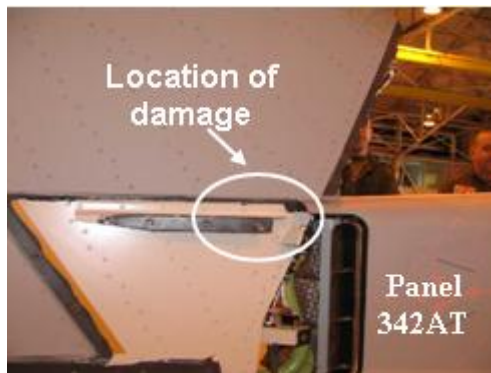
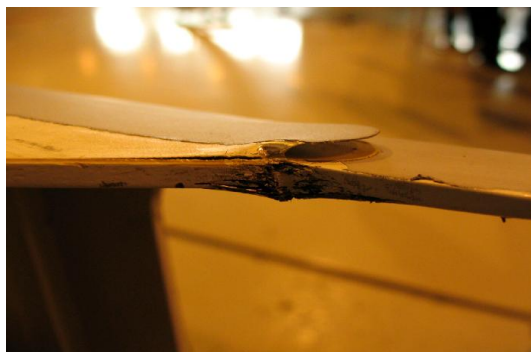
Figure 29

An example is the edge delamination occurred on the fairing 342 AT (figure 29a), which is subjected to damages (figure 29b) at the rear edges due to insufficient clearance between the pre-cooler panel and the base of the fin. A rework of the rear edges has been established to avoid the problem, that means a cut of the grey area in figure 29c followed by an US inspection (manual pulse-echo with a 5 MHz probe) of the new edge, represented by red area in figure 29c, to ensure absence of any remaining damage. In this case NDT is not used to detect the damage but only to assess the rework/repair effectiveness (figure 30).
