Structural, Material, and Geotechnical Solutions to Levee and Floodwall Construction and Retrofitting – Physical Modeling

December 2012

Final report

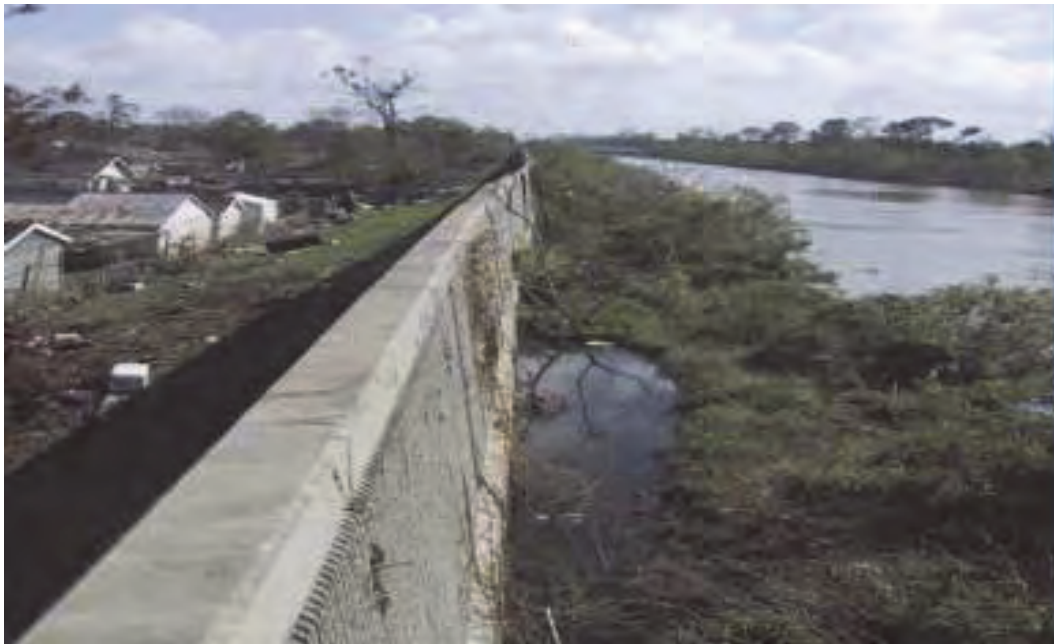
Figure 1. London Avenue Canal floodwall (I-wall) depicting wall deflection failure pattern. The I-wall is composed of concrete wall sections supported by steel sheet piles.

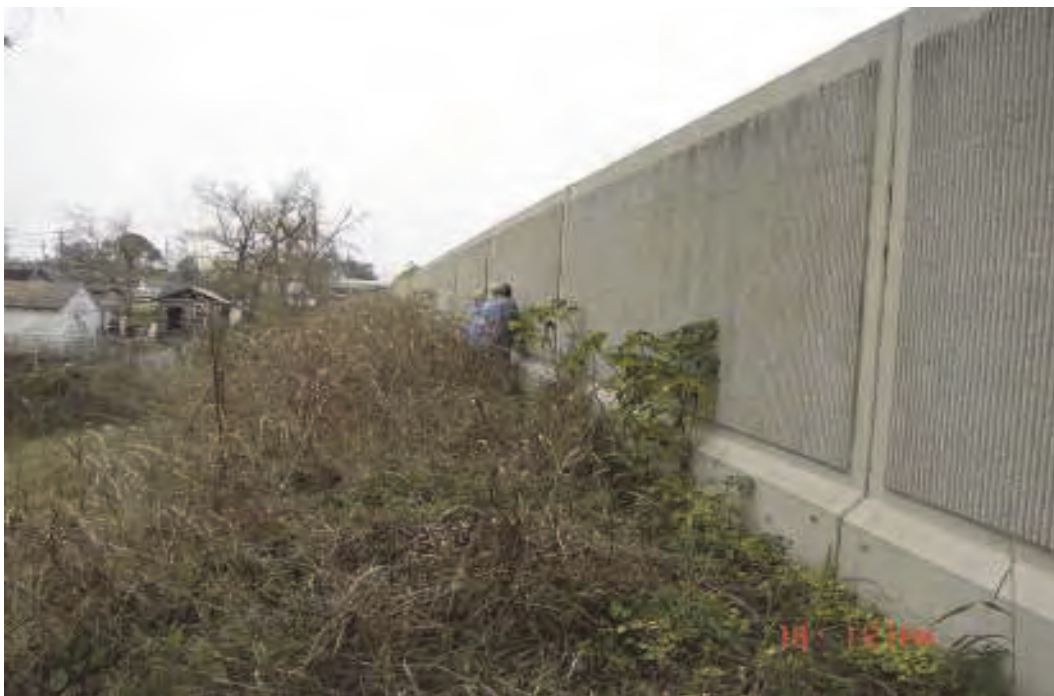
Figure 2. London Avenue Canal I-wall showing joints between panels spaced approximately 30-ft-apart.

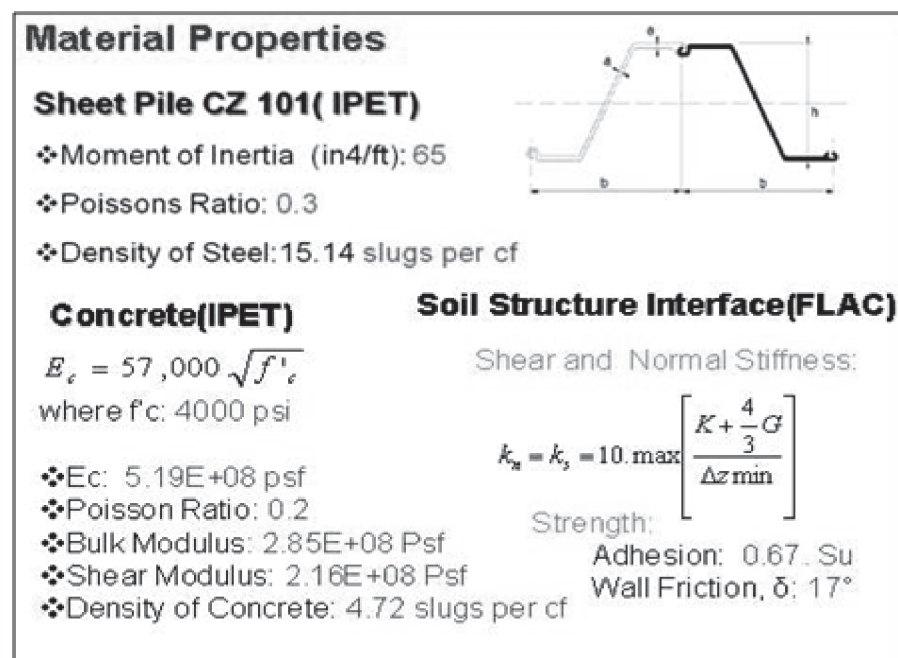
Figure 5. I-wall material properties (from Adhikari 2009).

UMiss conducted numerical modeling, Fast Lagrangian Analysis of Continua (FLAC) of the London Avenue Canal, New Orleans floodwall system, using the materials and dimensions shown in Table 1 and Figures 5 through 7 (from Adhikari 2009).

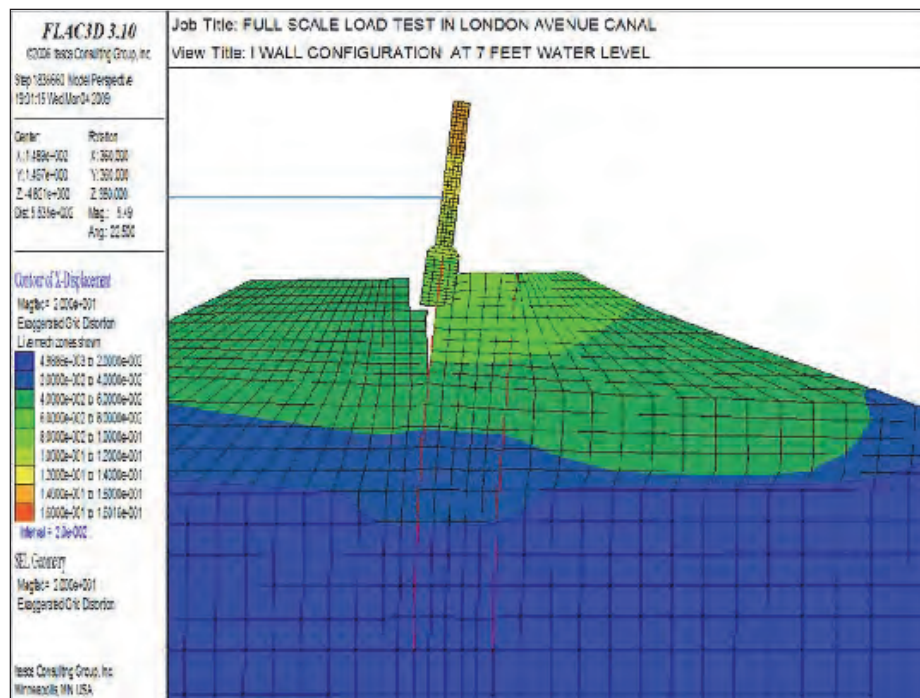
Figure 6. Numerical modeling results showing two-dimensional deflection at 7-ft water level (from Adhikari 2009).

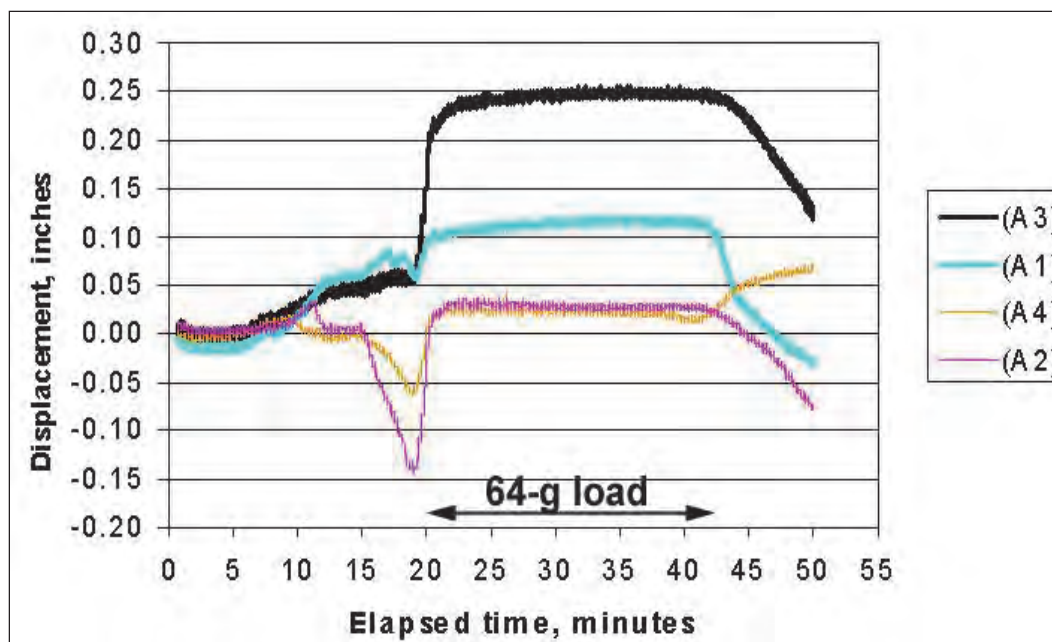
Figure 30. Test 1 laser (relative) displacement results. Positive displacement is toward the landside of the levee. Note the negative (toward the water) relative displacement of plates A2 and A4 during initial water inflow.

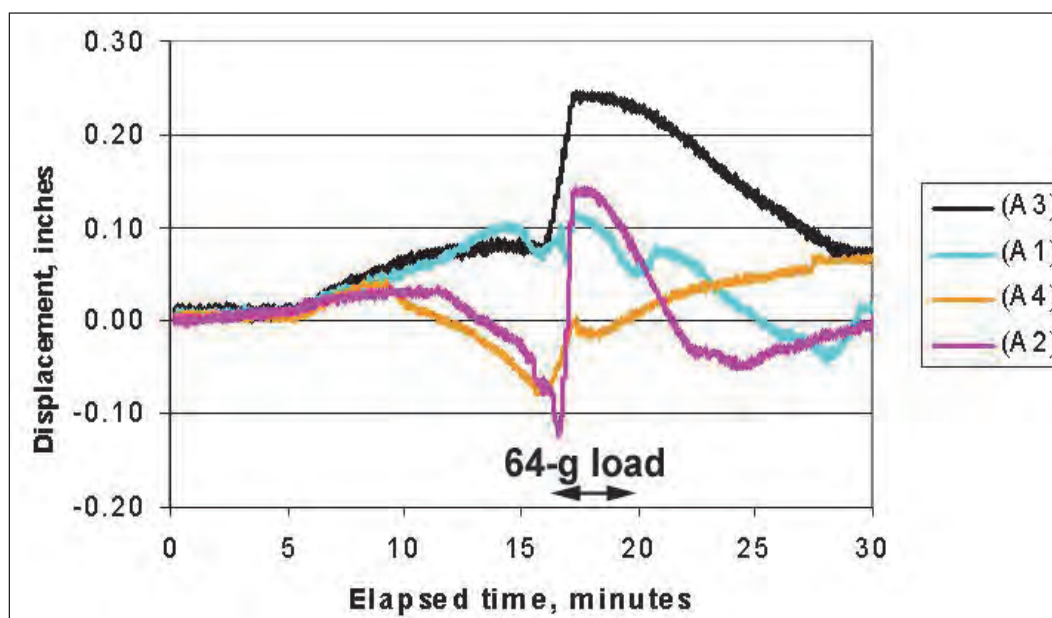
Figure 31. Test 2 laser (relative) displacement results. Positive displacement is toward the landside of the levee. Note the negative (toward the water) relative displacement of plates A2 and A4 during initial water inflow.

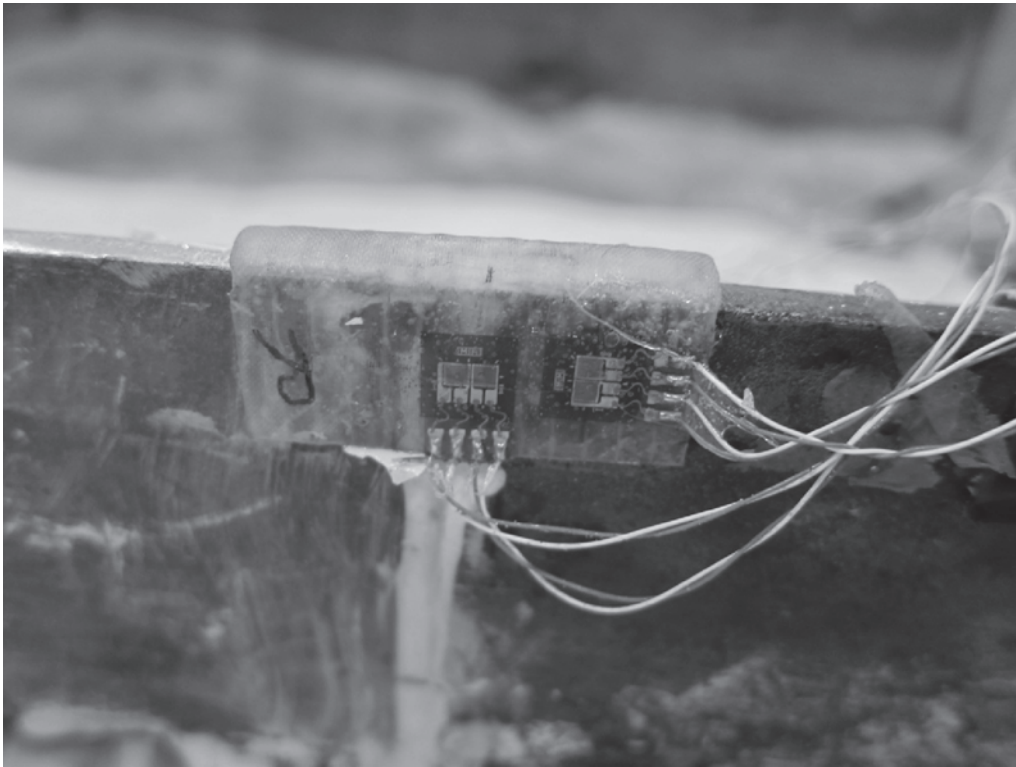
Figure 41. Instrumented polymer clip placed over two I-wall sections.

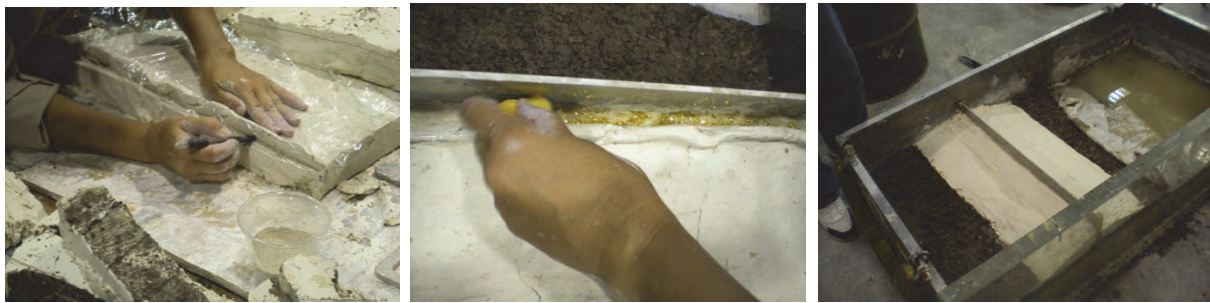
Figure 45. “Trenching” the levee, pouring in the filler, completed levee model.

Model construction for Test 8 was very different from that of previous test models. A single wall panel was used instead of the multiple I-wall sections to focus on the gap filler mitigation method. The sand and bentonite mixture was laced with gold glitter to facilitate tracing the movement and final position of the filler material. Construction of the levee sections from consolidated clay was standard practice. The riverside levee section was the mitigated side, where a 1-ft-square trench was “grooved” into the side of the levee 1 ft (prototype scale) below the crest (see schematic in Figure 44a). A thin plastic sheet (saran) was used to encase the filler to prevent in-place expansion and to facilitate the fall of the filler into a gap (Figure 44b). The plastic sheet was trimmed so that it was in contact only with the clay levee and not with the I-wall. The crest part of the grooved clay was peeled back to expose the trench. The bentonite-sand mixture was then placed against the I-wall in the model container. Once the levee section was in position, the filler mixture was poured into the trench; and the clay was folded back over to cover the fill. Various model construction procedures are shown in Figure 45. The model was spun up to 64-g. Failure of the I-wall occurred shortly after the specified g-force was reached.

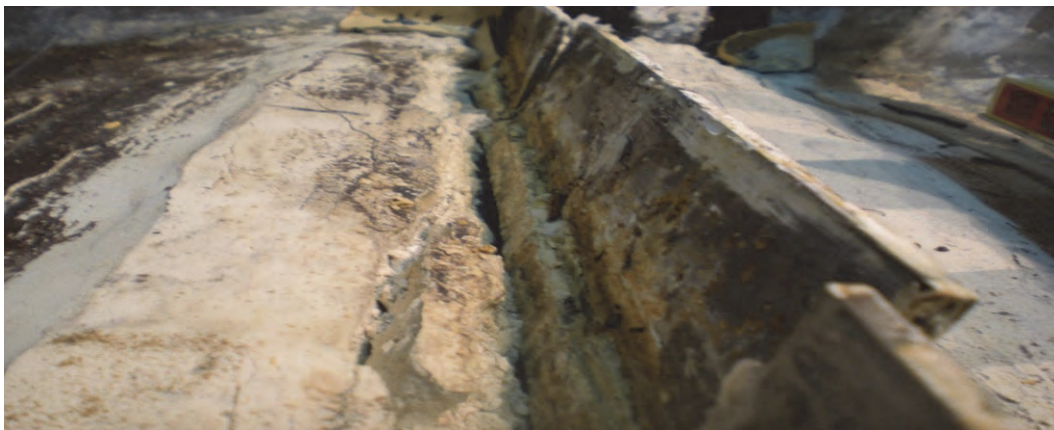
Figure 46. I-wall failure occurred without the clip mitigation.

The London Canal Avenue levee model without mitigation failed. Figure 46 shows the I-wall failure.

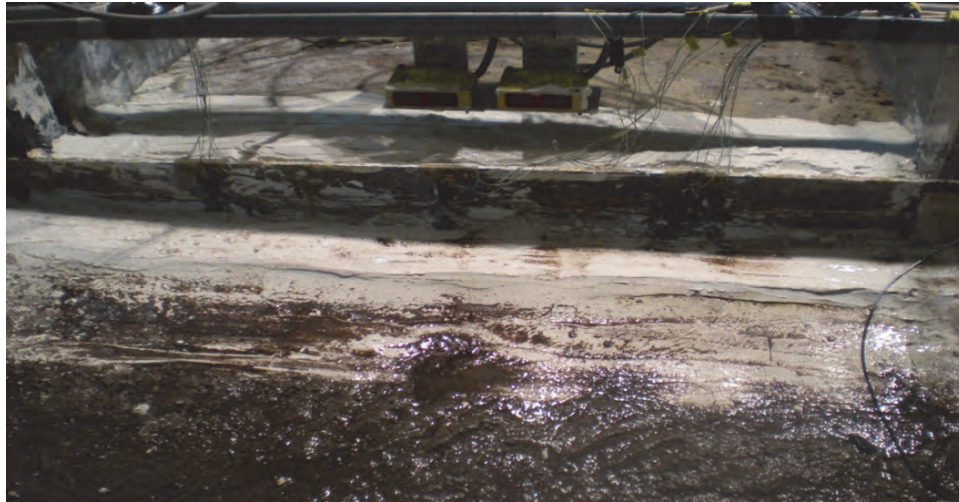
Figure 47. Test 4, London Canal Avenue I-wall sections with the clip mitigation did not fail.

The London Canal Avenue levee model with three polymer clips (sample 4) did not fail. This was a retest of Test 3 with modifications to the instrument-

ation. Because the I-wall did not fail at 64-g, the level was raised to 100-g in an attempt to induce the failure. Laser gages showed slight wall movement at 100-g, but no failure occurred and centrifuge testing was terminated. See Figure 47 for post-test results.

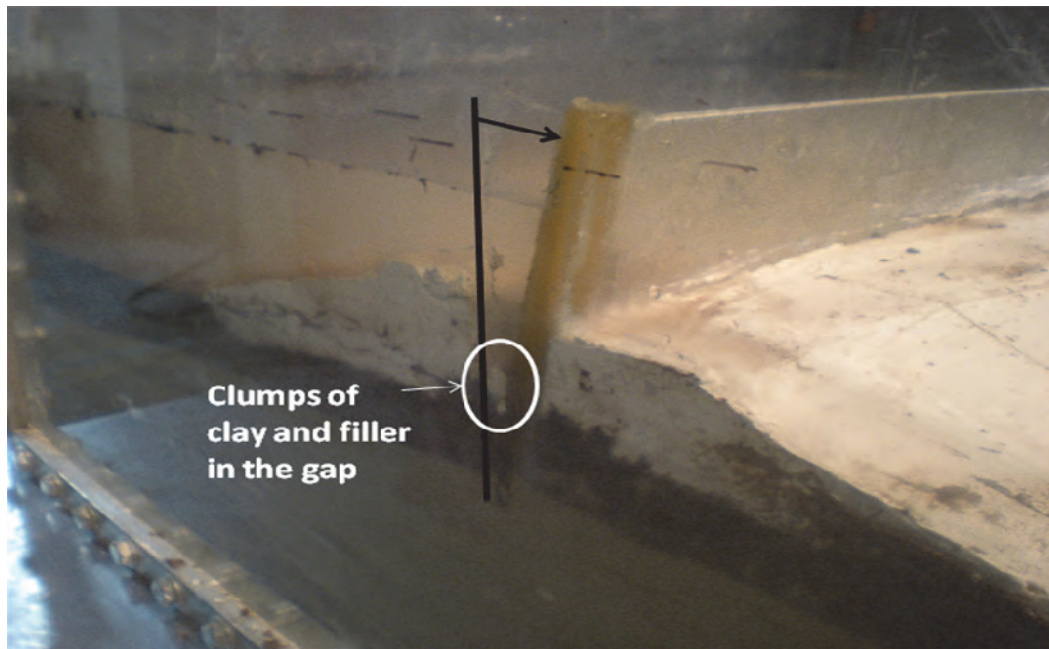
Figure 50. Visible clumps of clay and filler in the gap after a centrifuge test.

The London Canal Avenue levee model was tested with the gap filler. Figure 50 shows the gap opening filled with clumps of the clay (levee) before the water was drained out of the container. Some of the filler expanded in place and stuck to the I-wall at several places, as shown in Figure 51. The rest of the filler, along with the plastic wrap, fell into the gap roughly 5 ft (scaled) from the crest, or 3 ft from origin.

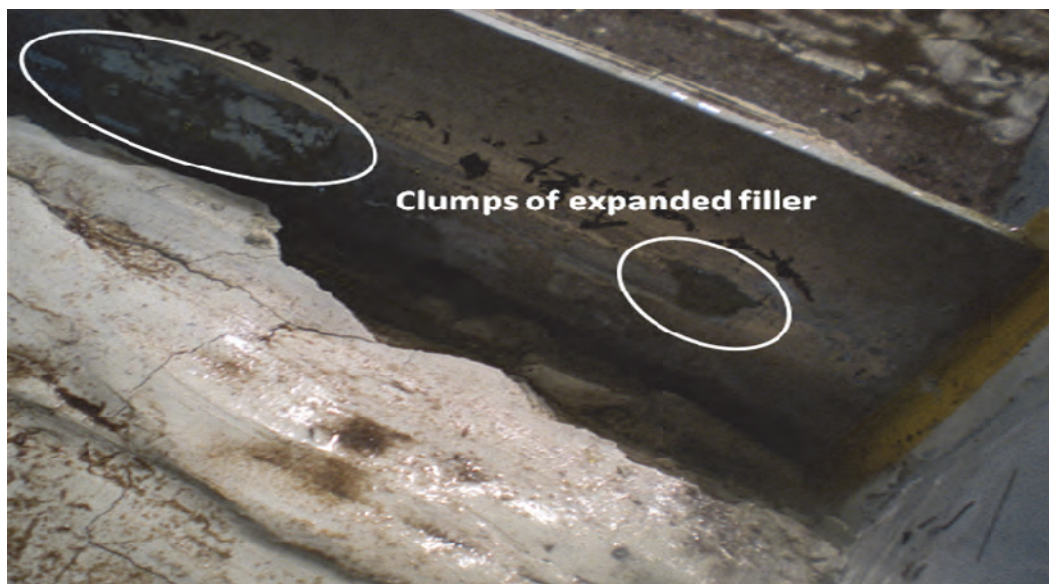
Figure 51. Filler that expanded in-place was stuck to the l-wall.
