Refractory Metal Liner Processing for M242 Medium Caliber Barrels

by William S. de Rosset and David Gray

ARL-TR-6301

January 2013

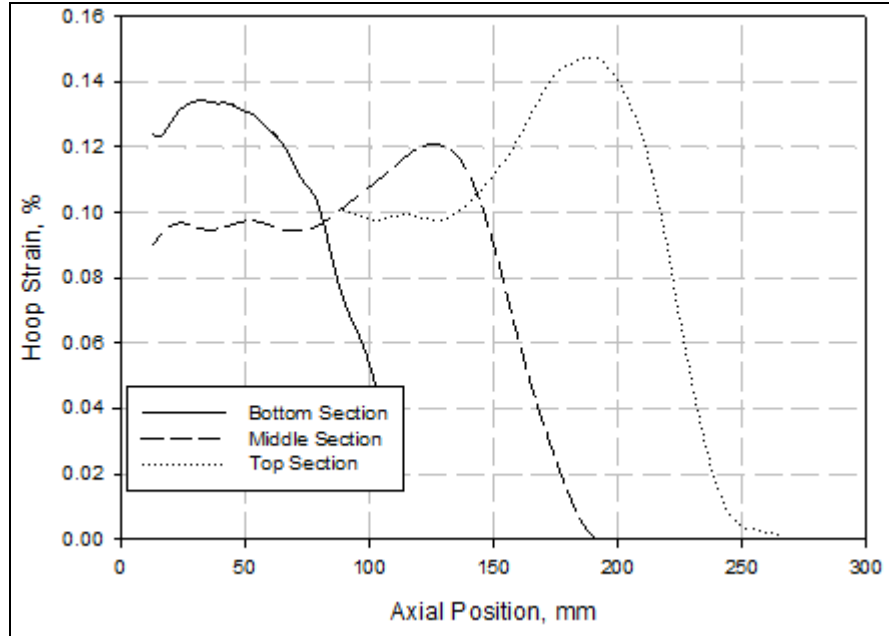
A compression load of 120,000 lb was used for the first cylinder which produced an internal pressure of 152.7 ksi, assuming no frictional effects. This was below the yield point of the steel, assumed to be 160 ksi. Hoop strain measurements are shown in figure 3, taken at the time the maximum load was applied to the elastomer. The origin of the plot is the bottom of the cylinder.

(One-half inch of the bottom of the cylinder is masked by the test fixture, so strain measurements at the very bottom could not be made.) After removal of the elastomer and seals, measurements of the inner diameter of the steel cylinder were taken with a telescoping gage. There was no indication plastic deformation.

Figure 3. Measured hoop strain as a function of axial position for first 12-in steel cylinder.

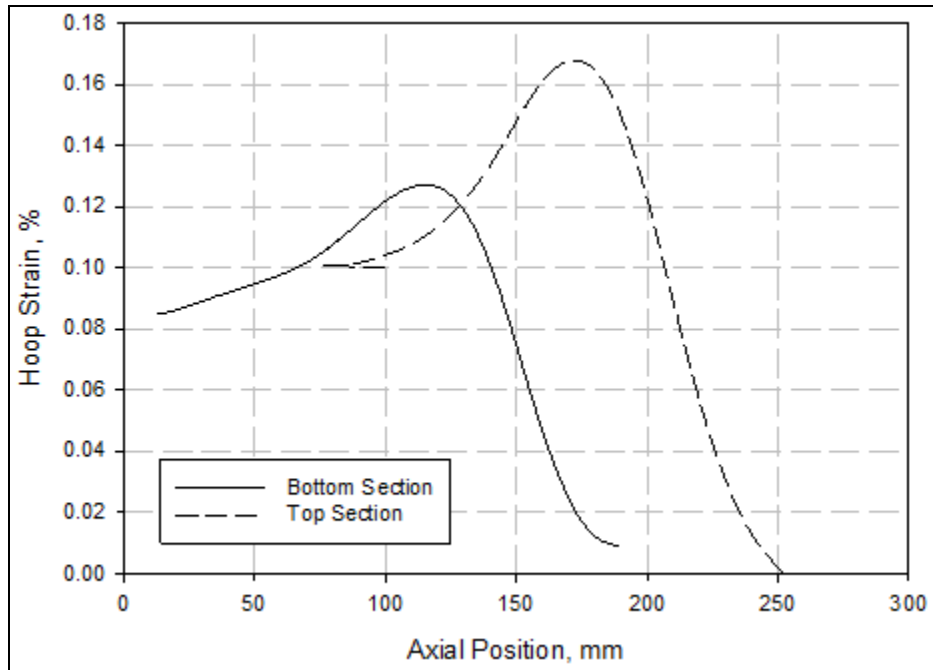
A second steel cylinder was pressurized using an 8-in elastomer section and a 4-in elastomer section. In choosing the 8-in length, a compromise was made. On one hand, the length had to be long enough to reduce the number of steps that would be needed for the truncated M242 tube. On the other hand, the length had to be short enough to reduce the effects of friction down the length of the elastomer section. A compression load of 160,000 lb was used for the second tube in order to obtain some plastic deformation of the steel cylinder; this load gave an internal pressure of approximately 204 ksi. DIC measurements were also used to obtain the strain components on the outer surface of the steel cylinder. Results are shown in figure 4. After the GLEEM process had been applied to the cylinder, measurements of the inner diameter of the steel cylinder were made. There was no noticeable enlargement of the cylinder.

Figure 4. Hoop strain measurements as a function of axial position for the second steel cylinder (8-in and 4-in plugs).

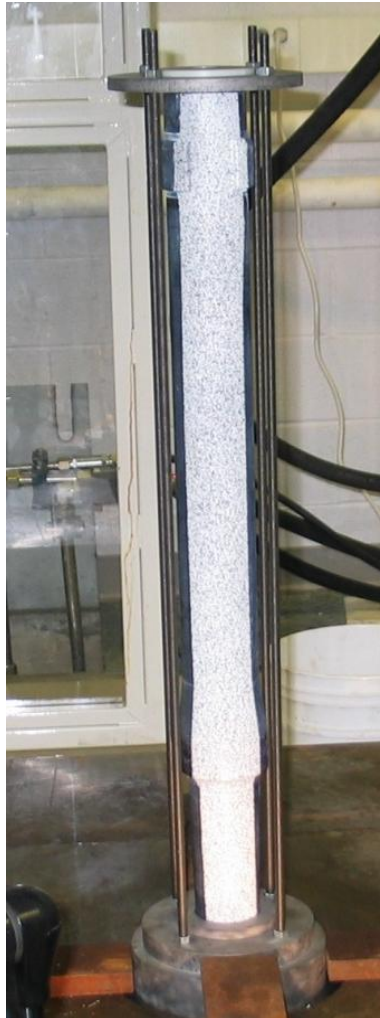
GLEEM processing of the first barrel called for four passes or loadings of the elastomeric material. However, several passes had to be repeated, resulting in a total of eight separate passes being made. The general approach was to use an 8-in long solid bar of Teflon² with a diameter of 1.088 in as the elastomeric material for each pass. Nylon seals were used at each end of the bar. The muzzle end of the barrel was the first portion processed. A picture of the barrel inside the holding fixture is shown in figure 6. The speckle pattern was used for the DIC measurements.

Figure 6. Truncated gun tube in GLEEM testing fixture at full scale.

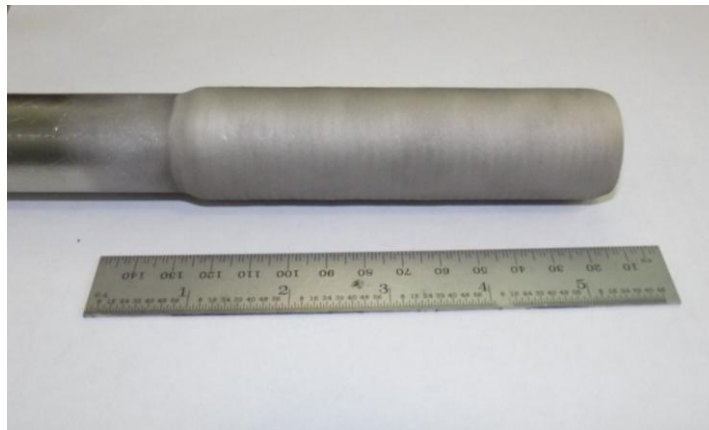
During the test firing of the first barrel, the liner was observed to extend in the tube (see section 6.1). Based on these results, the Stellite 25 liner was modified in an attempt to keep it in place during firing tests of the third barrel. The rear end of the Stellite 25 tube was cold sprayed with pure nickel, then machined so that it could fit precisely inside a matching surface of the gun tube. The small shoulder was expected to provide enough resistance to keep the liner in place during the firing trials. Figure 10 shows the end of the Stellite 25 tube after it has been cold sprayed.

Figure 10. Picture of Stellite 25 tube with nickel cold-sprayed at one end (not machined).

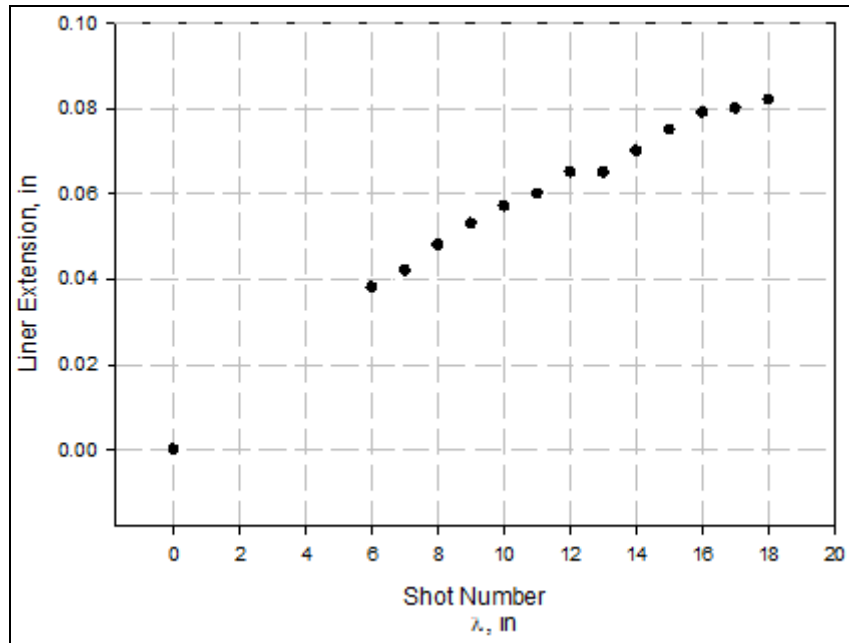
Firing of the first barrel continued in test facility 162A, building 390 at ARL. After the first shot, the liner extension out of the barrel was measured at a particular spot. Measurements were taken at this position for the remainder of the tests so that a consistent set of values was obtained. The results are shown in figure 11. The measurement taken after the eighteenth shot was 0.082 in. While the rate of liner extension out of the tube appeared to be decreasing with the shot number, it was still too large to be acceptable. A least squares fit to the data indicated that the liner moved 4.3×10^{-3} in (1.6×10^{-4} mm) per shot.

Figure 11. Liner extension versus shot number for barrel number 1.

The fact that the total liner extension observed for the first barrel was more than the measured liner displacement at the breech of the gun (0.082 in vs. 0.027 in) suggests that the extension is due to both liner displacement and liner stretching. This hypothesis was supported by the test results for the third barrel. Here, the rear of the liner was pinned in place by the cold-sprayed nickel shoulder. However, a liner extension of 0.062 in after 45 shots was observed. This extension must be due only to liner stretching. On a per-shot basis, the stretching of the liner in the third barrel is much less than that observed for the first barrel (0.0014 in/shot versus 0.0032 in/shot).

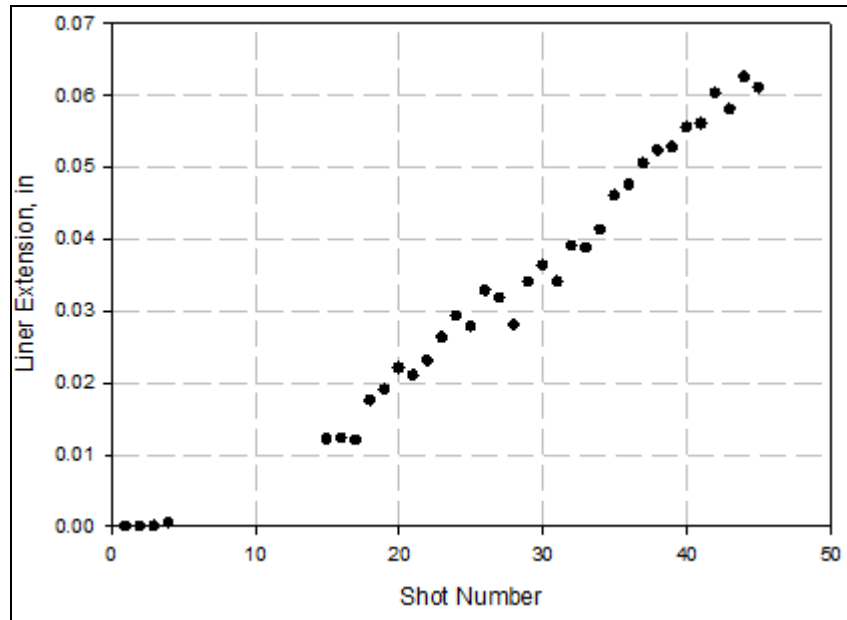
After 16 more firings, the firing pin in the breech mechanism broke, and tests were suspended until a new firing pin could be obtained. When testing resumed, the remaining 14 shots were fired. Figure 12 shows the measured liner extension as a function of shot number. A least squares fit to the linear portion of the curve indicated that the liner moved 1.7×10^{-3} in (6.7×10^{-5} mm) per shot. Figure 13 is a photograph of the muzzle end of the gun tube showing the liner extension after completion of all the firing tests.

Figure 12. Liner extension versus shot number for barrel number 3.
