Underwater Sensor System 2009 Field Trial Report

Northern Watch Technology Demonstration Project

Technical Memorandum

DRDC Atlantic TM 2010-241

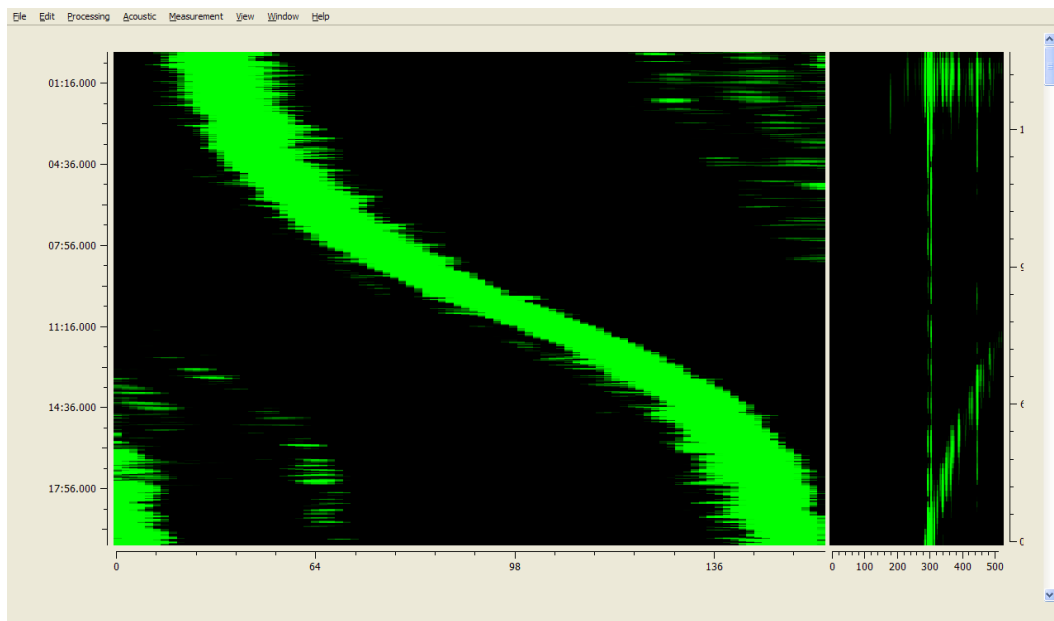
Figure 23. A bearing time history is shown on the left for the Bremen shown in Fig. 22. The plot on the right shows a FRAZ display at a moment when the ship is near end-fire of the array.

Figure 21 shows the resulting sonagram generated with data from Array 2 as the *Bremen* passed the CPA (closest point of approach). Using a 300-m telephoto lens we were able to photograph the ship in poor light and mist conditions of early morning (Fig. 22). The ship was at a range of approximately 8 km when it was photographed.

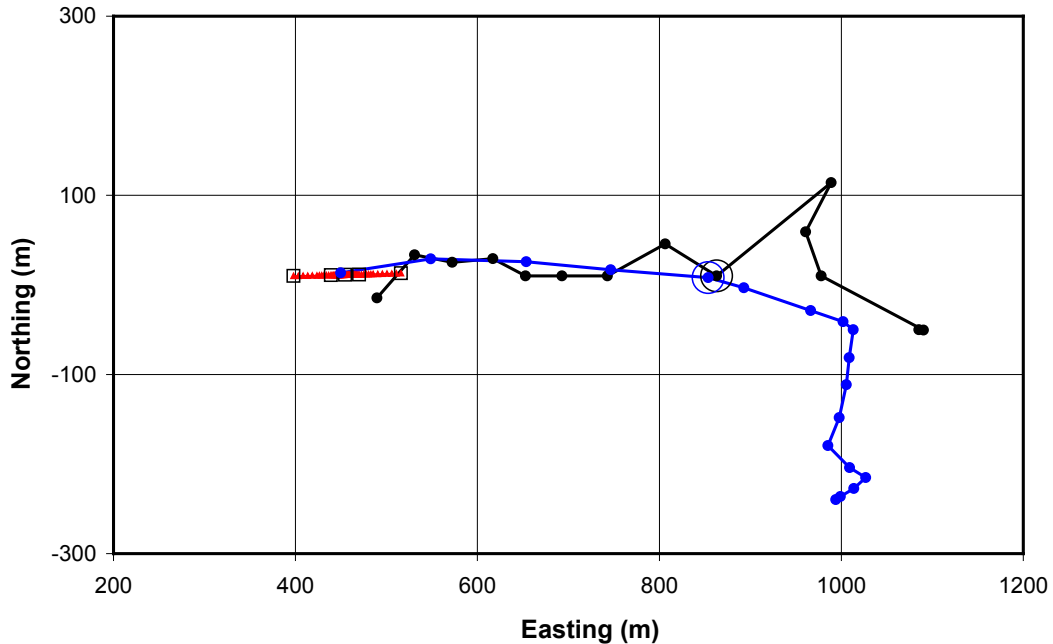
Figure 29. Comparison of the known RHIB track (blue) with the estimated track (black). The array of five hydrophones used in this example is denoted by the open black squares.

Figure 29 shows a plan view of the vessel course and compares it to the known course and position. The RHIB is tracked with good accuracy at a range of 465 m. The ability to determine a course, position, speed, and depth allows a target classification to be made.
