Navigation Systems Research Program

# Assessing Corrosion Damage and Corrosion Progression in Multistrand Anchor Systems in Use at Corps Projects

July 2013

Final report

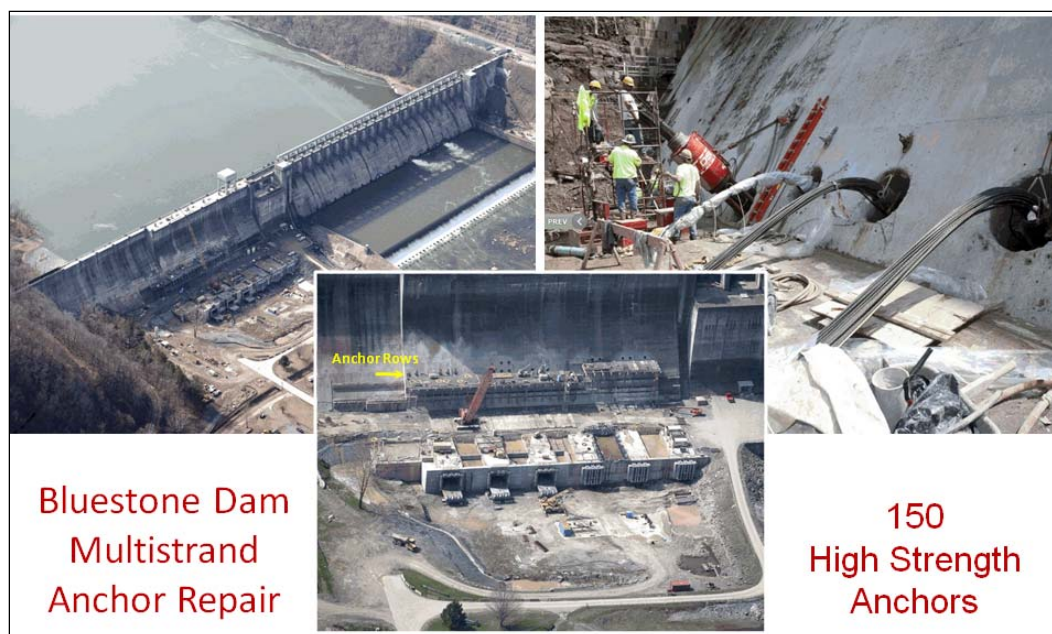
An example of a multistrand, post-tensioning anchorage system used to stabilize an existing dam is Bluestone Dam (Figure 2-2), a flood control project on the New River in the Huntington District. The Corps determined that the dam should be raised 8 ft and that anchors needed to be installed to secure its base to bedrock. Structural analyses indicated that the bedrock securing the dam might not be as strong as assumed when the dam was constructed and that adding anchors was of critical importance. Phase 2b of the overall dam safety assurance plan consisted of installing multistrand anchors in strategic locations to provide additional strength for the dam.

Figure 2-2. Bluestone anchor repair to prevent sliding.

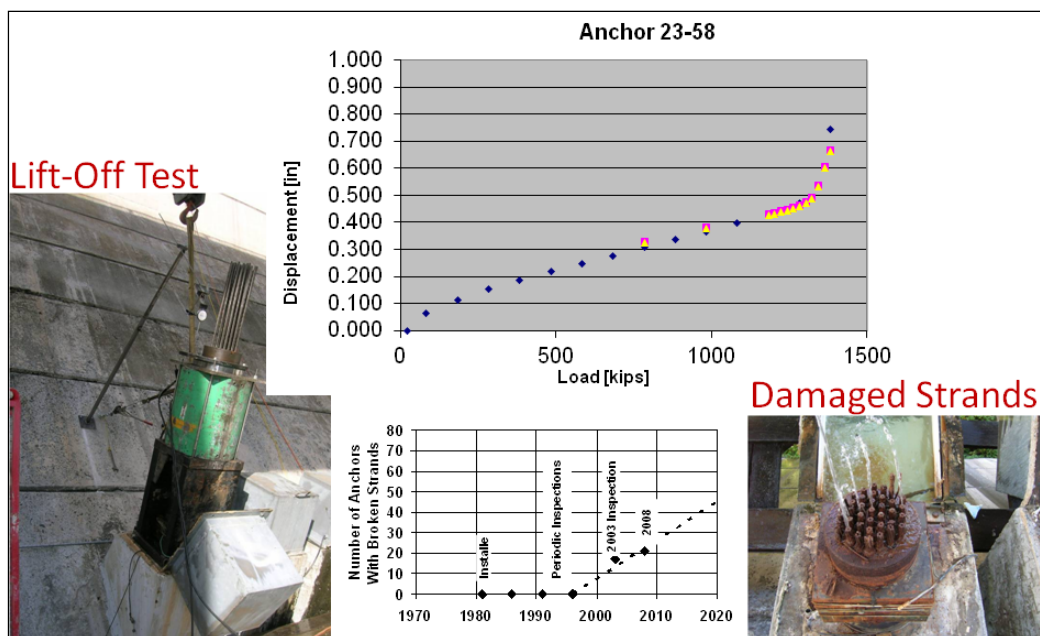
Figure 6-3. Performance of anchors during lift-off tests and evidence of corrosion.

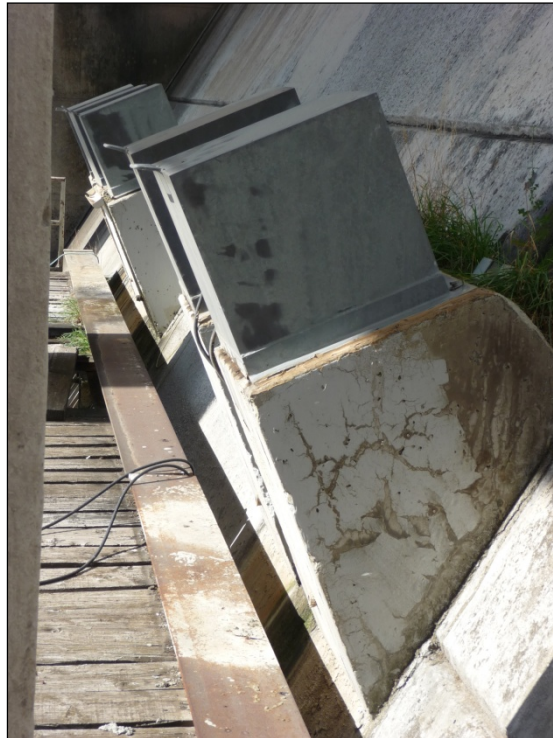
Figure 6-5. Covered anchor head at John Day.

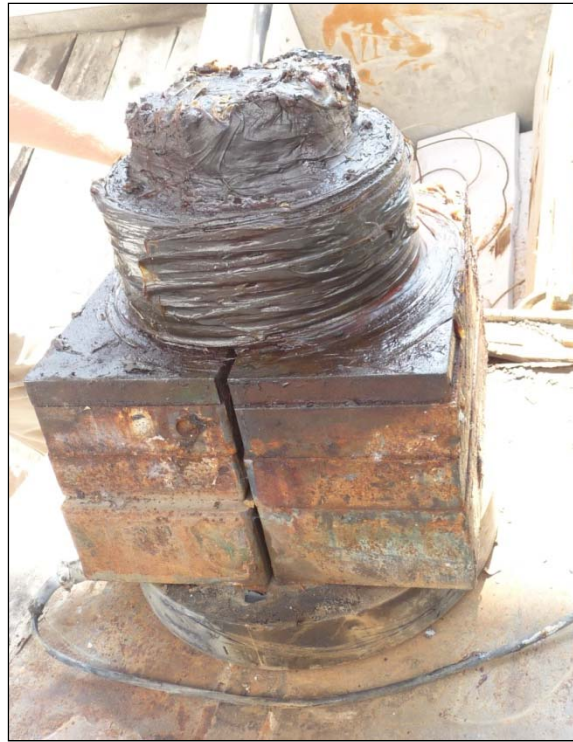
Figure 6-6. Anchor head before removing shim stack.

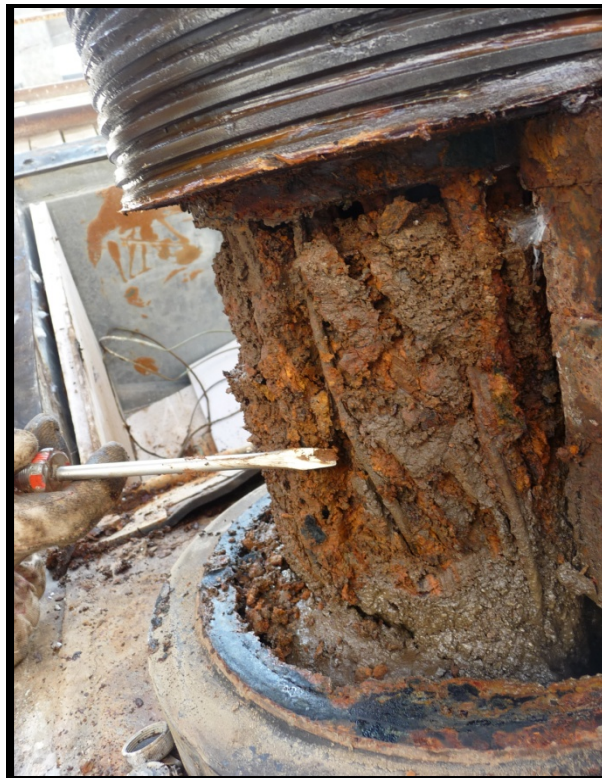
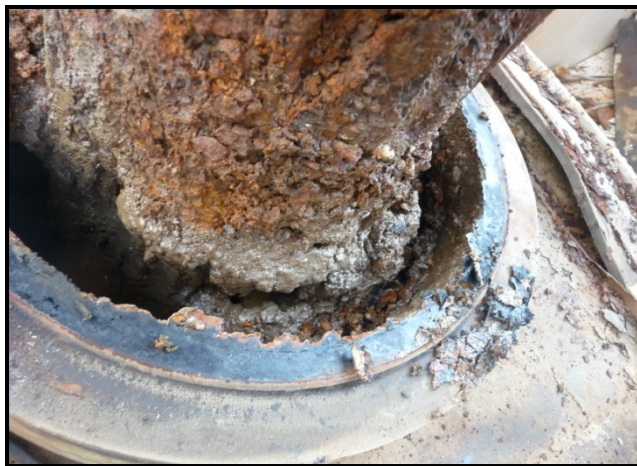
Once the shim stacks were removed, both anchor heads looked similar. A feeler rod was used to locate the grout in the trumpet. In both cases, no grout was detected. The grease appeared highly contaminated. In the upper section, it was red from rust products and, in the lower section, water and possible mildew had turned it black. Figure 6-7 shows the

contaminated grease. The grease with more rust product is stiffer and, as one moves down from the top of the anchor head, the grease is water saturated and softer.

Figure 6-7. Wet grease with rust and possibly mildew contamination (top) and the voided perimeter section (bottom).

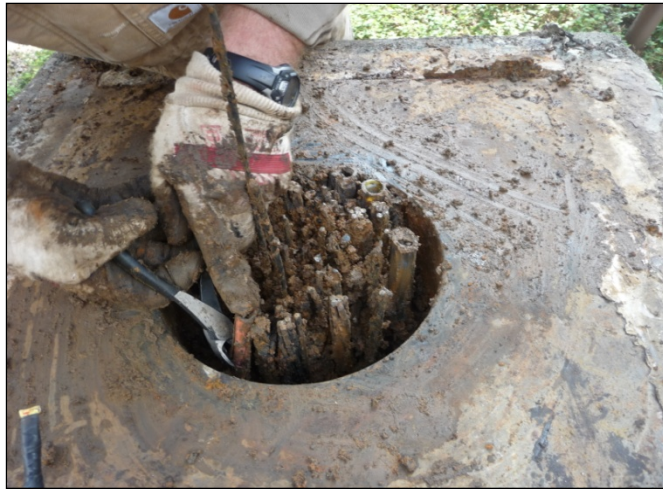
Figure 6-8. Anchor head removed for shipment to ERDC-Vicksburg.

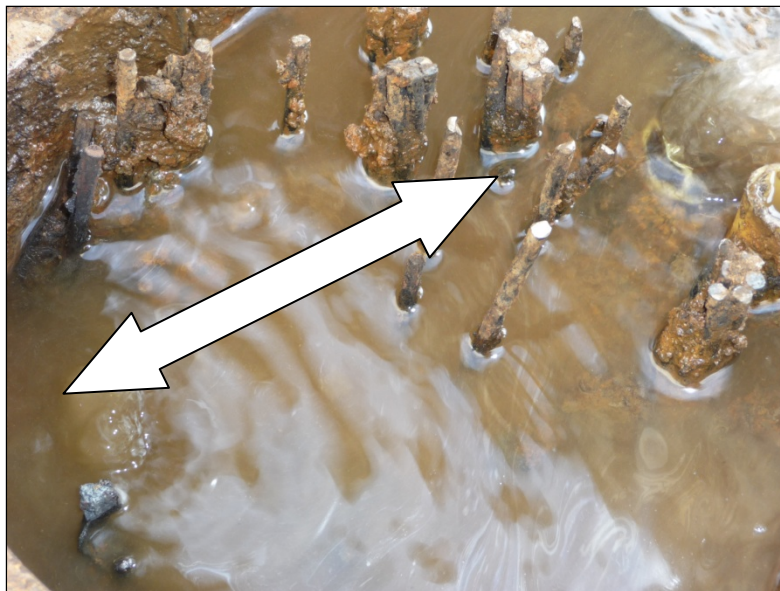
Figure 6-9. Water flowing up yellow tubes during lockages (observed at both heads).

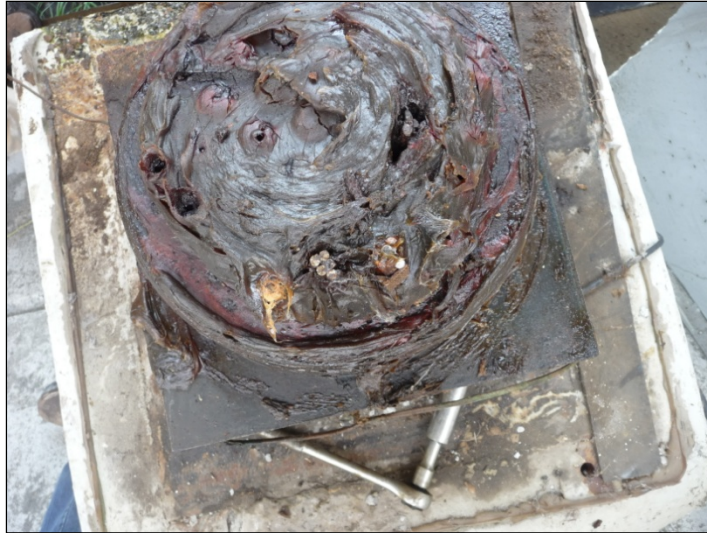
Figure 6-10. Water exits anchor heads through wedges and missing king wires.

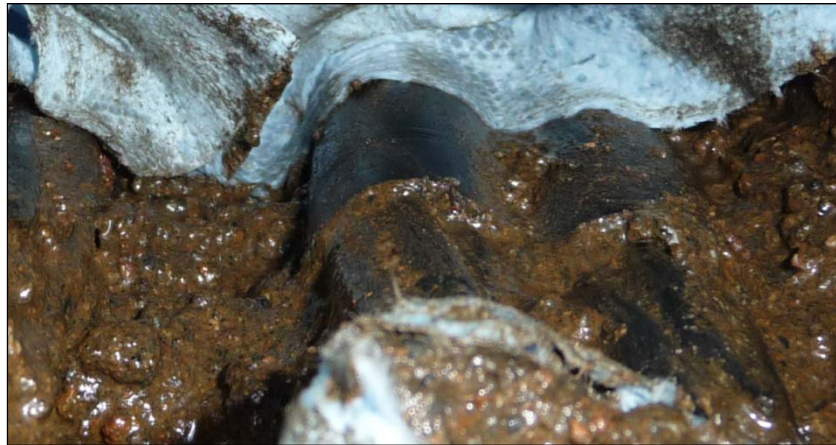
Figure 6-12 shows cable sheaths, of which little had been known. They appeared in good condition, with no signs of deterioration. As shown in Figure 6-13, no grout was detected in the trumpet section. A 3-ft feeler was used to verify that grout was not where it shouldn't be (at least 18 in. into the trumpet section). The removed anchor heads were being sent to ERDC-Vicksburg for further analysis. One speculated finding from this trip was the two analyzed anchor heads might have stopped taking grout during construction, explaining the absence of grout in the trumpet section. It also might

Figure 6-12. Cable sheaths with no signs of deterioration (3/4-in. diameter).

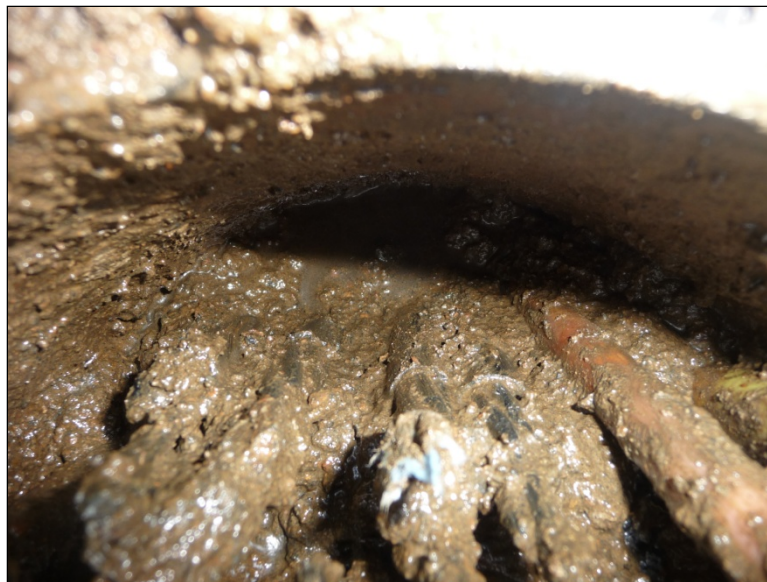
explain the open grout-vent tubes (yellow) that should by any standard have ended up grouted. The two heads disassembled were the worst case in terms of leakage, load loss, and so forth. It was not clear if this ungrouted tube was the primary deterioration problem in all cases.

Figure 6-13. No grout detected in anchor heads that were disassembled.

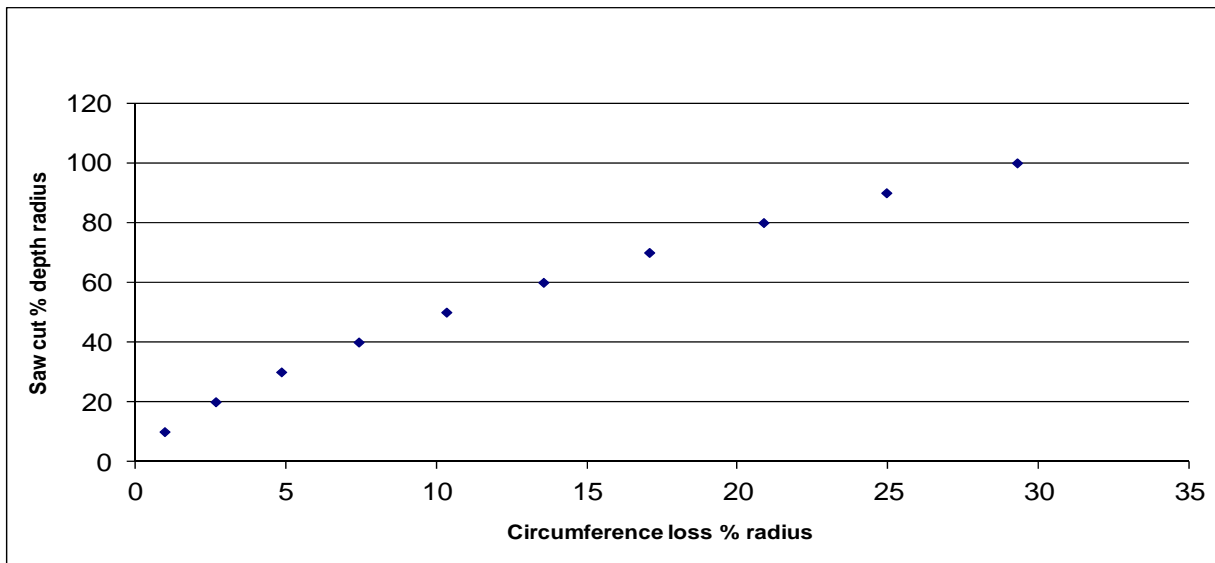
on the graph in Figure 8-3, a saw cut that is 10% of the radius is roughly equivalent to a 1% loss of radius all the way around the wire's perimeter. This 10% radial cut is the 0.01-in. cut used in this experiment, with a remaining wire area of 0.031 in.<sup>2</sup>. The 0.06-in. saw cut is a 60% reduction in radius, leaving 0.023 in.<sup>2</sup> of cross section. As shown in Figure 8-3, this results in a stress equivalent of roughly a 13% loss of radius around the perimeter.

Figure 8-3. One-sided notch area vs. circumference loss.

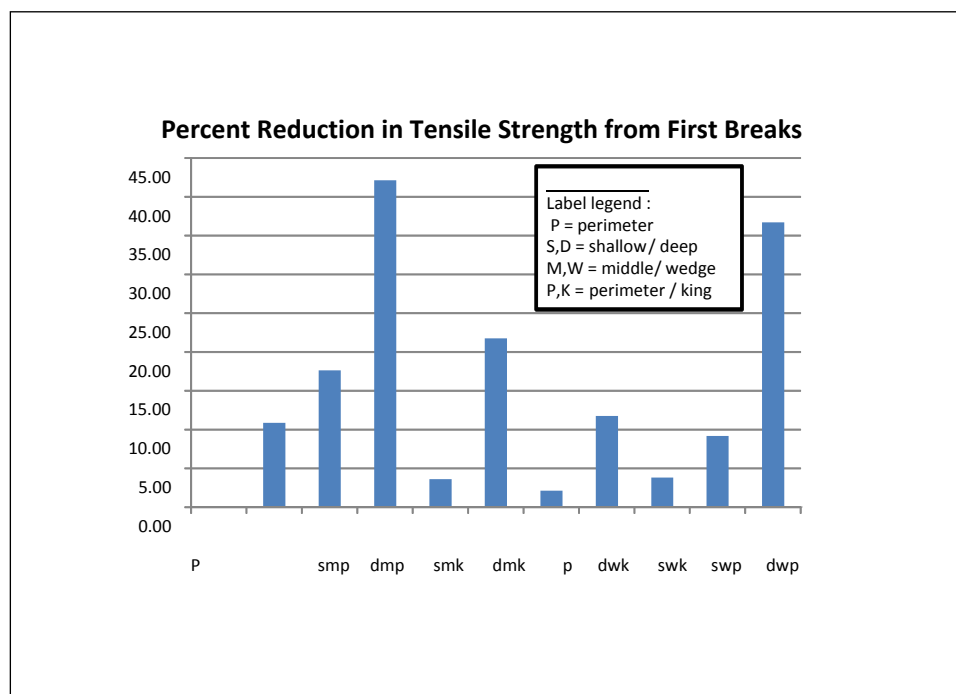
Figure 8-6 graphs the percent reduction in tensile strength at the first break (data in Table 8-2). This graph captures the relevant strength influences of the various defects in terms of the first break.

Some things about the varied parameter were observed. A notch in the perimeter wire had a greater influence than a notch of the same depth in the king wire, in terms of the first strand failure. This difference was an additional 17 to 22% reduction in ultimate strength. Likewise, a notch at midspan had slightly more impact than the same notch near the wedge

Figure 8-6. Tensile strength from a notch at various locations, depth, and wires.

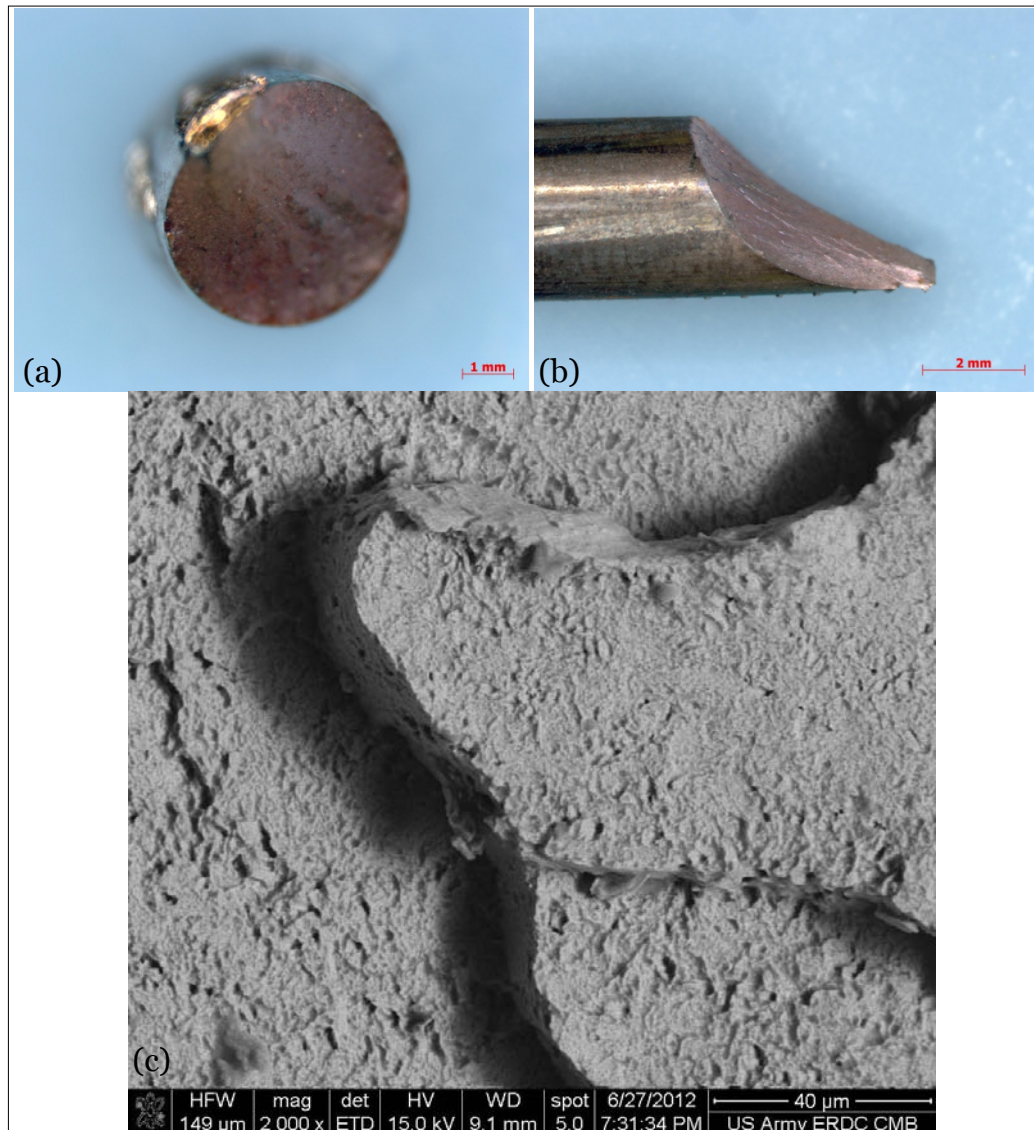
Figure 8-8. Images of shear failure: (a) section view, (b) side view, and (c) high-resolution view.

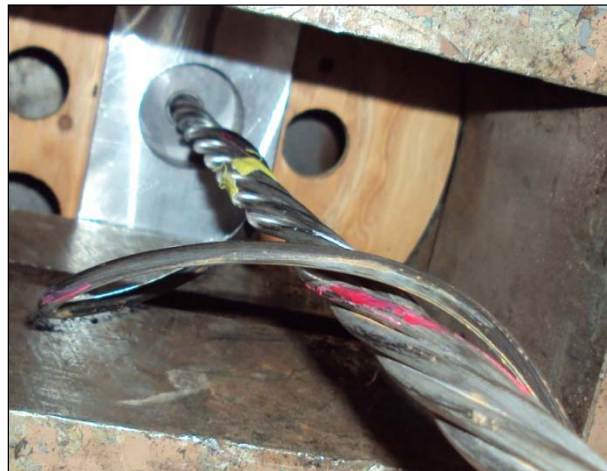
Figure 8-11. Cable unwinding due to energy release after failure.

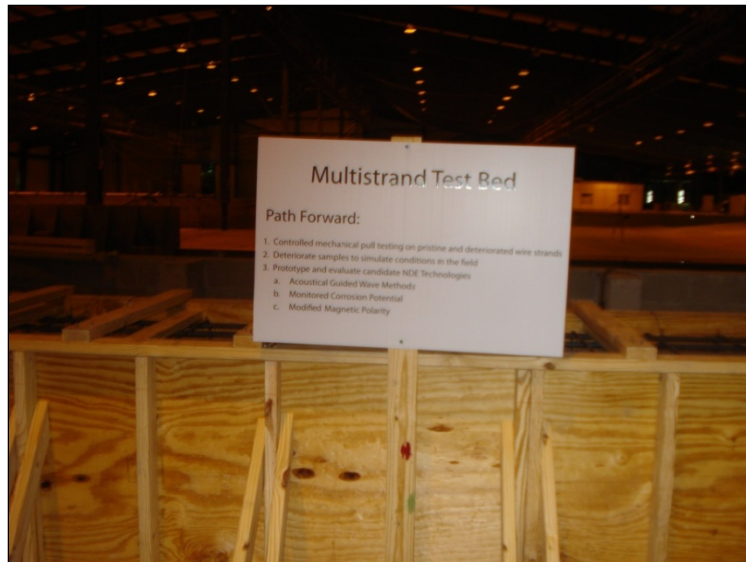
To apply tension and accelerate the corrosion of multistrand cables, a test bed was constructed at ERDC. It is 15 ft long and can support six single strands enclosed within six individual, 1.25-in. PVC tubes and two five-strand assemblies enclosed within 3-in. PVC tubes (Figure 10-1a, b). The initial design is shown in Figure 10-2.

Figure 10-1a. Side view of framing for test bed.

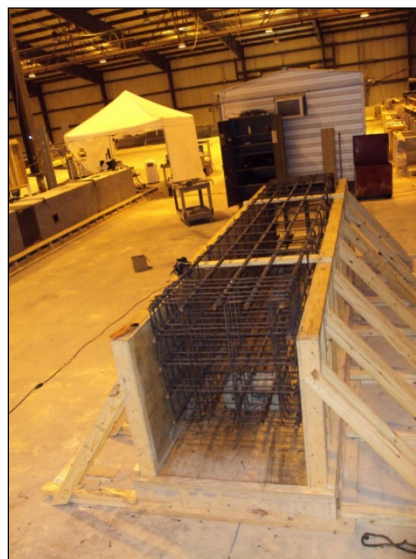
Figure 10-1b. End view of test bed with reinforcement rebar.

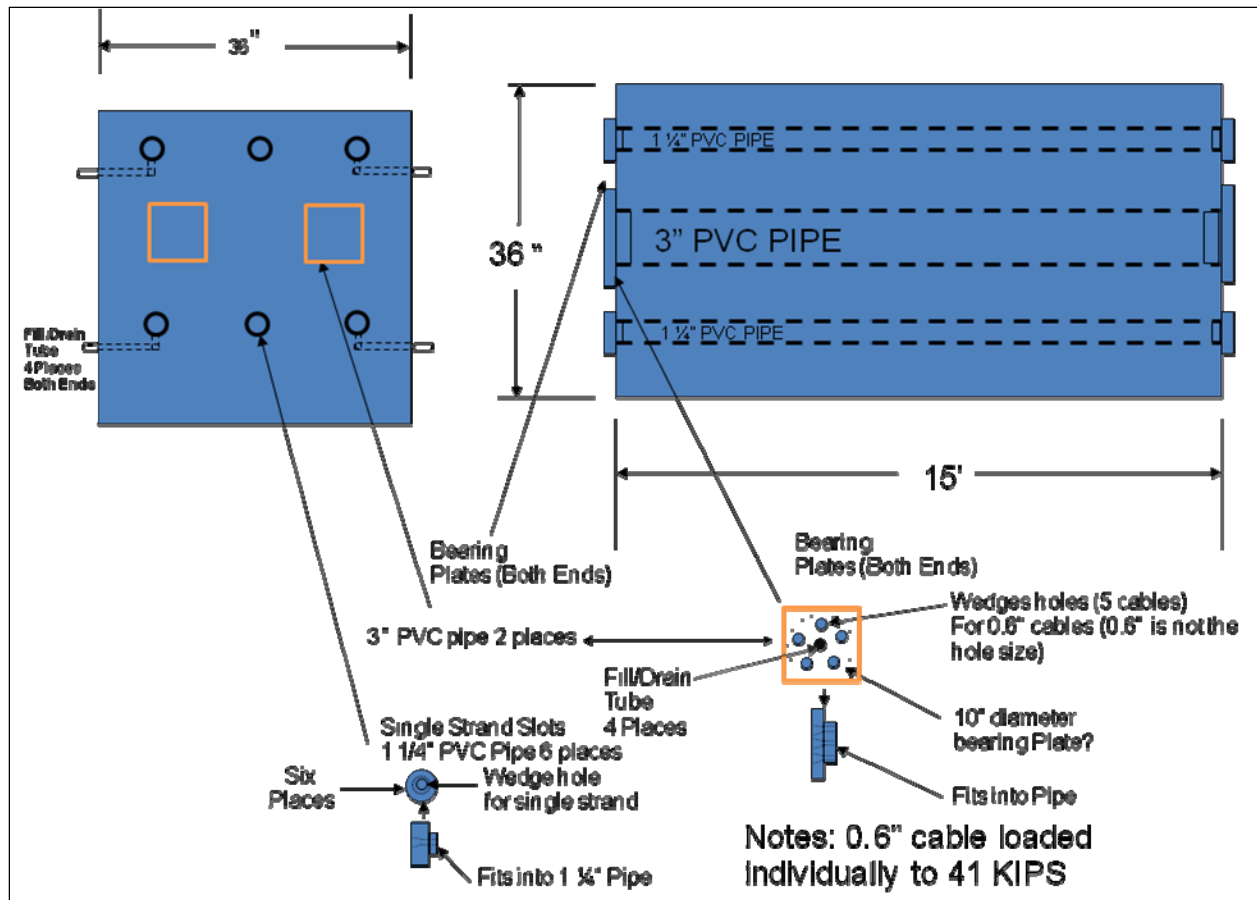
Figure 10-2. Test bed design with strand support hardware shown.

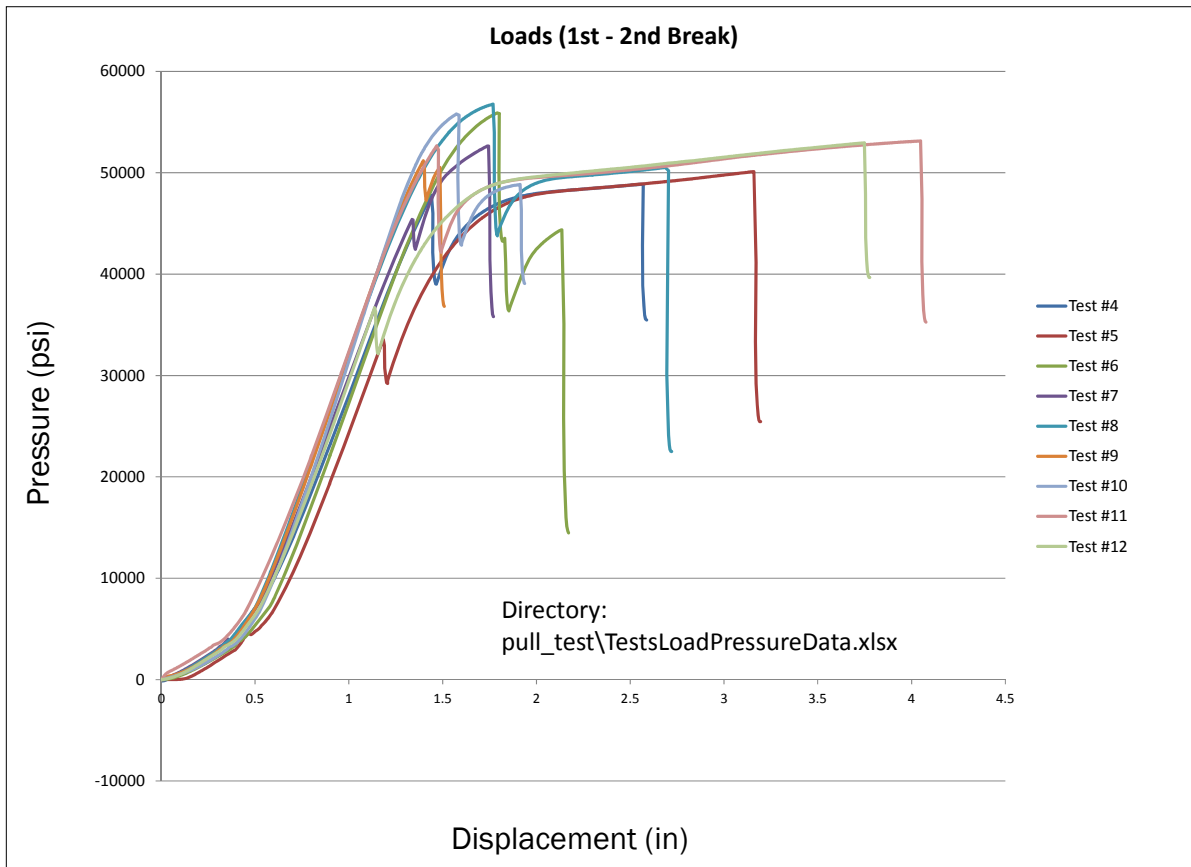
Figure A-13. Pressure vs. deflection pull test results to second wire break (Tests 4-12).

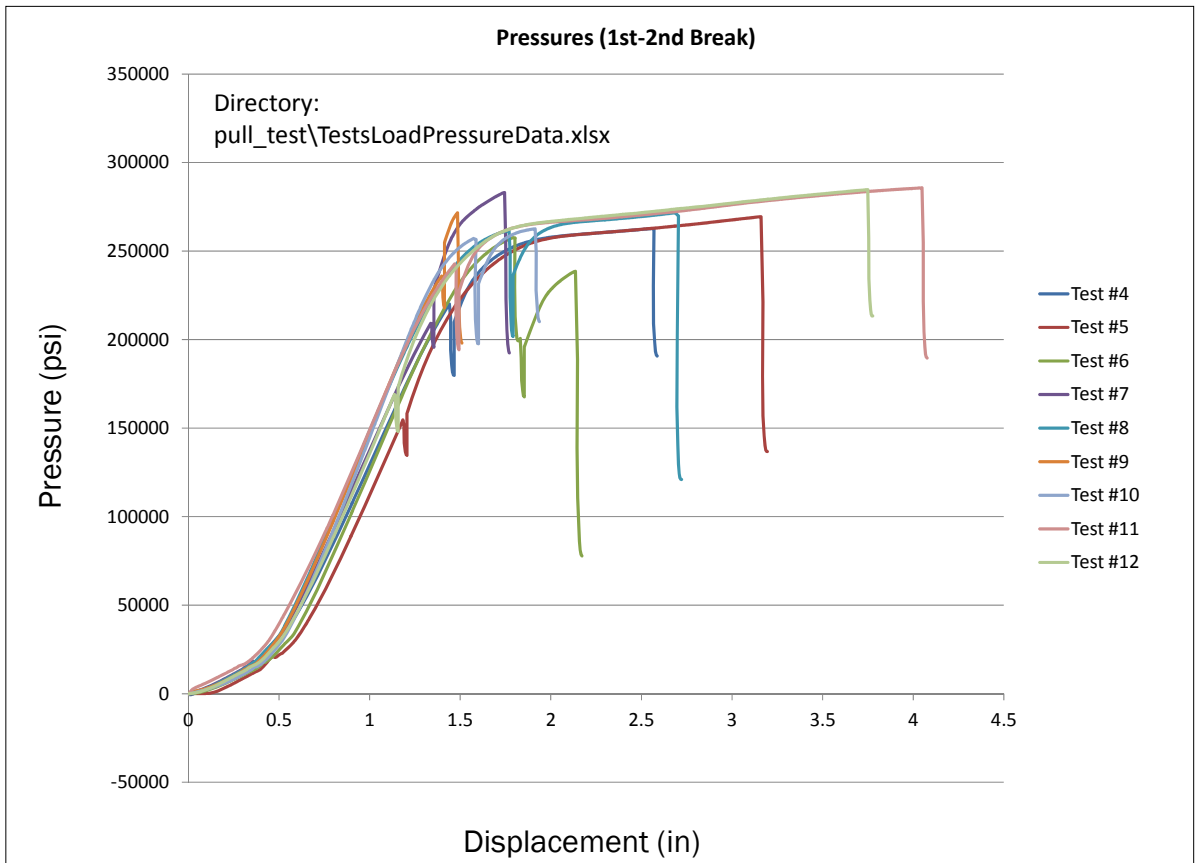
Figure A-16. Pressure VS. deflection pull test results to second wire break (Tests 4-12).
