Full-Scale Evaluation of DuraDeck® and MegaDeck™ Matting Systems

Timothy W. Rushing and Lyan Garcia

July 2013

Final report

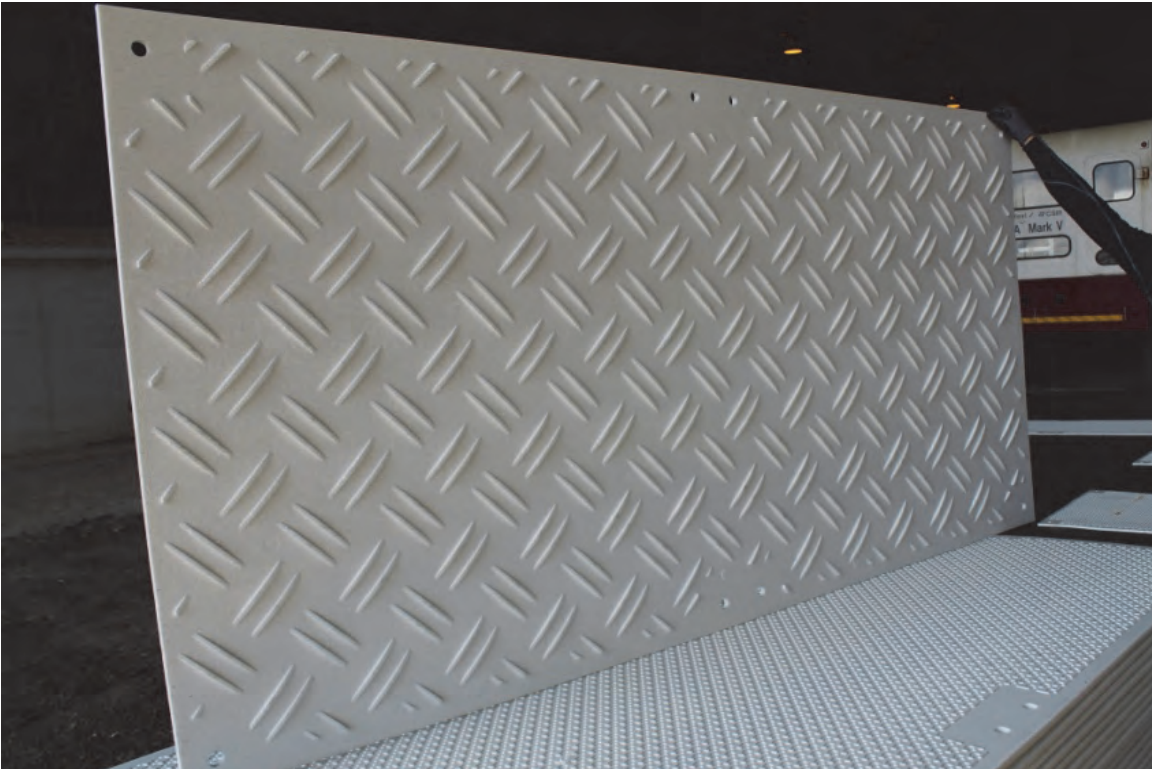
Figure 2. DuraDeck® mat panel, bottom surface.

The DuraDeck® matting system, shown in Figures 1 and 2, is made up of 4-ft-wide-by-8-ft-long-by-0.625-in.-thick panels. These panels come in standard colors of white, black, and sand, but can be customized. The panels are constructed of a proprietary blend of high-density polypropylene (HDPE) plastic that is compression-molded into a solid panel with a non-skid surface molded onto each face. Each panel weighs 86 lb and can be installed by two men without the assistance of material handling equipment (MHE). Panels are connected by placing metal plates studded with threaded

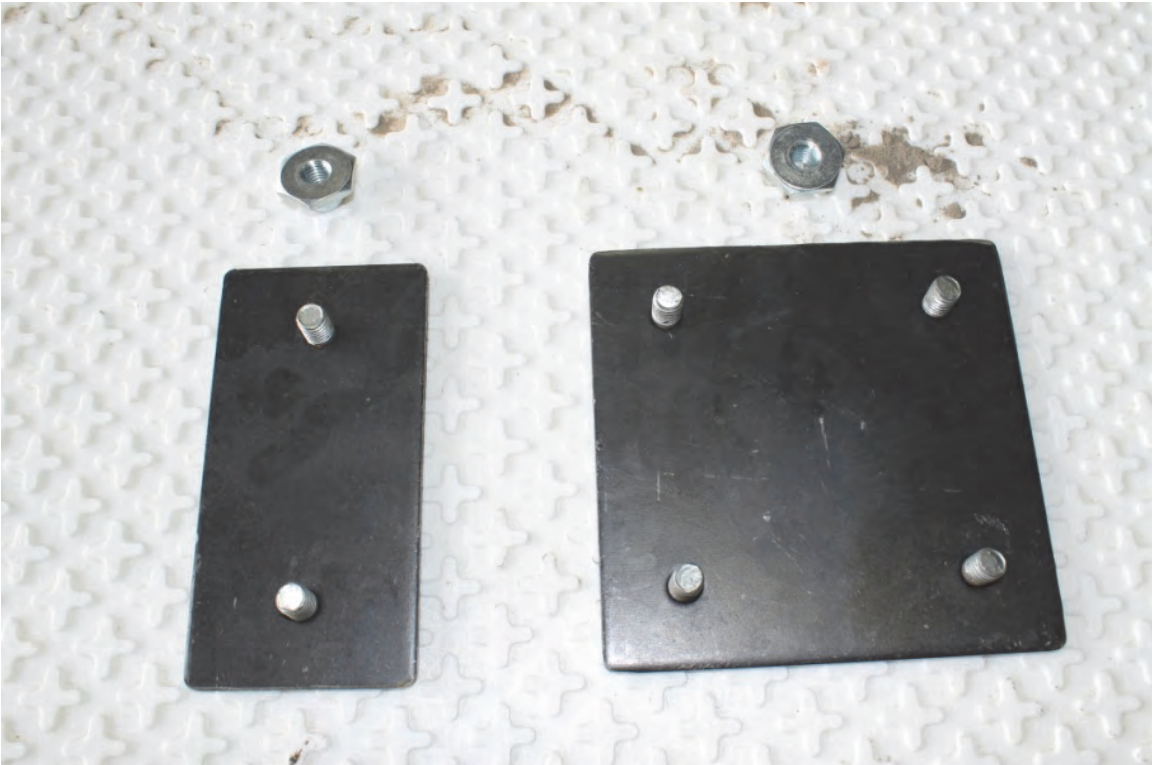
Figure 3. DuraDeck® metal plates and connector nuts.

bolts, as shown in Figure 3, underneath the mat corners and then installing special connector nuts from the top surface to secure the mats together. According to the manufacturer, the panels will not degrade with sun or aircraft fluid exposure. If anchoring is required by the user, COTS duckbill anchors are recommended to keep the surface from moving during operations; however, anchoring is not required by the manufacturer.

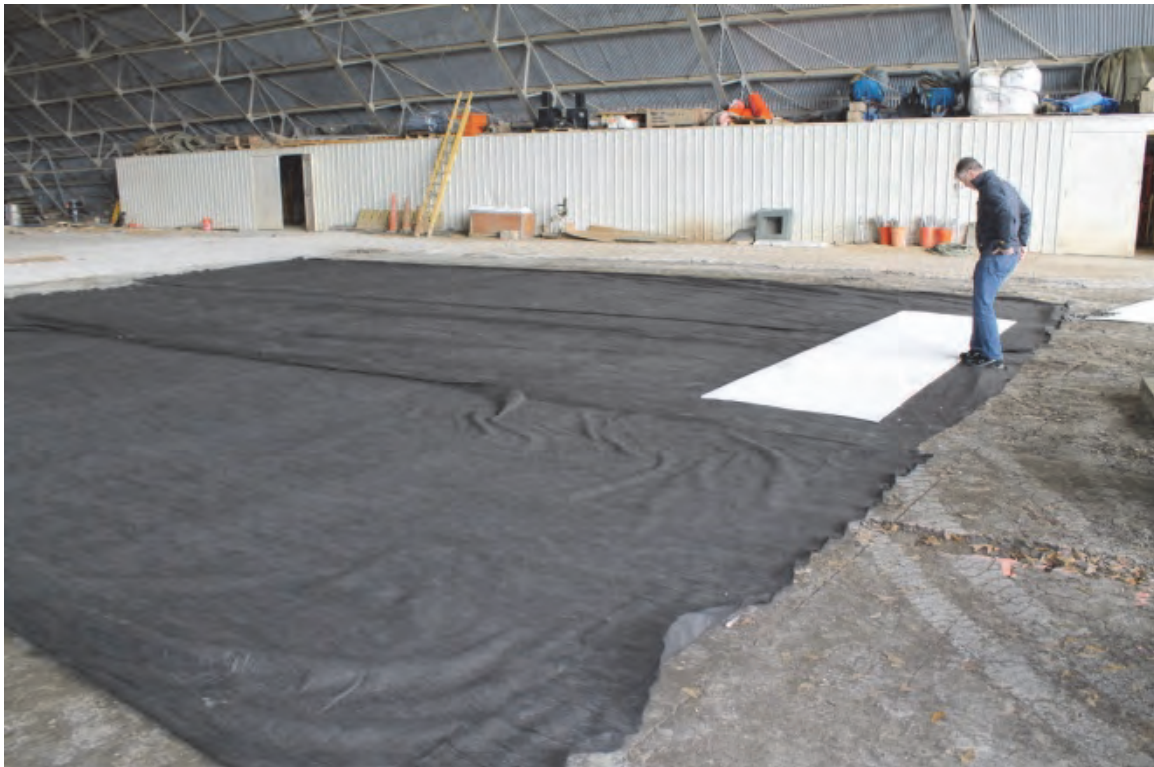
Figure 7. Geotextile-covered test bed.

According to the manufacturer, the DuraDeck® matting system performs best over soft, fine-grained soils when a geotextile fabric is installed on the soil surface (DuraDeck® Installation, n. d.). A standard, non-woven needle-punched geotextile was recommended. The geotextile keeps soil from coming through the panel joints and working its way onto the panel surface. The geotextile also offers some tensile resistance to reduce the permanent deformation in the subgrade. A 12.5-ft-wide by 360-ft-long roll of 6-oz. non-woven geotextile was acquired for the evaluation. The roll weighed approximately 120 lb and had a diameter of about 18 in. Three 40-ft-long sheets of geotextile were cut from the roll and placed side-by-side with 12-in. overlaps on the CH test bed prior to mat installation as shown in Figure 7.

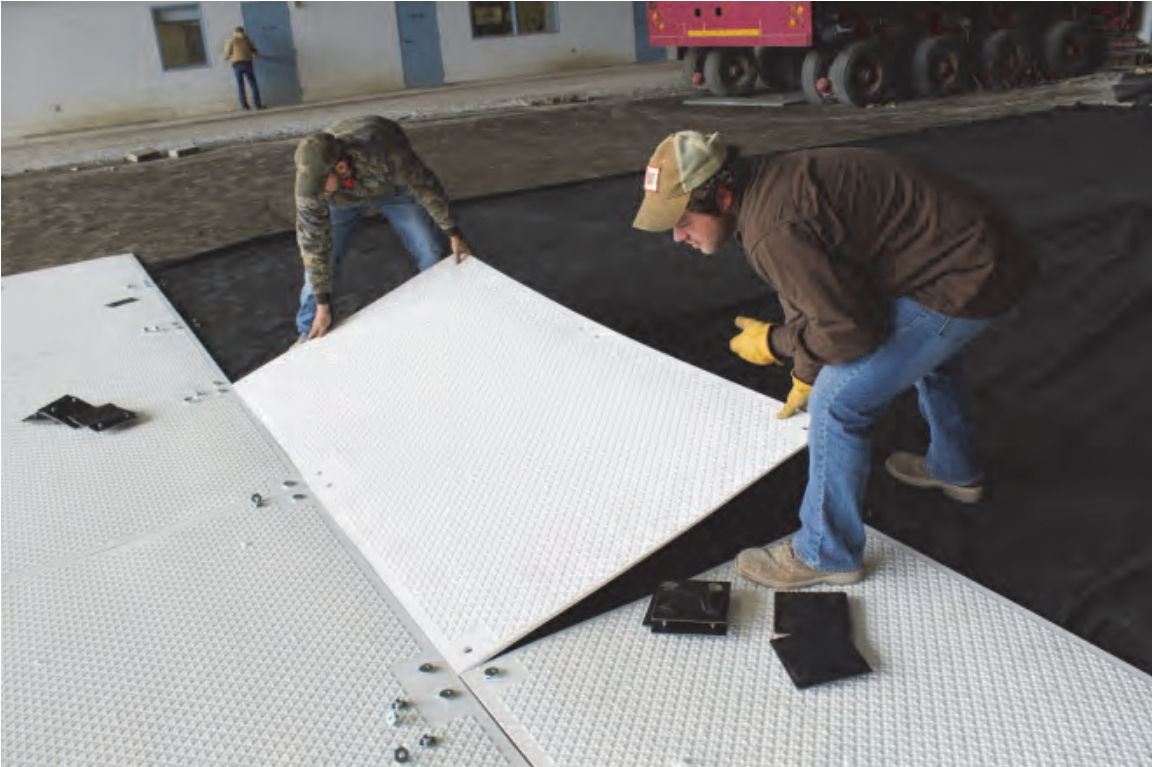
Figure 8. DuraDeck® panel installation.

underneath two pre-drilled corners of the panel. The plates were positioned so that the adjacent panel's opposite pre-drilled corners lined up over two other threaded studs on the same plates, allowing the panels to be connected. Once the second panel was positioned over the threaded connectors, nuts were installed on the threaded studs from the top side of the panels to fasten them securely. This process was continued until the entire panel array was complete. Each of the connector nuts was hand-started, then tightened using a cordless drill with a socket designed to fit the nuts. During installation, the manpower was divided as follows: two men carried the panels into position and aligned the bottom connector plates, two men hand-started connector nuts, and one man tightened the nuts with a cordless drill. After one hour of installation, the array of panels was complete. Assembly time was calculated and resulted in approximately 320 ft²/man-hr. Greater efficiency could have been gained by using a second cordless drill for tightening the connector nuts. Eight nuts were required for each interior panel, and six were required for edge panels. Half-panels were not used for this test; however, they are available from the manufacturer to ensure a square or rectangular array can be assembled with complete coverage of the area. Photos demonstrating installation of the DuraDeck[®] panels and the final layout of the test section are shown in Figures 8 through 11.

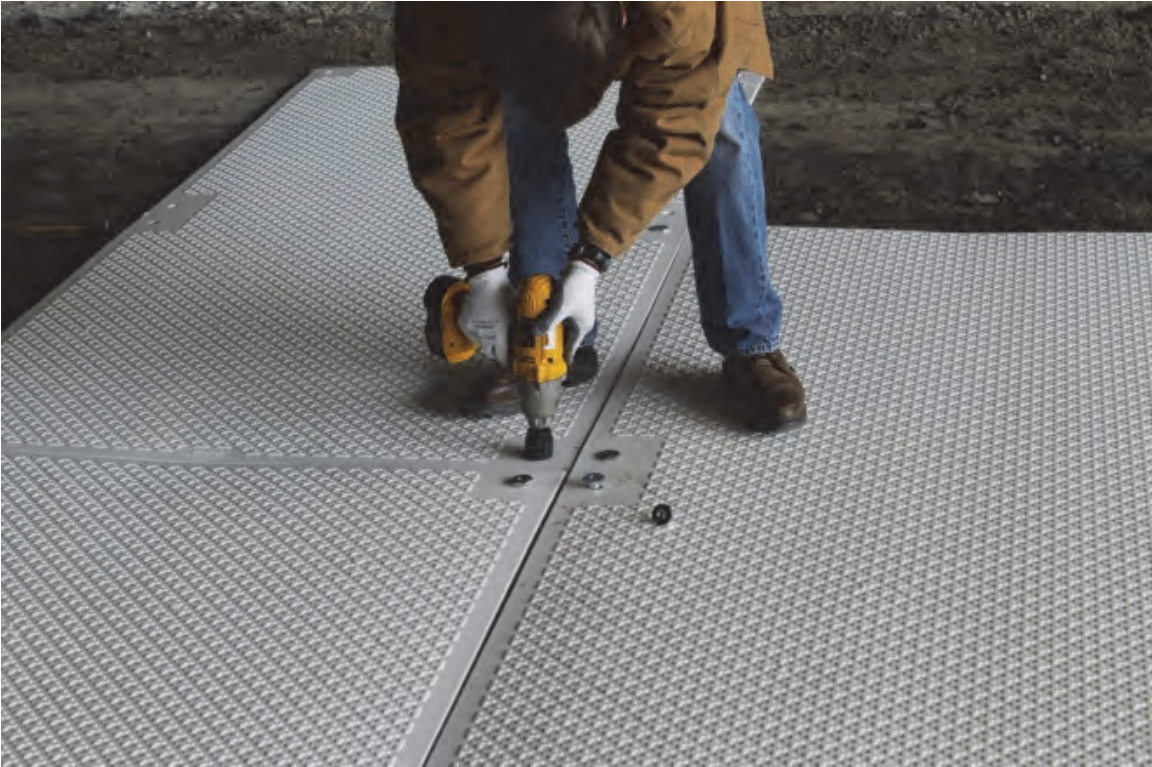
Figure 9. Tightening DuraDeck® connector nuts.

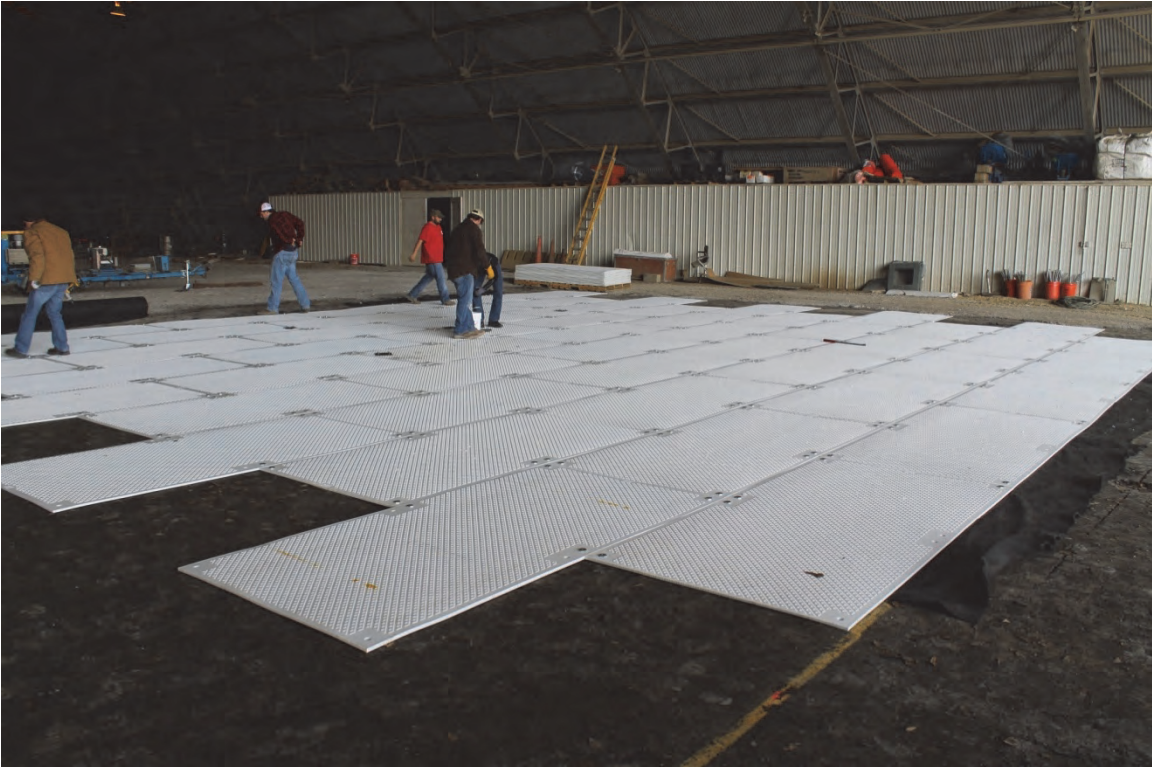
Figure 11. Final layout of DuraDeck® test section.

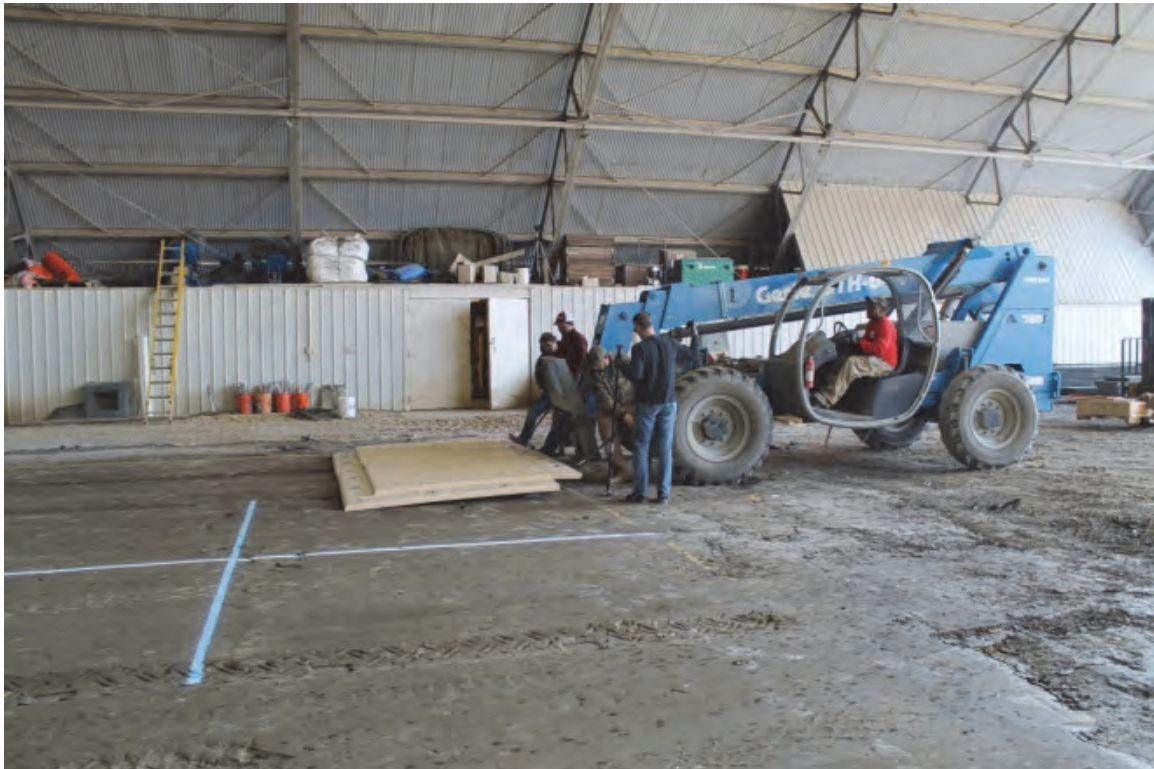
Figure 12. Positioning MegaDeck™ panel with an all-terrain forklift.

The MegaDeck™ panels required MHE for installation. Panels were removed from the shipping pallets by an all-terrain forklift and were carried into position on the CH test bed as shown in Figure 12. No geotextile was required prior to MegaDeck™ installation. Panels were assembled in a block array with continuous longitudinal joints according to manufacturer recommendations (MegaDeck™, n. d.). Panels were designed with underlap edges perpendicular to each other on two sides and overlap edges on the opposite sides. The overlap edges were positioned in the corner of the assembly so that the direction of construction was along the perpendicular underlap edges.

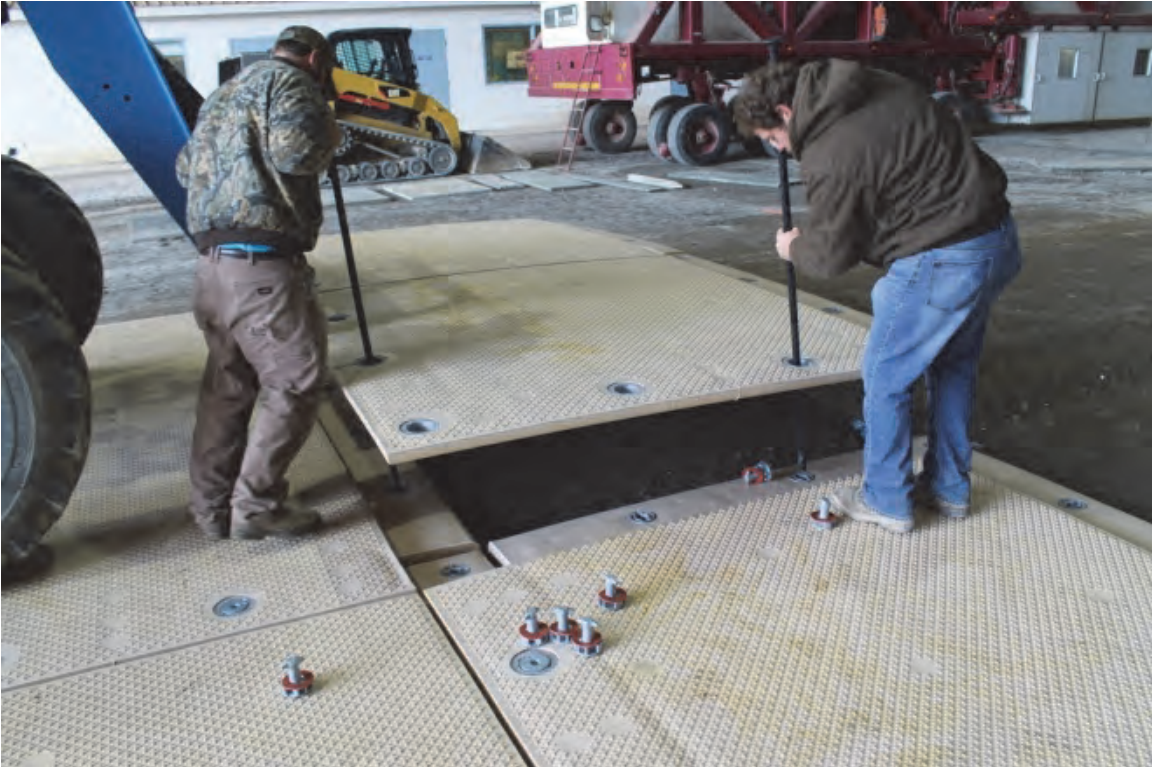
Figure 13. Guiding MegaDeck™ panels into position with guide rods.

The adjacent panels were moved to the test section by forklift. They were guided into position by inserting steel guide rods through connector holes in the overlap portion of the second mat and into the matching connector holes in the underlap edge of the first mat as shown in Figure 13. Once the second panel was on the subgrade, the guide rods were used as levers to adjust the position of the second mat so that connector pins could be easily

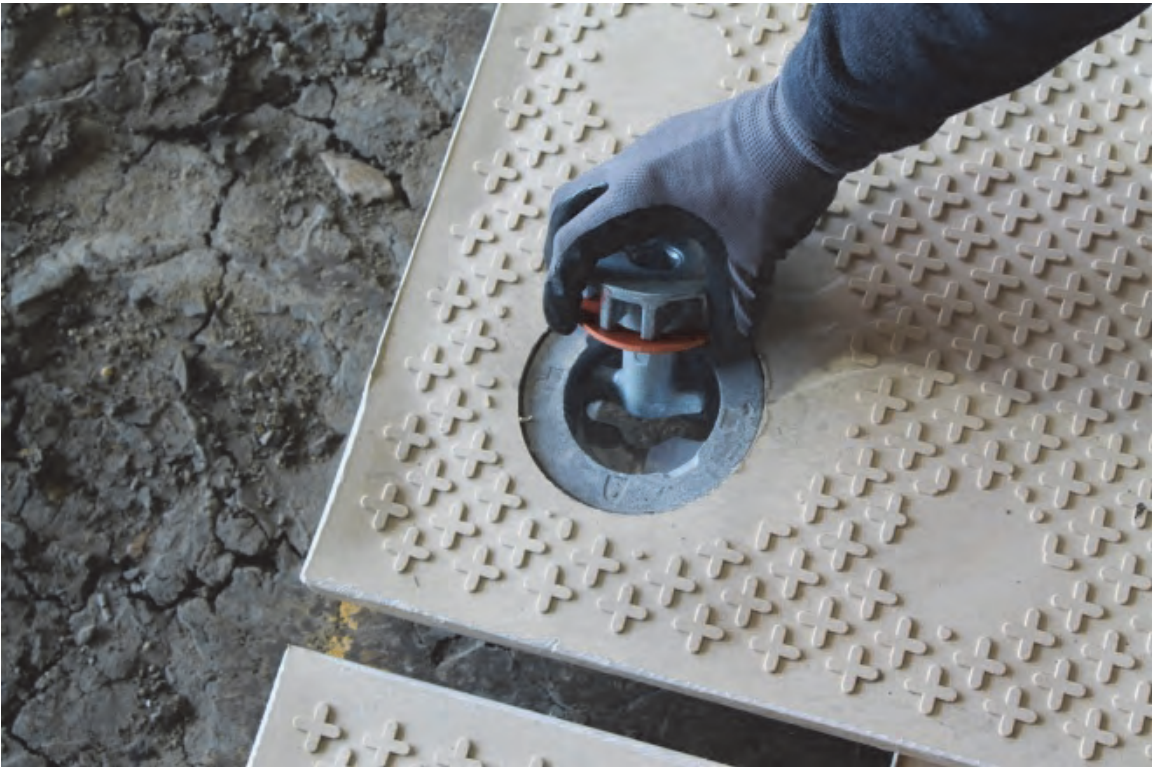
Figure 14. Installing MegaDeck™ connector pin.

inserted into the matching connector holes in the two panels as shown in Figure 14. Once the connector pins were inserted into the provided slots, a specialized T-handle tool was used to rotate the locking pins 90 deg and lock the two panels together as shown in Figure 15. Eight connector slots were supplied for each mat panel. This process was continued until the entire panel array was complete. During installation, the manpower was divided as follows: one forklift operator carried the panels into position, two men used steel guide rods to position the mats, and two men inserted locking pins into the connector slots and locked them into place with the supplied T-handle tool. After one hour of installation, the array of panels was complete. Assembly time was calculated and resulted in approximately 305 ft²/man-hr. Additional efficiencies were gained as the forklift operator and installers became more familiar with the procedure. A photo of the final layout of the MegaDeck™ test section is shown in Figure 16.

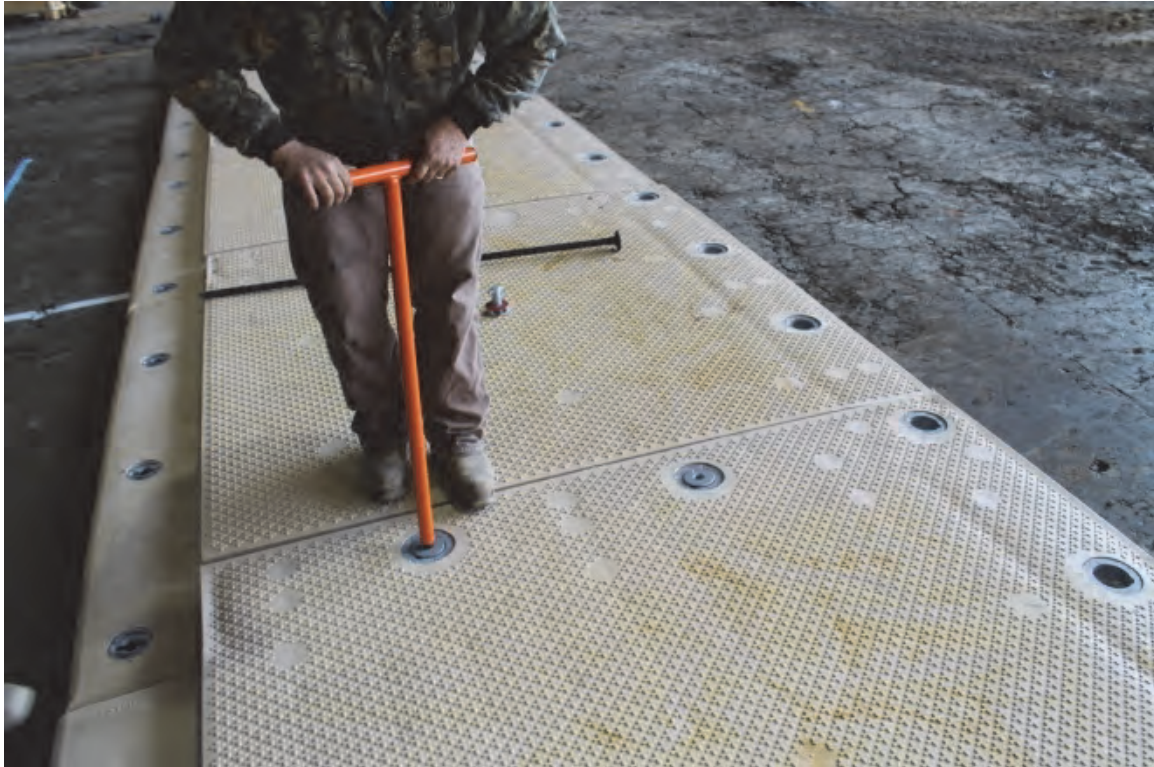
Figure 15. Locking MegaDeck™ connector pins with T-handle tool.

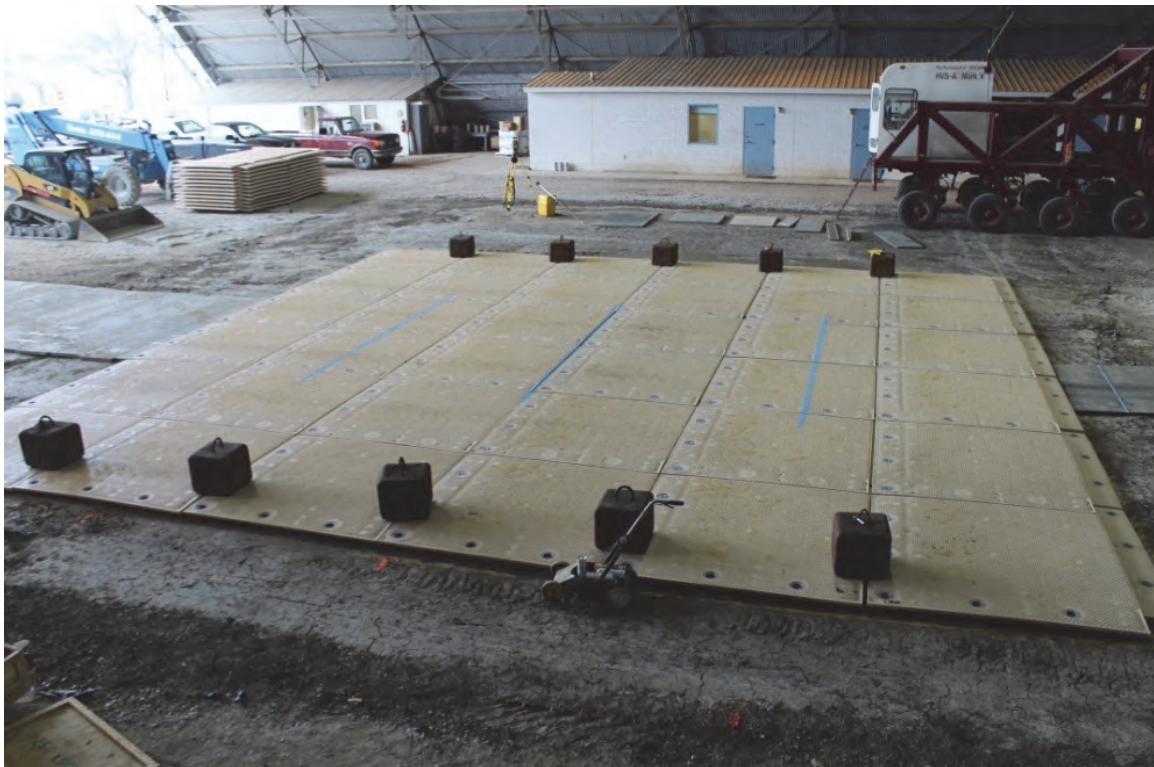
Figure 16. Final layout of MegaDeck™ test section.

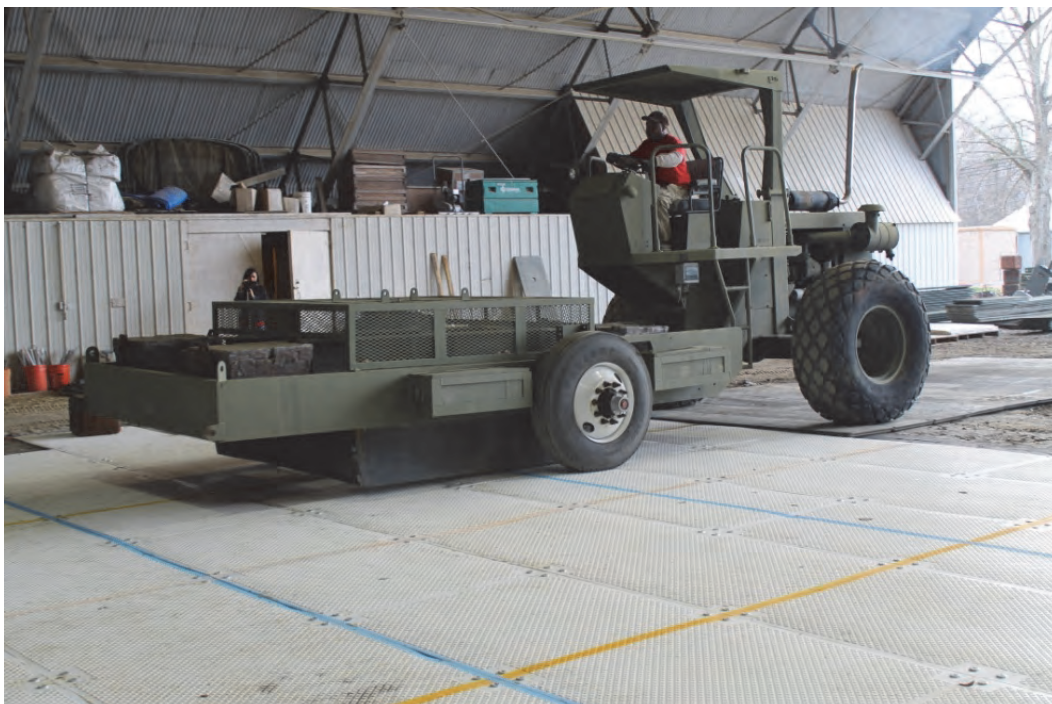
Figure 17. Simulated F-15E load cart.

The F-15E model is the most damaging aircraft in USAF inventory to pavement surfaces because of its high tire pressure and heavy single-wheel loading. A fully armed F-15E has a gross weight of 81,500 lb and a single-wheel loading of 35,235 lb with a tire pressure of 325 lb/in². This gross vehicle weight and wheel load are not representative of aircraft using a temporary hangar facility; therefore, the load was reduced from maximum gross weight to a standard weight of 68,500 lb to represent an un-armed aircraft. The resulting single-wheel load was 29,395 lb. A simulated F-15E load cart, equipped with an F-15E tire and wheel assembly, was loaded to the required weight and used for trafficking. This load cart, shown in Figure 17, was specially designed to test both pavement and matting surfaces to determine aircraft compatibility.

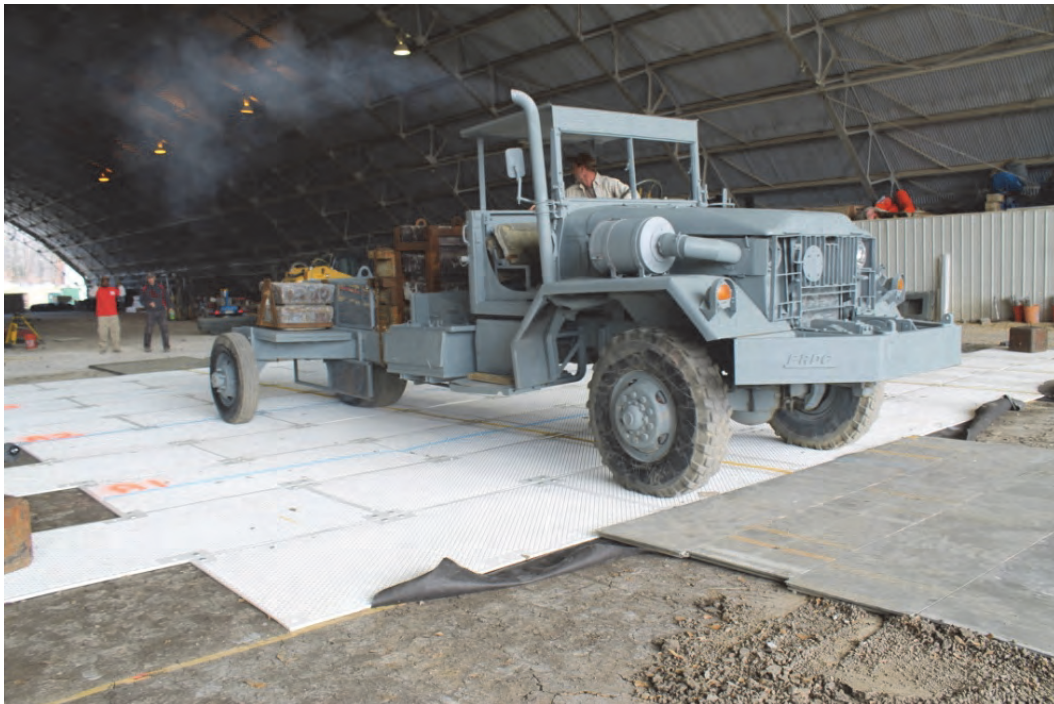
Figure 18. Simulated 25 kip forklift load cart.

The heaviest wheeled vehicle believed to utilize the BEAR shelters is the 25 kip capacity forklift. Based on vehicle data, the front axle when lifting a loaded 20-ft ISO container is 59,560 lb with a single-wheel load of 29,780 lb and a tire pressure of 80 lb/in². The exact vehicle was not available for testing; however, a single-wheel C-17 load cart was used to match the required loading and tire pressure, as shown in Figure 18. The contact area of the tire might have differed slightly than that of the actual forklift; however, the test vehicle closely matched the specifications and should give comparable results in terms of determining compatibility. The test vehicle was specially designed to test both pavement and matting surfaces.

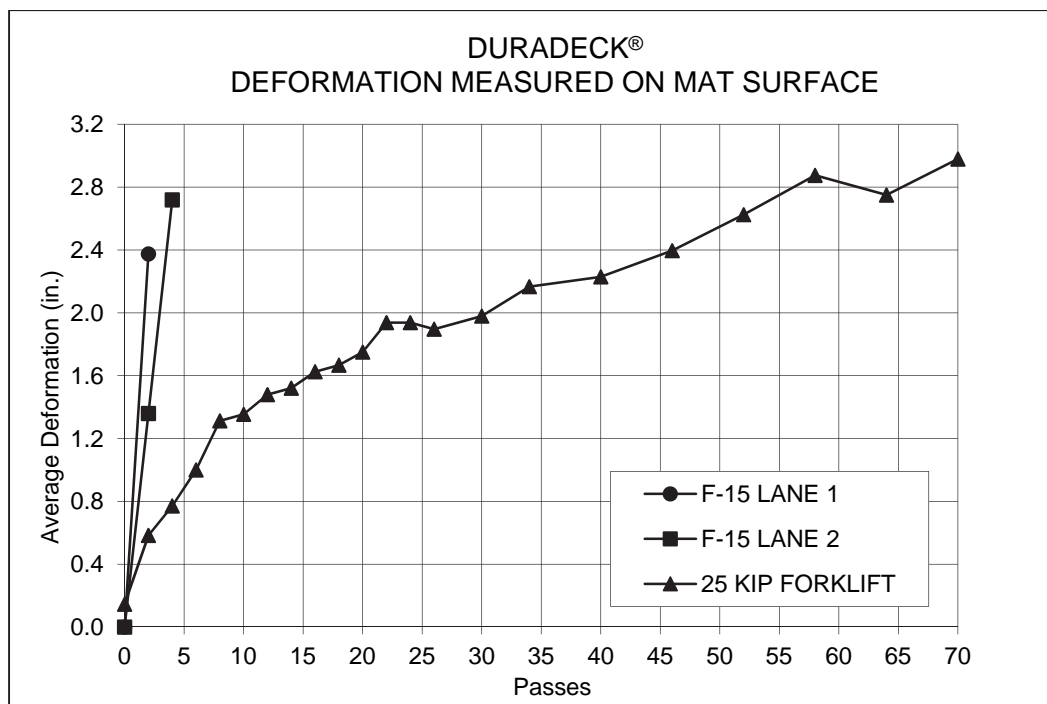
Figure 21. Summary of subgrade deformation for DuraDeck®.

The DuraDeck® evaluation consisted of trafficking with the simulated F-15E and 25 kip forklift. F-15E traffic was applied in two distinct traffic lanes. Lane 1 was positioned so that the test wheel was aligned directly along a longitudinal mat joint to simulate a worst-case trafficking scenario, since the longitudinal joints are unsupported. Lane 2 was positioned directly between the longitudinal joints so that all traffic crossed over the central portion of the mat panels and avoided the longitudinal joints, simulating a best-case scenario. The 25 kip forklift traffic was applied similar to Lane 1 for the F-15E, where the test wheel was aligned directly along a longitudinal mat joint. A summary of the rate of rut formation in each of the traffic lanes is shown in Figure 21. The discussion that follows explains these results.

After trafficking of Lane 1 was completed, Lane 2 was designated over an area between longitudinal joints. After the load cart completed one forward pass and one reverse pass, the soil underneath the matting panels was considerably deformed. Deformation measurements exceeded 1.38 in., and Lane 2 failed by excessive deformation after 2 passes; however, traffic was continued since no tire hazard was presented. After two more passes, traffic was concluded since the permanent deformation averaged 2.75 in. as shown in Figure 21. The condition of the mat after trafficking is shown

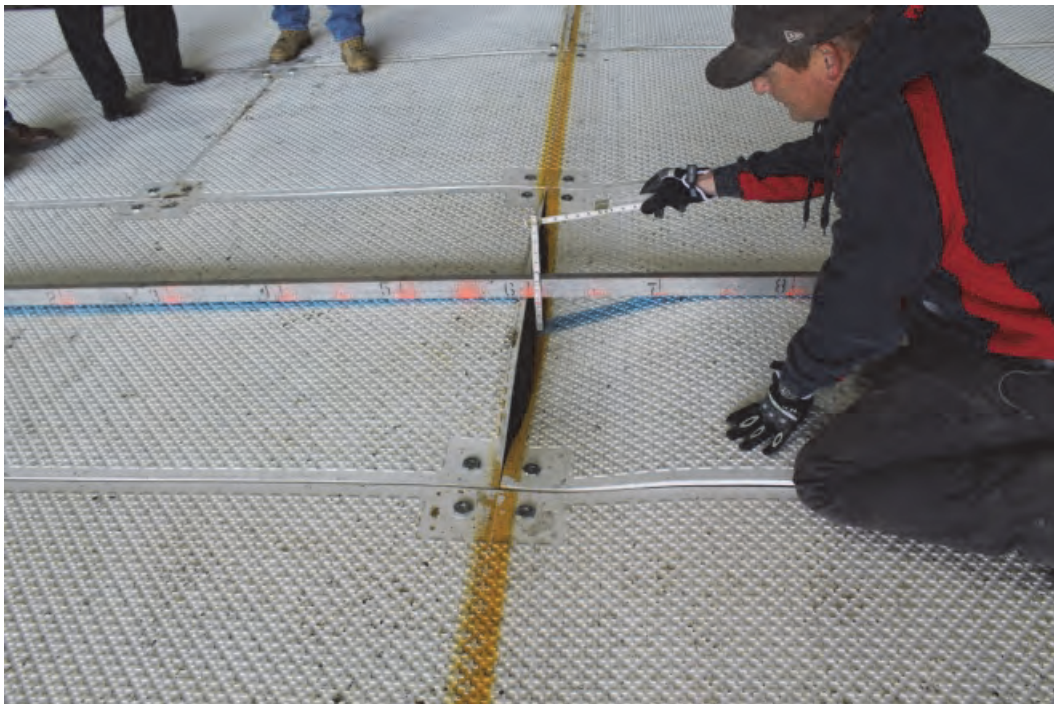
Figure 22. DuraDeck® subgrade deformation after 2 passes on F-15E Lane 1.

Trafficking with the simulated F-15E was first applied to Lane 1 of the test section. After the load cart completed one forward pass and one reverse pass, the matting panels along the joints were deeply embedded into the CH material. The entire area of the wheel path was deformed considerably. Measurements of rutting and permanent deformation showed the depth of rut averaged 2.4 in., as shown in Figure 21. Since the failure criteria limits permanent deformation to 1.25 in. for the F-15E, Lane 1 of the DuraDeck® matting was considered to have failed after two passes. No mat breakage occurred during trafficking. Photos of F-15E Lane 1 after complete trafficking are shown in Figures 22 and 23.

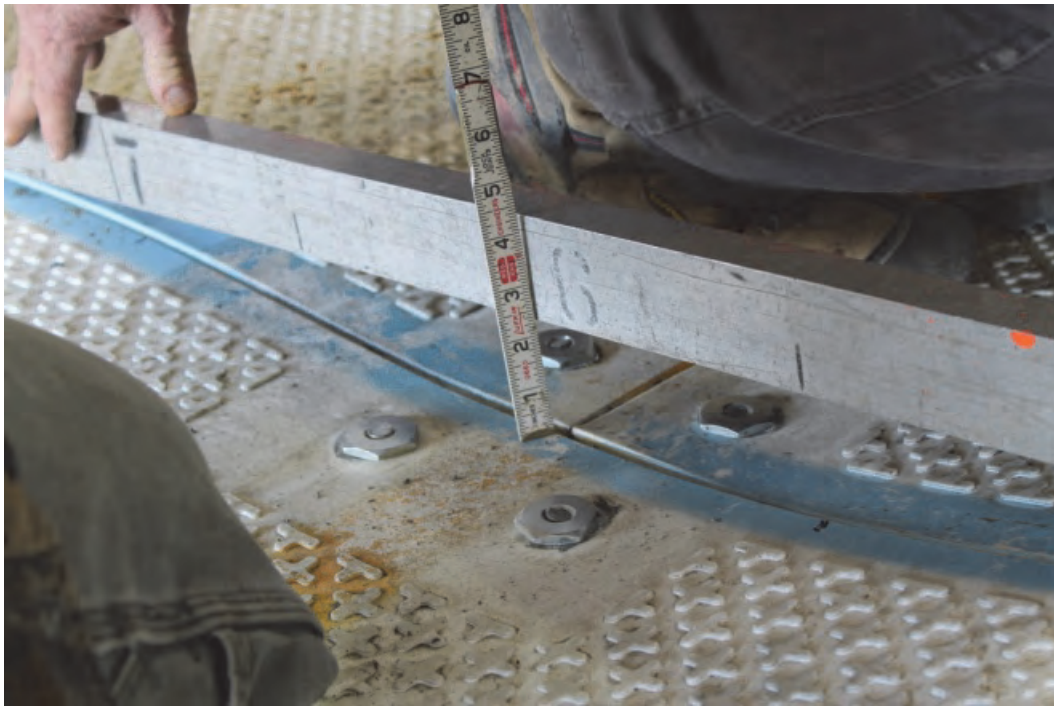
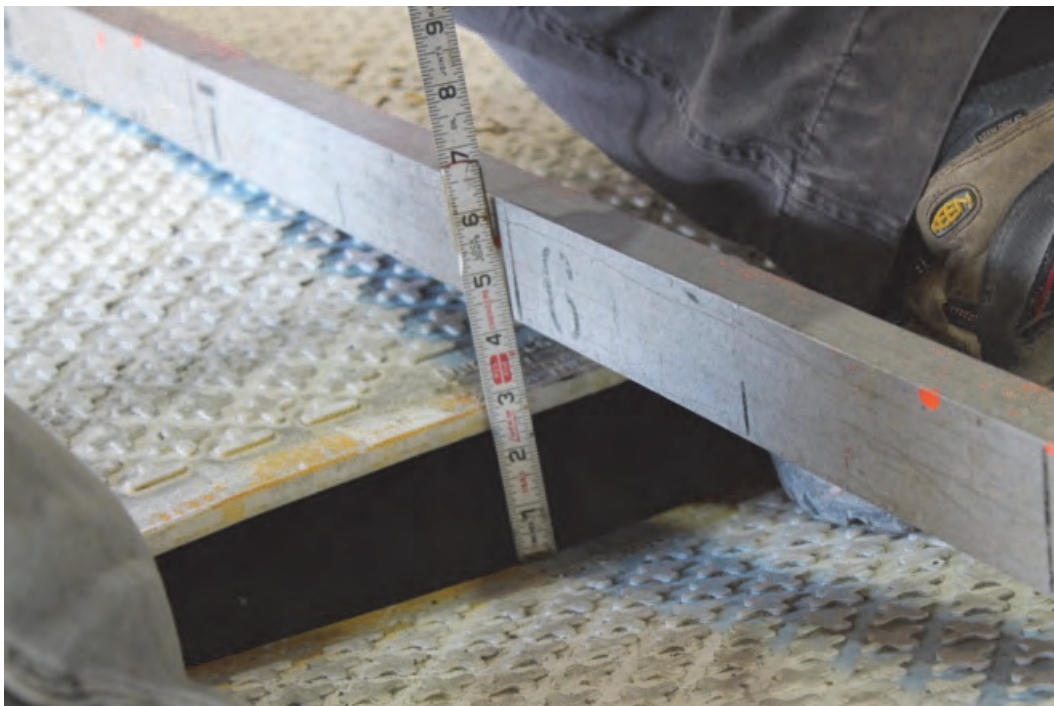
Figure 26. DuraDeck® final deformation on 25 kip forklift lane at connector plate location.

Figure 27. DuraDeck® final deformation on 25 kip forklift lane along unsupported joint.

Simulated 25 kip forklift traffic was applied on the DuraDeck® matting system. After 30 passes, a deformation of 2 in. was measured. Since there is no failure criterion in terms of permanent deformation for wheeled vehicles, trafficking was continued. The deformation continued to increase until it reached 3 in. after 70 passes, as shown in Figure 21. At that time, excessive deformation on the surface caused the wheel guards on the side of the test vehicle to nearly touch the mat surface. To avoid damage to the test vehicle, the test was concluded. Although there was significant movement of the matting during trafficking and large deformation in the subgrade, no damage to the matting or connection system was noted. Applied stresses from protruding threaded studs caused a slight elongation of connector holes in the mat, but the panels could be reused without concern or modification. Photos of deformation on the mat after concluding trafficking are shown in Figures 26 and 27.

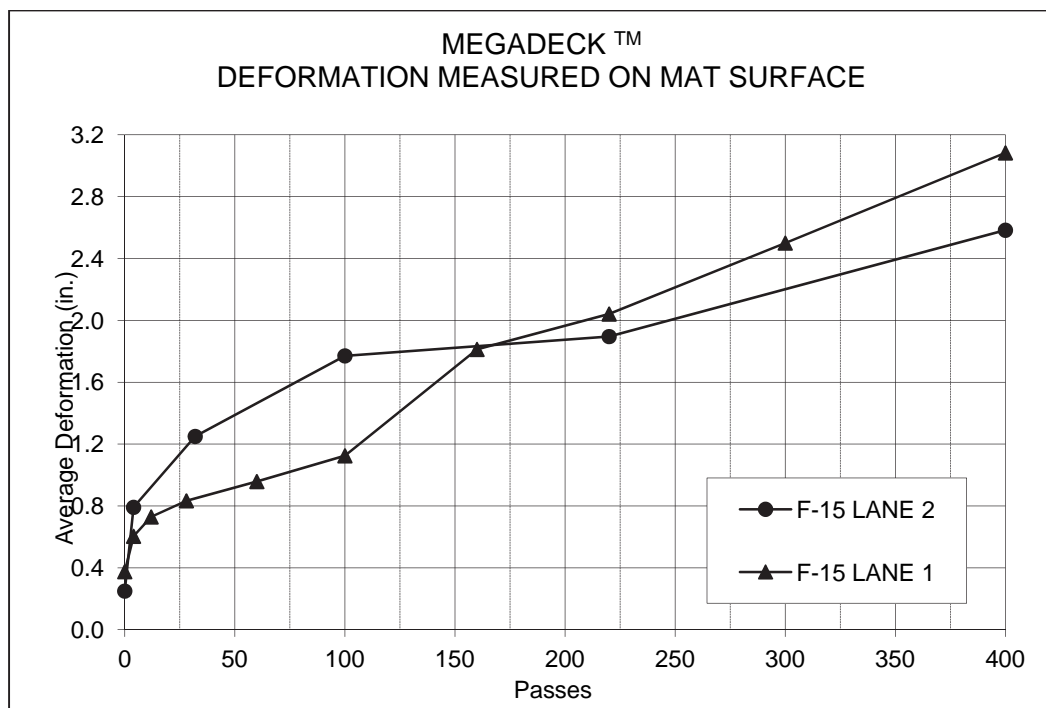
Figure 28. Summary of subgrade deformation for MegaDeck™.

Lane 1 was positioned so that the test wheel was aligned directly along a continuous longitudinal mat joint. Lane 2 was positioned directly between two longitudinal joints. For Lane 1, a standard F-15E with a gross weight of 68,500 was simulated for the first 100 passes. Then, weights were added to the test vehicle to represent a fully-loaded F-15E with a gross weight of 81,500 lb for comparison to previous AM2 test results for outdoor parking apron applications. The maximum loading condition was applied for the remainder of trafficking on Lane 1 and for all trafficking of Lane 2. A summary of the rate of deformation in both traffic lanes is shown in Figure 28. The discussion that follows explains these results.

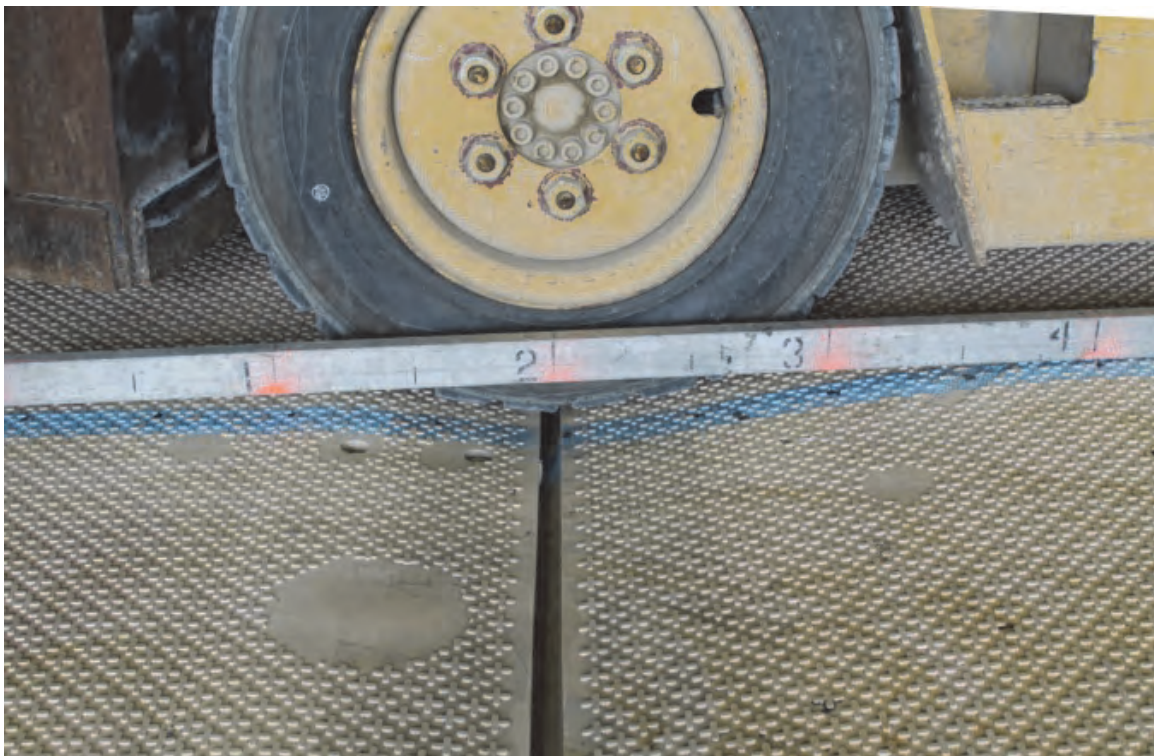
Figure 29. MegaDeck™ final loaded deformation along the joint on F-15E Lane 1.

after removal from the test section showed the bottom skin had begun to push through on the underlap side of the panels. This mat damage might have contributed to the rate of deformation in the wheel path. Figure 29 shows the final loaded deformation along the joint, Figure 30 shows a photo of the lane after trafficking was concluded, and Figure 31 shows a photo of the bottom skin damage.

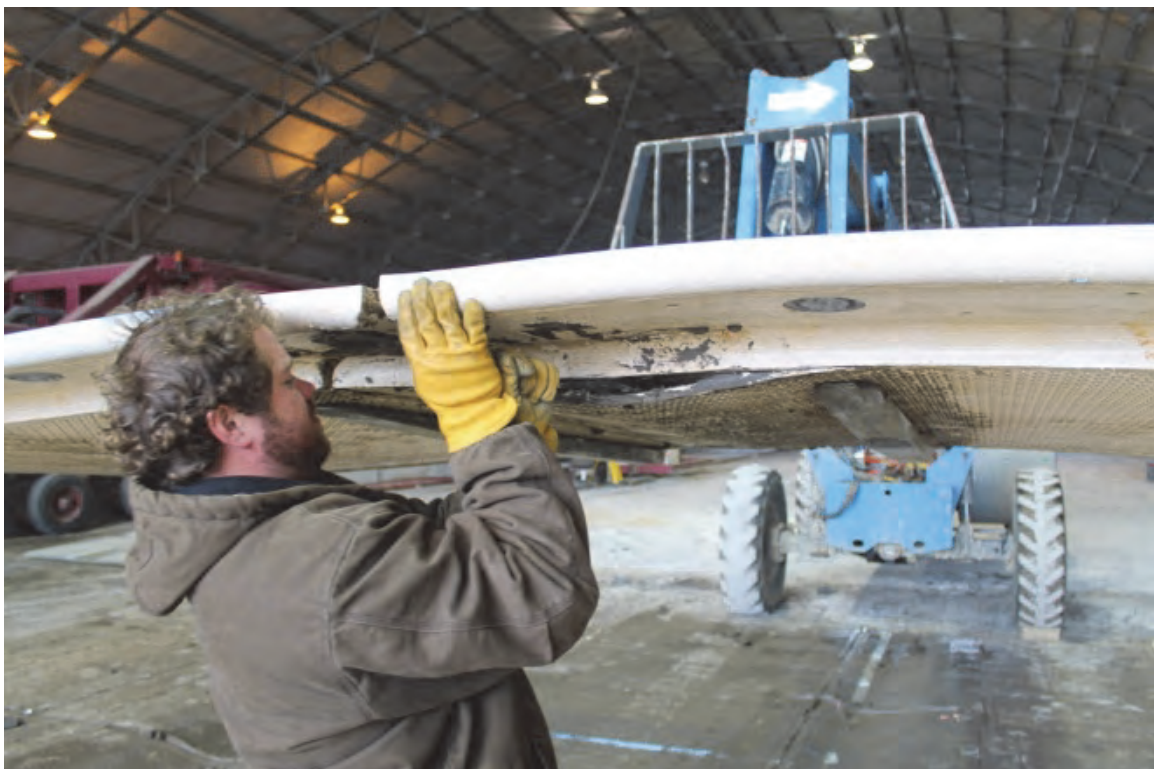
Figure 31. MegaDeck™ F-15E Lane 1 bottom skin damage.

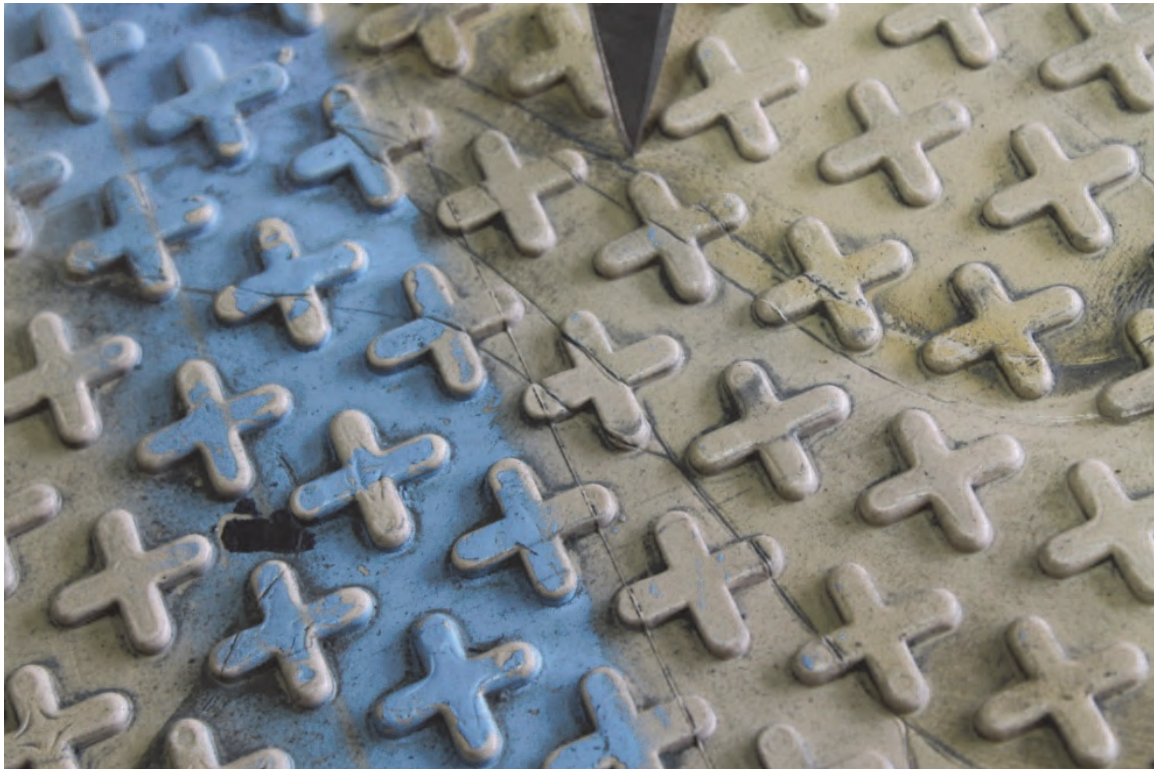
Figure 32. Minor cracking on MegaDeck™ after 400 passes on F-15E Lane 2.

Traffic was moved from Lane 1 to Lane 2 located between longitudinal joints to determine the difference in rates of deformation. After 32 passes, the permanent deformation was 1.25 in., and Lane 2 was considered to have failed by exceeding the deformation limits of the F-15E aircraft. Traffic was continued, since no breakage was noted. The deformation increased until 2.5 in. was measured after 400 passes. Minor cracking was noted on the surface of the skin, as shown in Figure 32; however, it did not pose a tire hazard. Trafficking was concluded to prevent instability of the load cart. The deformation on the surface caused the wheel guards on the side of the test vehicle to nearly touch the mat surface. The deformation on the mat surface after trafficking was concluded is shown in Figures 33 and 34. Lane 1 outperformed Lane 2, because the solid structure of the overlapping flanges

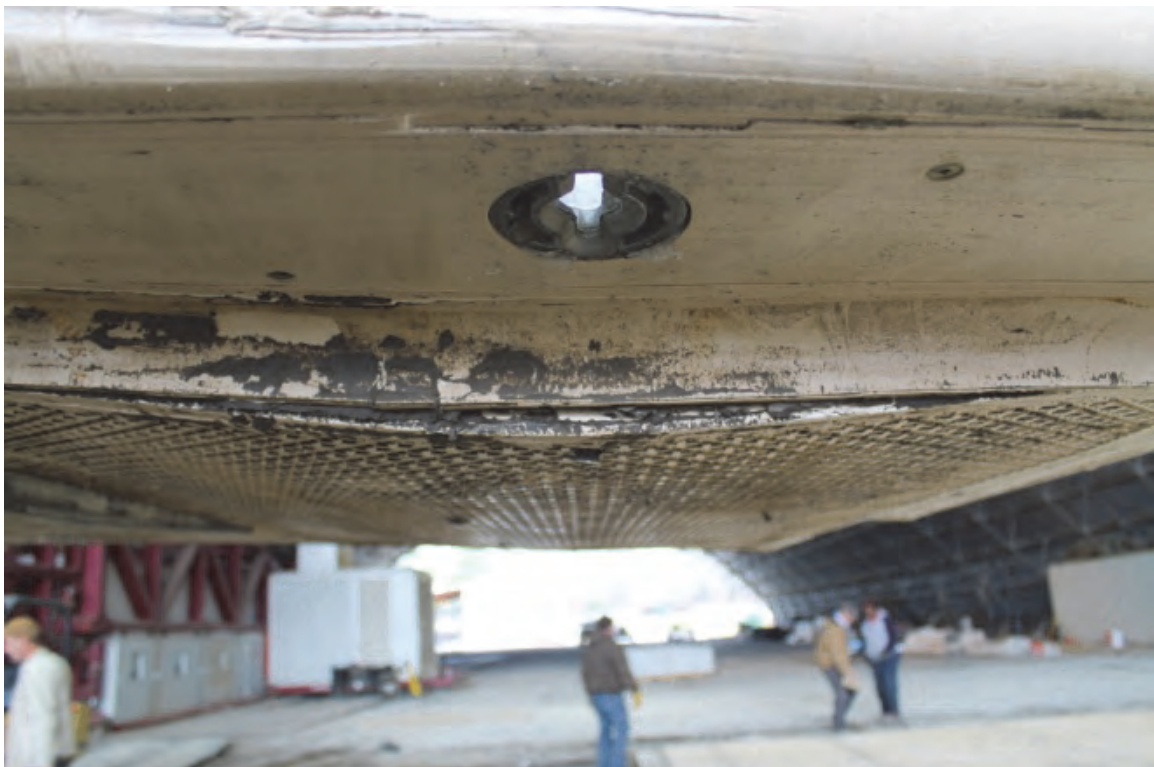
Figure 33. MegaDeck™ bottom skin debonding on F-15E Lane 2.

was able to handle the load better than the hollow structure of the mat's core. Once the MegaDeck™ panels were removed from the surface, researchers noted that the core of the individual panels had begun to crush, and the bottom skin was debonded from the panels as shown in Figure 35. Since this damage could not be seen from the surface and no tire hazard resulted, the actual number of passes before mat breakage occurred could not be determined. The damage resulted in earlier failure of Lane 2 over the central portion of the panels than Lane 1 with traffic along the joints.
