US Army Corps  
of Engineers®

# Initial Morphologic Evolution of Perdido Key Berm Nourishment, Florida

*by Ping Wang, Katherine E. Brutsche, Tanya M. Beck, Julie D. Rosati,  
and Linda S. Lillycrop*

**PURPOSE:** This Coastal and Hydraulics Engineering Technical Note (CHETN) documents the initial morphologic evolution of the Perdido Key, FL, swash-zone berm based on beach-nearshore profile, sediment samples, and nearshore wave data collected during the first six months after berm construction.

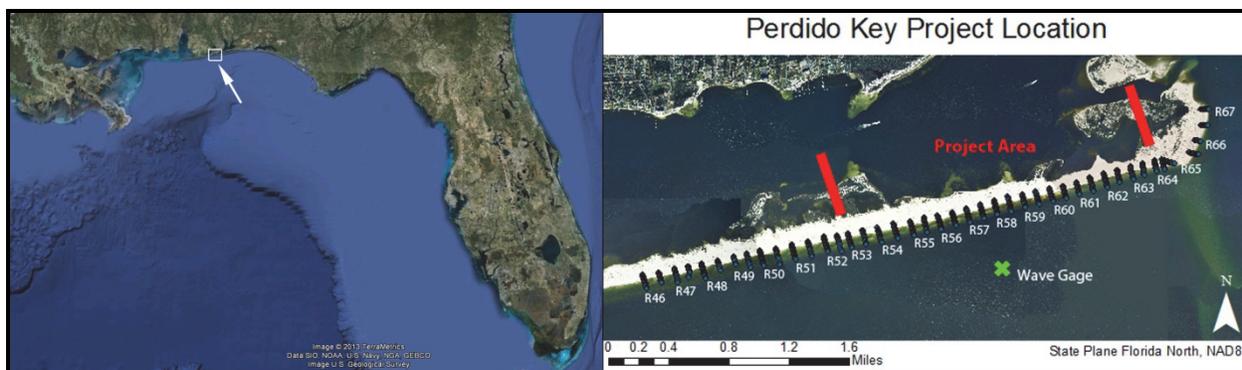
Figure 1. Study area with survey lines spaced roughly 500 ft apart. The surveyed profile between R-monuments is indicated by “0.5” (e.g., R55.5 denotes the line between R55 and R56). The west control area extends from R46 to R53). The east control area extends around the inlet from R64 to R67.

The 2012 Perdido Key artificial berm was placed west of Pensacola Pass (Figure 1). This berm is different from all existing documented berms reviewed by Wang et al. (in preparation). The crest of this artificial berm was constructed at +3 ft NAVD88, which was just 1.3 ft below the elevation of the 1989 beach nourishment. Based on the NOAA Tide Station 8729840 at Pensacola, Mean Sea Level (MSL), Mean High Water (MHW), and Mean Higher High Water (MHHW) are at 0.30 ft, 0.91 ft, and 0.94 ft NAVD88, respectively. Therefore, the crest of the Perdido Key berm was located about 2 ft above MHHW. The sand was pumped onto the beach between Florida Department of Environmental Protection (FDEP) monuments R53 and R64 through a pipeline, and graded to an elevation of +3 ft NAVD88 (Figure 2).

**METHODOLOGY:** This study is based on beach-nearshore profiles, sediment samples, and wave data collected during the first 6 months following placement. Pre- (November 2011) and post-construction (January 2012) shore-perpendicular profile surveys were conducted by the Mobile District. The pre-construction survey included beach and offshore areas. The post-construction survey only included the beach portion. Additional profiles extending from +9 ft to -11 ft NAVD88 were surveyed bimonthly by the Coastal Research Laboratory at the University of South Florida (USF-CRL) following level-and-transit procedures using an electronic total survey station and a 12.5-ft survey rod. Surface sediment samples were collected before and after berm placement to examine the compatibility of native and nourished sand. Sediment samples were collected at various cross-shore locations extending from the dune edge to roughly 4 ft water depth. Sediment grain size was analyzed using standard sieves. Nearshore tide and wave conditions were measured using a PUV directional wave gauge, located roughly 2,000 ft from shoreline in 18 ft water depth (Figure 1).

East of the berm, the shoreline extends north along the western shore of Pensacola Pass. Bathymetry along this stretch varies substantially, ranging from the steep slopes along the inlet to the extensive, shallow channel-margin linear bar (Figure 1). Overall, the profiles were stable during the 6-month period, as shown by profile R65 (Figure 10). A small amount of accumulation was measured over the dry beach, resulting in a roughly 20-ft seaward propagation of the active berm crest. Profile R65 extends perpendicular to the shoreline bend along the inlet (Figure 1). Profile R66.5 has a steep slope that extends into the channel (Figure 11). Little change occurred

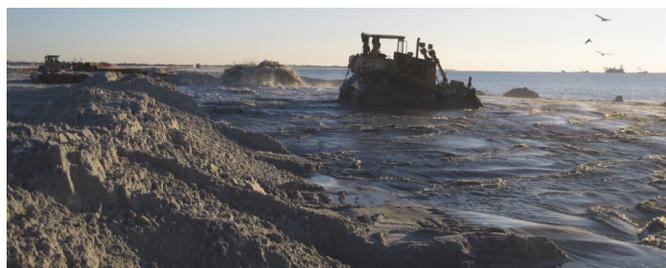
Figure 2. Berm construction: Sand is pumped onto the beach and graded (photo taken December 18, 2011).

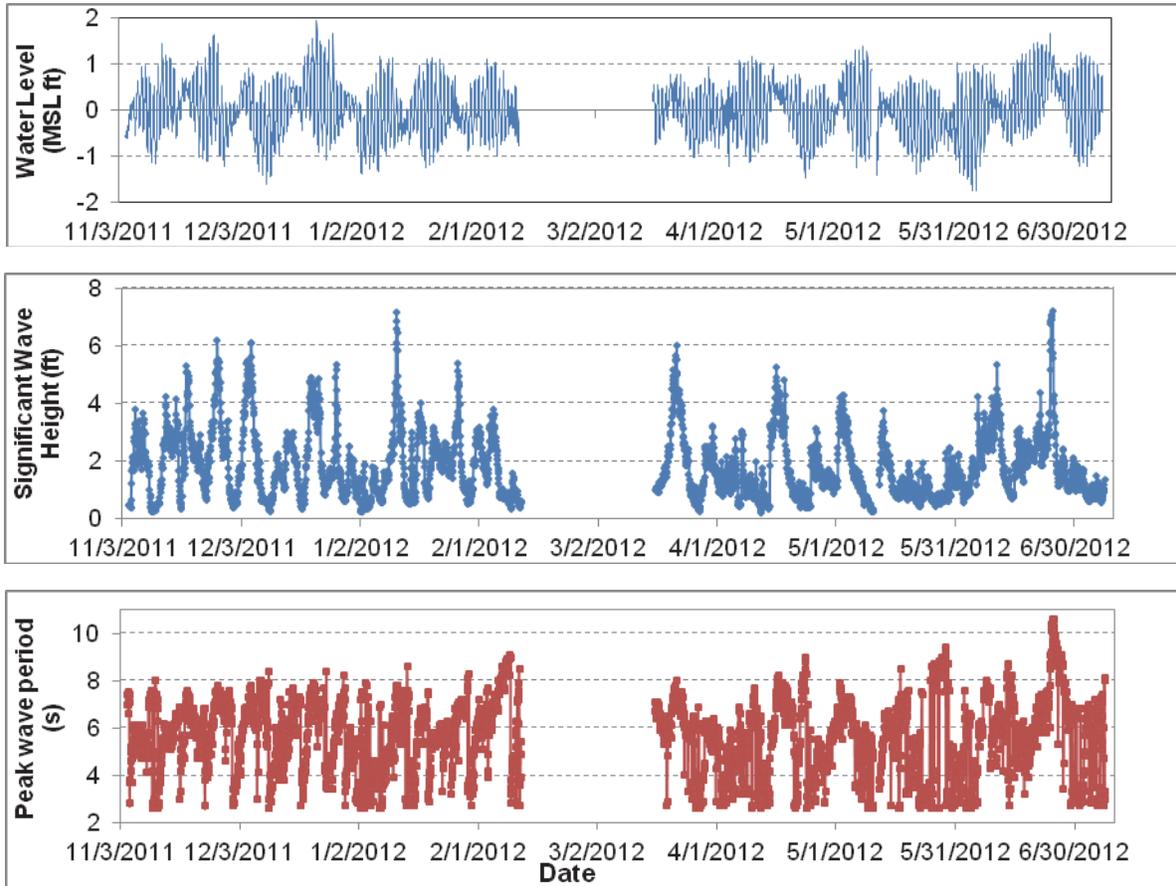
Figure 3. Water level (top), significant wave height, (middle), and peak wave period (bottom) measured during the study period. Wave gauge location is shown in Figure 1.

The study area experiences small diurnal tides with spring tides ranging slightly over 2 ft and neap tides less than 1 ft (Figure 3). Meteorological conditions have a significant influence on water-level fluctuations. The average wave height during the study period was 1.8 ft, with a standard deviation of 1.2 ft. High waves occurred during the episodic passages of cold fronts in the winter and tropical storms in the summer.

The highest wave of 7.2 ft, also occurred with the longest period of 10.6 s, and was the peak wave height measured during the distal passage of Tropical Storm (TS) Debby in late June 2012. An elevated water level of roughly 0.5 ft was measured. High wave events were more frequent during the winter (November to April) than during the summer (April to July). It is worth noting that based on NOAA wave buoy 42012 about 14 miles offshore of Perdido Pass (in water depth of 90 ft), three energetic events occurred between mid-February and mid-March when the CRL-USF nearshore wave gauge was out of power.

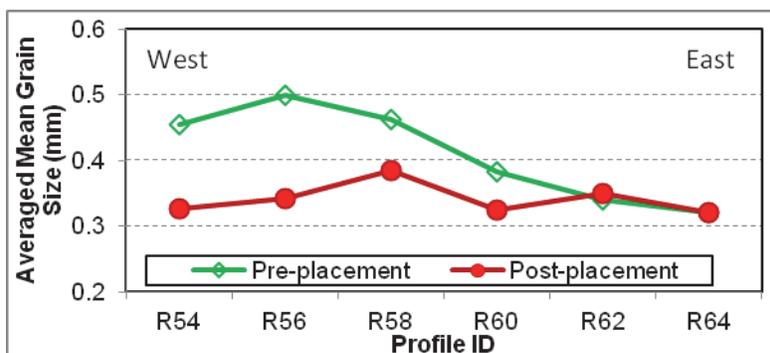
Figure 4. Comparison of the mean grain size between the native sediment (pre-placement, sampled Nov. 2011) and the placed sediment (sampled Jan. 2012).

averaged across each sampling profile to provide a representative grain size of pre-placement and post-placement (Figure 4). Prior to placement, the average back-beach grain-size decreased from nearly 0.50 mm on the western side of the project to 0.34 mm at the eastern terminus of the island. All surface samples taken along the back-beach following construction of the berm indicated an alongshore, uniform grain size ranging from 0.32 to 0.39 mm of well-sorted, medium quartz sand.

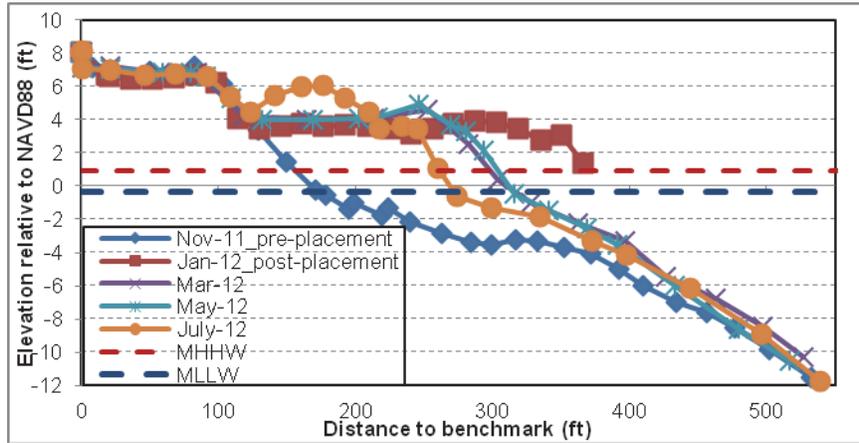
Figure 5. Time-series beach-nearshore profile at R58.5 in the middle of the berm project area. Location of the profile is shown in Figure 1.

**MORPHOLOGICAL EVOLUTION:** Morphologic evolution during the first 6 months was examined by comparing profiles surveyed before, immediately after, and 2, 4, and 6 months post-construction. Profile changes in the control areas (Figure 1) were compared with changes in the project area, to examine alongshore spreading of the berm material. Profile R58.5 provides a representative example of morphologic change in the middle of the project (Figure 5). The initial placement extended the shoreline roughly 250 ft seaward. The shoreline retreated landward nearly 100 ft during the first 2 months. As the shoreline moved landward, a berm crest developed over the placement. This natural berm crest was 2.0 ft higher than the constructed berm. This natural process of beach building was clearly illustrated by the substantial storm-berm development associated with the distal passage of TS Debby. A storm berm nearly 100-ft-wide with a crest of nearly +6 ft NAVD88 developed (Figures 5 and 6), and was measured along the entire project area with widths and heights varying alongshore.

Significantly more landward retreat of shoreline occurred during the first 2 months (Figure 7) near the western end of the berm as compared to the rest of the project (Figure 5). This is due to alongshore spreading of the placement material. The shoreline retreated landward over 120 ft or about half of the nourished width, followed by another 30 ft associated with TS Debby. The storm berm that developed during TS Debby was nearly 100-ft-wide and welded to the higher pre-placement beach (Figure 7). It was a different shape as compared to the morphology measured in the middle of the project.

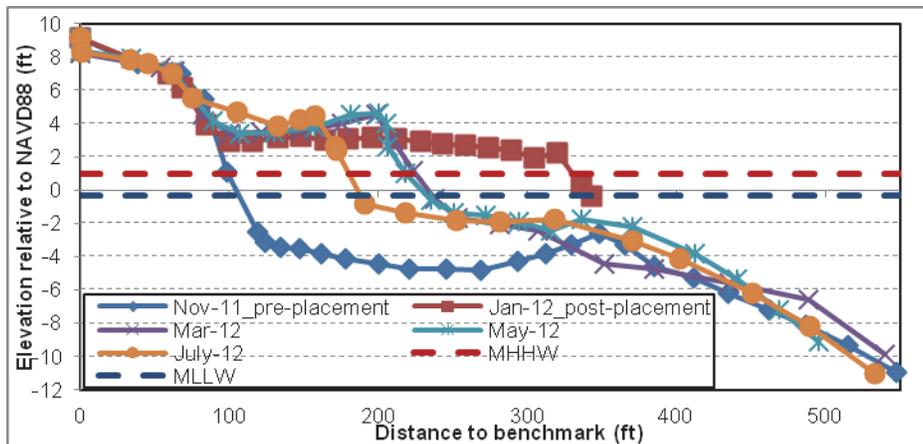
Figure 7. Time-series beach-nearshore profile at R54 at the western end of the berm project area. Location of the profile is shown in Figure 1.

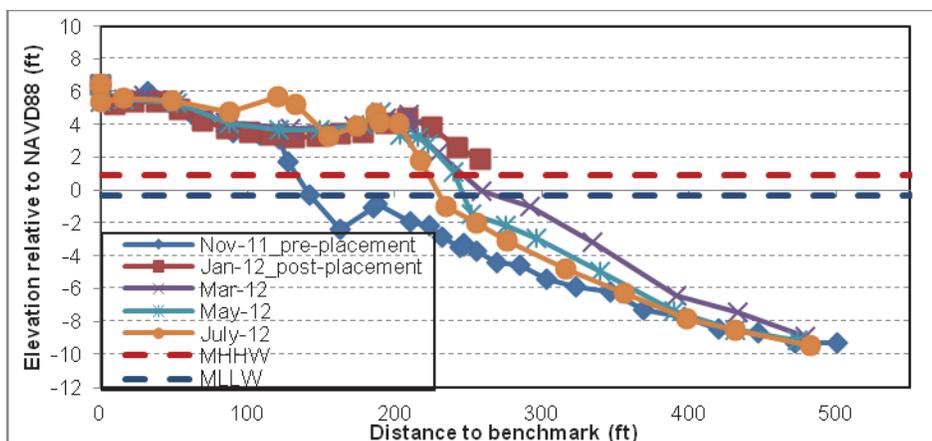
Figure 8. Time-series beach-nearshore profile at R63 at the eastern end of the berm project area. Location of the profile is shown in Figure 1.

The constructed berm at the eastern end of the project was roughly 150 ft wide, or about half of the width of the western portion. The berm width did not change significantly during the first 6 months (Figure 8). The shoreline retreated landward roughly 20 ft during the passage of TS Debby. A storm berm nearly 100 ft wide and up to +6 ft NAVD88 in elevation was developed. Compared to the western portion of the berm, the eastern end had smaller profile change, or erosion in this case. This may be attributed to some trapping of eastward sediment transport near the inlet due to the

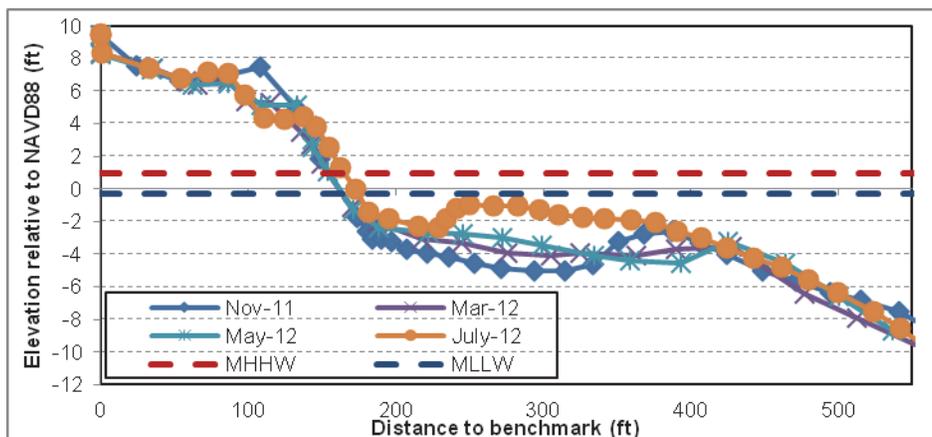
Figure 9. Time-series beach-nearshore control profile at R52, approximately 1,000 ft west of the berm project. Location of the profile is shown in Figure 1.

Volume gain was measured at profile R52, 1,000 ft west of the artificial berm (Figure 9). Most sand-volume gain occurred in the subtidal zone, while the subaerial beach remained stable. The pre-placement profile shows a bar-trough morphology, with a 200-ft-wide trough up to 6 ft deep and a small bar. Six months later, much of the trough accumulated nearly 4 ft of sand and evolved into a shallow platform. The significant change occurred between May and July and is attributed to the passage of TS Debby.

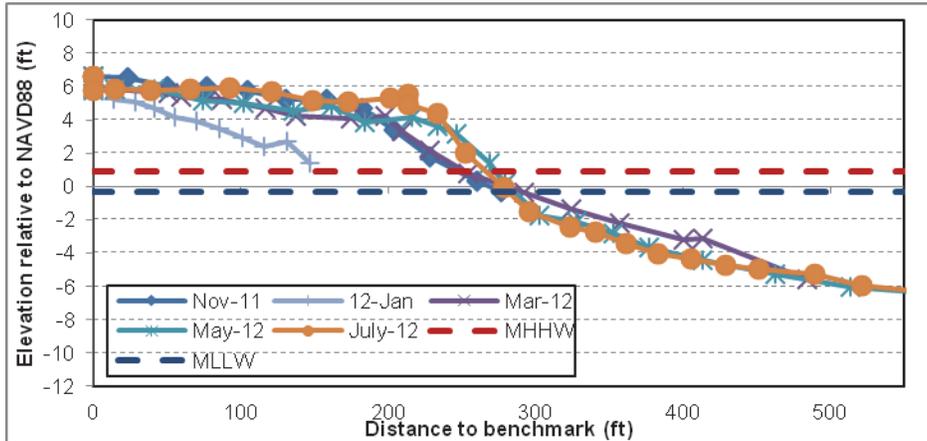
Figure 10. Time-series beach-nearshore profile at R65. Location of the profile is shown in Figure 1. This profile extends perpendicular to the sharp curve of the beach.

deposited as a storm berm. The distance of shoreline retreat decreased eastward. Seaward shoreline advance occurred east of the berm. Accretion measured at profile R65 east of the berm was related to localized beach morphodynamics due to the curve in the shoreline (Figures 1 and 10) at the inlet, and does not represent changes at other locations. The shoreline to the west was stable.

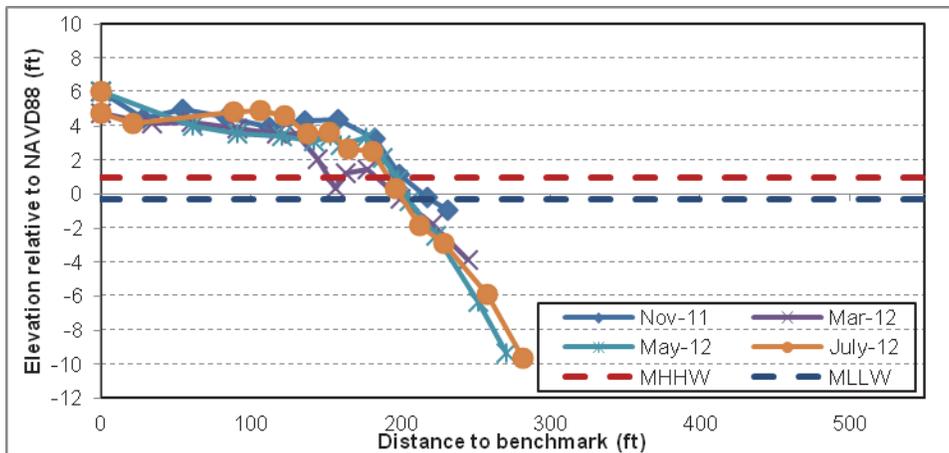
Figure 11. Time-series beach-nearshore profile at R66.5, along the western edge of Pensacola Pass. Location of the profile is shown in Figure 1.

along this and adjacent profiles, indicating minimal deposition of placement material along the inlet shoreline.

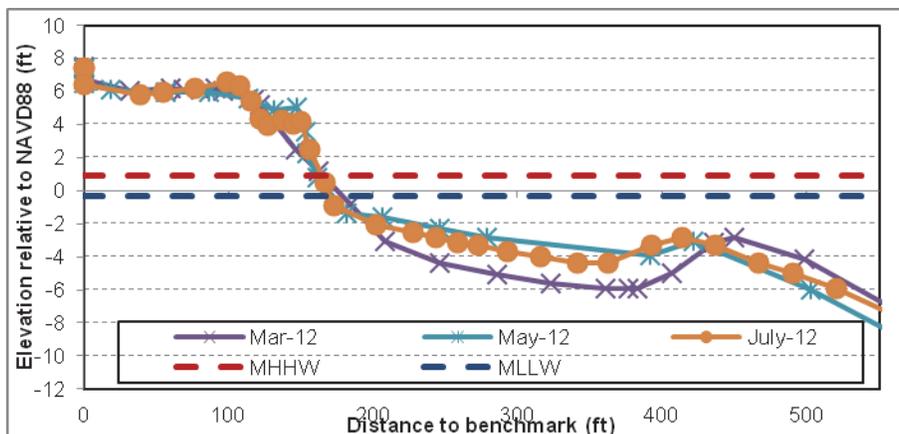
Figure 12. Time-series beach-nearshore profile at R48, approximately 5,000 ft west of the berm project area. Location of the profile is shown in Figure 1.

Minimal changes over the backbeach occurred farther west of the artificial berm (Figure 12). Sand accumulation across the trough was measured between March and May 2012, while erosion was measured following TS Debby. TS Debby did not develop a storm berm along this location. This may be attributed to the fact that storm surge and waves did not transport material to the natural backbeach at an elevation of +6 ft NAVD88.

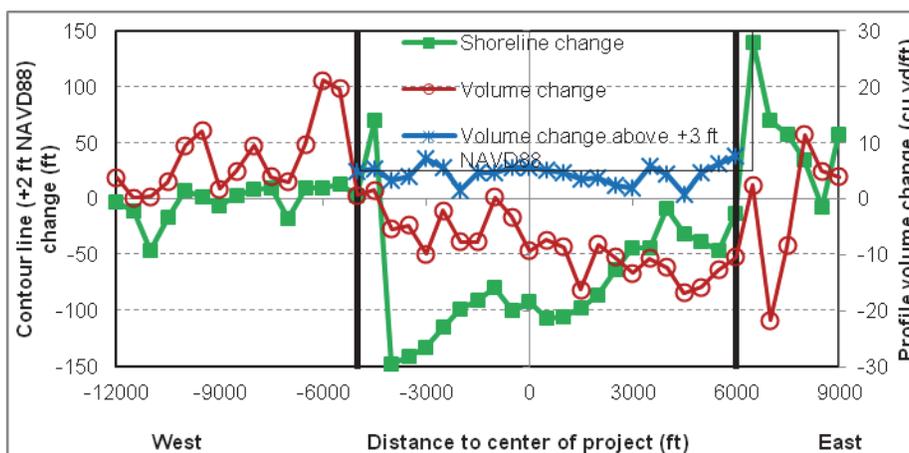
Figure 13. Shoreline (represented by +2 ft NAVD88 contour) and profile-volume change during the first 6 months. The berm project area is marked by the vertical lines.

**INITIAL SHORELINE AND VOLUME CHANGES:** Shoreline along the artificial berm, represented here by the +2 ft NAVD88 contour (Figure 13), moved landward 50 to 150 ft in the first 6 months. The +2 ft contour coincides with the upper foreshore and does not fluctuate on the timescale of tidal cycles and should provide monthly to seasonal trend of shoreline change. Most landward retreat occurred in the first 2 months due to initial profile equilibration. TS Debby induced further landward shoreline movement and some of the eroded sand moved onshore and

The post-placement survey conducted in January 2012 included only the beach portion, and therefore was not used to calculate volume change. Volume change was calculated from the dune edge to -11 ft NAVD88 from March to July 2012. Almost all the profiles in the berm project area lost sand during the 4 months, totaling 91,000 yd<sup>3</sup>, or about 18 percent of the entire 520,000 yd<sup>3</sup> placement. Most profiles in the west control area gained sand, totaling 48,000 yd<sup>3</sup> or 9 percent of the placed sand. This suggests a westward alongshore spreading, consistent with direction of net longshore transport. Most profiles in the east control area directly adjacent to the inlet gained sand, except for profiles R65.5 and R65 (Figure 13). These two profiles are located at the sharp shoreline curve along the flood-marginal channel of Pensacola Pass where tidal currents may play a

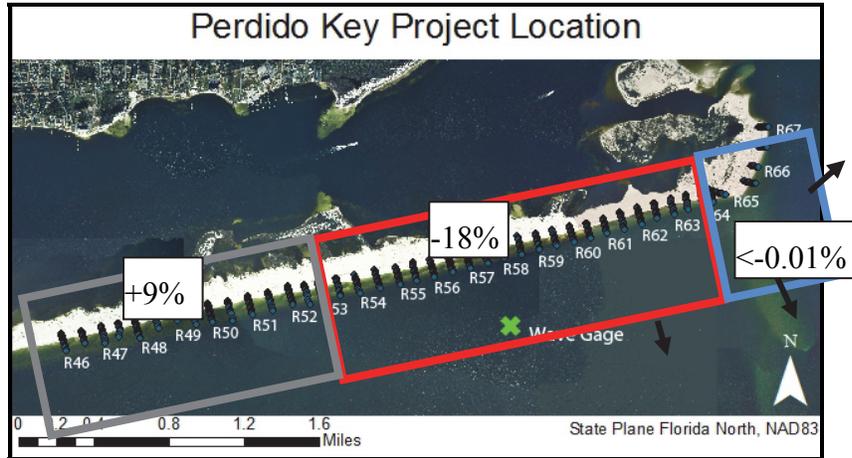
Figure 14. Summary of sand volume change in the project and control areas. Arrows pointing out of the boxes indicating possible volume loss not accounted by the survey.

dominant role in sand transport. The east control area had a net volume loss of 3,000 yd<sup>3</sup>, suggesting that a negligible volume of sand moved into the inlet. Figure 14 summarizes the volume change over the project area and the adjacent beaches. Over the entire study area, a net loss of 46,000 yd<sup>3</sup>, or nearly 9 percent of the total placement, was measured. Depositions in the offshore, into the inlet, and dispersion over the ebb delta are possible explanations of the net loss.
