Structural Damage Identification in Stiffened Plate Fatigue Specimens Using Piezoelectric Active Sensing

B. L. GRISSO, G. PARK, L. W. SALVINO and C. R. FARRAR

ABSTRACT

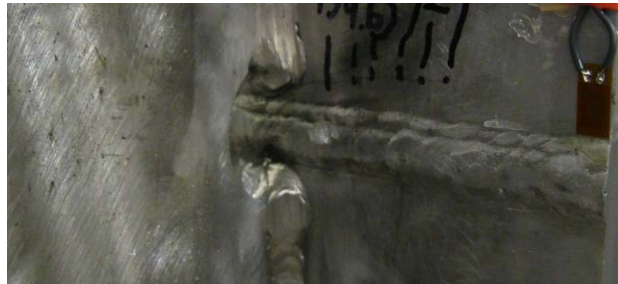
Figure 2. The front of the specimen shows the butt weld and rathole where crack initiation occurs.

As the fatigue test progressed, a crack was initially observed at 167,300 cycles. The crack was located in the heat-affected zone adjacent to the main plate butt weld. The crack started in the center of the plate, directly under the rathole in the stiffener. A rathole feature (seen in Figure 2) allows for the stiffener to be welded to the plate without having to grind the butt well flush with the plate surface. As previously mentioned, the test was not terminated due to the initiation of a crack, but allowed to continue. The crack grew through the plate thickness to the back of the specimen, and then along the butt weld towards the free edges of the test specimen. Figure 3 shows the crack in the back of the plate with the length of the crack identified at different cycle counts. Eventually, the crack extended completely to the edge (right side of

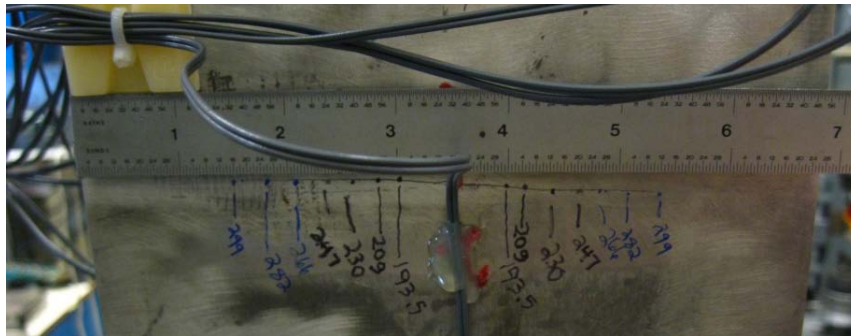
Figure 3. The crack, with propagated length labeled at fatigue cycle counts (in thousands), is visible on the back of the specimen (butt weld covered by ruler).

Cycles	Specimen Temp	Visually Observed Damage
none	70° F	none
1k	69° F	none observed
60,826	69° F	none observed
110,452	69° F	none observed
185,601	69° F	crack detected
217,727	70° F	around 1.5" crack
232,008	66° F	2" crack
251,709	68° F	growing
268,276	68° F	growing
299,296	70° F	4" crack
314,728	70° F	growing
325,365	65° F	crack extended through left edge of specimen (between PZTs 1&2), less than 1" from edge on other side

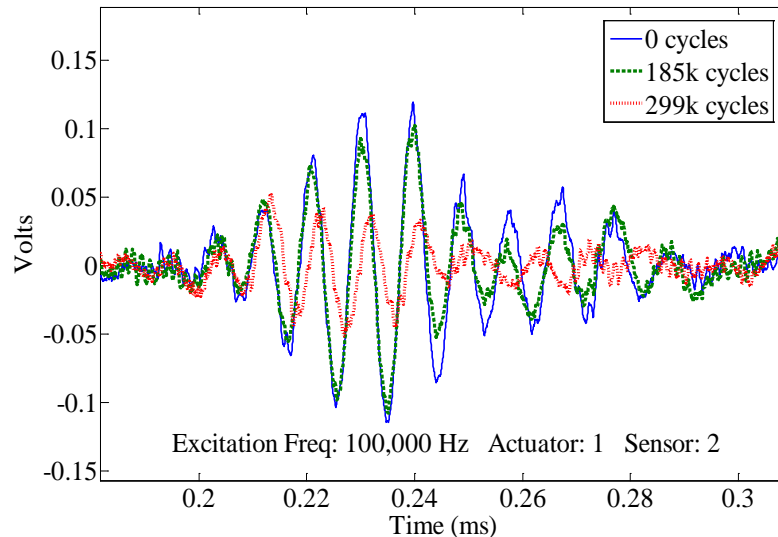
Figure 4. The isolated A_0 mode first arrival, recorded at PZT 2, is shown at 3 different fatigue levels.

As mentioned in the previous section, the PSD analysis was applied to the first arrival of the first asymmetric mode. In Figure 4, the A_0 mode is isolated in the time domain for 100 kHz excitation generated at piezo 1 and measured at piezo 2. As the crack grows across the stiffened plate, changes to the waveform can be visually observed. The signal with the largest amplitude was acquired before any fatigue testing began. By 185,601 fully reversed cycles, attenuation of the curve is clearly noticeable. After 299,296 fatigue cycles, there is a significant difference in amplitude as well as a phase delay.

After applying the PSD analysis to the waves seen in Figure 4 (as well as the rest of the data described in Table 1), charts were generated to describe the average recorded signal power as a function of the number of fatigue cycles. Figure 5 displays one of these bar graphs for 100 kHz excitation measured on the path from piezo 1 to piezo 2. Each bar represents an average power calculation, and two measurements are shown for each of the data sets described in Table 1 (i.e. the first two bars correspond to the measurements acquired with no cycling, the next two correspond to 1,000 cycles, and so on).

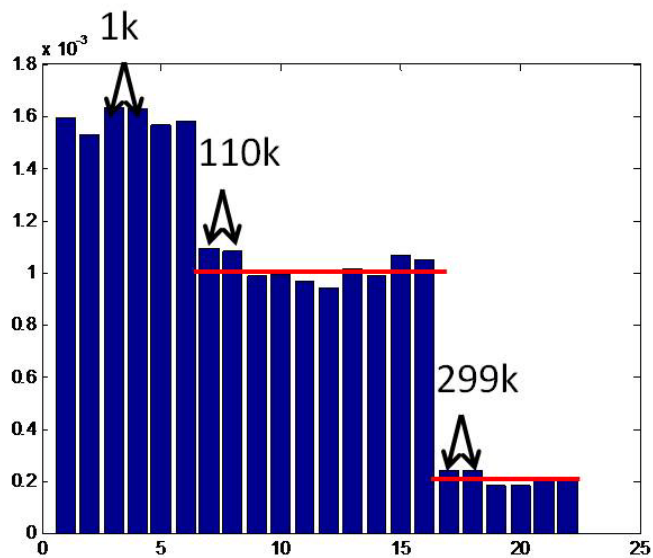
Figure 5. The area under the PSD curve, calculated twice at each fatigue level, is shown for the path from piezo 1 to 2 at an excitation of 100 kHz.

As seen in Figure 5, there are two distinct energy levels that happen along this path from 1 to 2. At the measurement taken at 110,452 cycles, there is a significant decrease in the signal power. This power level generally remains constant until 299,296 cycles when there is another large decrease in signal power (as visually observed in Figure 4). These dramatic power reductions at the sensor are likely caused by two distinct fatigue stages of the specimen. As previously mentioned, the crack was first visually observed at 167,300 cycles. This Lamb wave technique is

likely showing changes in energy at the onset of cracking before it can be felt or visually detected, indicating the presence of imminent damage. By 299,296 cycles, the crack was near four inches in length and directly in the path between piezos 1 and 2, thus severely limiting the amount energy transfer along that path. The PSD average power calculated along path 3 to 4 shows similar results.
