ARMY RESEARCH LABORATORY

**Corrosion Behavior of Sacrificial Coatings on Grade 10.9
Fasteners for Multimetal Armor Applications**

ARL-TR-6538

August 2013

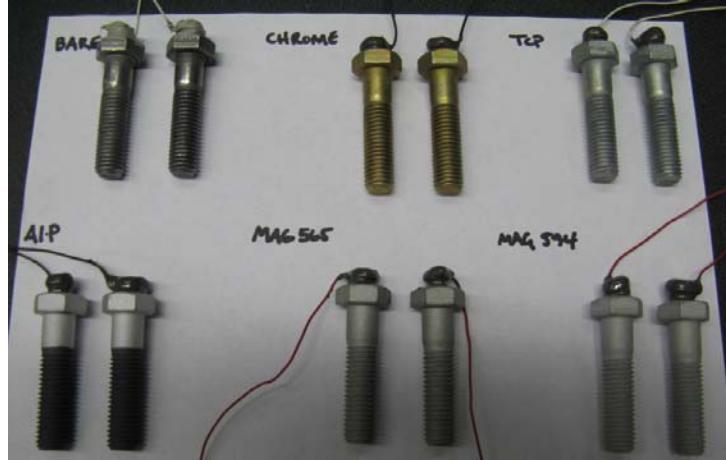
A thermostatic bath was filled with a 5% NaCl solution. This bath was heated to 75 °F for the duration of the experiment and was constantly agitated by an internal mechanism. For each bolt candidate and baseline (figure 2), two were immersed in the solution for a period of 500 h. Open circuit potential (OCP) measurements were taken at 1, 2, 4, 8, and 24 h, then every 24 h following that using a digital multimeter.

Figure 2. Prepared bolts prior to immersion in thermostatic bath.

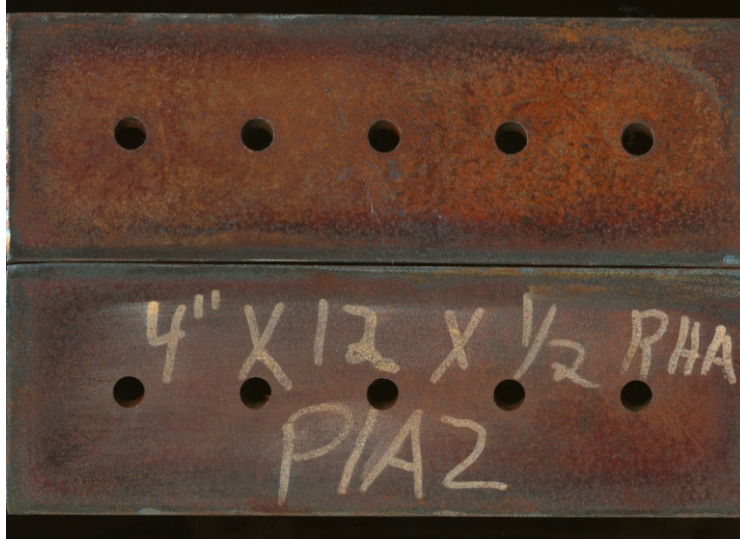
Figure 3. RHA steel prior to surface finishing.

Preparation for the GM9540P (7) cyclic corrosion tests involved creating test jigs to simulate bolt-on armor. Steel and Al plates were prepared as shown in figures 2 and 3. All of the steel and Al plates had either five 13-mm-diameter *through* holes or five 13-mm *threaded* holes. The face plate of each set was equipped with *through* holes, whereas the base plate was the one equipped with *threaded* holes. Each bolt was placed through the face plate and affixed into the base plate with the *threaded* holes. The plates were approximately 4-in wide by 12-in long and were of various thicknesses. Table 1 shows a list of the plates used in this experiment.

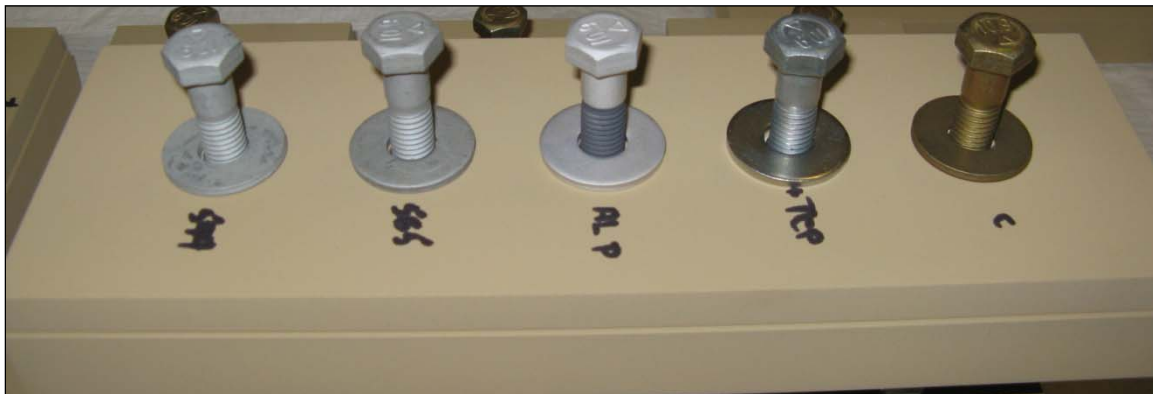
consists of two replicates of this combination: one AL 5059 (1-in-thick) plate that was blasted, pretreated with TCP, and CARC coated, coupled with one RHA Steel (1/2-in-thick) plate that was blasted, pretreated with TCP, and CARC coated. All groups have one of each bolt (figure 5)

Figure 5. Photograph of plate assembly prior to final assembly (from left to right: Magniplate 594, Magniplate 565, Alumiplate, TCP, Hexavalent chrome).

Each bolt was hand fastened into the test plates, using a box wrench when necessary, using its corresponding washer. A calibrated torque wrench was then used to apply a 60-in-lb load on each of the seated fasteners. The plate assemblies were labeled 1–18, and each of the fasteners was labeled on the surface of the plate for easy identification. Each plate assembly was placed into a GM 9540P test chamber at an angle that was dictated by the protrusion of the fastener from the back of the assembly. Care was taken to ensure that the angle for all assemblies was similar (figures 5 and 6).

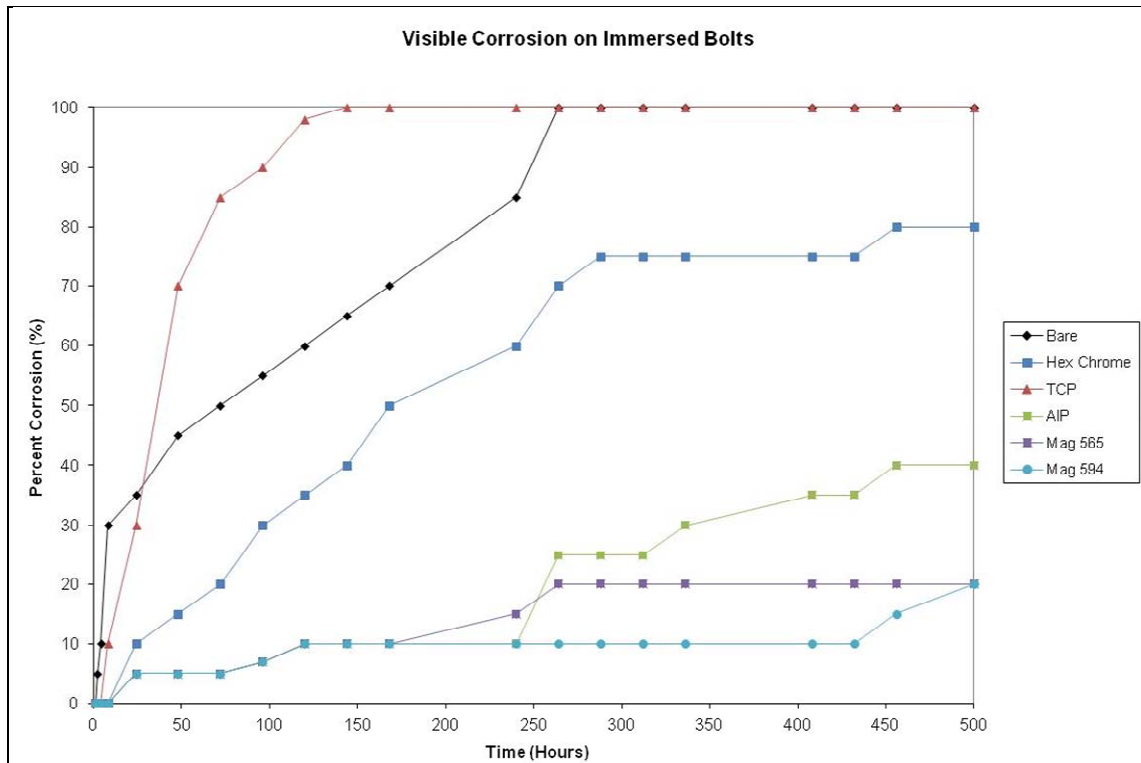
The percentage of corrosion observed on each bolt following 500 h of immersion is plotted in figure 8. Visually, the corrosion rate of the TCP-coated bolt was much higher than that of all other coatings tested, scans of which are presented in figure 9. With respect to the hexavalent chromium baseline, only the TCP and uncoated steel had a higher percentage of visual corrosion over the same time period. 100% of the surface area of the TCP treated bolts had corroded approximately within 150 h in contrast to the untreated bare steel bolt, which lasted approximately 250 h before reaching total surface corrosion. The AlumiPlate-coated bolt never exceeded 40% corrosion of the total surface area, whereas the Magniplates never exceeded 20%. These fasteners were among the most corrosion resistant in the total immersion experiment, having the lowest total corrosion after 500-h immersion. By contrast, 80% of the surface area of the hexavalent chromium had corroded by the end of the experiment.

Figure 8. The amount of corrosion observed visually on the immersed bolts samples during periodic measurements over 500 h.

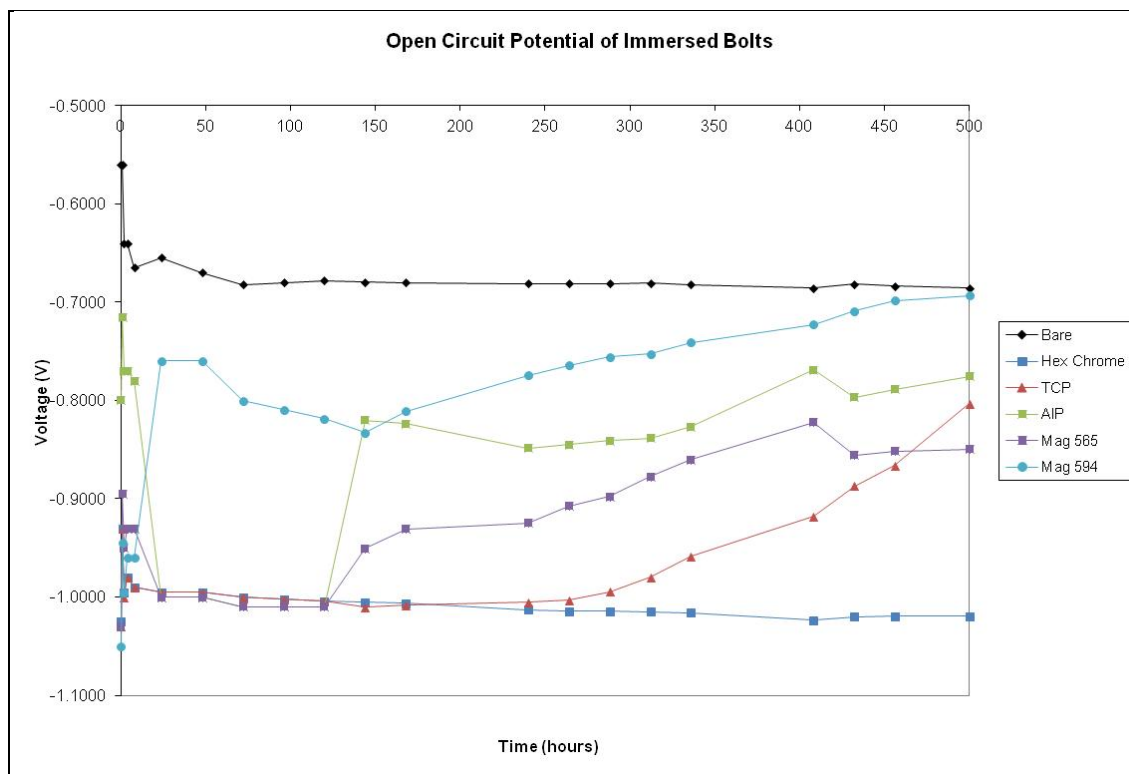
The open circuit potential of the bolts was monitored while immersed in the heated 5% NaCl solution over a period of 500 h. Figure 10 illustrates the changes in OCP throughout the test. Both the uncoated steel and the hexavalent chrome experienced very little change over the course of the 500-h immersion. The Magniplate 594 underwent a very large drop of about 0.25 V in the first 24 h. However, the OCP of the AlumiPlate bolts significantly increased by more than 0.20 V over the first 24 h before dropping back down after 100 h to its original 0.8 V before dropping down to 0.76 V at the end of 500 h. At the nominal voltage (nV) of OCP, the

Magniplate 565 also began to drop, but not as sharply as the AlumiPlate (approximately 0.50 V), but experience a steady drop in OCP. Magniplate 565's total drop after 500 h was 0.15 V. The TCP and hexavalent chrome-coated bolts followed an almost identical trend until they reach about 250 h of immersion, after which the OCP of the TCP began to drop steadily. Visually, the most prominent difference between TCP and Cr⁶⁺ was the amount of surface corrosion. At the 250-h point, the TCP coating was 100% corroded, whereas the hexavalent chromium was approximately 60% corroded. From the 250-h mark until the end of testing at 500 h, the TCP dropped approximately 0.20 V.

Figure 10. The open circuit potential of the immersed bolt samples over 500 h.

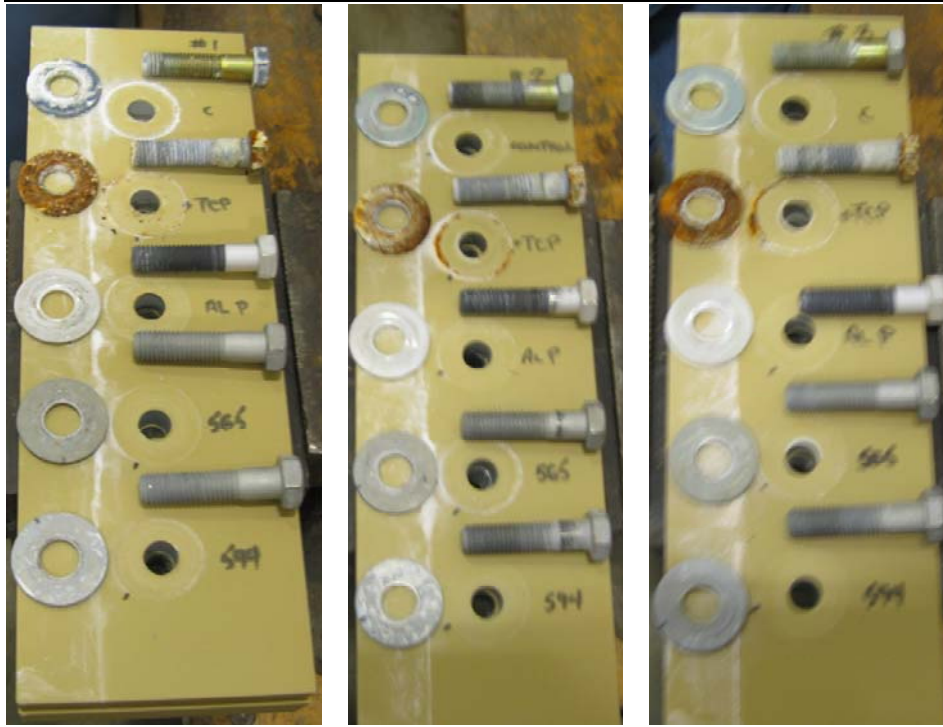
Figure A-1. Plates 1–3 disassembled after 120 cycles GM9540P.

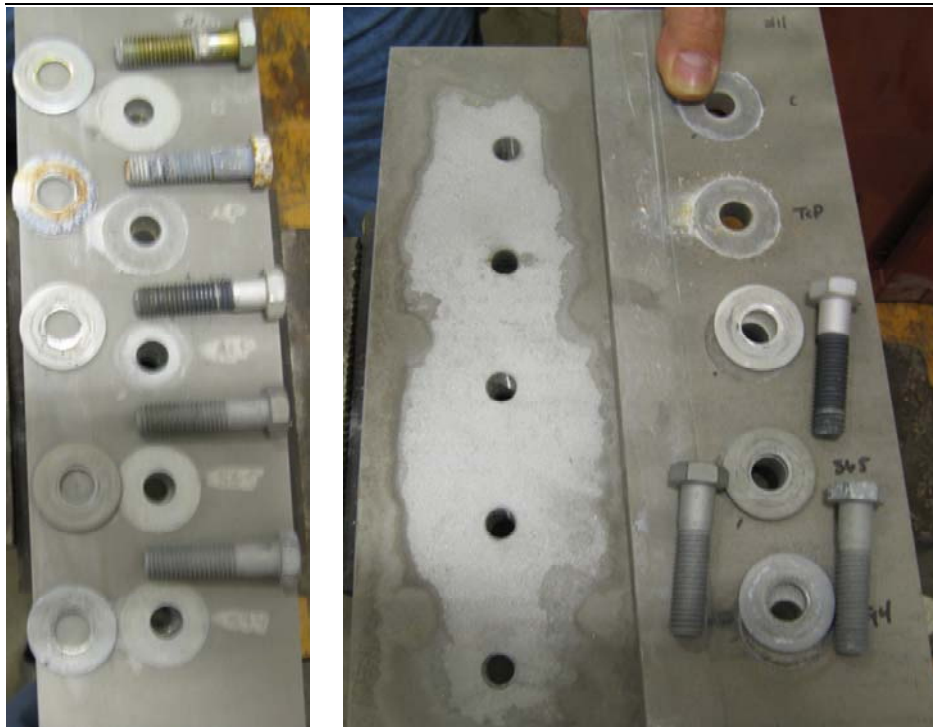
Figure A-4. Panels 10 and 11 disassembled after 120 cycles GM9540P (including interior shot to show moisture penetration on panel 11).

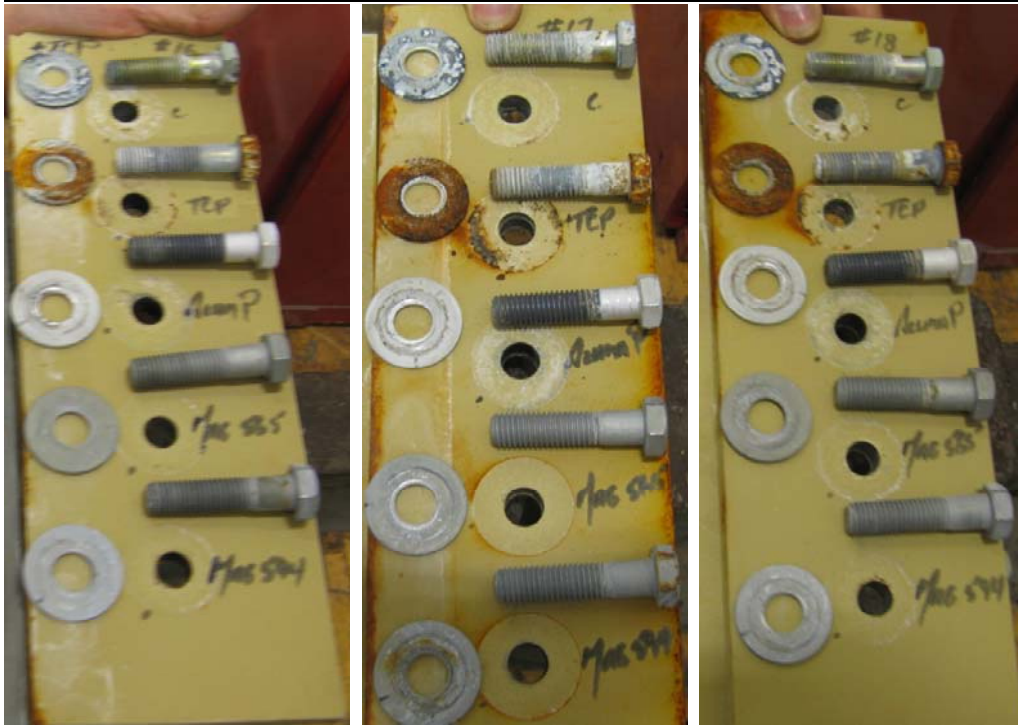
Figure A-7. Panels 16, 17, and 18 disassembled after 120 cycles GM9540P.

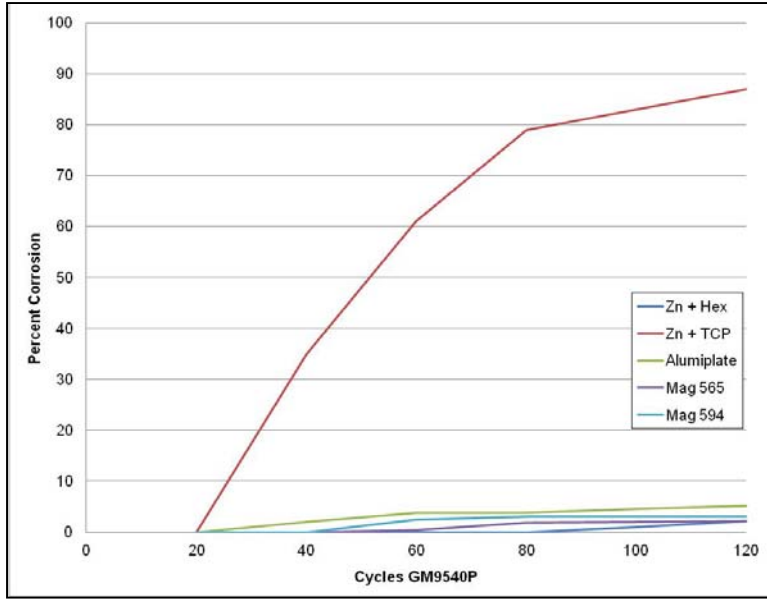
Figure B-1. Group I combination; Al5059 (abrasive blast-TCP-CARC) / Al5059 (abrasive blast-TCP-CARC).

Only the TCP bolts exhibited corrosion in excess of 10% of the total surface area evidenced by the graphs of the percent visible corrosion of the bolt heads and washers in the bolt-in plate in appendix B. All of the other coatings provided adequate protection to the steel bolts.

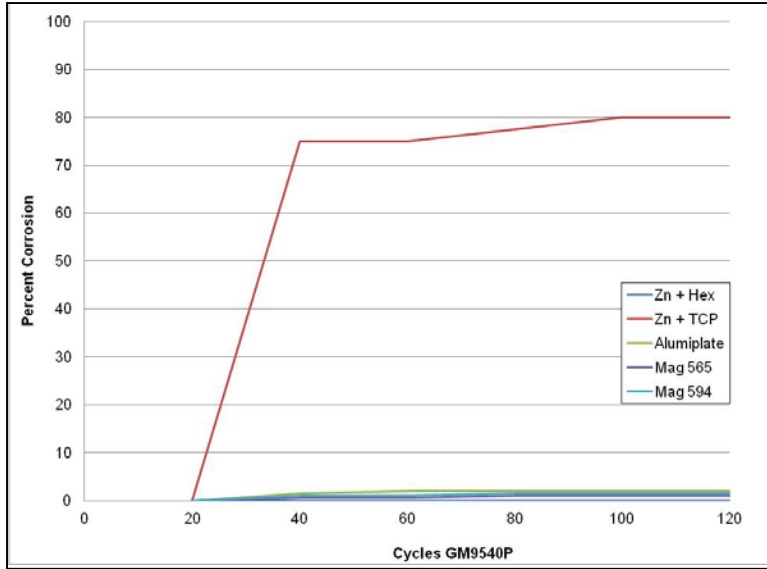
Figure B-3. Group III combination; A15059 (abrasive blast only) / A15059 (abrasive blast only).

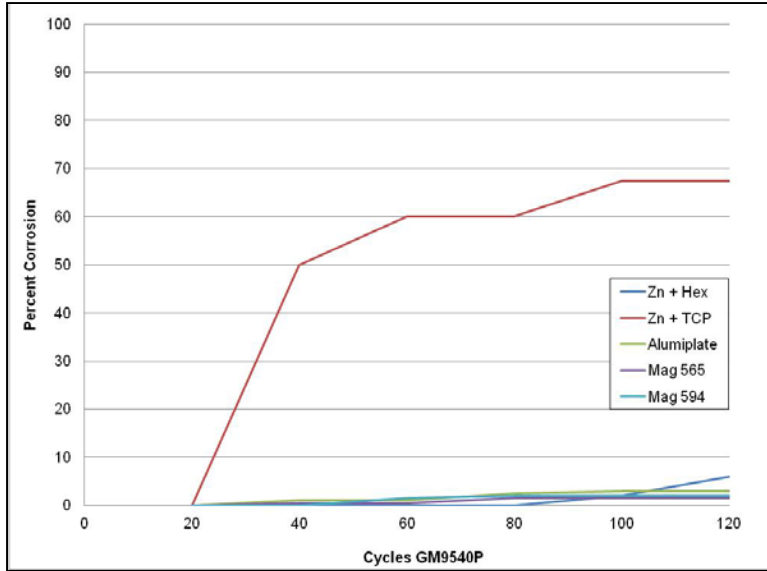
Figure B-5. Group V combination; Al5059 (abrasive blast-TCP) / RHA steel (abrasive blast-TCP-CARC).

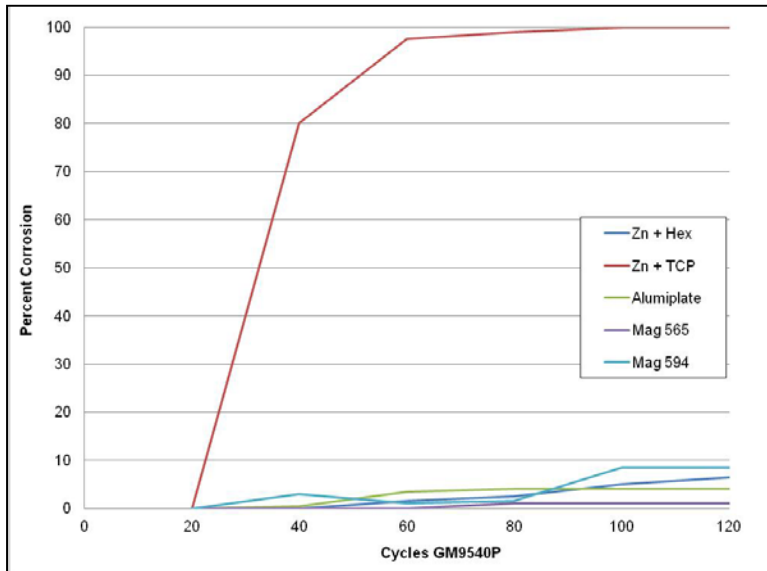
Figure B-6. Group VI combination; Al5059 (abrasive blast only) / RHA steel (abrasive blast-TCP-CARC).
