Technical Report ARWSB-TR-09012

Variant M4 Barrel Characterization

July 2009

ARMAMENT RESEARCH, DEVELOPMENT AND ENGINEERING CENTER
Weapons & Software Engineering Center
Benét Laboratories

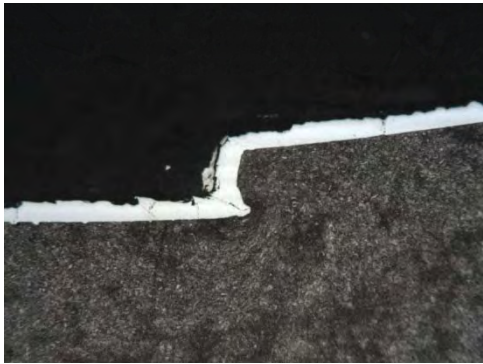
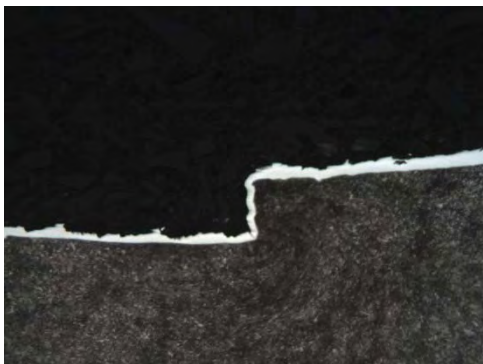
Figure 2: As-received and Fired Configuration 1 Cross-sections

Image height equals 0.020"

The three ¼” ring sections from each as-received and fired barrel (Location 1, 3, and 5) were metallographically mounted in cross-section and polished to a mirror finish. The samples were then etched with Nitol to reveal the steel microstructure. Representative images comparing the as-received and fired barrels are posed as Figures 2 through 5.

The microstructure of the two steels was indistinguishable. All fired barrels showed a tempering in the microstructure, when compared to the as-received steel. This is confirmed in section 4.3 *Microhardness*. Heat affected zones seen in the fired barrels are relatively thin and localized to wide cracks and surfaces where the chromium has been completely removed.

All fired barrels show extensive copper deposits and damage to the rifling lands, and the type of damage appears to be dictated by the rifling profile. The Configuration 1 and 4 button broach barrels had large deposits of copper at the root of the lands; in addition to collecting copper and firing debris at surface cracks and disparities. The Configuration 2 and 3 hammer forged barrels have a rougher as-received surface. During firing, the rough surface tended to collect copper and debris in the surface troughs. For all fired barrels, the damage was heavier at Location 3 compared to Location 5.

The Configuration 1 and 4 button broach barrels exhibited a limited amount of cracking in the steel in the as-received barrels. These cracks were relatively shallow and extended into the wall at a 45° angle from the bore surface at the root of the land. During firing, these 45° cracks initiated and extended at each land root, on both the driving and leeward side of the land. The location and orientation of the cracks suggest shear forces on the side of the land are the motivating force for cracking. In some instances, the driving and leeward side cracks of a land eventually linked up, and the land is completely removed.

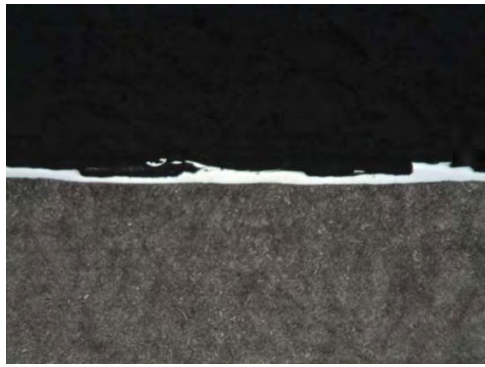
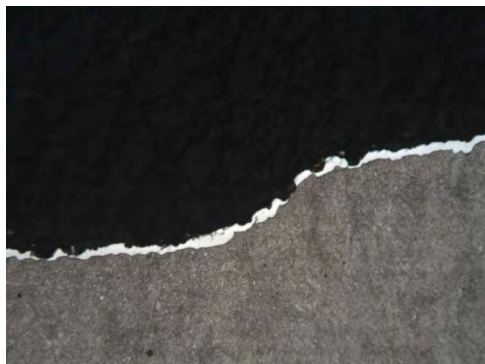
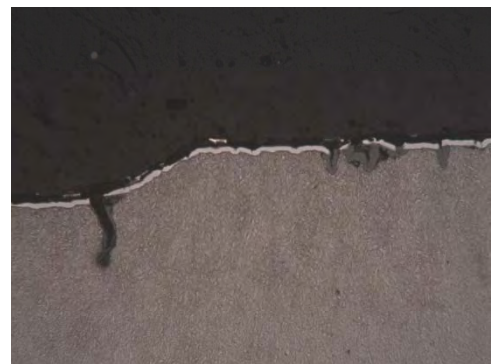
Figure 3: As-received and Fired Configuration 2 Cross-sections

Image height equals 0.020"

The Configuration 2 and 3 hammer forged barrels showed deeper and more extensive cracking in the as-received barrels. However, the cracks were oriented perpendicular to the bore surface, and were not associated with a land corner. These cracks tended to occur in the middle of the land or groove surface. During firing, these cracks widened and extended further through the wall. Damage to the land was predominately wear to the driving side land wall. The driving side wall was worn down to a very shallow slope; while the leeward land side was relatively undamaged.

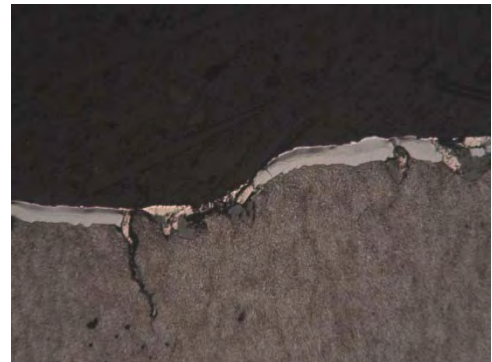
Figure 4: As-received and Fired Configuration 3 Cross-sections

Image height equals 0.020"

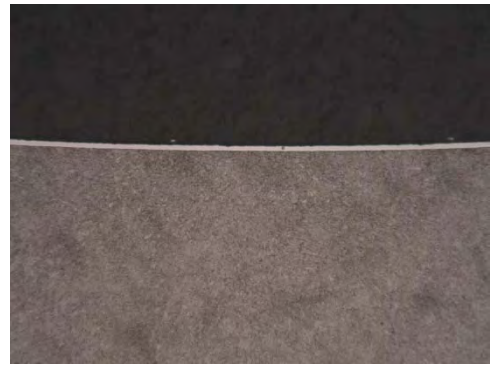
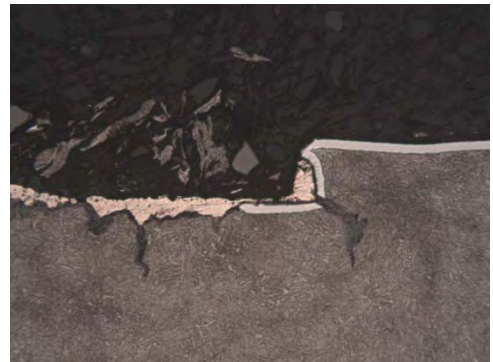
Figure 5: As-received and Fired Configuration 4 Cross-sections

Image height equals 0.020"
