Reformulation of the CBR Procedure

Report II: Design, Construction, and Behavior Under Traffic of the Pavement Test Sections

Carlos R. Gonzalez, Walter R. Barker,
and Alessandra Bianchini

December 2013

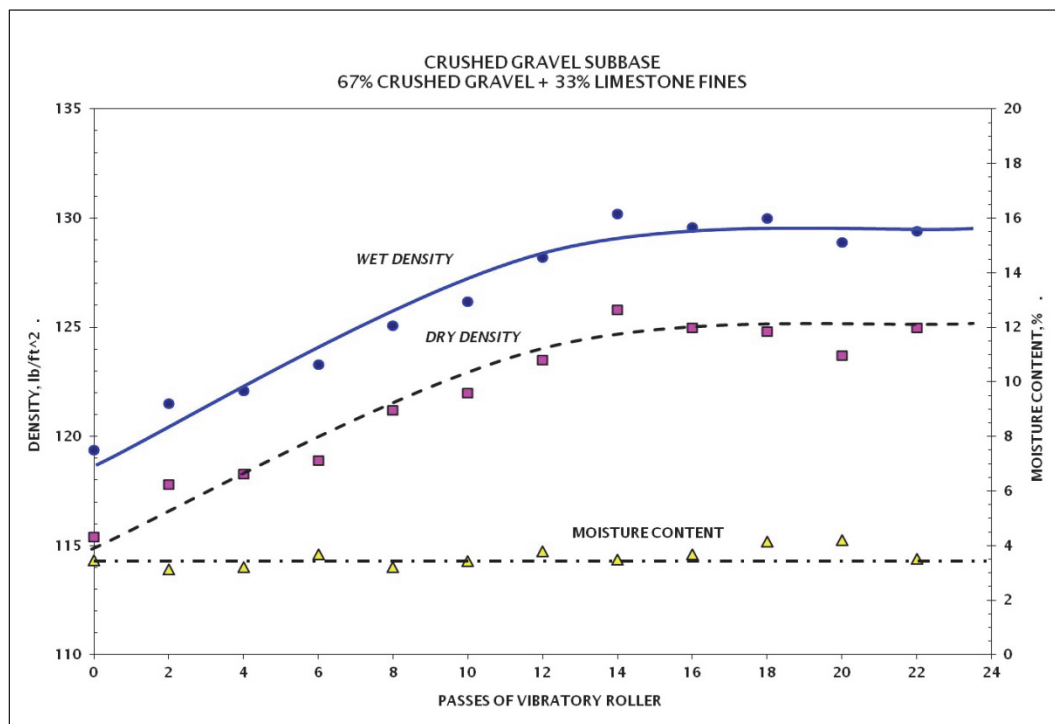
Figure 26. Subbase material field characteristics.

The dry density, wet density, and moisture content of the subbase material were monitored during compaction to determine at what pass level the material would achieve maximum density. A nuclear gauge was used to obtain measurements of density and moisture in accordance to ASTM D-6938-10. Maximum density was achieved after approximately 16 to 18 passes of the self-propelled vibratory steel roller. The moisture content remained constant at about 3.5% during placement. Figure 26 shows dry

density, wet density, and moisture content values as a function of the number of passes of the vibratory roller. Table 5 contains the measured values of density (wet and dry) and moisture content in relation to the number of passes of the vibratory roller. CBR tests were executed after placement and final compaction of the granular material. Table 6 contains the CBR test results for each test item.

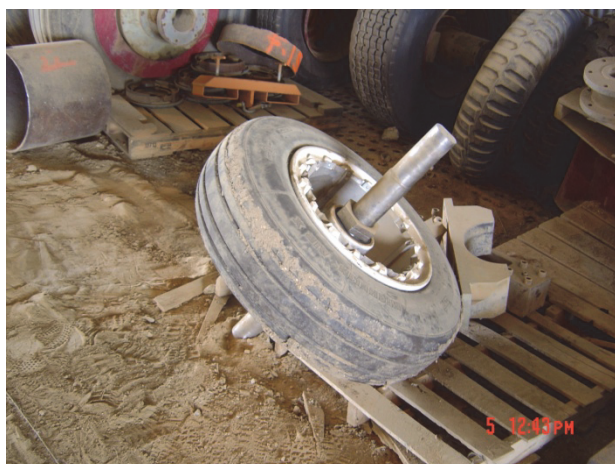
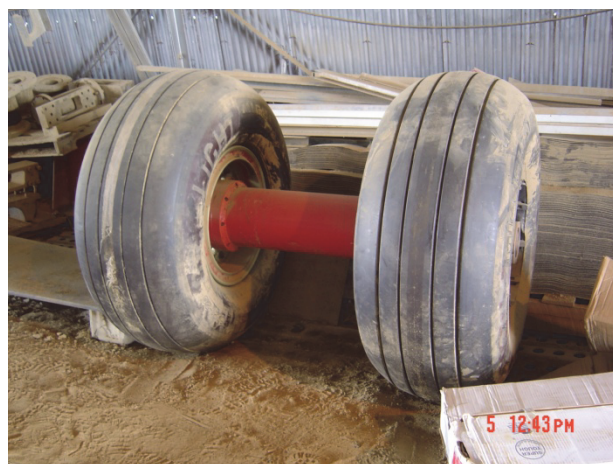
Figure 40. Single F-15E gear (left) and dual C-17 gear (right) tire assemblies.

items. The test section was divided into three traffic lanes to apply traffic with the F-15E single tire, the C-17 single tire, and the C-17 dual-tire gear. The nominal widths were 5 ft, 10 ft, and 5 ft for traffic lanes 1, 2, and 3, respectively, with 5 ft of buffer strip between each lane and a 5-ft clearance at each end of the test section. Figures 5 and 39 show the section layout with an indication of the traffic lanes. Figure 40 shows the single- and dual-tire assemblies used for the testing.

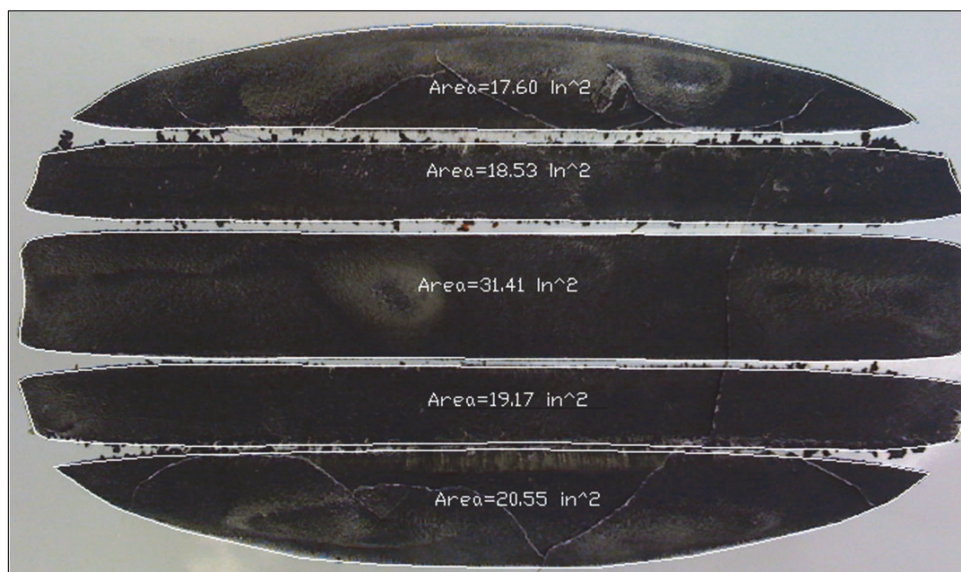
Figure 41. F-15 tire imprint.

Lane 3 was trafficked with the F-15 tire. The tire was loaded to 35,235 lb with an internal tire pressure of 325 psi. This loading and tire pressure yielded a computed contact area of 108 in². The measured contact area had a width of 8.8 in. and a length of 15 in. The computed area, based on the assumption of an elliptical shape, was 104 in². The contact area for this tire was slightly squarer than an ellipse; thus, the computed elliptical area would be slightly lower than the actual contact area (Figure 41). Nevertheless, it was concluded that the approach of using the tire load and tire pressure to compute an elliptic contact area was sufficiently accurate for design and evaluation.

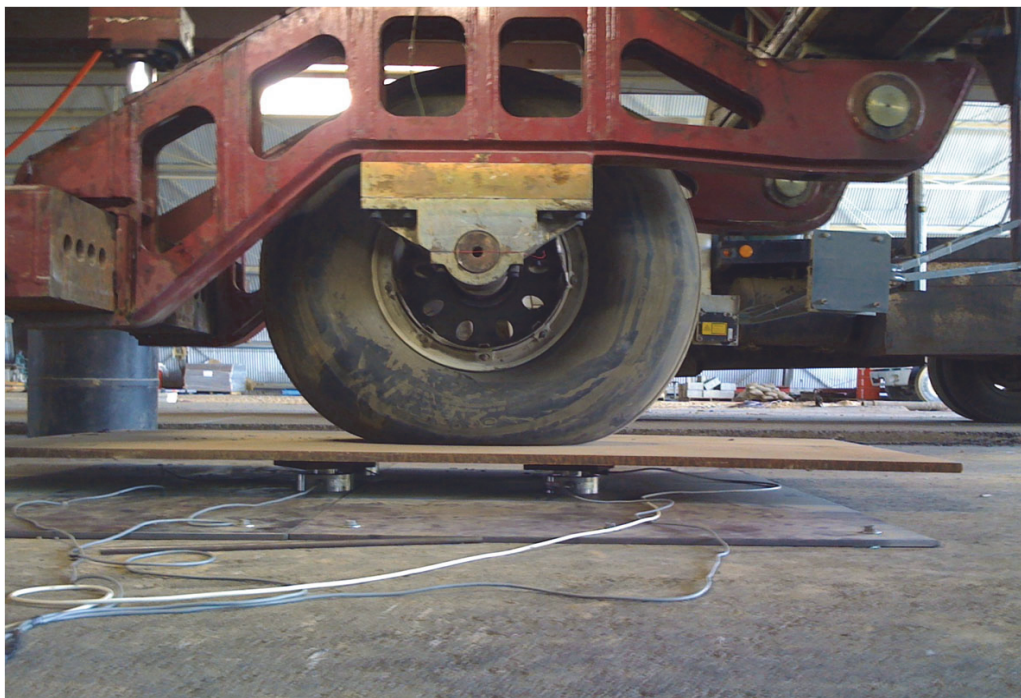
Figure 46. HVS-A calibration.

The HVS-A was calibrated prior to traffic to ensure the correct loading was applied (Figure 46). The HVS-A applies the load through a hydraulic ram and lever arm system.
