**INSPECTION OF STRYKER ENGINES EVALUATED
USING SCPL IN A 20K MILE RAM-D TEST**

**INTERIM REPORT
TFLRF No. 452**

**U.S. Army TARDEC Fuels and Lubricants Research Facility
Southwest Research Institute[®] (SwRI[®])
San Antonio, TX**

February 2014

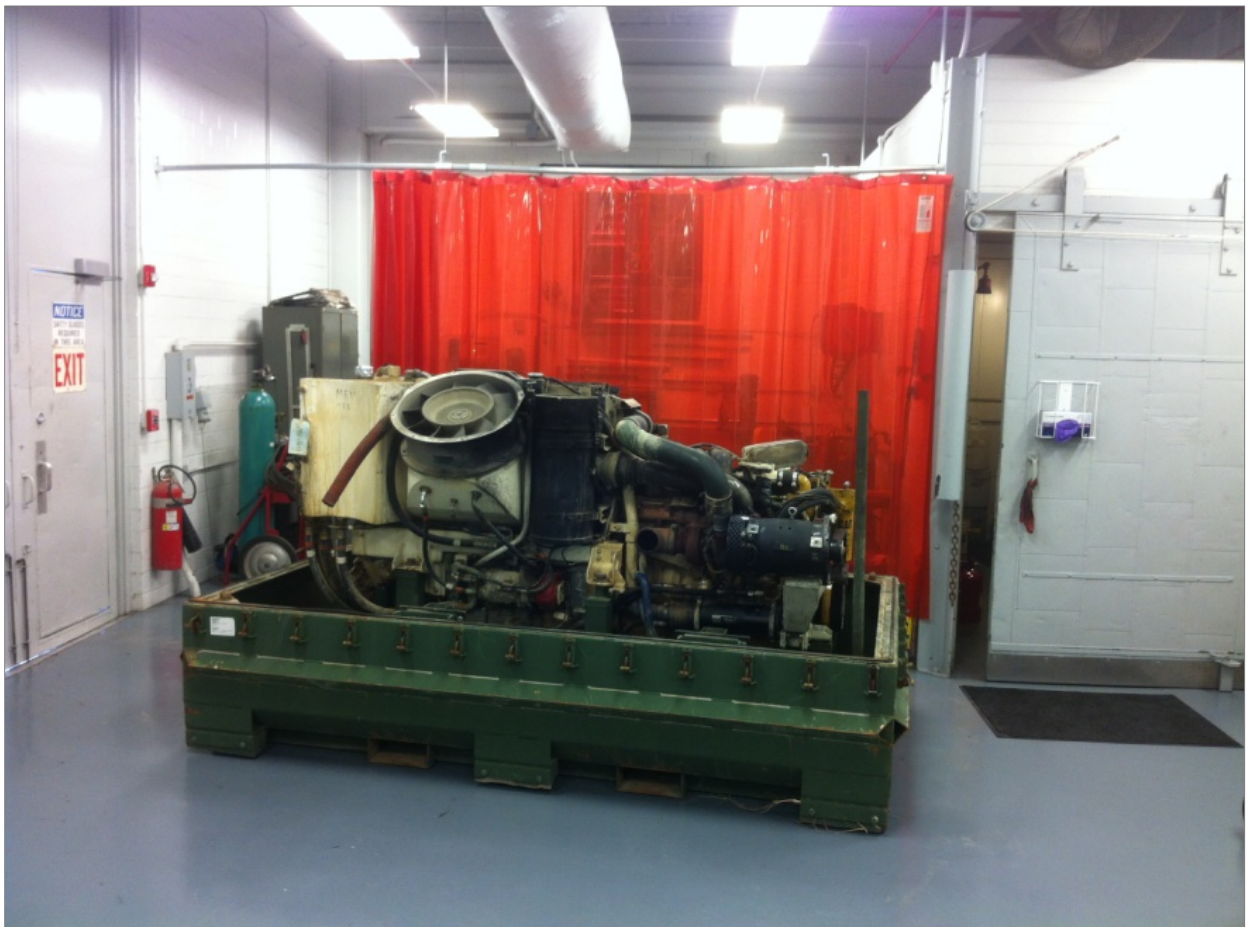
The engines were sent to TFLRF in fully assembled powerpack form. This was done as additional work is expected in regards to the transmissions in a future work directive. Once received, the shipping container tops were removed from the powerpack crates, and the container base and pack were moved indoors to facilitate disassembly. Figure 1 and Figure 2 show the powerpack assembly of Stryker MEV-013 (CONTROL) prior to tear down.

Figure 1. Stryker MEV-013 Powerpack – 1

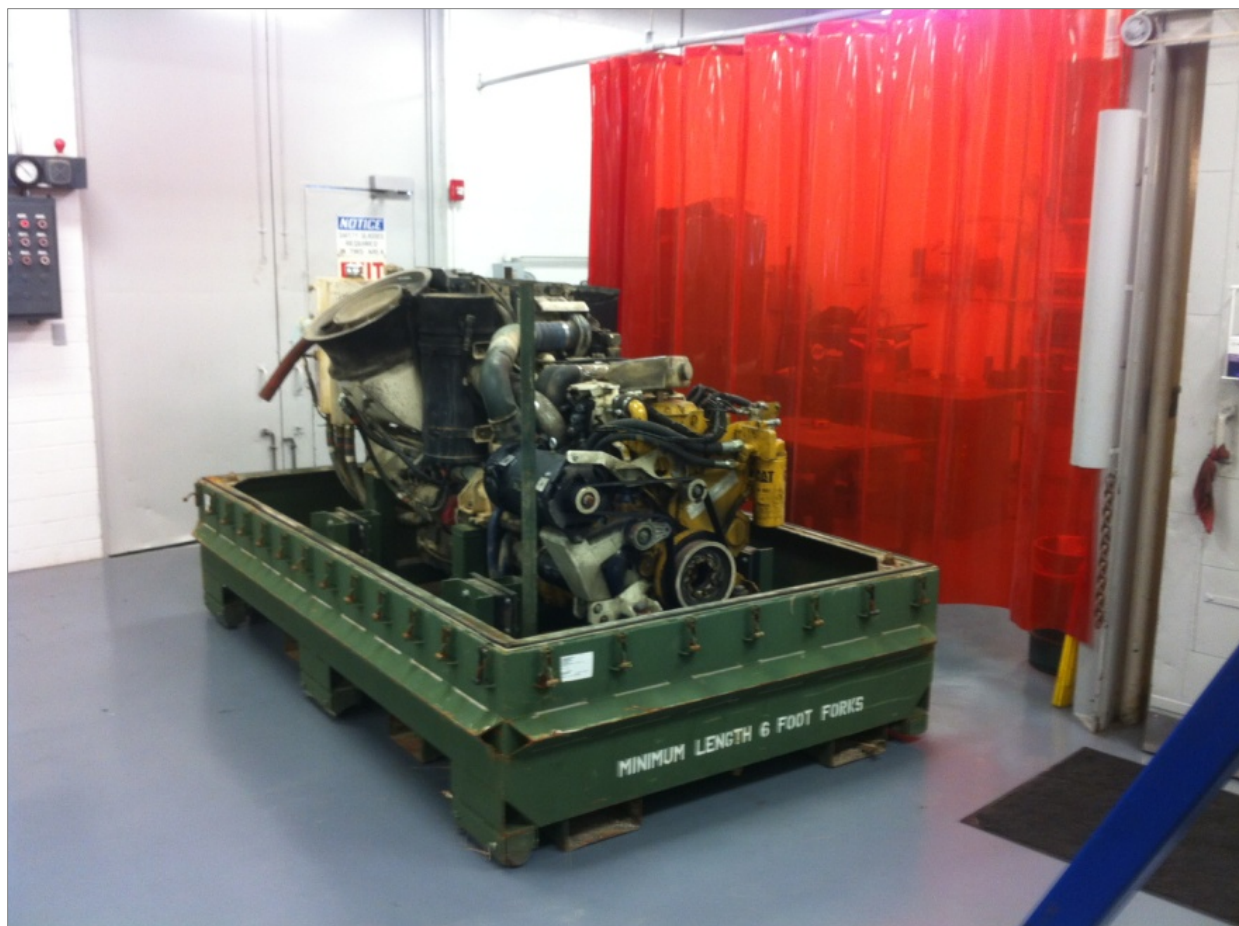
Figure 2. Stryker MEV-013 Powerpack -2

Once indoors, all ancillary equipment was removed from the powerpack to facilitate removal of the engine. This included all cooling, hydraulic, air conditioning, and electrical control systems. The engine and transmissions were then removed from the main power pack frame assembly, and all removed components were packed back into the crate for disposition.

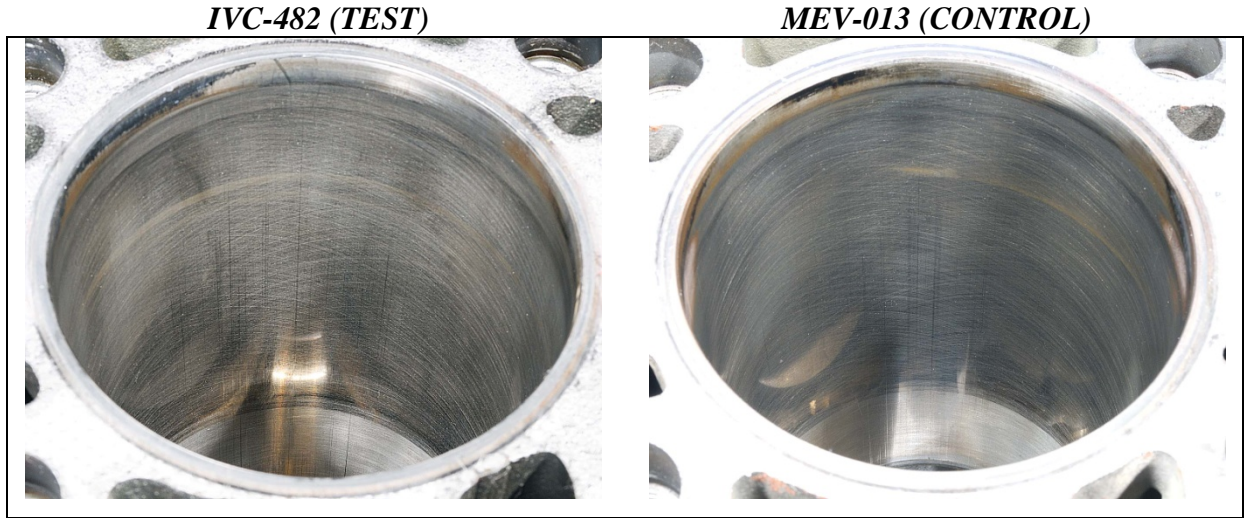
Figure 3 and Figure 4 below shows the best and worst bores of each engine. In these photos you can see the scuffing tendency for the baseline MIL-PRF-2104 oil used in Stryker MEV-013 (CONTROL). All bore photos were shot on the thrust side of the cylinder bore.

Figure 3. Cylinder Bore “Best”, TEST: #5, CONTROL: #5

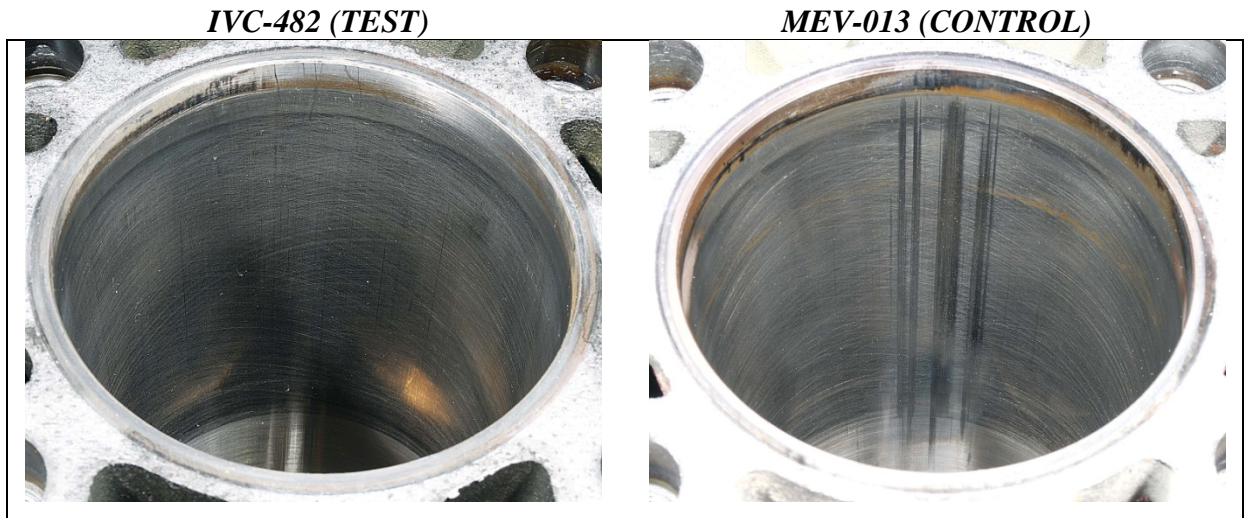
When inspected for scuffing, Stryker IVC-482 (TEST) showed no evidence on the ring surfaces or the piston skirt and bore interface. On the other hand, Stryker MEV-013 (CONTROL) showed several cylinders with one to five percent (1-5%) scuffing on the bore and piston skirt surface. Overall these numbers are relatively low in terms of scuffing that would present major operational problems in an engine, but when comparing to previous testing data for the CAT C7, the presence of scuffing at all does seem unusual. No other CAT C7 engine tests conducted at TFLRF has exhibited scuffing in the past, despite the tested oils viscosity, oil sump temperatures maintained, or the total test duration (up to 630 hours continuous operation at 260 °F oil sump temperatures in one particular case). Although this scuffing could be contributed to the performance of the MIL-PRF-2104, it could also be impacted by engine build parameters (i.e. tighter piston skirt to bore clearance due to piston size, or overall bore diameter variation), any differences in operating conditions, or differences in the previous history between the two vehicles. None of these are completely known, and as a result, we cannot definitively identify the cause of the scuffing in MEV-013 (CONTROL), other than to say it is unusual in nature based on past experience.

Figure 4. Cylinder Bore “Worst”, TEST: #5, CONTROL: #2

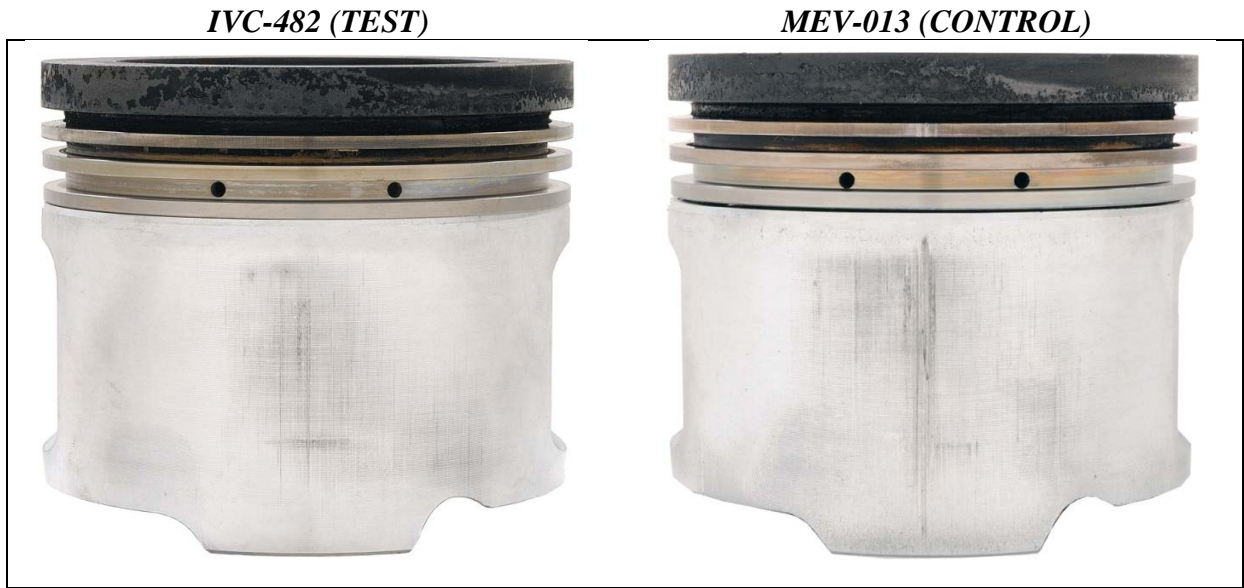
Figure 5 and Figure 6 show the best and worst piston skirts from each engine. Like that seen in the bore photos, the pistons from Stryker MEV-013 (CONTROL) do show more markings consistent with the identified scuffing. Like the bore photos, all piston photos shown are the thrust side of the piston skirt, which is typically the highest wear area. Deposit formation appears similar in each photo shown. (Additional photos of the anti-thrust side of the piston skirt, and shots of the piston crown and under crown can be seen in Appendix B).

Figure 5. Thrust Side, Piston Skirt “Best”, TEST: #6, CONTROL: #3

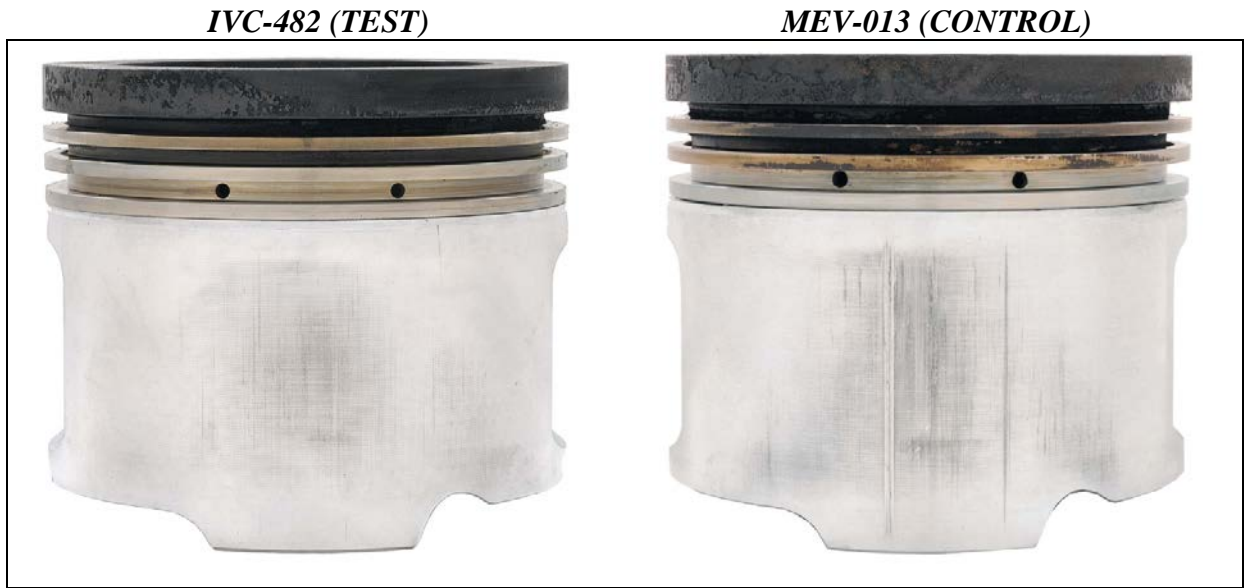
Figure 6. Thrust Side, Piston Skirt “Worst”, TEST: #1, CONTROL: #4

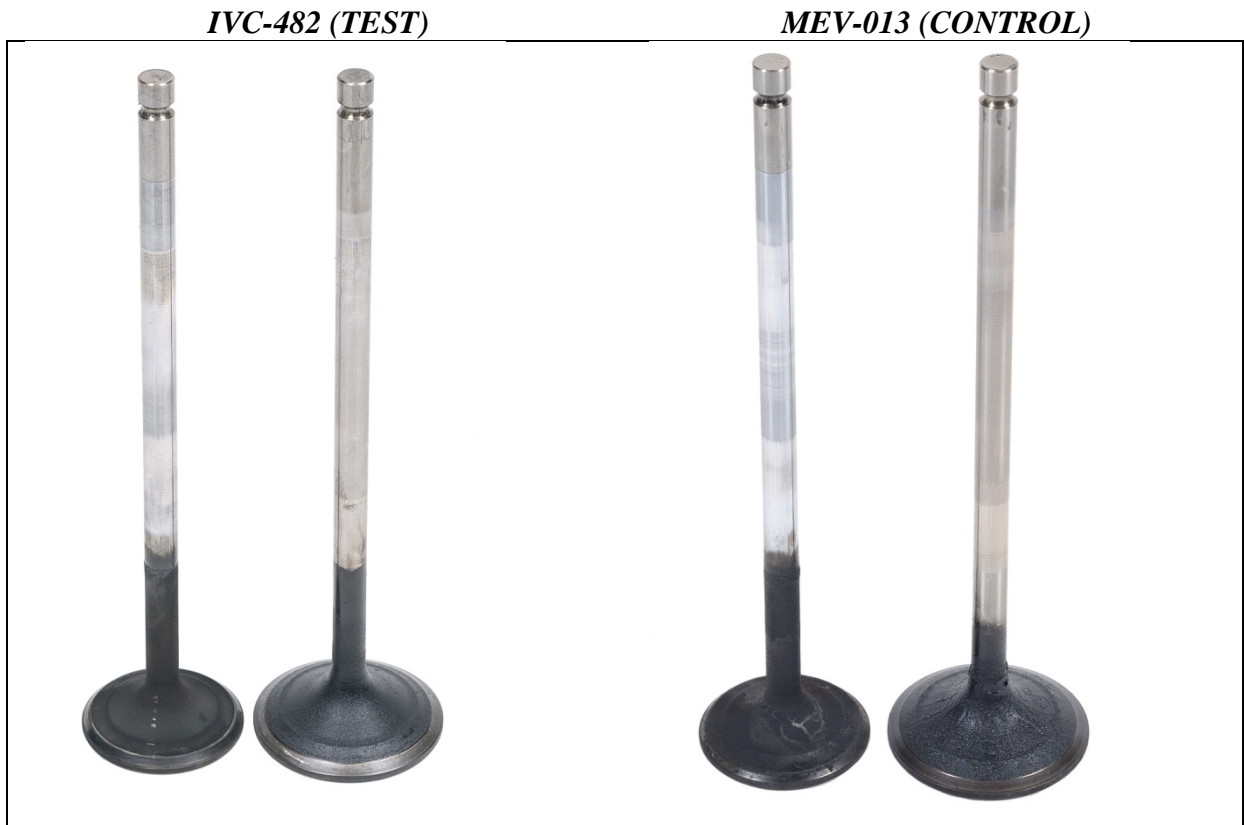
Lastly for valve deposits, Stryker IVC-482 (TEST) yielded a rating of 8.9 and 8.6 merits for the exhaust and intake valves respectively, while Stryker MEV-013 (CONTROL) received ratings of 8.0 and 7.2 respectively. This shows the SCPL having a slight advantage over the baseline MIL-PRF-2104 in valve deposit control, but like the piston deposits, both results are considered acceptable. As mentioned previously, without more detailed information of each engines history, or the exact duty cycle experienced by each vehicle, direct deposit comparisons are difficult. Regardless, the engine tear downs showed no major piston or deposition problems from either lubricant that would be expected to cause symptomatic problems in the vehicles.

Figure 7 shows the best exhaust and intake valve for the TEST and CONTROL engine. As previously mentioned, valves are rated on a merits system, thus a higher score is better. The valves chosen for best and worst representation are the highest and lowest sum total merits for both the intake and exhaust valves from the ratings. Deposit formation here is primarily visible on the back side of the intake valve tulip (the larger valve, shown right in each photo). The intake valve for IVC-482 is almost completely clean, while the intake of MEV-013 shows light deposition.

Figure 7. Exhaust and Intake Valves “BEST”, TEST: #3, CONTROL: #1

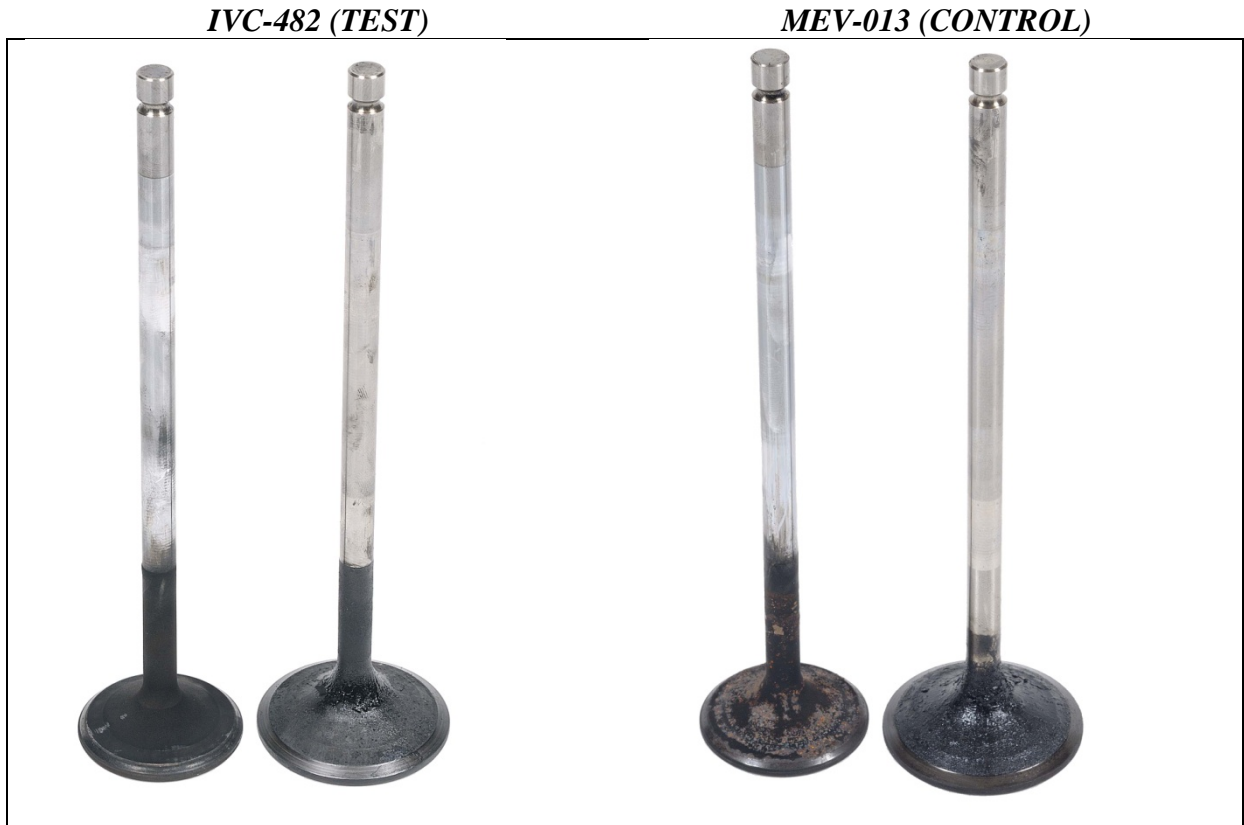
Figure 8 shows the worst pair of exhaust and intake valves. Note the increased accumulation of deposits on the back side of each intake valve tulips compared to the valves shown in the previous photos.

Figure 8. Exhaust and Intake Valves “WORST”, TEST: #2, CONTROL: #5

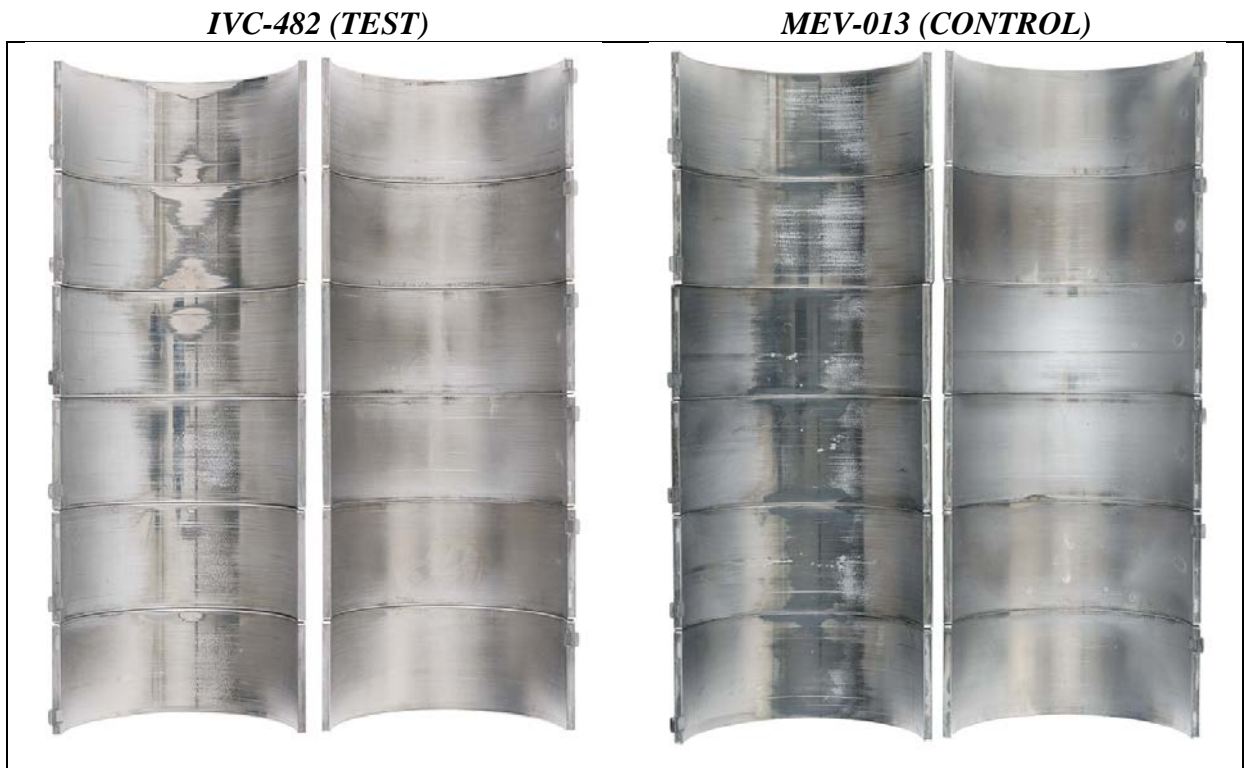
Figure 9 shows the connecting rod bearings removed from each engine. Engine bearings typically are a good indicator of the oils performance and condition during testing, especially the connecting rod bearings which experience high loading from combustion. The orientation of the bearings shown are upper shells on the left, lower on the right, cylinder number one through six top to bottom. An increased amount of distress is seen on outer edges of the shells from Stryker IVC-482 (TEST), while only heavy polish is noted on Stryker MEV-013 (CONTROL). This is undesirable, and could potentially be attributed to the lower viscosity of the SCPL, or differences in the initial build of the engine. Without more information, the root cause is unknown. Despite this, bearings from IVC-482 still show good overall condition, and do not appear to be of concern for immediate engine issues. Review of used oil analysis from samples taken during testing is recommended to determine if any significant accumulation differences in wear metals typical of bearing wear exist.

Figure 9. Connecting Rod Bearings (ALL)

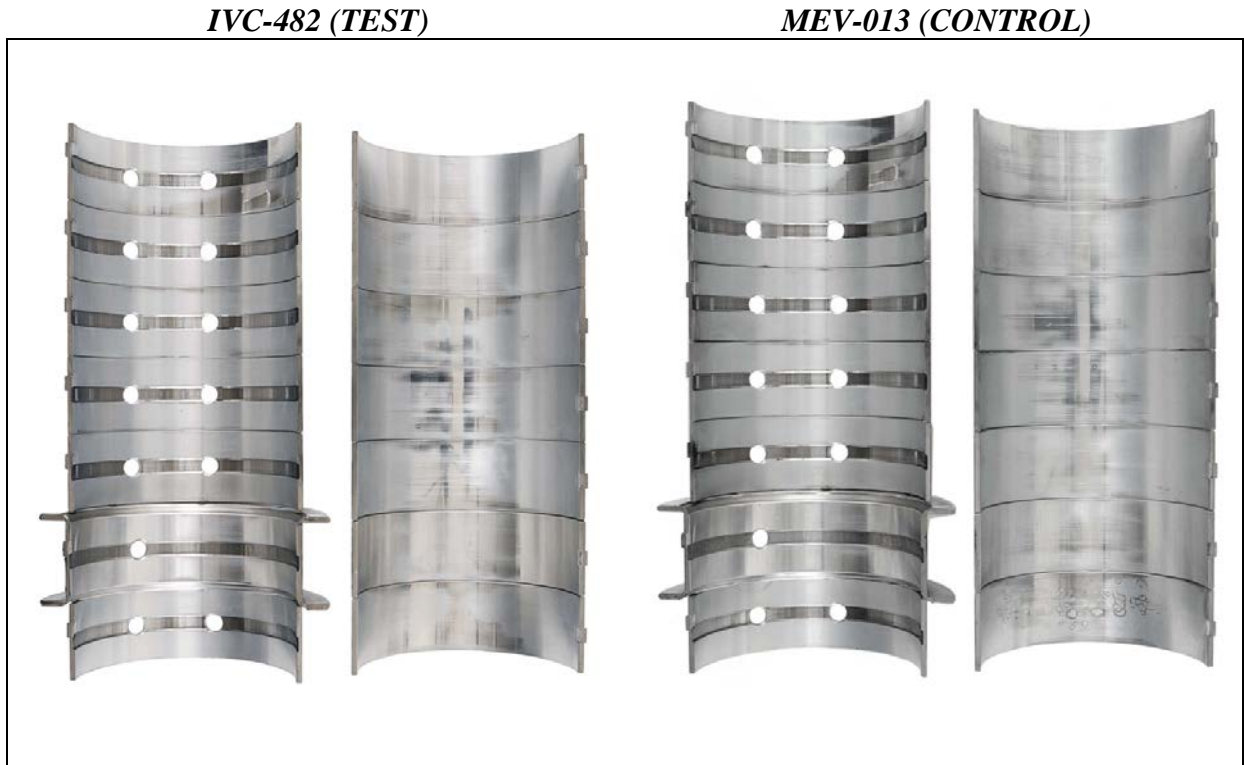
Figure 10 shows the crankshaft main bearings for the TEST and CONTROL vehicles. Both sets of bearings removed from the engine showed similar wear patterns, and no signs of heavy distress or wear. Overall main bearing condition was found to be better than the connecting rod bearings.

Figure 10. Crankshaft Main Bearings (ALL)

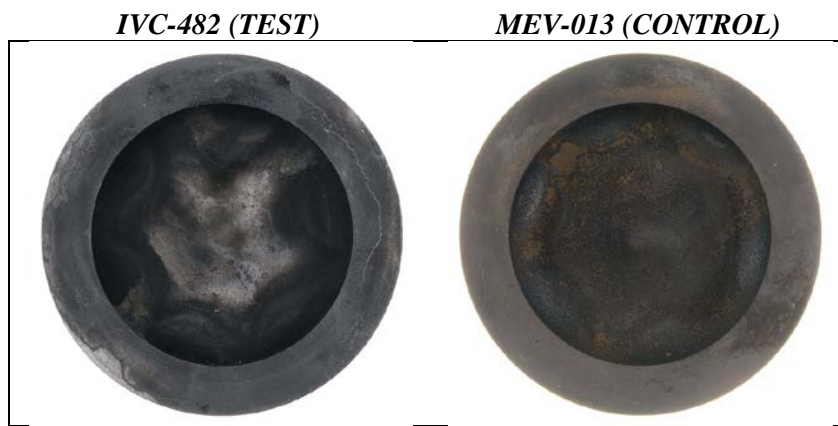
Figure B-1 Figure B-2 below show the best and worst piston crowns. As with the previous photos, best and worst selection was based on the total demerits for each piston. Apart from coloration, both vehicles showed similar condition.

Figure B-1. Piston Crown, “Best”, TEST: #6, CONTROL: #3

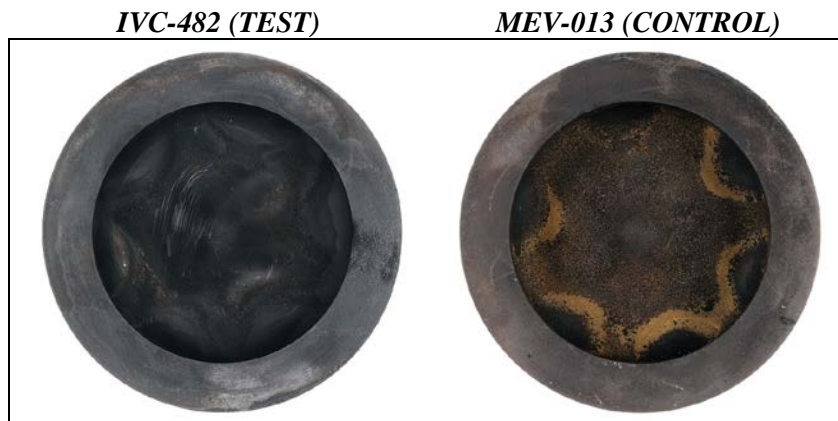
Figure B-2. Piston Crown, “Worst”, TEST: #1, CONTROL: #4

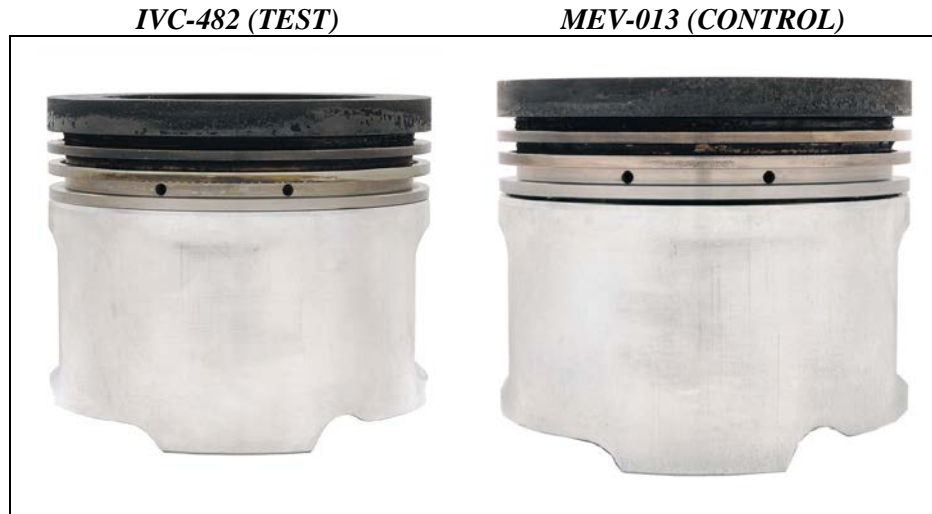
Figure B-3 and Figure B-4 show the best and worst anti-thrust side of the piston skirt. The scuffing tendency seen by MEV-013 is not apparent on the anti-thrust side, as it is the more lightly loaded surface of the piston compared to the thrust side.

Figure B-3. Piston Skirt Anti-Thrust, “Best”, TEST: #6, CONTROL: #3

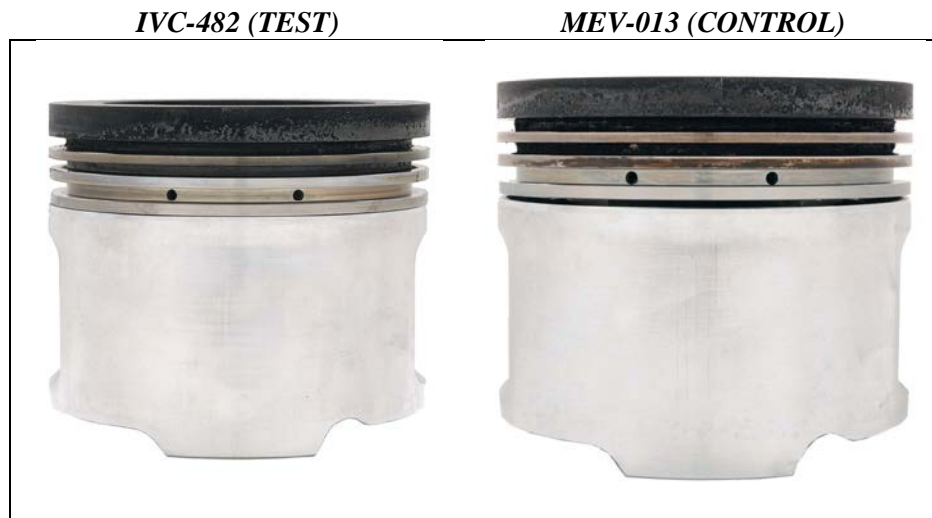
Figure B-4. Piston Skirt Anti-Thrust, “Worst”, TEST: #1, CONTROL: #4

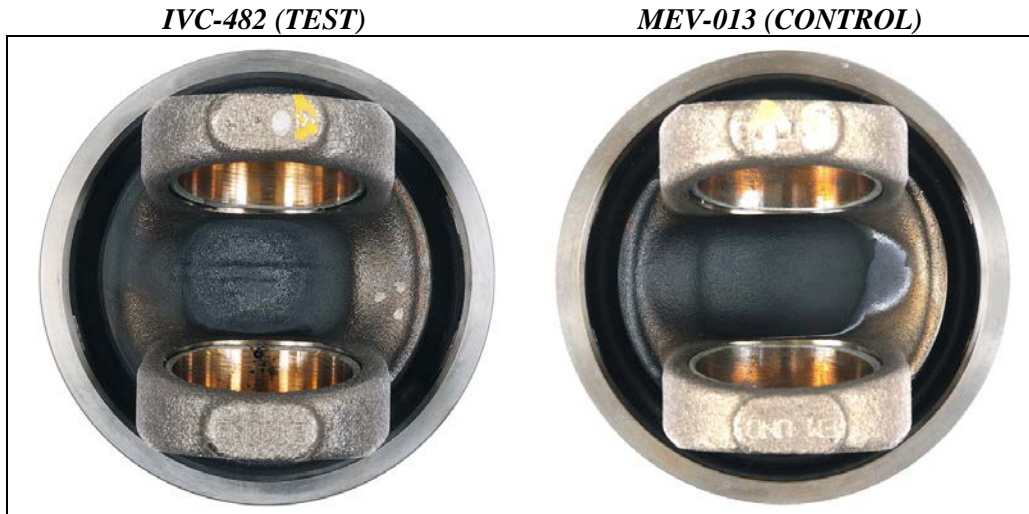
Figure B-5 and Figure B-6 show the best and worst under crown. Conditions of each are similar, with the IVC-482 under crowns appearing to show a slightly higher deposition level, consistent with the overall piston deposits ratings reported.

Figure B-5. Piston Under Crown, “Best”, TEST: #6, CONTROL: #3

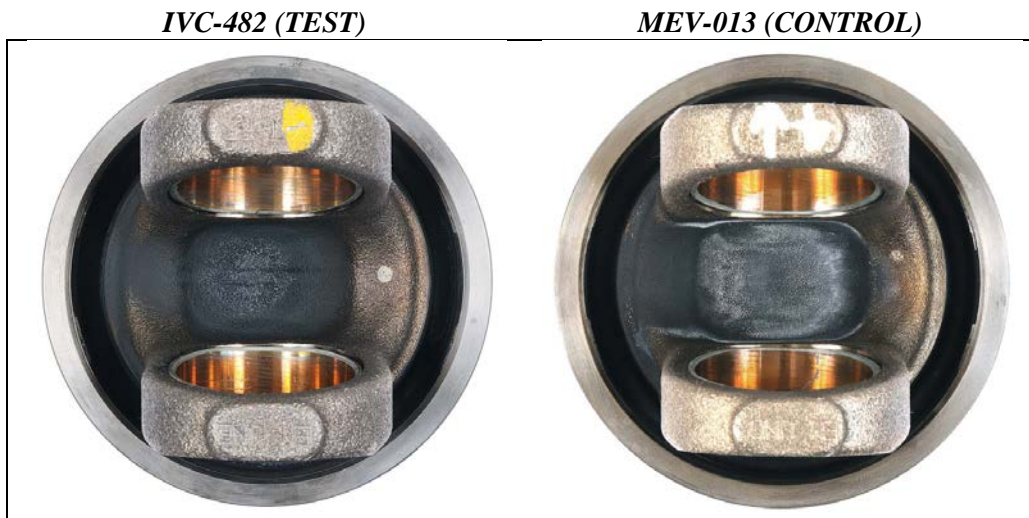
Figure B-6. Piston Under Crown, “Worst”, TEST: #1, CONTROL: #4

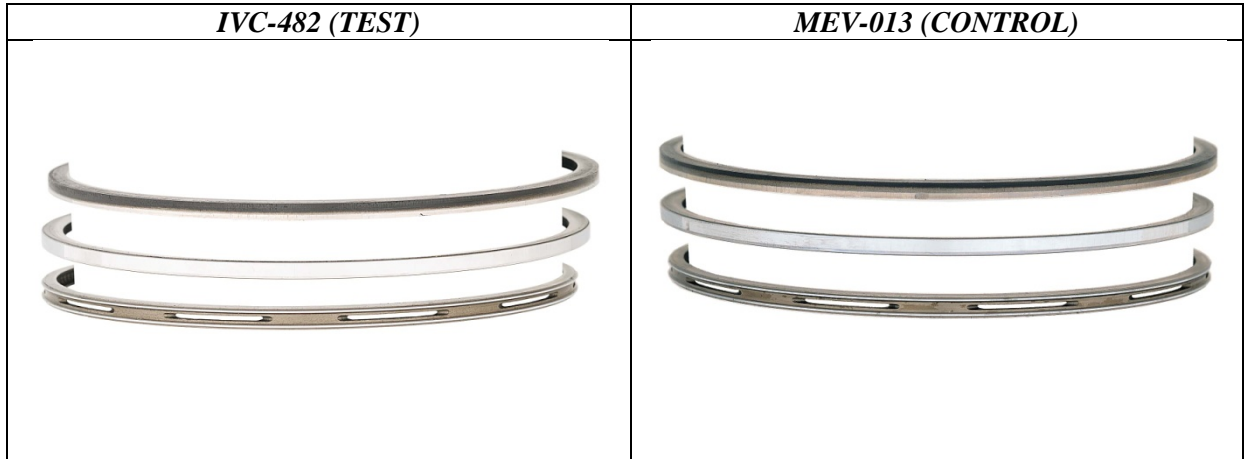
Figure B-7 and Figure B-8 show the piston rings. Condition of each were found to be very similar upon removal, with no major signs of distress or wear on each.

Figure B-7. Piston Ring Pack, “Best”, Test: #6, Control: #3

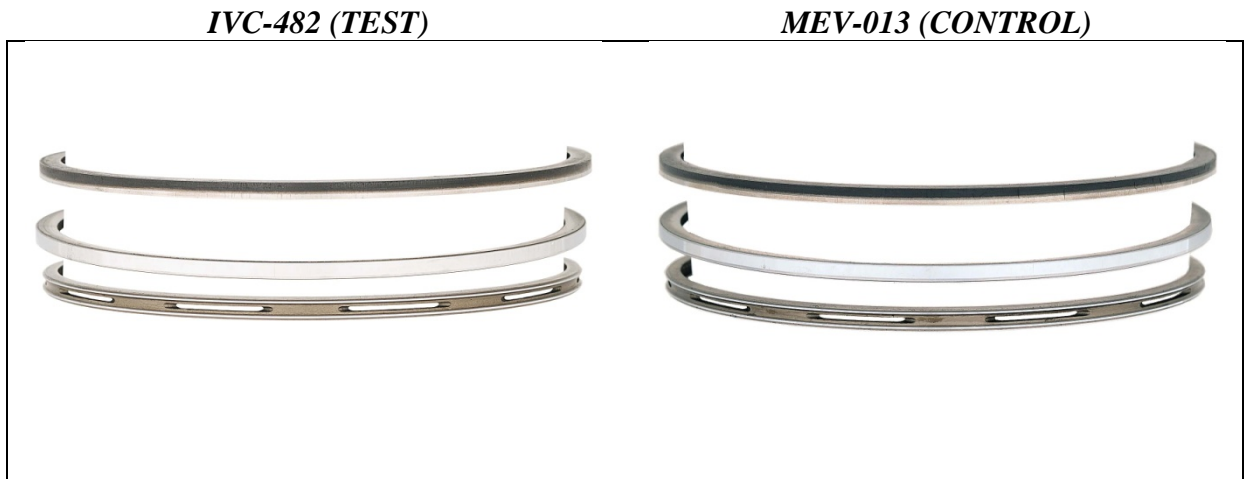
Figure B-8. Piston Ring Pack, “Worst”, Test: #1, Control: #4

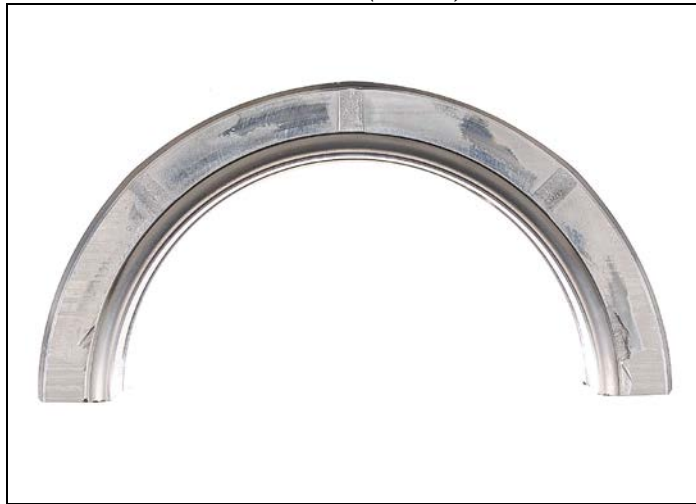
IVC-482 (TEST)

Figure B-9 and Figure B-10 show the back side (facing the flywheel) of the crankshaft thrust bearing surface. This is the area of highest wear for the thrust bearing. Both removed bearings were found to be in good condition overall.

Figure B-9. Thrust Bearing Back, TEST

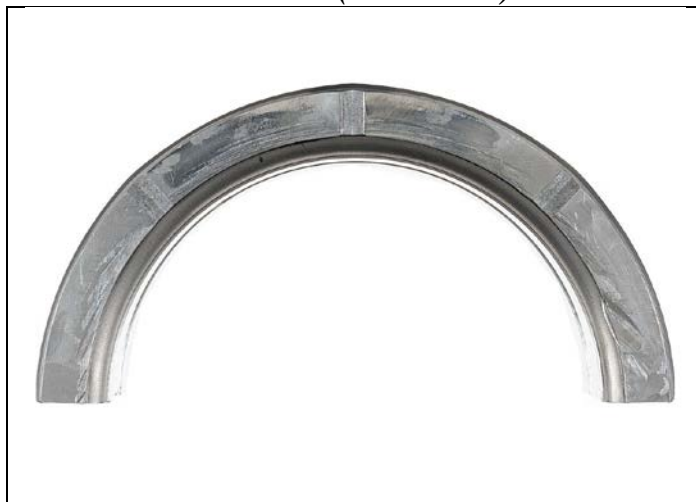
MEV-013 (CONTROL)

Figure B-10. Thrust Bearing Back, CONTROL

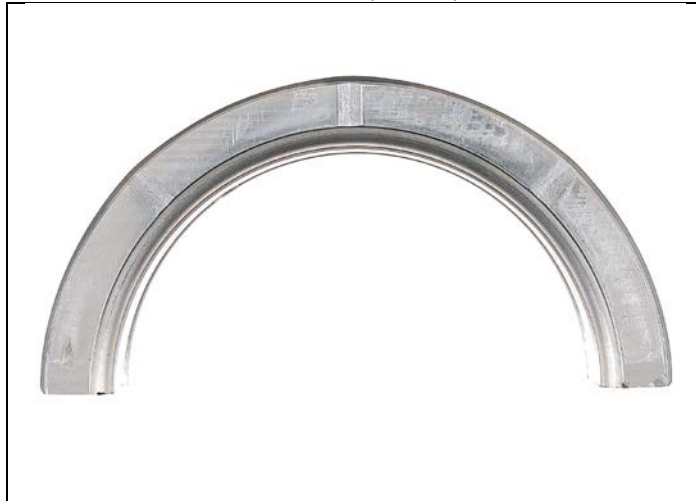
IVC-482 (TEST)

Figure B-11 and Figure B-12 show the front side of the crankshaft thrust bearing surface, which should see less wear typically than the back side. Like the back surfaces, both removed bearings were found to be in good condition overall.

Figure B-11. Thrust Bearing Front, TEST

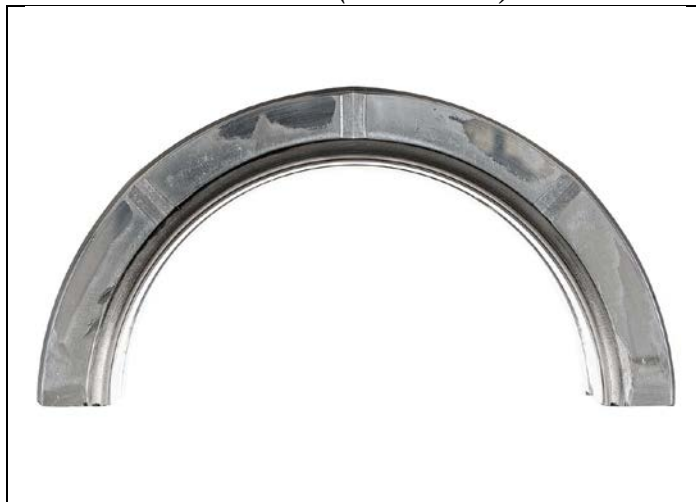
MEV-013 (CONTROL)

Figure B-12. Thrust Bearing Front, CONTROL
