# JCAT Update

## Cadmium Alternative Studies for C-17 P<sup>2</sup> Projects

Stephen P. Gaydos

March 16, 2005

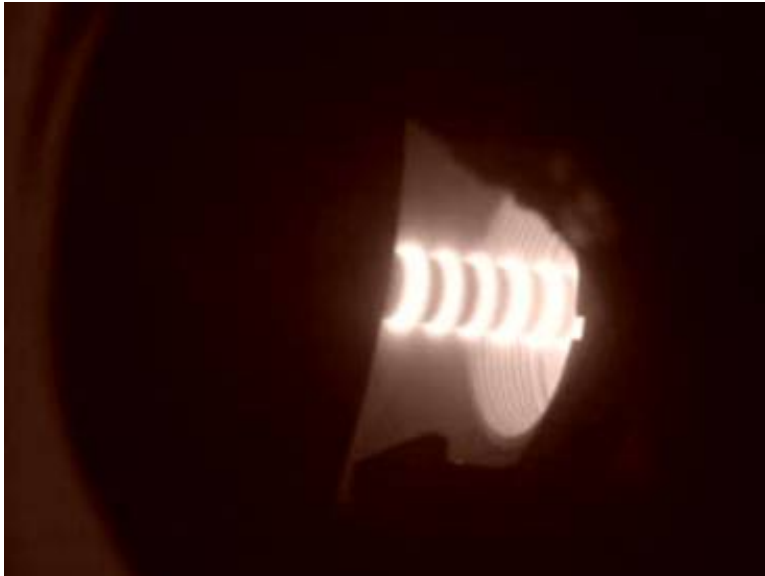
Sputter Al Coating Applied on ID of Axle

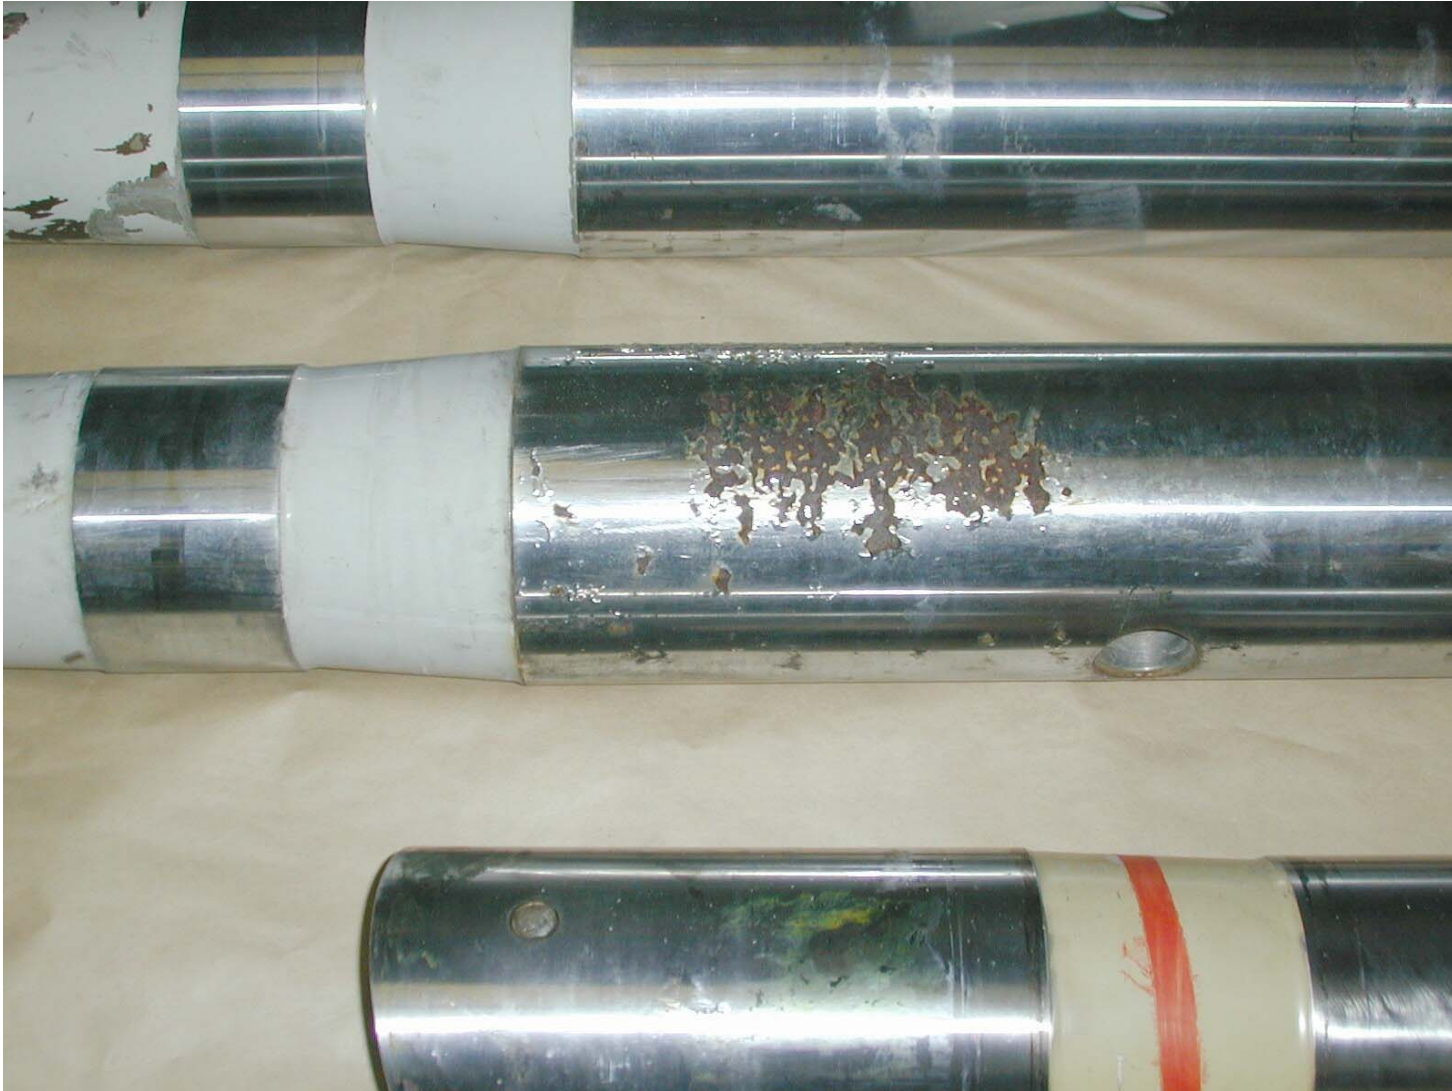
Scrap C-17 Axles Prior to Cleaning

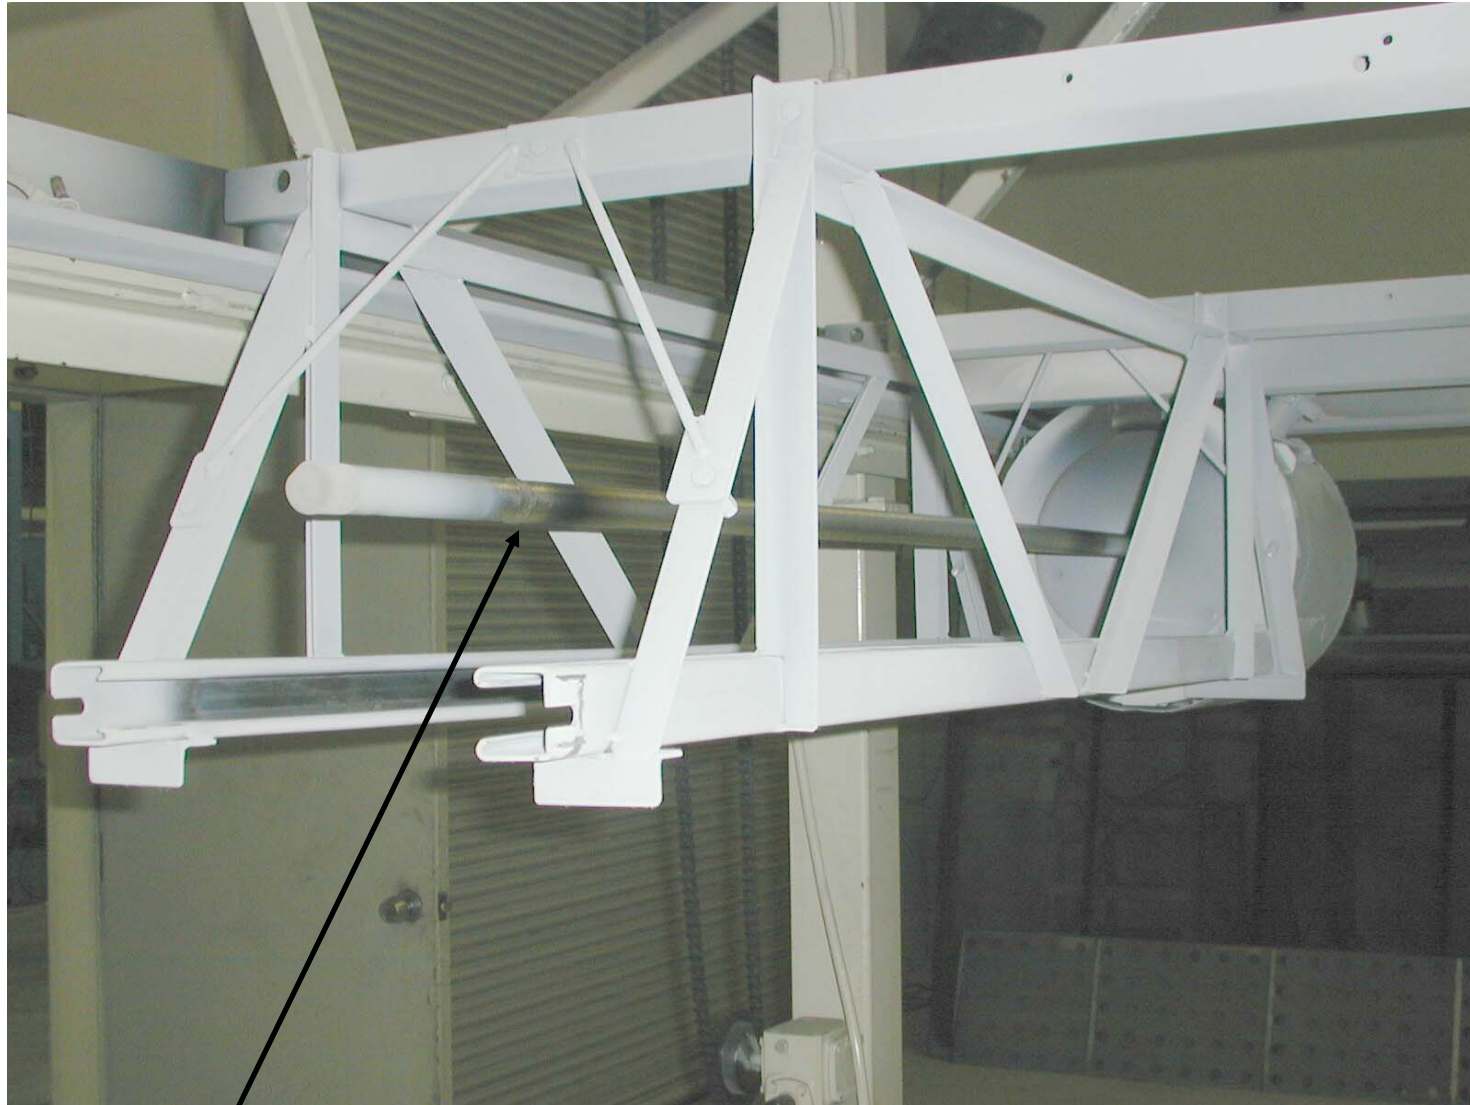
Long Aluminum Sputter Probe on IVD Rack

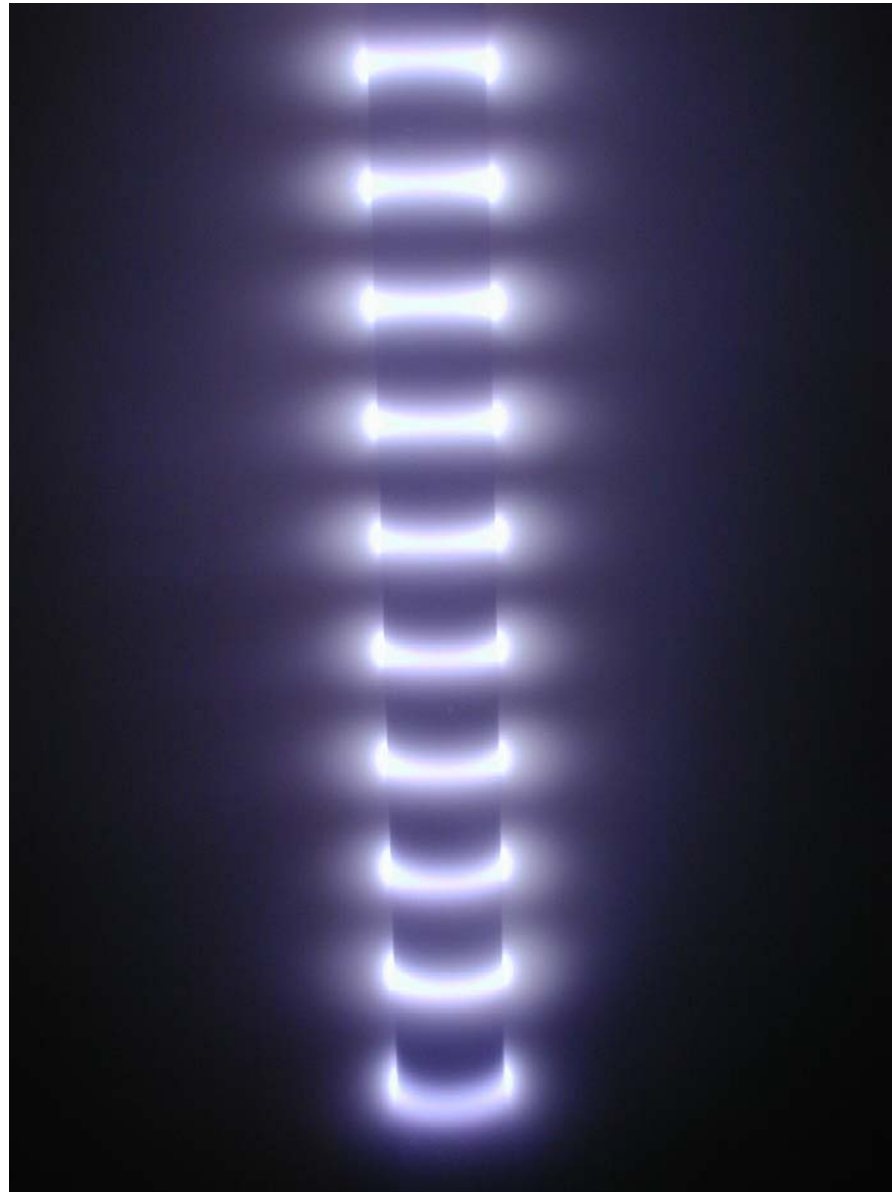
Sputter Probe Energized

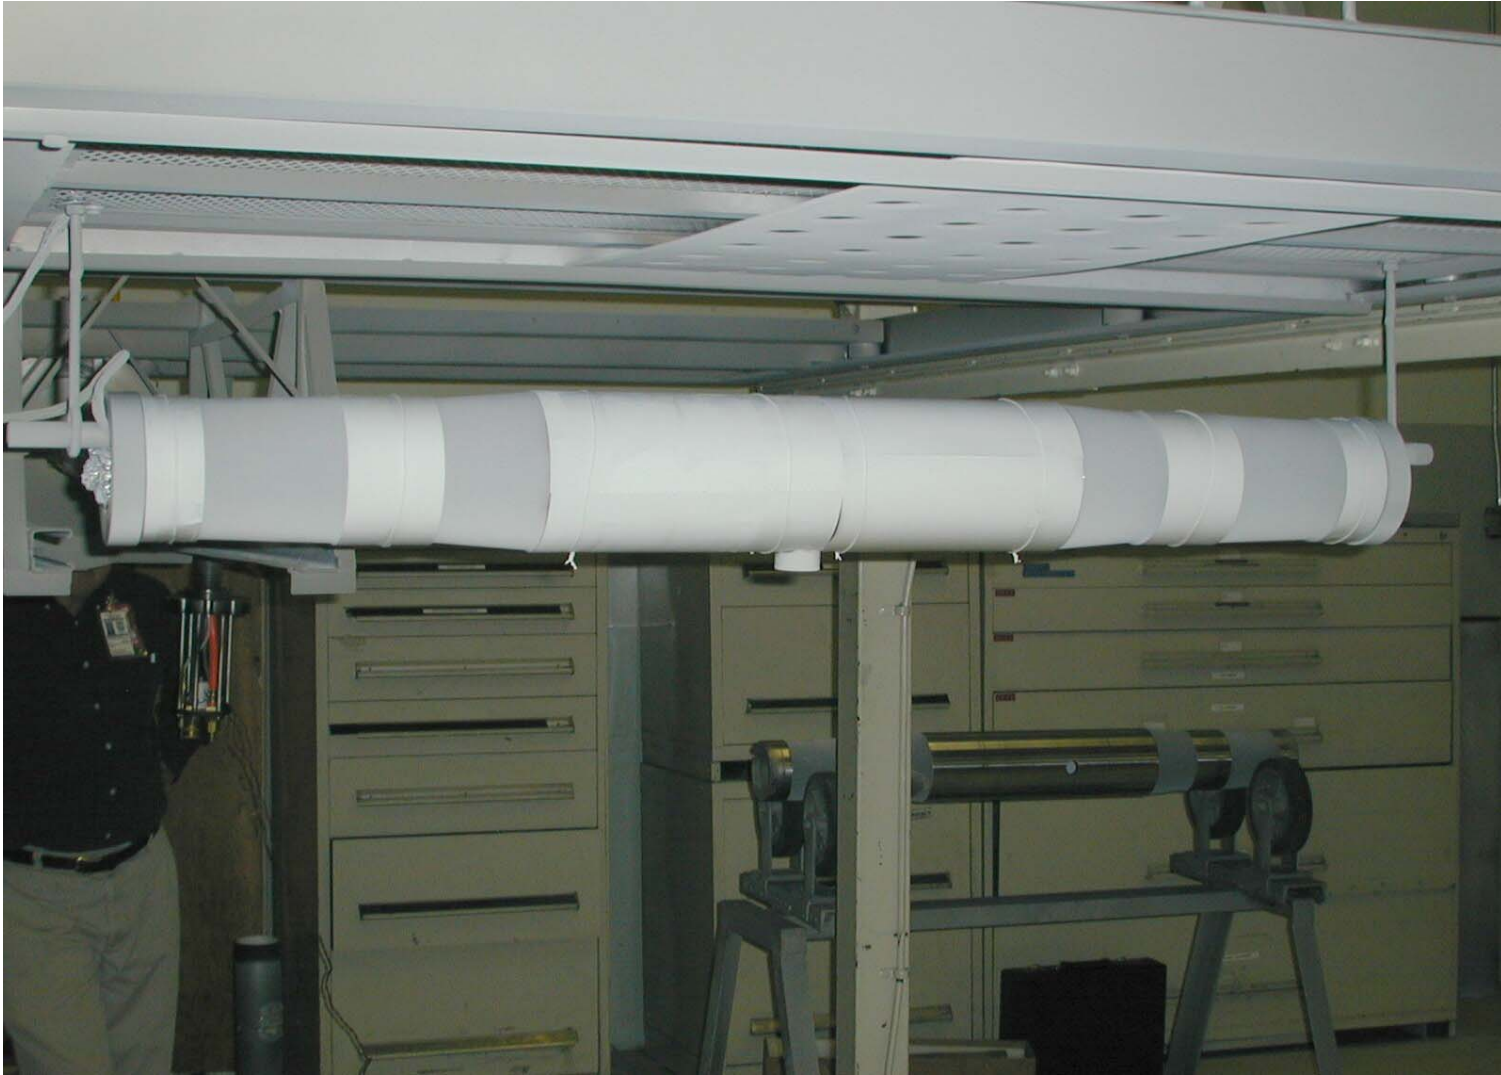
C-17 Axle After Sputter / IVD Aluminum Coating

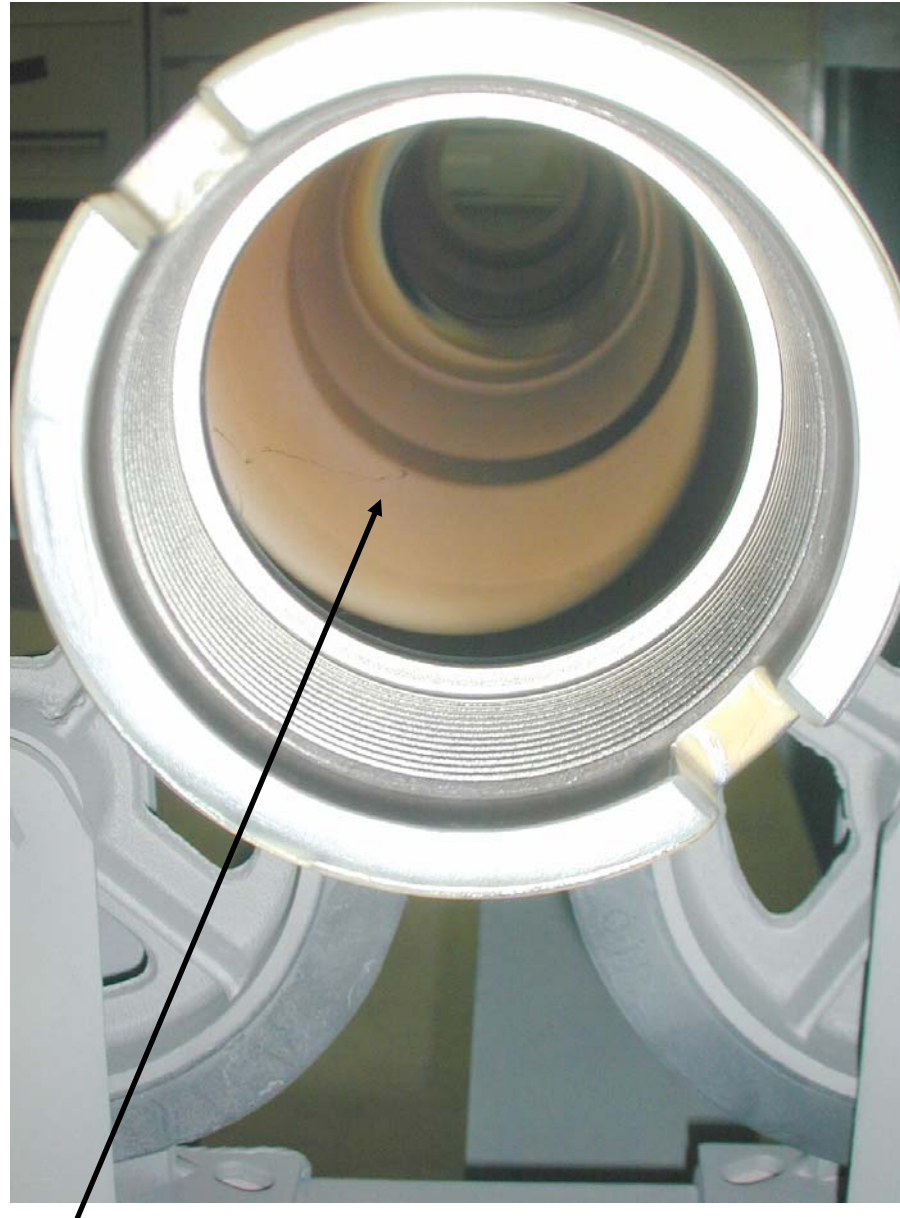
Conversion Coating On Sputter Aluminum Inside Axle

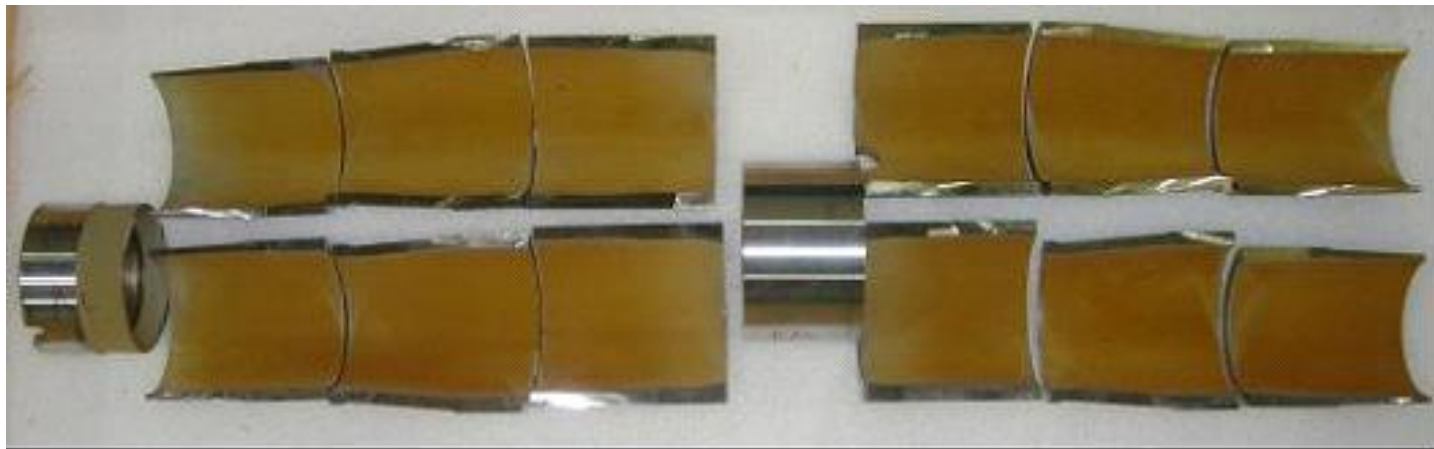
## **C-17 Long MLG Axle Cut Into Test Specimens.**

**Top is OD and bottom is ID. Gold-brown areas are IVD aluminum (on the OD) and Sputter aluminum (on the ID) with conversion coating applied.**

- Initial Testing
  - Cut Up Axles Into 6” Tubes and Split Each Tube in Half (Along Length)
  - Check Thickness
    - Checked Sputter Aluminum and Paint Coatings
  - Check Adhesion
    - Adhesion of Sputter Aluminum to Steel
      - Tape Adhesion and Glass Bead Burnishing (20 - 80 psig)
    - Adhesion of Paint to Sputter Aluminum and Steel
      - Scribed Dry and Wet Tape Tests

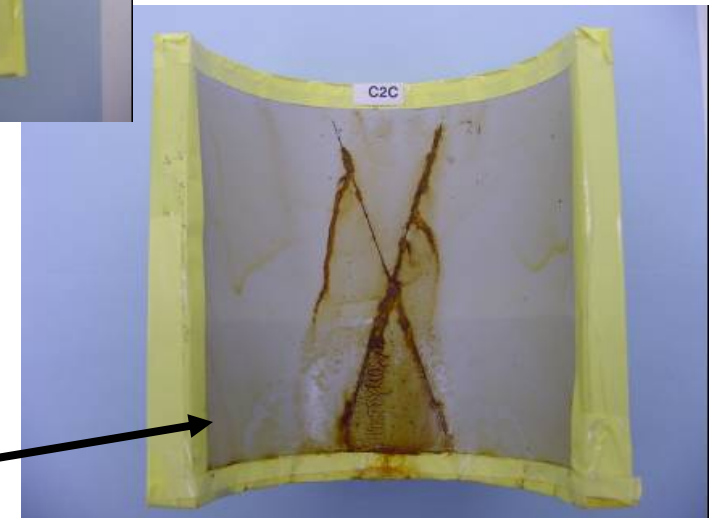
Bare Steel + Primer +  
Polyurethane + CPC –  
Red Rust!

- Axles B, C and D Subjected to Unscribed and Scribed Salt Spray (ASTM B 117)
  - B = Sputter Aluminum + Paint
  - C = Bare Steel + Paint + CPC
  - D = Sputter Aluminum Only
- ID Surface of Axles Tested for 1000 Hour Exposure

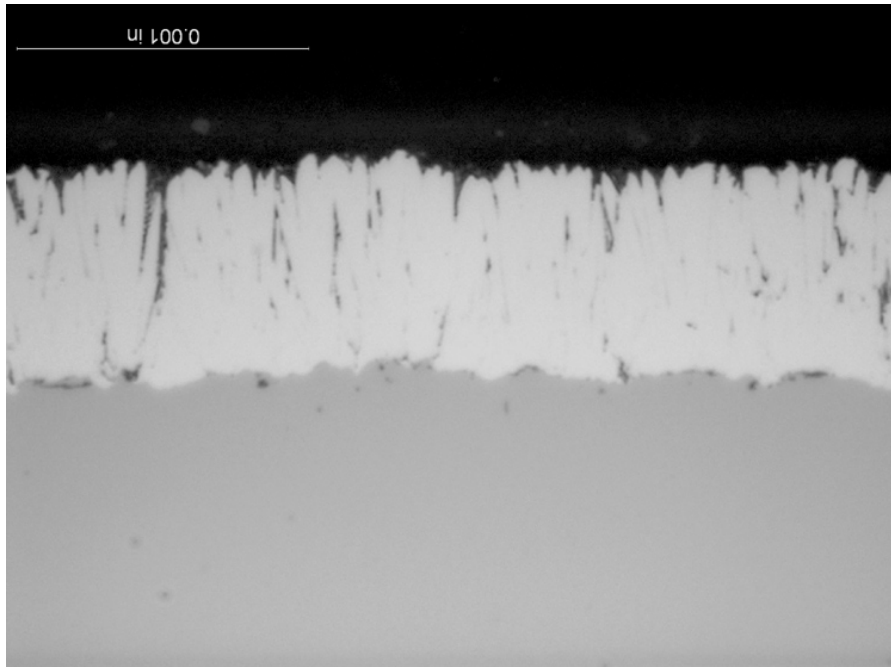
- Look at Microstructure of Sputter Aluminum
  - Metallography
  - SEM
- Check Thickness and Density of Sputter Aluminum
- Sputter Aluminum Typically Denser and More Uniform Than IVD Aluminum Coatings

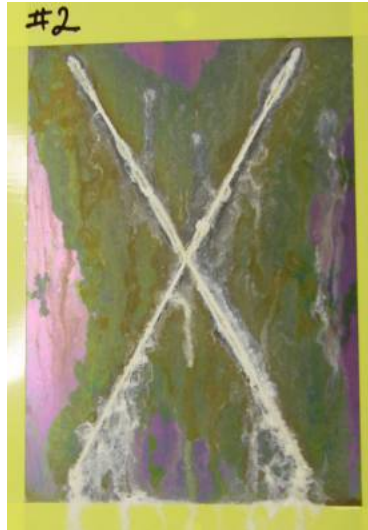
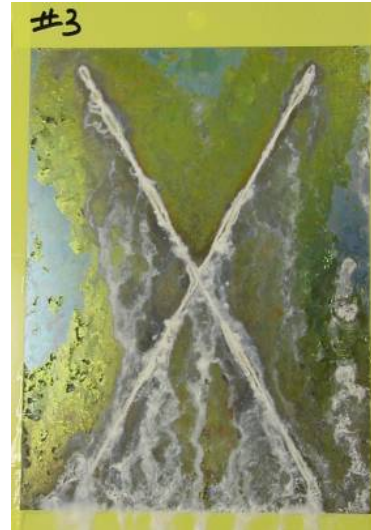
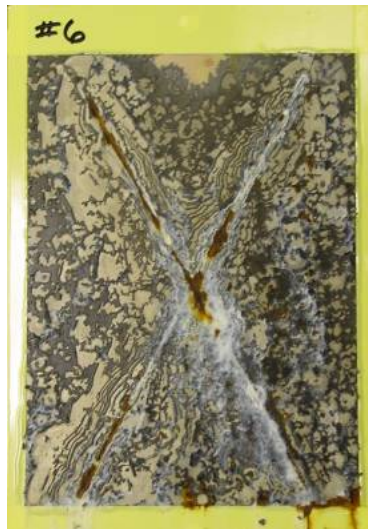
- Develop and Evaluate LHE Alkaline Zn-Ni
  - Work with an Experienced Plating Vendor
- Evaluated Seven Potential Formulations
  - Corrosion (Scribed and Unscribed)
  - Thickness / Composition
  - Hydrogen Embrittlement
- Not All Zn-Ni Perform the Same Way
  - See Corrosion Test Results

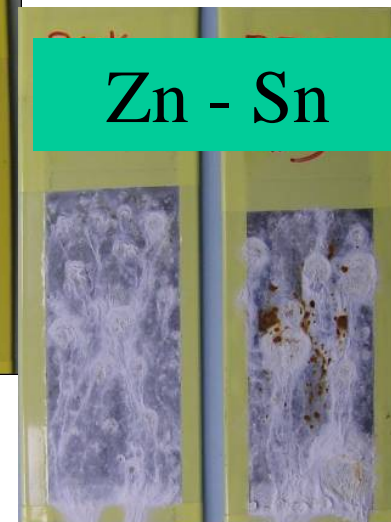
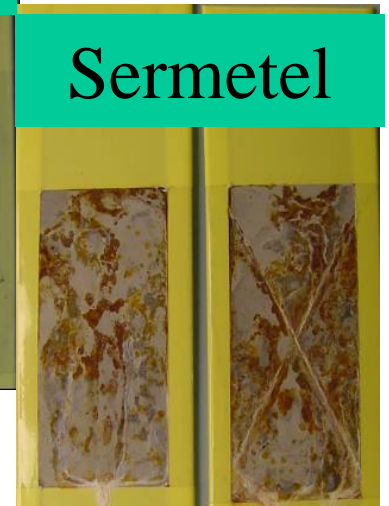
# After 672 Hours in Salt Spray

- Need Brush Cadmium Alternative Repair for High Strength Steels
  - No Bake after Plating!
    - Zn-Ni
    - Sn-Zn
    - Zn-Sn
    - Others
- Sn-Zn is Very Promising
  - Acceptable Corrosion and HE Performance
  - More Testing Required
