**Cobalt-Base Alloy Gun Barrel Study**  
by William S. de Rosset and Jonathan S. Montgomery

**ARL-RP-0491**

A reprint from *Wear*, Vol. 316, pp. 119–123, 14 May 2014.

# Cobalt-base alloy gun barrel study

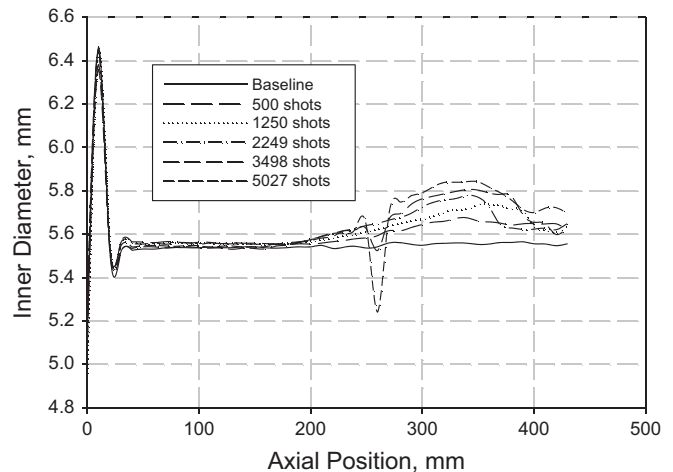
The bore diameter measurements for Barrel 1 (sustained cadence) are shown in Fig. 1. The plots are keyed to the baseline and five phases, shows the accumulated bullet count. These measurements were performed at the land location. The measurements start near the origin of rifling, and the initial spike in the data is due to bore diameter variations prior to that point. The barrel length is 463 mm, including the chamber. In order to relate the axial position shown in Fig. 1 to the distance from the rear face of the tube (RFT), 30 mm must be added to the axial position. That is, 400 mm axial position corresponds to 430 mm from the RFT.

There is no discernible wear for the first 200 mm of bullet travel for all phases. Increased barrel diameter is observed starting at about 200 mm (axial position). The diameter goes through a peak at about 340 mm and then decreases. There is a sharp decrease in bore diameter observed for Phases 4 and 5 at around 250 mm. This is attributed to the effects of the gas port at this location.

Fig. 1. Inner diameter as a function of axial position for Barrel 1.

diameter begins to increase at approximately 230 mm from the RFT (200 mm axial position in Figs. 1 and 5), which suggests that there is a critical velocity (or spin rate) necessary to begin material removal from the bore. At 360 mm from the RFT, the rate of material removal begins to decrease. One possible explanation involves the hot hardness of the CBA. The bore surface temperature decreases as a function of axial position. This will lead to an increase in the surface hardness of the CBA, making material removal more difficult. However, it is unlikely that the temperature gradient down the gun tube is large enough to give the observed effect. In addition, the starting point of the material loss tends to move toward the breech as the number of shots increases. This observation argues against a fixed critical velocity needed to begin the process.

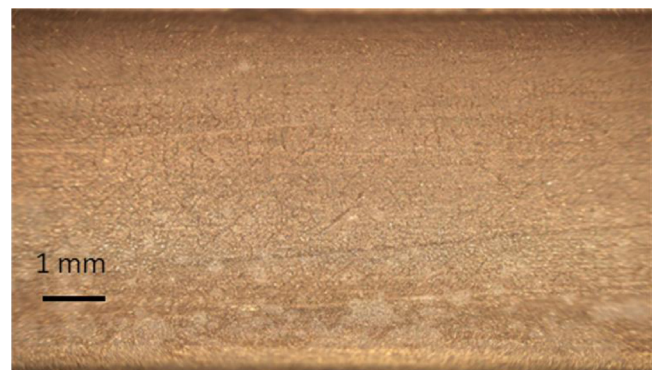
Fig. 2 shows a micrograph of the bore surface for Barrel 1 at 10 mm from the muzzle. The surface is relatively smooth and is colored red. An energy dispersive spectrometry (EDS) scan of the surface is shown at 450 mm from the RFT shown in Fig. 3. The primary element on the surface of the bore is copper, coming from the bullet jacket. There are also trace amounts of cobalt and

Fig. 2. Bore surface of Barrel 1 at 450 mm from the RFT.

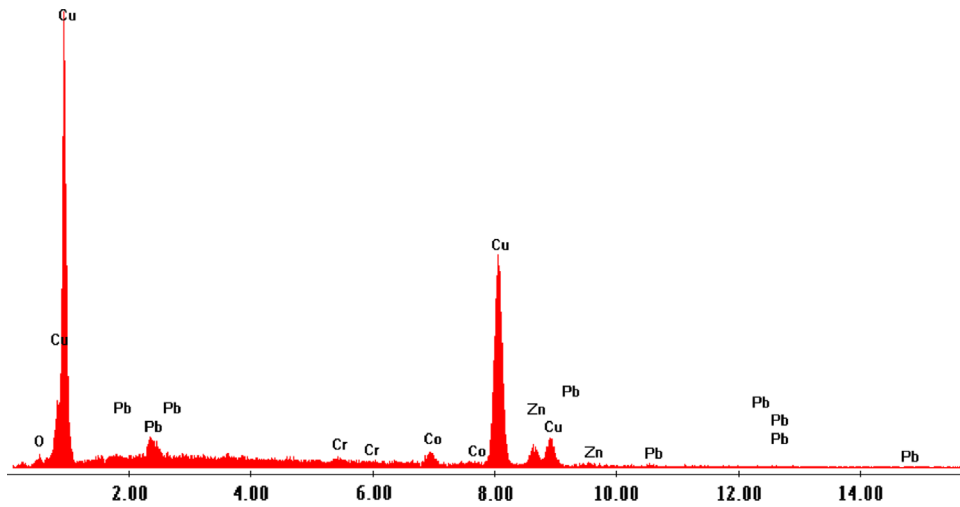
Fig. 3. EDS scan of the surface of Barrel 1 (450 mm from the RFT). (For interpretation of the references to color in this figure, the reader is referred to the web version of this article.)

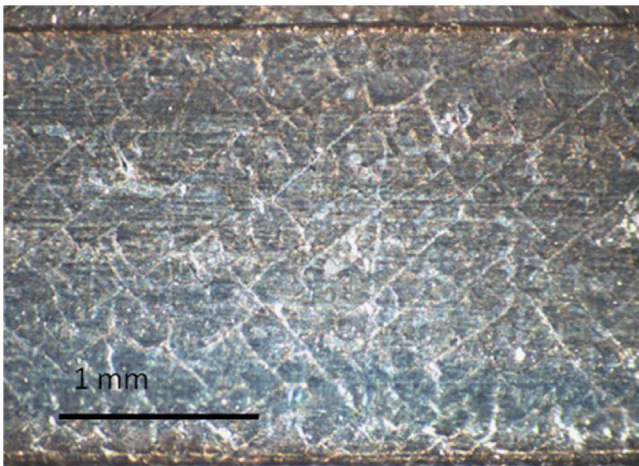
A micrograph of the surface 200 mm from the RFT is shown in Fig. 4. The dark lines at the upper and lower portion of the micrograph are the edges of the land. There appears to be a cross-hatch pattern of surface cracks in the CBA. Also, it appears that there are small deposits of copper on the edges of the land.

Fig. 4. Bore surface of Barrel 1 at 200 mm from the RFT.

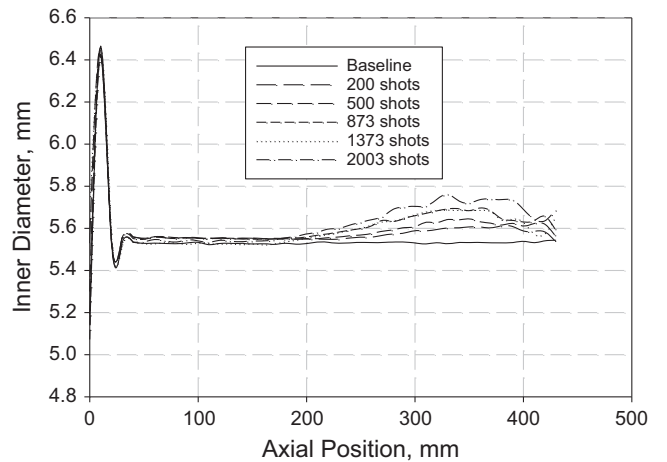
Barrel 2 was fired at a higher rate than that for Barrel 1 but for a shorter period of time. As a result, fewer rounds were fired through Barrel 2. Inner diameter measurements at the land location are shown in Fig. 6. No discernible wear is observed for the first 200 mm of bullet travel. The bore diameter begins to increase at 200 mm axial position and then goes through a maximum at approximately 340 mm. The bore diameter decreases

Fig. 6. Inner diameter as a function of axial position for Barrel 2.

near the muzzle in the same manner as observed with Barrel 1. The total number of shots was 2003. No anomalous decrease in the bore diameter was observed near the gas port for Barrel 2. Barrel 2 was not sectioned.

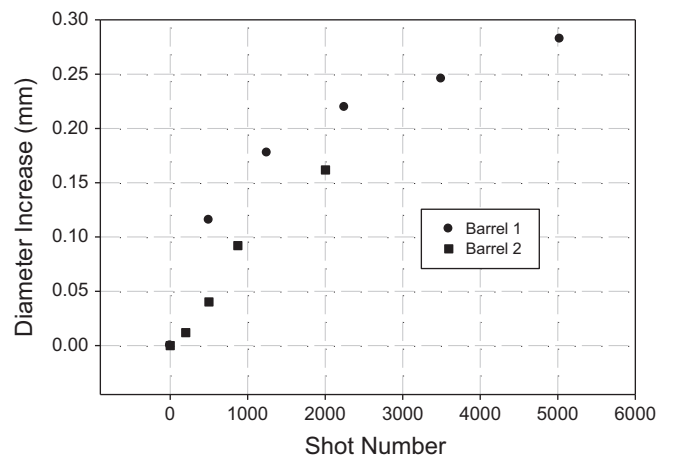
Fig. 7. Maximum barrel wear as a function of shot number.

The maximum wear observed in both barrels does not appear to depend on the firing rate. Fig. 7 shows the maximum wear at

the land location for both barrels as a function of shot number. (This maximum did not always occur at 340 mm, but was generally close to this location.) Both barrels initially show a rapid increase in wear as a function of shot number. Barrel 2, which was fired at a higher rate than Barrel 1, does not show quite as much wear over the first 2000 shots. The rate of wear in Barrel 1 appears

to taper off for shot numbers greater than 3000. This may be due to the fact that the lands have worn away at this point (see Fig. 5) and further wear must occur for the entire surface of the bore.
