FINAL REPORT

Infrared Reflectance Imaging for Environmentally Friendly Corrosion Inspection Through Organic Coatings

ESTCP Project WP-0407

MAY 2008

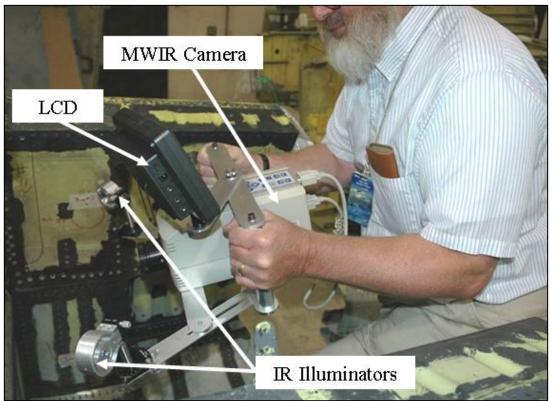
Figure 2-1: IRRIT System

The technology developed in the SERDP Project PP-1137 as described in Section 2.1.1 is the base technology. Figure 2-1 illustrates the IRRIT system.

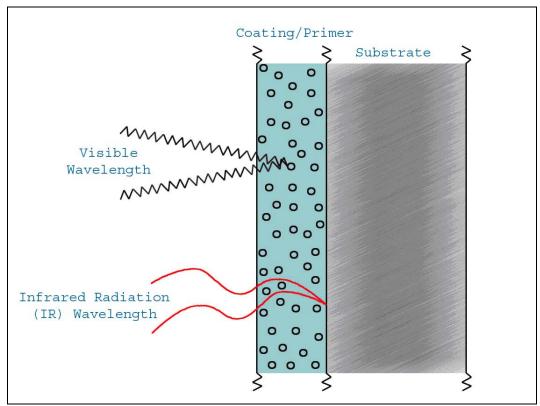
Figure 2-2: IR Wavelength versus Visible Wavelength

One way to detect corrosion products at the paint/metal interface is to use an optical reflectance probe to detect changes in reflectance as a result of corrosion. Spectral reflectance signatures may be used to detect the presence of various chemical species, including corrosion products. An IR beam must be able to pass through the coating, reflect from the metal surface, and pass back out through the coating. Coatings are normally designed with pigment sizes tailored so that they are opaque in the visible region of the spectrum (0.40 to 0.75 micrometer (μ m)), so they preclude using optical techniques in the visible to "see" through the coating to the metal. However, the scattering power of pigments is diminished as the probe wavelength becomes longer. For many coatings, a spectral window opens in the near and mid-wave infrared (MWIR, 3-5 μ m) spectral regions. As a result, a correctly adjusted IR camera can simply see through some paints (refer to Figure 2-2).

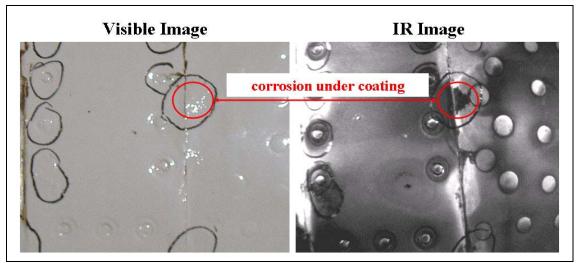
Figure 2-3: Visible Image versus IR Image

There is a significant reduction in reflectance from a corroded substrate. By identifying the ratio of the reflectance spectra of the painted clean aluminum to the spectra of the painted corroded aluminum, a contrast enhancement technique was developed. It was found that the corrosion signature in the paint transmission window can be "seen" through this paint system with this camera. Figure 2-3 illustrates an IR image with corrosion beneath the coating, note the corrosion and how it appears dark.

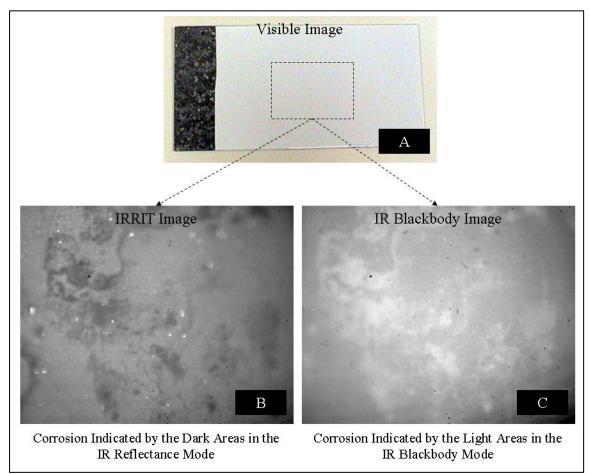
Figure 2-4: IR Reflectance versus IR Blackbody

In the reflectance mode, as illustrated in Figure 2-4 (B), the observed corrosion is denoted by the dark areas while in the case of the Blackbody Mode the observed corrosion is white.

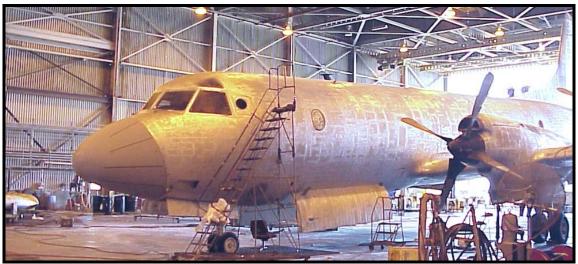
Figure 3-1: Paint Removed from P-3 Aircraft by Chemical Paint Stripping

Corrosion inspection currently consists of visual inspections. Chemical stripping of the aircraft (Figure 3-1) occurs on set intervals regardless of the corrosion findings. It was the goal of this project to demonstrate that the IRRIT can successfully identify the surface condition beneath the paint.

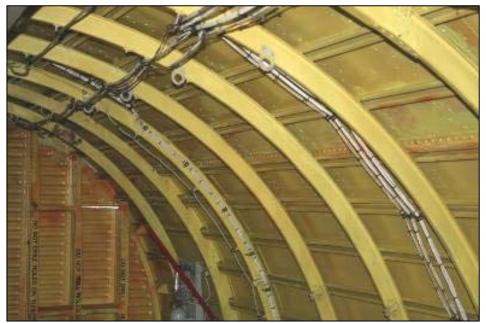
Figure 3-2: Typical KC-135 IML

KC-135 and B-52 lead maintenance engineers expressed a high degree of interest in the IRRIT technology due to potential labor and maintenance cost savings. Ms. Hoang Nguyen, the engineer in charge of B-52 maintenance, showed interest due to the fact that areas of the B-52 IML are coated with a chromated primer. Some of these chromated areas have been stripped and replaced during required fleet-wide inspections, which might have been avoided through use of the IRRIT. Mr. Steve West and Mr. Jeff Catron, senior NDI engineers at OC-ALC, also showed interest in the implementation of IR systems, and supported the selection of the KC-135 as a target for the Dem/Val. Currently, the KC-135 IML corrosion inspection technique consists of visual and eddy current inspections of structurally critical areas. Incorporating IRRIT could reduce the amount of paint stripping required.

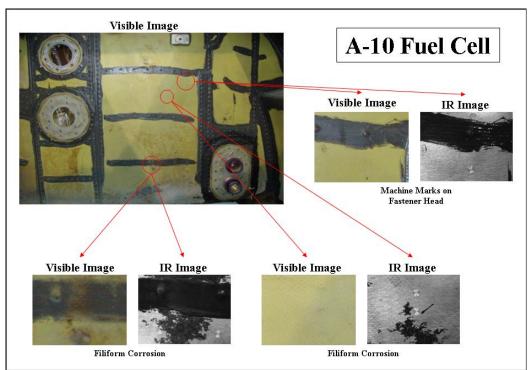
Figure 3-3: A-10 Fuel Cell - IR Images

A mini-demonstration was held at Hill Air Force Base (HAFB) in Ogden, UT in March 2005 utilizing the IRRIT. It was shown with this demonstration that corrosion could be detected in areas not readily observable without the aid of this IR inspection tool. Current practice was to visually inspect the coatings for indications of corrosion, prior to rework of the corrosion. It was demonstrated that HAFB had the potential to visually "miss" corrosion not readily observable on the surface of the coating, and in fact this was the case. IR photographs that were taken clearly demonstrated that corrosion was visible under the coating and not on the surface (refer to Figure 3-3). If not properly maintained in a timely manner this would result in additional corrosion and more pollution (refer to Figure 3-4).

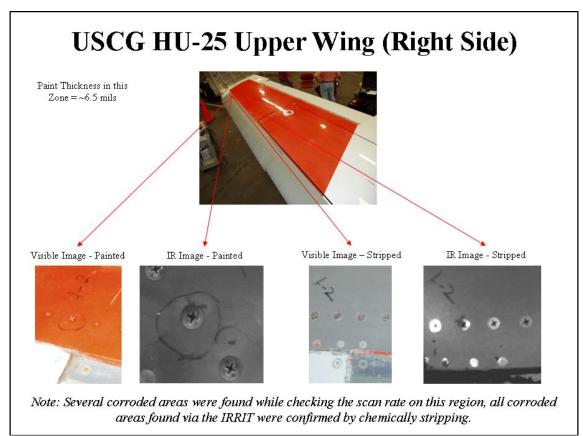
Figure 3-5: USCG HU-25 - IR Images

The IRRIT demonstrated the ability to detect corrosion under the HU-25 paint scheme of cross section thickness between 8-10 mils. This was successful, despite the relatively thick coatings and glossy paint scheme of the aircraft. The camera was easy to use, lightweight, and demonstrated enhanced capability as compared to visual inspection and flash thermography.

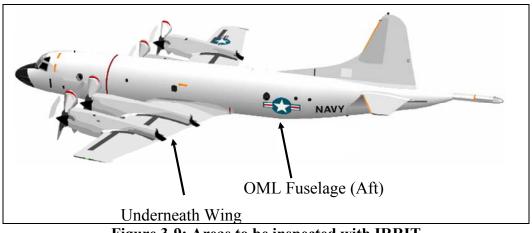
Figure 3-9: Areas to be inspected with IRRIT

and critical structural areas were selected on both the wing and fuselage OML (refer to Figure 3-9). The areas inspected were located (or indexed) according to the P-3 structural stations, as defined by the applicable P-3 assembly drawings.

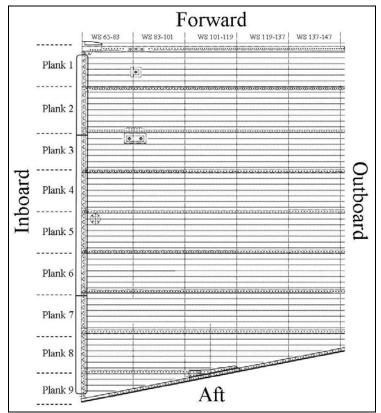
Figure 3-10: Navy P-3 Wing Section inspected with IRRIT

The lower section of the inner port wing made from corrosion-prone aluminum alloy 7075-T6 was inspected between the forward and aft spar and Stations 65 and 147 (refer to Figure 3-10).

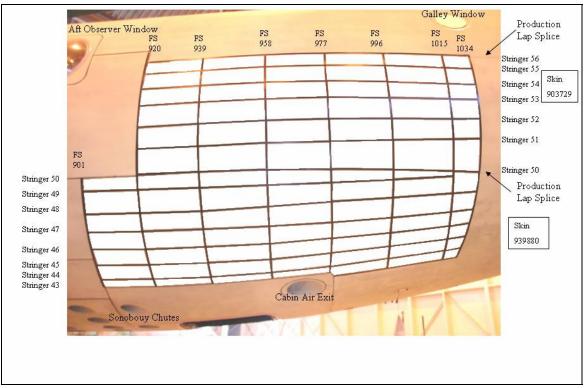
Figure 3-11: Navy P-3 Fuselage Section inspected with IRRIT

The fuselage section that was inspected (refer to Figure 3-11) is manufactured out of aluminum alloy 2024-T3 and located approximately between Stringers 43 to 46 and Stations 850-1050. The fuselage section is curved and is representative of locations on the fuselage with a fuselage radius of 48 inches to 68 inches, while the underneath section of the wing is mostly topographically flat. The radius section was selected to demonstrate dynamic illumination, orientation of the IR camera and a potential reduced FOV.

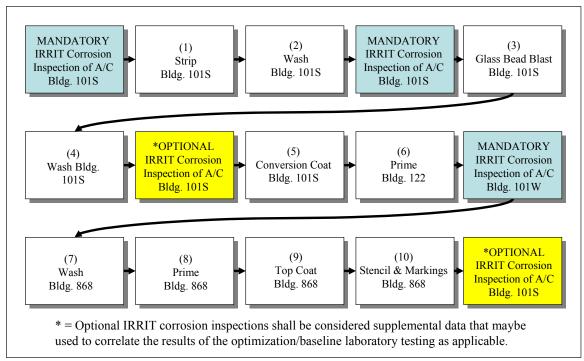
Figure 3-12: Process Stream w/IRRIT Added

The process stream is summarized in Figure 3-12. Inspection points were selected to validate and document each step. However, actual implementation after Dem/Val would anticipate only one inspection point.

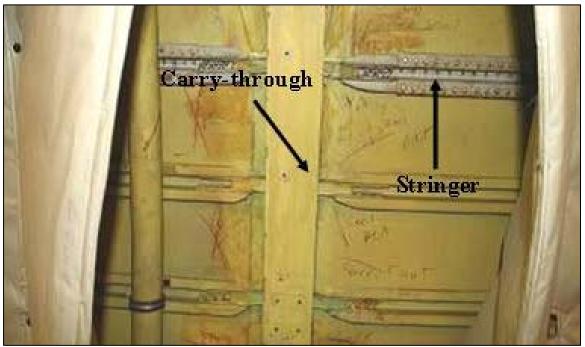
Figure 3-13: KC-135 IML IRRIT Inspection Area

The KC-135 areas of interest were internal structural components. The "horseshoe fittings" are load-bearing members that help distribute loads from one wing to the other, wrapping around the diameter of the fuselage like vertical horseshoes. Several similar structural frames ("formers") had been identified as areas of interest to KC-135 maintenance personnel. Finally, the "carry-throughs" that connect "stringers" (light structural frames running lengthwise inside the skin of the aircraft) through the formers had also been identified as prone to corrosion and cracking. Wing spars were also considered, but preliminary tests during the 19 April 2006 visit to OC-ALC demonstrated that the many hydraulics and secondary structural components made access difficult with the current FLIR camera. The total inspected area would be about 100 square feet per aircraft.

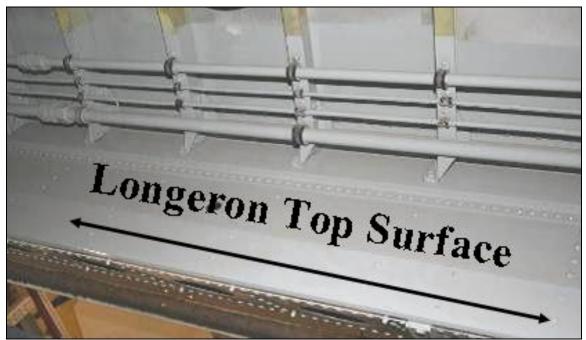
Figure 3-14: B-52 IML Bomb Bay Longeron

The B-52 areas of interest were in the bomb bay, partly due to their corrosion issues (they are exposed to outside weather conditions) and partly due to their accessibility and minimal interference with maintenance schedules. Within the bomb bay, the primary target was the longerons (heavy lengthwise structural members) at the bottom sides of the bay. The total inspected area was about 40 square feet or less. Unlike the KC-135 inspections, the longerons have previously been stripped and repainted for corrosion control purposes.

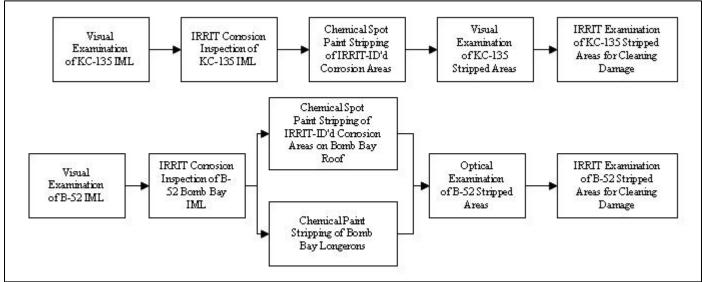
Figure 3-15: OC-ALC Process Stream with IRRIT Added

The process stream is summarized in Figure 3-15. Inspection points were selected to validate and document each step. However, actual implementation after Dem/Val would anticipate only one inspection point.

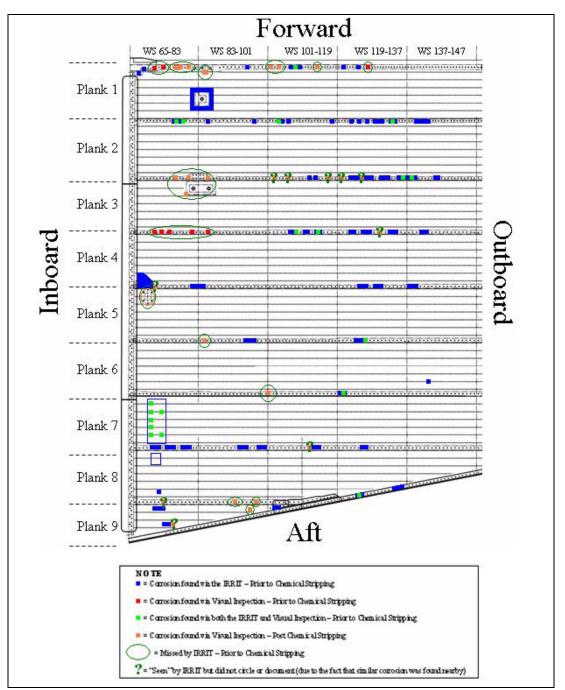
Figure 4-4: Navy P-3 OML Wing Section Corrosion Location Identification

Figure 4-4 illustrates the corrosion locations that were identified during the Navy P-3 (Tail #772, BUNO 162772) Dem/Val. The note within the figure defines the corrosion location and what method they were found and documented.

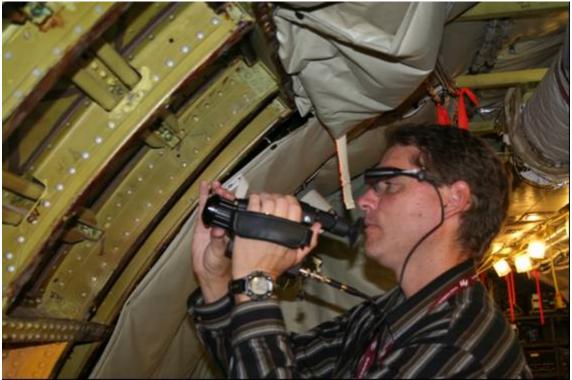
Figure 4-5: MilCam used at OC-ALC

The purpose of the IRRIT inspection on KC-135 #3 was to demonstrate the utility of the new-model IRRIT camera (MilCam) for inspecting the wing spar. This entailed working in a tight space that had prevented IRRIT inspection with the Merlin® MWIR camera. In addition, a technology demonstration was performed for Navy E-6 field engineers located at OC-ALC.

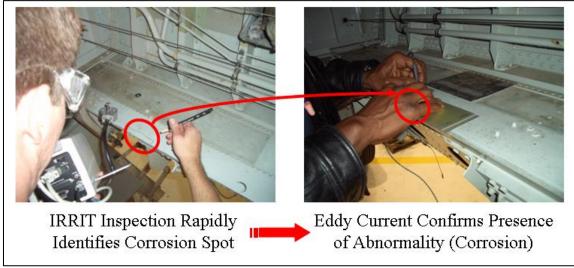
Figure 4-6: IRRIT versus Eddy Current

The IRRIT inspection process performed acceptably on the B-52 IML with no significant inspection performance impacts due to complex geometry (found in KC-135 IML). Based on the IML Dem/Val results, future IRRIT inspections will require the removal (dry-wiping) of surface contamination, known to be problematic in IR (i.e., dirt, dust, oil, grease, etc.), prior to inspection (refer to Figure 4-7). Early detection of corrosion allows the user to minimize or prevent structural damage and pollution prevention through the use of the IRRIT (refer to Figure 3-4). IRRIT inspection process provides improved sensitivity for detection of surface corrosion as compared to standard eddy current and visual inspection methods utilized at OC-ALC (refer to Figure 4-6).

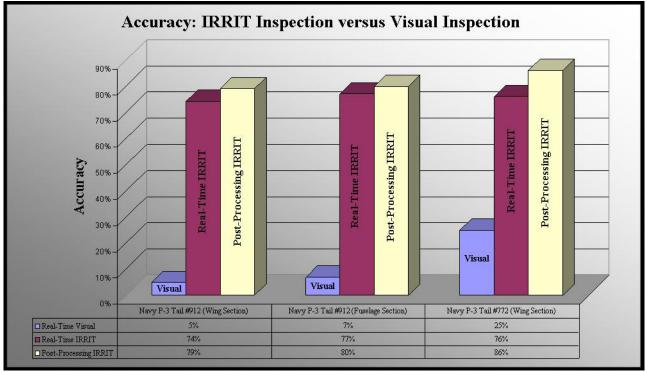
Figure 4-10: Navy P-3 OML - Accuracy of IRRIT Inspection versus Visual Inspection

Figure 4-10 illustrates the high level of accuracy of the IRRIT inspection method (79%, 80%, and 86% Post-Processing IRRIT) as compared to the visual inspection method (5%, 7%, and 25% Real-Time Visible), during the Navy P-3 OML Dem/Val. The IRRIT inspection identified three times (3X) the amount of corrosion located by visual inspection. The IRRIT as compared to the visual inspection method allows for post-processing the images after the inspection, which can assist the identification of corrosion present but not observed during the real-time inspection. Probable IRRIT inspection errors can be found in Table 4-3.

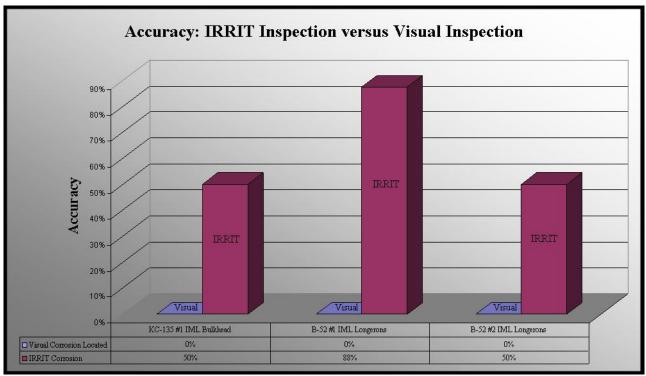
Figure 4-11: KC-135/B-52 IML - Accuracy of IRRIT Inspection versus Visual Inspection

Figure 4-11 illustrates the high level of accuracy of the IRRIT inspection (50%, 88%, and 50%) method as compared to the visual inspection method (0%, no corrosion visually noted), during the USAF KC-135 and B-52 IML Dem/Val. During this Dem/Val the inspected aircraft had low levels of corrosion, thus reducing the data set that was recorded. No corrosion was detected via visual inspection, whereas IRRIT successfully identified several corrosion locations. Probable IRRIT inspection errors can be found in Table 4-7.

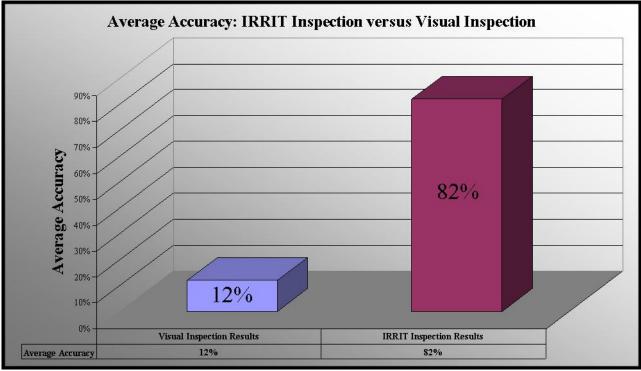
Figure 4-12: Average Accuracy of IRRIT Inspection versus Visual Inspection

Figure 4-12 illustrates the average level of detection, comparing visual inspection versus IRRIT inspection. This is a weighted average, where all corrosion sites where weighted equally for both OML and IML Dem/Vals. This chart illustrates the high level of accuracy of the IRRIT inspection method as compared to the visual inspection method. In total (including OML and IML Dem/Vals) there were 352 corrosion sites. The IRRIT found 287 corrosion sites out of the 352, equaling 82% accuracy. Visual inspection found 42 corrosion sites out of the 352, equaling 12% accuracy.

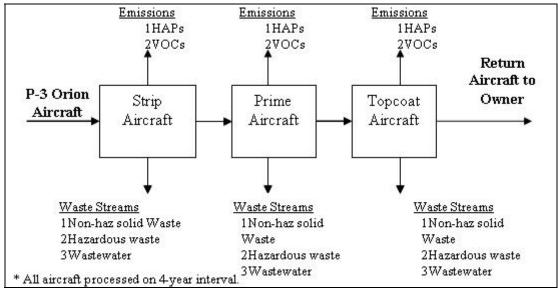
Figure 5-1: Baseline Maintenance Process

Currently, P-3 aircraft undergo paint strip, corrosion treatment, and repaint at NAVAIR Jacksonville. The baseline chemical stripping and repainting process of P-3 aircraft evaluated for this report was broken down into three basic steps that are generally repeated every four years for each aircraft. Approximately 25 P-3 aircraft are processed in this manner each year. As illustrated in Figure 5-1, each step generates air emissions and wastes.

In the first step, the aircraft is brought into the strip hanger, where it is secured, stripped of paint using a chemical agent, and surface corrosion is treated. In the second and third steps, the aircraft is taken to the paint hanger where the entire surface area is primed and repainted. Significant costs for the baseline procedure include:

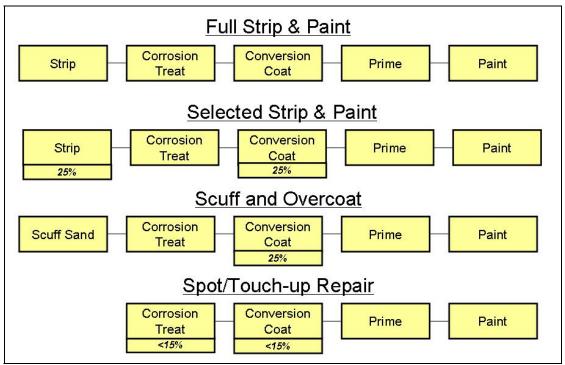
Figure 5-2: Percentage of Baseline Labor and Materials Used in Alternatives

The percentages of the baseline strip and repaint process required by each of the alternative maintenance procedures are illustrated in Figure 5-2 below.

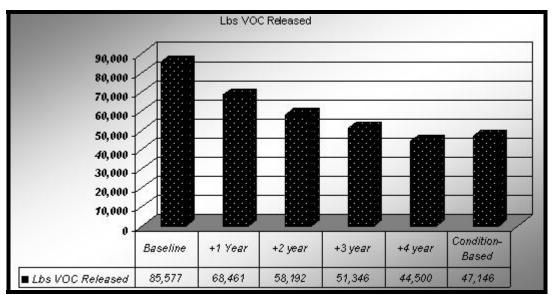
Figure 5-3: Annual VOC Emissions for Alternative Scenarios

The annual VOC emissions and the alternative scenarios for a medium-sized aircraft (using P-3 as a baseline) are compared graphically in Figure 5-3 below (rationale for Figure 5-3 can be found in Table 5-24).

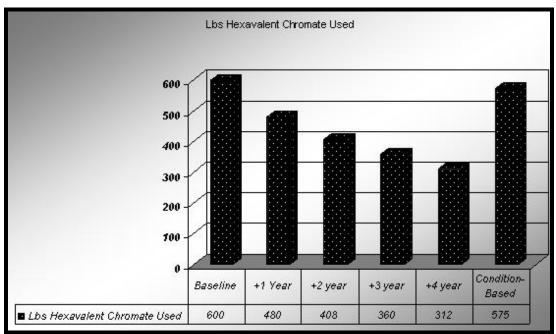
Figure 5-4: Annual Hexavalent Chromate Use for Alternative Scenarios

The annual hexavalent chromate use in the alternatives scenarios is illustrated graphically in Figure 5-4 (rationale for Figure 5-4 can be found in Table 5-24).

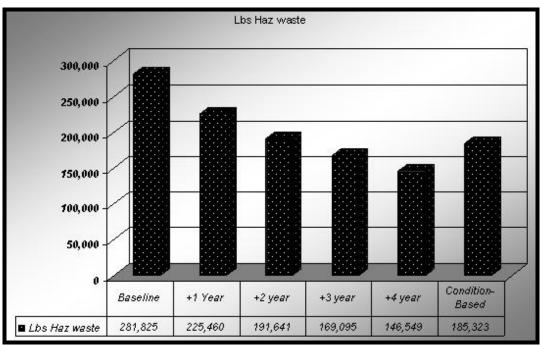
Figure 5-5: Annual Hazardous Waste Produced in Alternative Scenarios

Annual hazardous waste generated in the alternatives scenarios are illustrated graphically in Figure 5-5 below (rationale for Figure 5-5 can be found in Table 5-24).

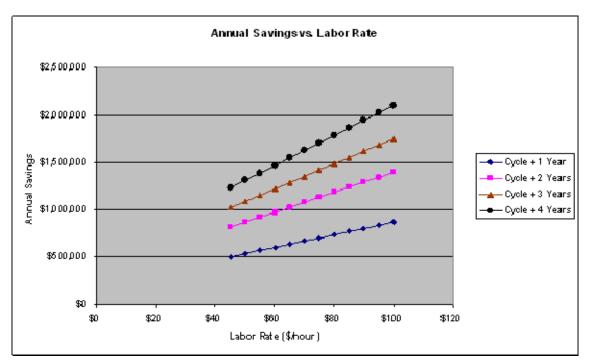
Figure 5-6: Annual Savings vs. Labor Rate

Figure 5-6 illustrates that, as the labor rate increases, so does the estimated annual savings. This is due to the fact that savings related to labor are anticipated when the IRRIT camera is implemented and/or when the maintenance cycle is increased. Therefore, as labor rates increase, the potential for savings related to labor costs also increases. The amount of savings for the 1-year increase in maintenance cycle is significant moving from about \$500,000 to nearly \$900,000 – an increase of about \$400,000. This increase becomes more substantial for each incremental increase in the maintenance cycle. At the 4-year cycle, the values range from just over \$1 million to over \$2 million, which is an increase of \$1 million.

The results of Table 5-25 and Table 5-26 are illustrated graphically in the following figures. Figure 5-6, Figure 5-7, and Figure 5-8 illustrate Labor Rate vs. Annual Savings, Payback Period, and Savings per Aircraft, respectively.

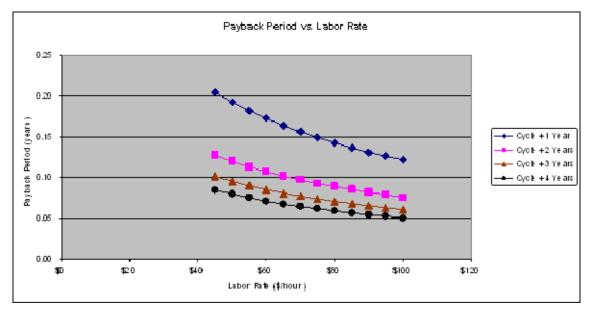
Figure 5-7: Payback Period vs. Labor Rate

Figure 5-7 illustrates that the payback period decreases as labor rate increases. This is logical because annual savings increase with the rising labor rate, so the time required recovering the capital investment is expected to be reduced.

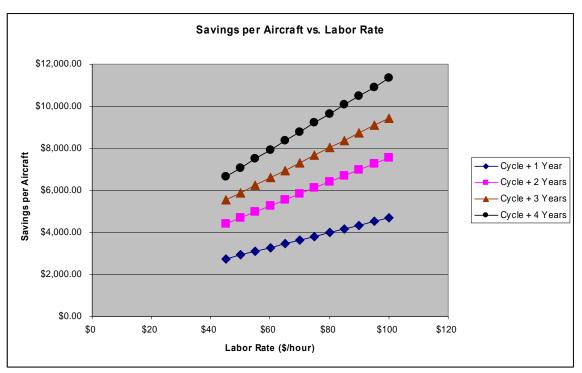
Figure 5-8: Savings per Aircraft vs. Labor Rate

As was the case with Annual Savings, the Figure 5-8 illustrates the Savings per Aircraft also increases with the labor rate. As noted previously, this is expected because labor is expected to be saved by using the IRRIT camera and/or increasing the maintenance cycle. The expected savings by increasing the cycle one year is significant (ranging from about \$3,000 to \$4,500), and if the maintenance cycle increase to four years, the estimated savings is expected to more than double (ranging from about \$6,500 to over \$11,000).

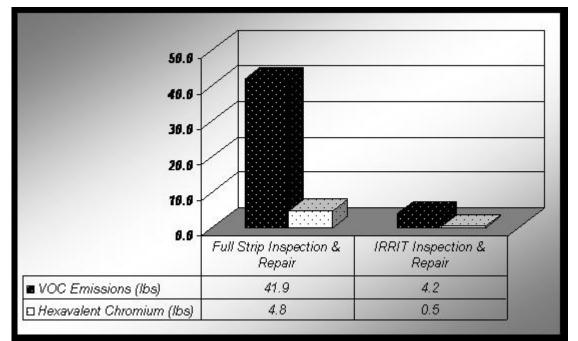
Figure 5-9: IML Full Strip vs. IRRIT Inspection EHS

Figure 5-9 below illustrates the potential impact the elimination of a single one-time inspection through use of IRRIT could have on EHS emissions.

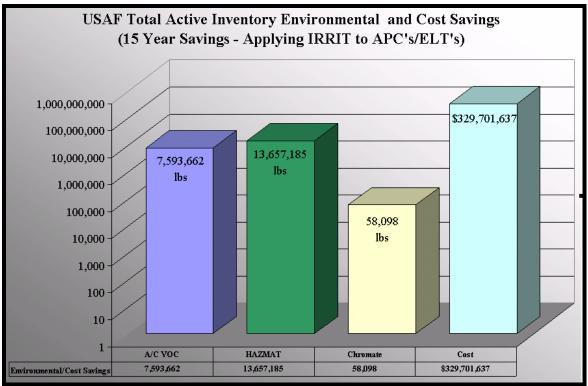
Figure 6-3: Potential USAF Environmental and Cost Savings (with APC's/ELT's)

also be noted that a value of 5,636 lbs was used for the USAF HAZMAT calculations, due to the use of plastic bead media for OML paint removal.

Scale-up of this technology across Navy and USAF aircraft inventories compatible with IRRIT system OML and IML inspection requirements would result in significant environmental reductions of VOC, HAZMAT, and chromate waste with corresponding process cost savings (refer to Figure 6-1, Figure 6-2, and Figure 6-3) as a result of reduced inspection driven depaint functions and/or paint process deferments. The methodology or rationale that was used in generating Figure 6-1, Figure 6-2, and Figure 6-3 is as follows: all aircraft within the Navy and USAF total active inventory (based on 2006 estimates) were taken into account. P-3 data was used as the baseline values for subsequent calculations. The baseline P-3 values are as follows:

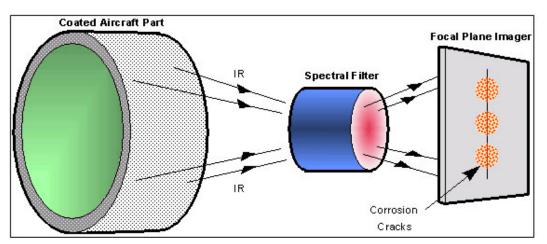
Figure A-1: Principal of IRRIT on Corroded Painted Metal Components

Figure A-1 below illustrates a schematic of the IRRIT. In this schematic the IR camera lens is between the spectral filter and the coated aircraft part. The camera body includes the spectral (or bandpass filter) and the focal plane detector.

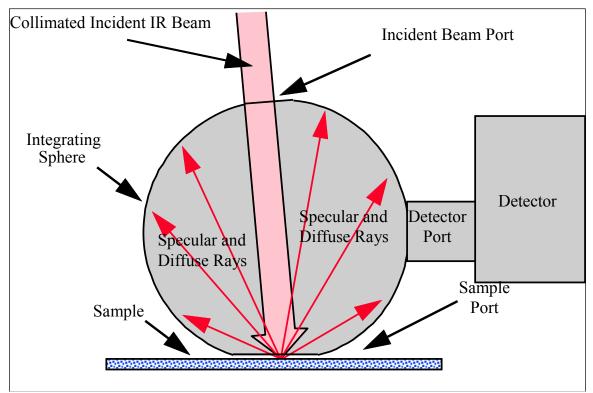
Figure A-2: Integrating Sphere System used to Measure DHR

The spectral imaging concept depends on the generation of a database of spectral signatures of corroded surfaces and various coating reflectance and transmission data. Directional Hemispherical Reflectance (DHR) was utilized to determine the spectral properties of surfaces. As illustrated in Figure A-2, a collimated IR beam in the range of 1.8 to 15.4 μ m was directed near normal to the surface, and the reflected light, both specular and diffuse, was measured in an integrating sphere. Reflectance was then plotted as a function of wavelength or wavenumber or equivalent wavelength in micrometers (μ m). It was important to collect the diffuse component of the reflected light since the reflectance signal from any corrosion at the metal surface will be significantly scattered by the overlying paint layer.

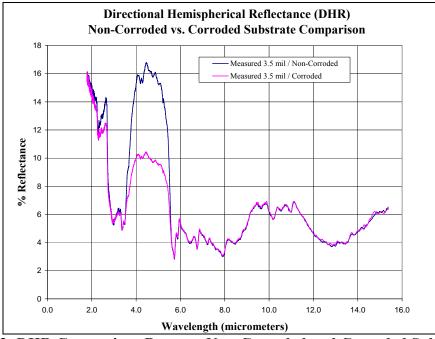
Figure A-3: DHR Comparison Between Non-Corroded and Corroded Substrates

To test the spectral imaging concept using DHR measurements, NGC layered paint films of various thicknesses over non-corroded and corroded aluminum panels. The corroded aluminum panels were made by exposing them to salt fog. This resulted in a thin surface layer of oxide on the panel. Figure A-3 illustrates the DHR spectra of the same paint coating on two substrates, one non-corroded, the other corroded. The prominent reflectance of the non-corroded substrate between 3.5 to $5.0 \,\mu\text{m}$ is the result of the substrate reflecting the IR light through the transmissive window of the paint. Clearly the corrosion signature in the substrate is affecting the overall reflectance of paint on substrate combination.

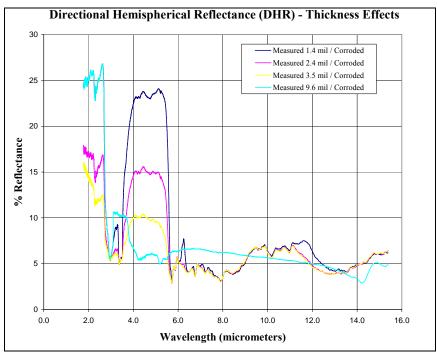
Figure A-4: DHR of Aluminum Panels with Variations in Coating Thickness

Figure A-4 illustrates the DHR of a series of topcoat films of various thicknesses on top of a corroded aluminum substrate. The transmissive window in the $3.5 - 5.0 \mu m$ range becomes less prominent as the coating thickness increases.

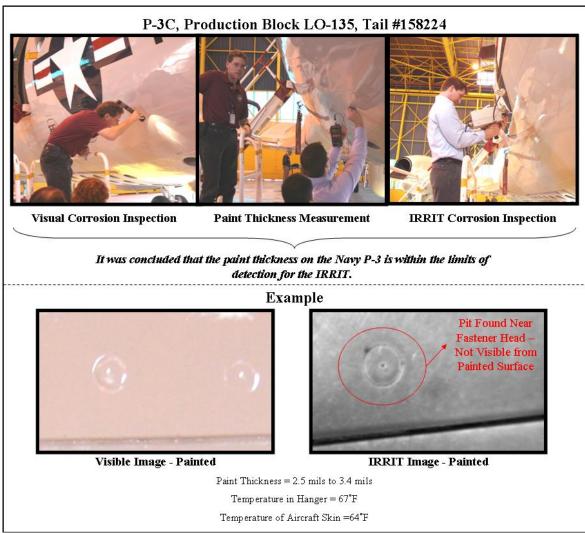
Figure B-1: Risk Reduction at NAS Jacksonville

The objective of this trip was to demonstrate a final risk reduction of the IRRIT system, prior to beginning the Dem/Val on the Navy P-3 in February 2006. This objective was achieved and the IRRIT system successfully imaged through the coating system that is currently used on the Navy P-3 aircraft (refer to Figure B-1).

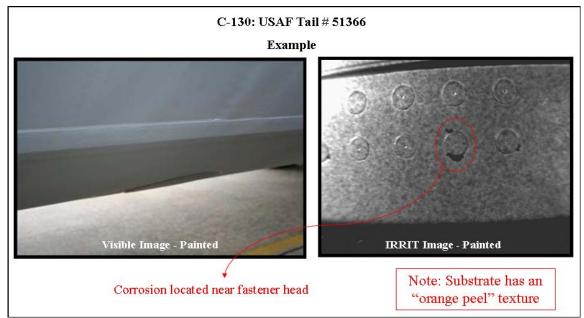
Figure B-3: Corrosion Under OML Coating of C-130

Demonstrated IRRIT system on two C-130 aircraft (C-130 USAF Tail # 0987, C-130 USAF Tail # 51366). This was the first time the IR camera was used utilizing 110 power supplied from a portable power unit. No problems were observed with the utilization of this type of power. The first survey was of a C-130 (C-130 USAF Tail # 0987) with a coating thickness of approximately 9 to 16 mils. It was reported that the aircraft came from Hill AFB and that the top coat was the Deft Advanced Polyurethane Topcoat (APC) or also known as the Extended Life Top Coat. This aircraft was difficult to image the substrate under the coatings and it is surmised that this was due to the thickness of the coating present as well as the APC formulation in the darker color which may contain carbon black that tends to block IR transmission if the concentration is too high in the coating. The coating was also heavily "orange peeled", which may have been a contributing factor with contrast issues of the local coating thickness variations. The second survey was of another C-130 (ANG 51366 from the Texas Air National Guard) exhibiting coating thicknesses approximately 4.5 mils on exterior sections. Both IR photographs and conventional photographs were taken on this exterior location (refer to Figure B-3). The IML was also investigated on this aircraft (refer to Figure B-4). The IRRIT system successfully imaged through the thinner coated sections of the aircraft.

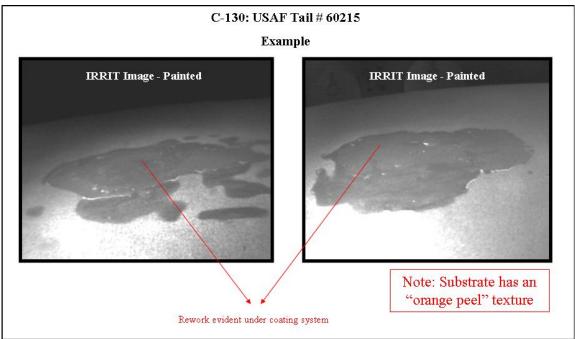
Figure B-5: Rework Under OML Coating of C-130

- 27 October 2005
- Demonstrated IRRIT system on C-130 aircraft (C-130 USAF Tail # 60215). The fourth survey was of another C-130 (USAF Tail # 60215) exhibiting coating thicknesses approximately 3.5-9 mils on exterior sections. Both IR photographs and conventional photographs were taken on this exterior location (refer to Figure B-5). The IRRIT system successfully imaged through the thinner coated sections of the aircraft. However, the IRRIT system was unable to image through the thicker coated sections.

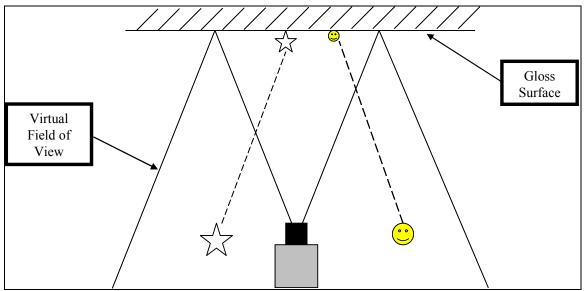
Figure D-2: Virtual FOV

When the camera is looking at a gloss painted surface care must be taken with the IR illumination. If the camera is looking at a gloss reflective surface, hot sources within the virtual FOV will be imaged (see Figure D-2), as with a mirror. Hot IR sources should be placed outside the virtual FOV with the sources directed toward the area to be viewed. An approach that may be used is to illuminate the area with a low temperature broad area diffuse source within the FOV, which would not saturate the camera, but would provide sufficient illumination to see under the paint. If the surface is a matt or "camouflage" type surface the light would be diffused and would not be re-imaged.

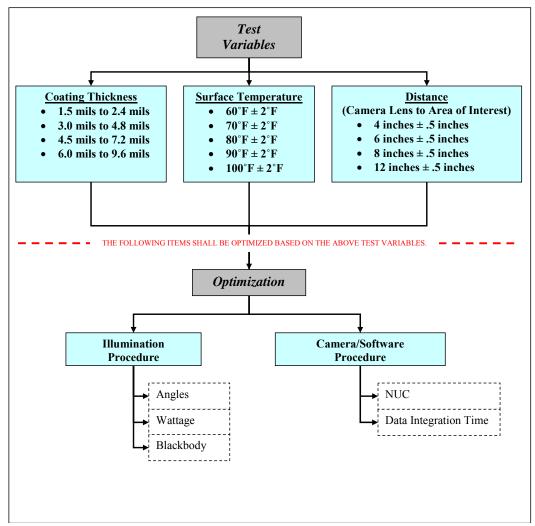
Figure D-3: Approach for Optimizing/Baselining the IRRIT + Blackbody Technique

The goal of this optimization/baseline test plan is to test variables that could be encountered in the field and test them in the lab. This will allow the IRRIT to be better "prepared" for use at the Dem/Val.

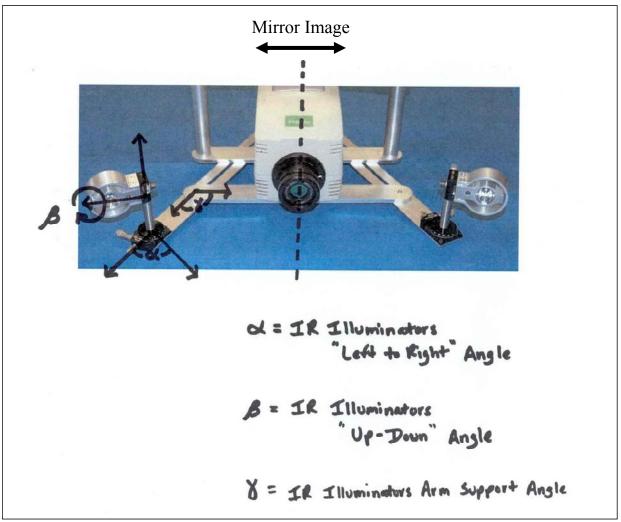
Figure D-4: Angle Designations for IR Illuminators

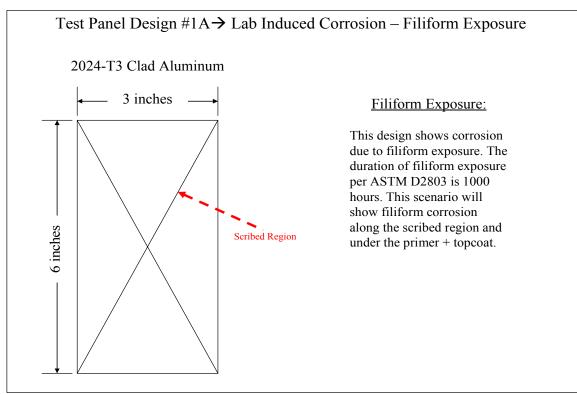
Figure D-5: Panel Design #1A

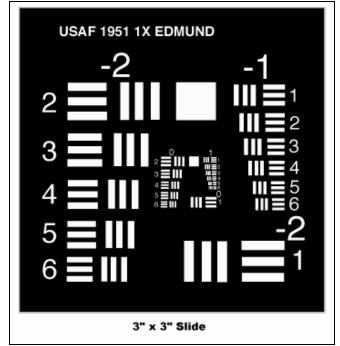
Figure D-6: 1951 USAF Glass Slide Resolution Target (Negative)

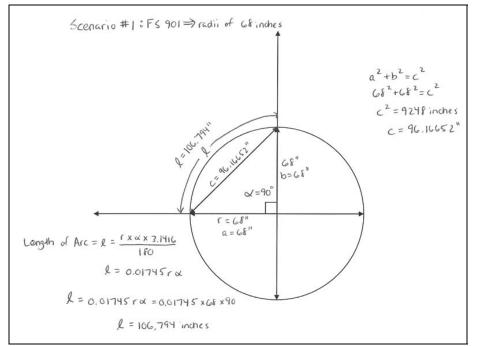
Figure D-7: P-3 Fuselage Contour Scenario #1 - FS901 (Radii = 68 inches)

Figure D-7 and Figure D-8 illustrates the curvature of the P-3 fuselage at fuselage station (FS) 901 and fuselage station (FS) 1117 respectively.

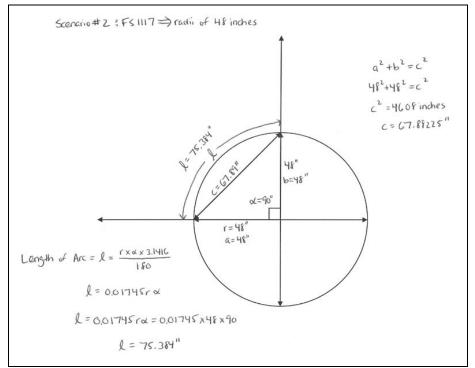
Figure D-8: P-3 Fuselage Contour Scenario #2 - FS1117 (Radii = 48 inches)

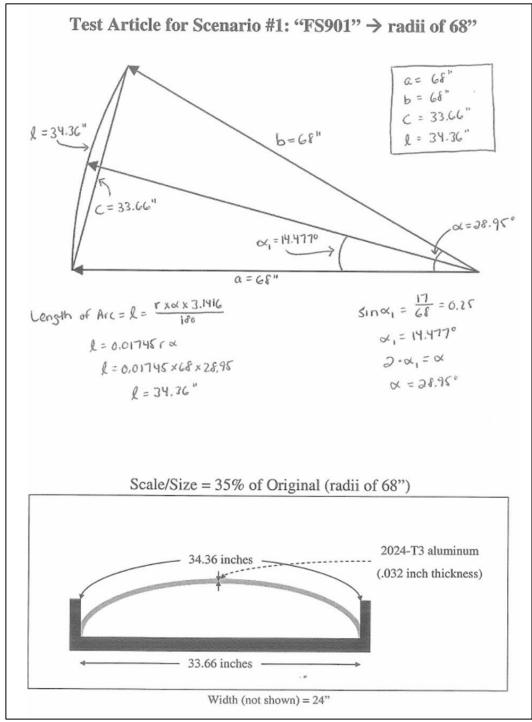
Figure D-9 shows the calculations that were required to generate a scaled down test article, which were based on the calculations shown in Figure D-7. This test article will simulate the curvature of the fuselage that will be encountered on the P-3 aircraft during the Dem/Val.

Figure D-9: P-3 Fuselage Contour - Test Article for Scenario #1

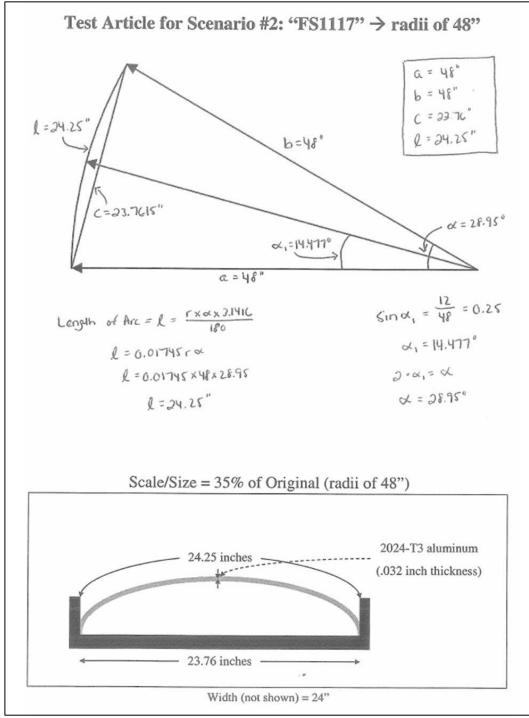
Figure D-10 shows the calculations that were required to generate a scaled down test article, which were based on the calculations shown in Figure D-8. This test article will simulate the curvature of the fuselage that will be encountered on the P-3 aircraft during the Dem/Val.

Figure D-10: P-3 Fuselage Contour - Test Article for Scenario #2

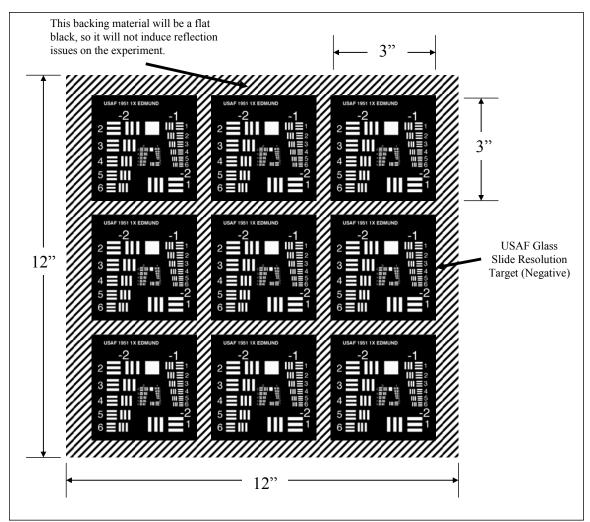
Figure D-11: Sample Required to Resolve Curvature of Camera Lens Issues (FOV)

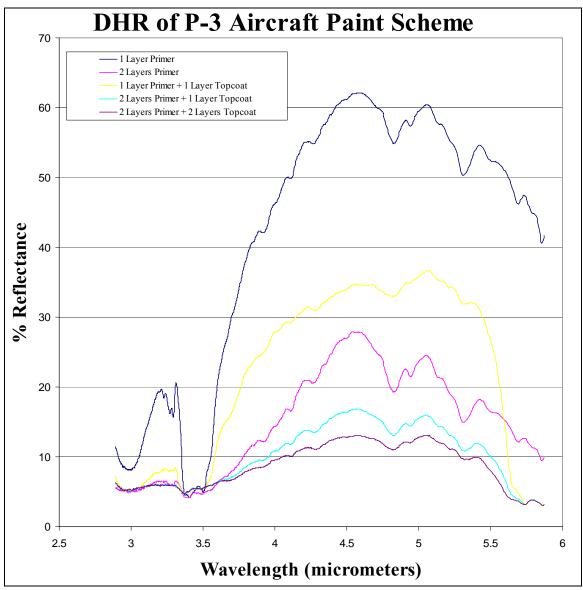
1P = .9 mils 2P = 3.2 mils 1P1T = 2.1 mils 2P1T = 4.16 mils2P2T = 4.61 mils

Figure E-1: Spectral Signature of Navy P-3 Coating

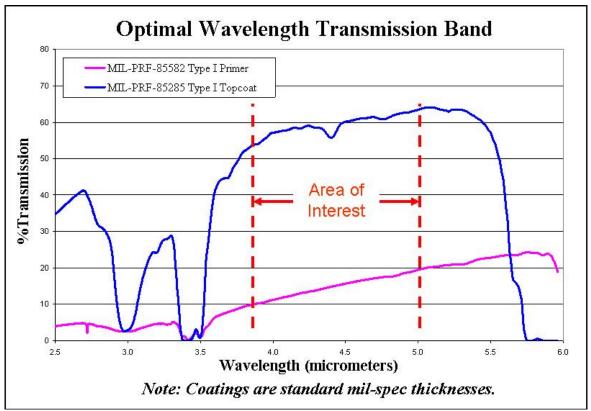
Figure E-2: Improved Spectral Window for IRRIT

IR filter optimization activity was performed based on the transmission spectra of the P-3 paint scheme (see Figure E-2). Selection of the optimized filter was conducted at FLIR/Indigo Operations in Goleta, California. Several possible spectral filters were considered. Figure E-3 illustrates DHR spectra for individual candidate spectral filters. The filters were installed on a filter wheel that was connected to a laboratory Merlin® Mid IR camera (liquid-nitrogen cooled). Figure E-4 illustrates the filter evaluation setup whereby a sample was imaged using both a standard Merlin® IR camera and a Merlin® IR camera equipped with a filter wheel.

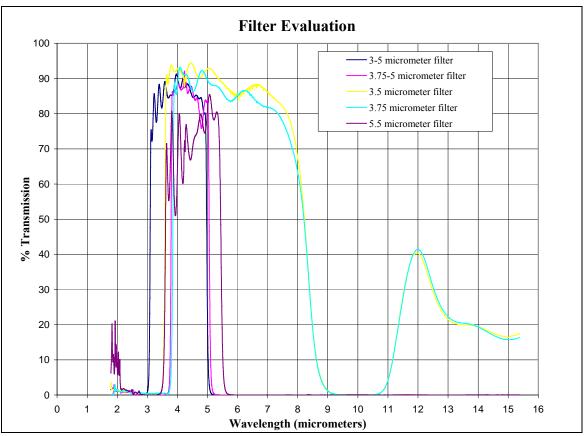
Figure E-3: Spectra of Filters Evaluated

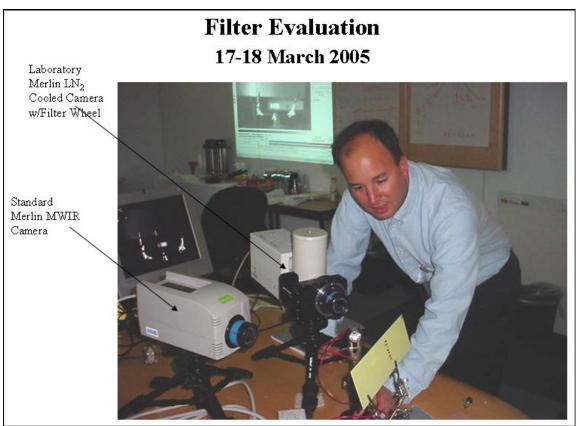
Figure E-4: Filter and Camera Comparison

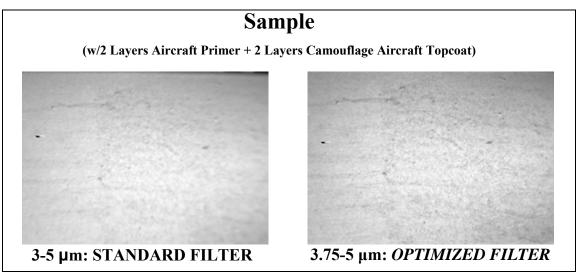
Figure E-5: Optimized Filter versus COTS Filter

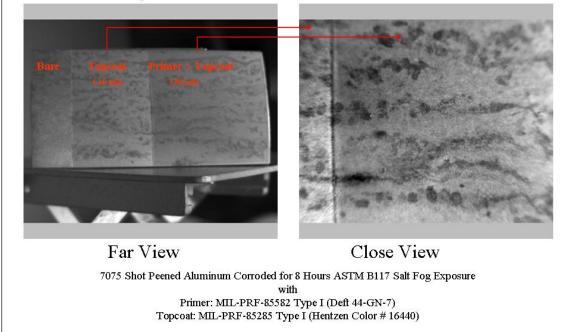
Figure E-6: Rtools Results

Figure E-6 represents images that were obtained using the RTools software. In addition to optimizing the IR camera filter, it was also thought that the RTools software would be able to generate superior images compared to the previous method which was to capture them directly from the IR camera and store them as digital files. However, the results concluded that the RTools software, for this particular application was of no added benefit to the Dem/Val, and actually complicates an otherwise simple process.

Figure E-6 also shows the results of the optimized filter system, which cuts off the lower wavelength glare allowing the camera to be more sensitive in the 3.75 to 5 μ m window. It was found that the 3.75 -5 micrometer filter produced the best contrast between corroded and non-corroded surfaces as seen in Figure E-5. The final selected filter was incorporated into the Merlin® Mid IR camera. Indigo measured the spectral response of the specialized filter system. Figure E-7 illustrates the normalized performance of the Merlin® camera lens system with the specialized filter.

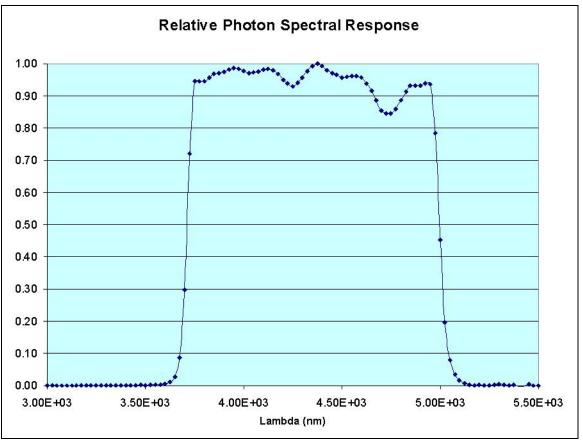
Figure E-7: Spectral Response Curve for Optimized Filter

Indigo-measured spectral response curve for filter-lens system to be incorporated into the IRRIT camera.

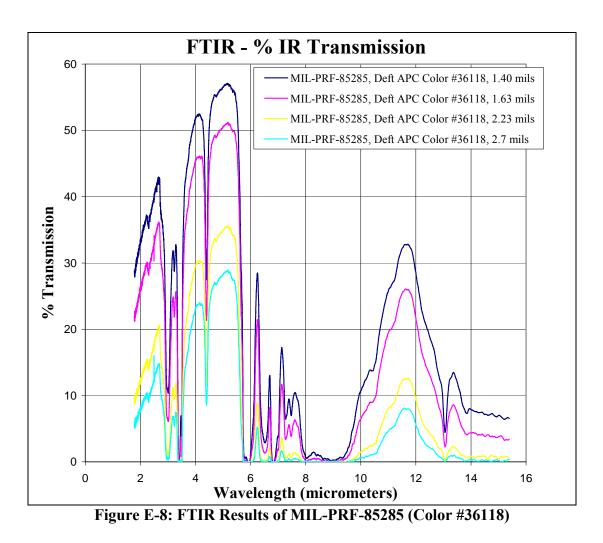
Figure E-8 illustrates the dark camo gray topcoat has a big transmission drop off with increasing film thickness.

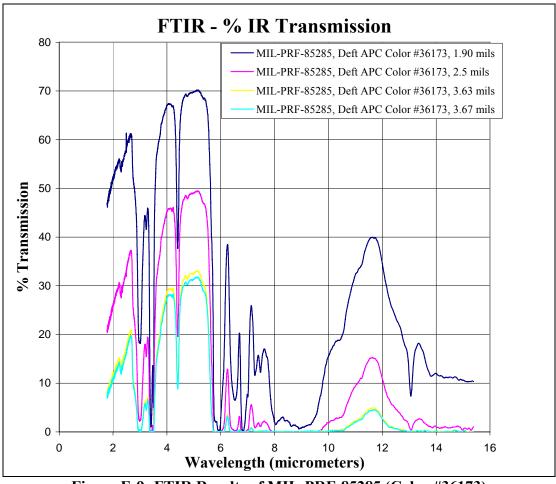
Figure E-9: FTIR Results of MIL-PRF-85285 (Color #36173)

Figure E-9 illustrates the light camo gray topcoat is a little more transmissive than the dark camo gray when comparing thicknesses.

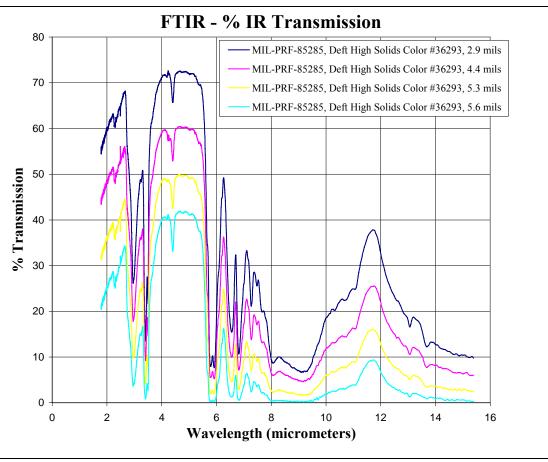
Figure E-10: FTIR Results of MIL-PRF-85285 (Color #36293)

Figure E-10 illustrates the high solids topcoat and as coating thickness increases, transmission capability in the 3-5 μ m wavelength region decreases. This spectra is on the same scale as the primer FTIR spectra. A typical coating of 3 mils yields about 70% transmission.

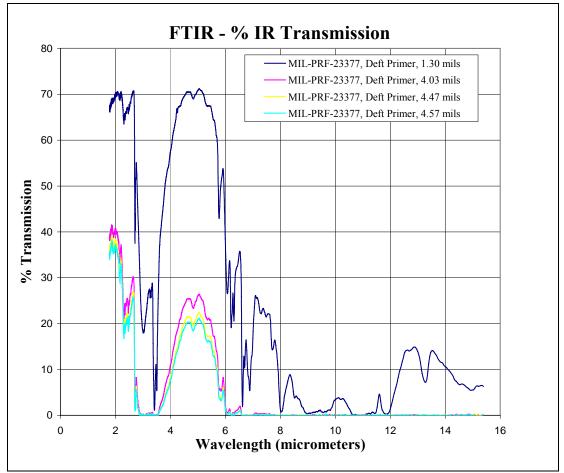
Figure E-11: FTIR Results of MIL-PRF-23377

Figure E-11 illustrates the thick primer has very little transmission in the region of interest (3-5 μ m). If the 23377 primer is properly applied on the aircraft, the Merlin® MWIR camera should be able to image through to the substrate.

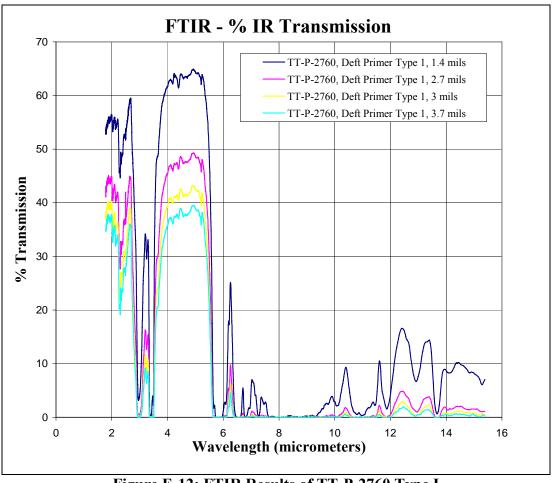
Figure E-12: FTIR Results of TT-P-2760 Type I

Figure E-12 illustrates the 2760 primer is just as transmissive as the 23377 primer when it is thin. Note the large absorbance at $3.4\mu m$.

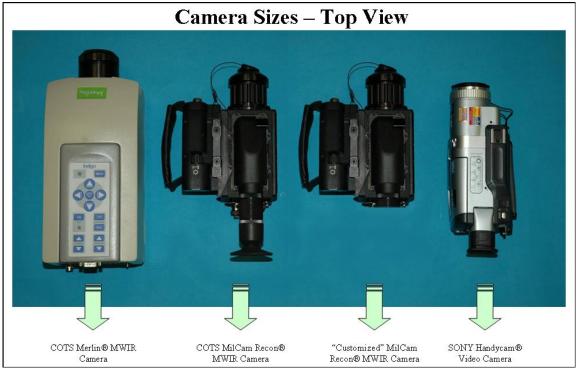
Figure E-13: Camera Dimension Comparison (View 1)

The purpose of this test report was to investigate methods of improvement regarding ergonomics and the IRRIT system. During initial technology demonstrations it was noted that the IRRIT system operator could only hold the camera for short durations (minutes) before becoming physically fatigued. Packaging the MWIR camera into a smaller/lighter system will improve ergonomics (Figure E-13, Figure E-14, and Figure E-15).

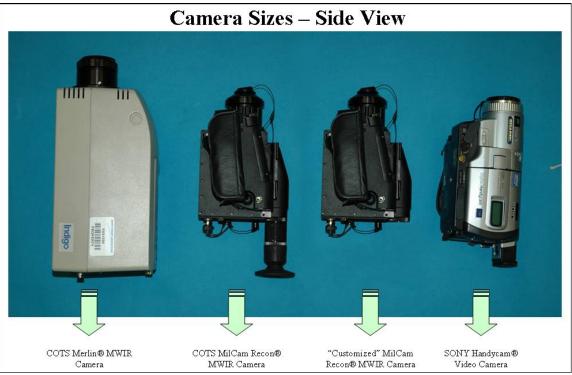
Figure E-14: Camera Dimension Comparison (View 2)

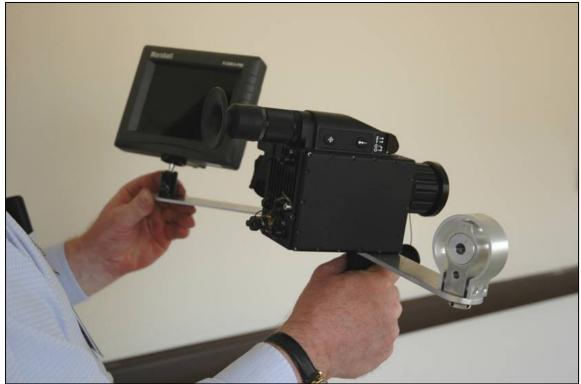
Figure E-15: FLIR MilCam w/IR Illuminators and LCD

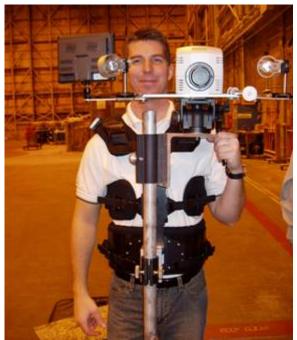
Figure E-16: User with IRRIT Equipment Mounted on Vest/Harness

In general, it is good practice (ergonomically) to use the largest appropriate muscle groups available when muscular force is exerted. However, the initial set-up of the IRRIT system required the operator to hold the camera. Holding the camera caused fatigue in the users arm and shoulder muscles. This led to mounting the IRRIT system on a vest/harness and also on a tripod. Implementation of the vest/harness and the tripod occurred during the Navy P-3 Dem/Val. Previously, the operator could only hold the IRRIT system for a matter of minutes before becoming fatigued; with the use of the vest/harness the operator was able to use the IRRIT system for hours. Mounting the IRRIT system on a tripod (Figure E-17) or harness/vest (Figure E-16) requires little to no effort (physically) on the operator.

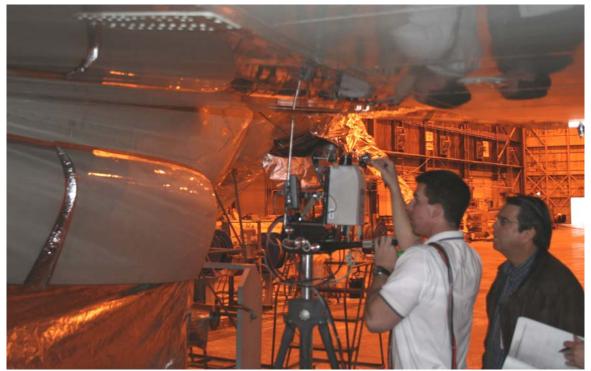
Figure E-17: User with IRRIT Equipment Mounted on Tripod

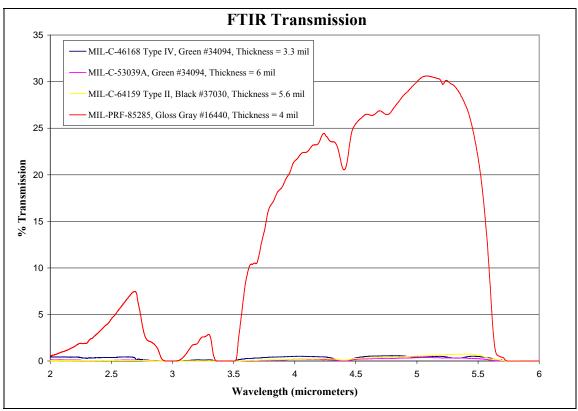
Figure E-18: FTIR Transmission Results of CARC Free Standing Films

Figure E-18 depicts the transmission spectra for the CARC free standing films compared to the Hentzen P-3 topcoat. The 46168 Black (both thicknesses) is not plotted as its spectra is zero in the 2-6 μ m range.
