FINAL REPORT

Infrared Reflectance Imaging for Environmentally Friendly Corrosion Inspection Through Organic Coatings

ESTCP Project WP-0407

MAY 2008

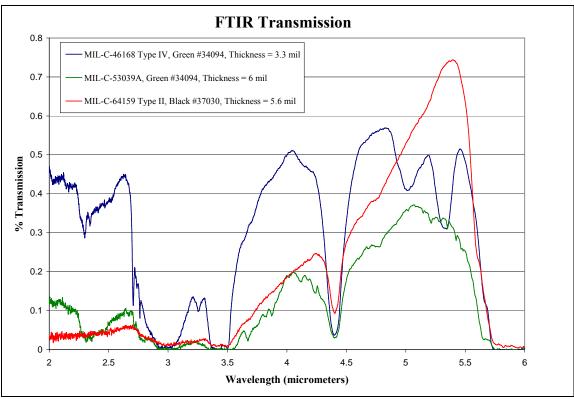
Figure E-19: FTIR Transmission Results of CARC Free Standing Films

Figure E-19 illustrates the expanded transmission scale of the CARC coatings FTIR. Note the scale of the % transmission.

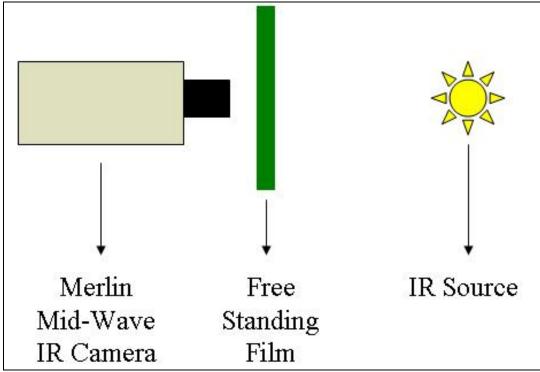
A standard halogen light was used as a source to view the paint films with the Merlin® IR camera. The IR camera was set up to view the light source. The paint films on the plastic substrate were then introduced between the source and the IR camera. Photos were taken for no film in the FOV, Hentzen 2 mil P-3 paint film (single and double layer), and for a single layer of the CARC 3 mil 46168 Green top coat.

Figure E-20: Schematic of Free Standing Film Test

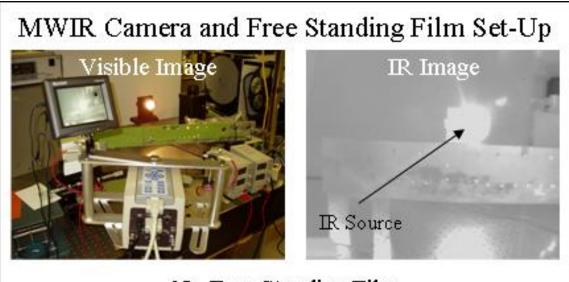
No Free Standing Film

Figure E-21: No Sample Between IR Source and IR Camera

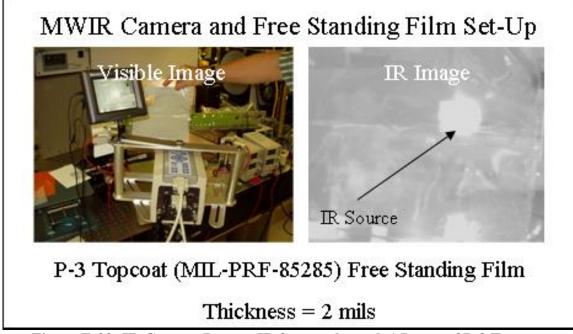
Figure E-22: IR Camera Detects IR Source through 1 Layer of P-3 Topcoat

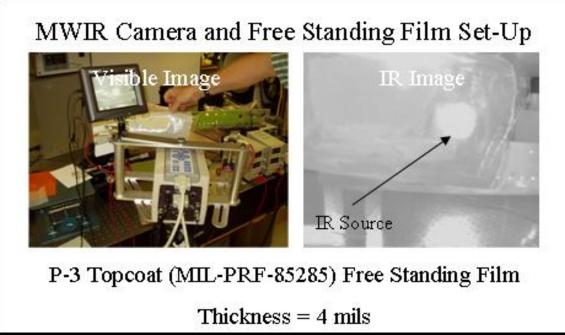
Figure E-23: IR Camera Detects IR Source through 2 Layers of P-3 Topcoat

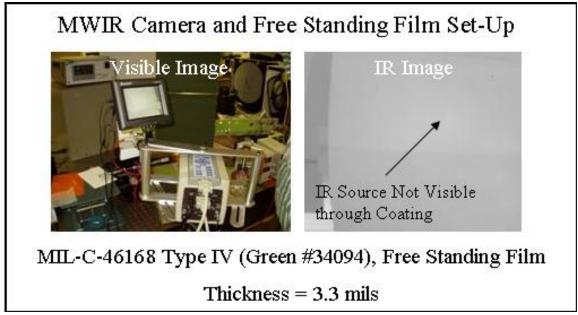
Figure E-24: IR Camera Cannot Detect IR Source through CARC Coating

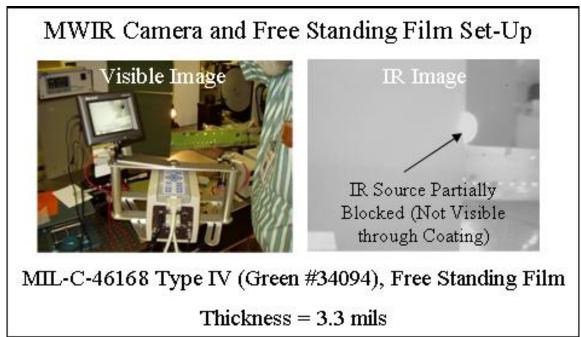
Figure E-25: IR Camera Cannot Detect IR Source through CARC Coating

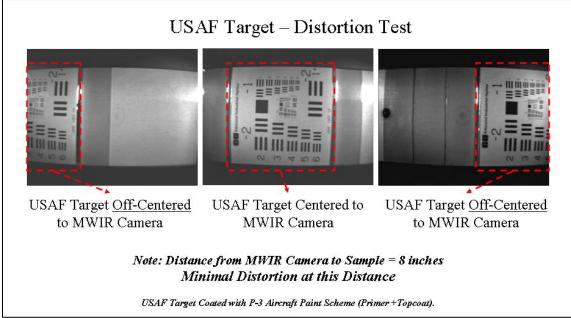
Figure E-26: AF Target Distortion Test

Figure E-26 illustrates IR Image of a 3 inch square Air Force resolution target. A 2 layer coating of the P-3 paint scheme covers this sample. The center of the sample was translated to the edges of the FOV of the camera. The smallest resolution pattern was maintained in the camera's FOV.

A test set up was designed for the test program that fixtures the AF target sample produced to establish if the lens and FOV are uniform over the whole FOV. This is needed to confirm the uniformity of the field so that detection thresholds of various corrosion defect sizes can be established with accuracy. The test fixture was utilized in the Lab and produced images indicating the degree of distortion. The section, FOV Testing for Image Resolution and Quality, below illustrates some of the images produced in this on going study.

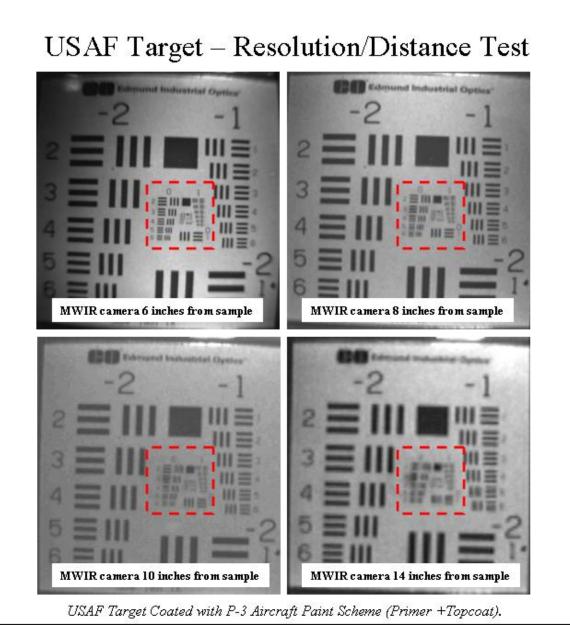
Figure E-27: AF Target Resolution-Distance Test

Figure E-27 illustrates IR Images of painted AF Target Standard taken from differing camera to sample distances.

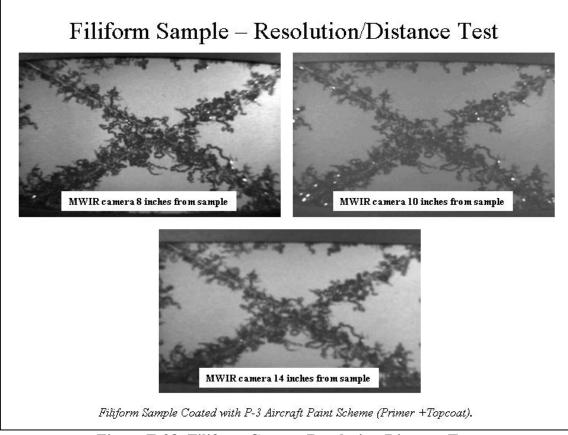
Figure E-28: Filiform Coupon Resolution-Distance Test

Figure E-28 IR Images of P-3 painted filiform coupon taken at differing camera to sample distances.

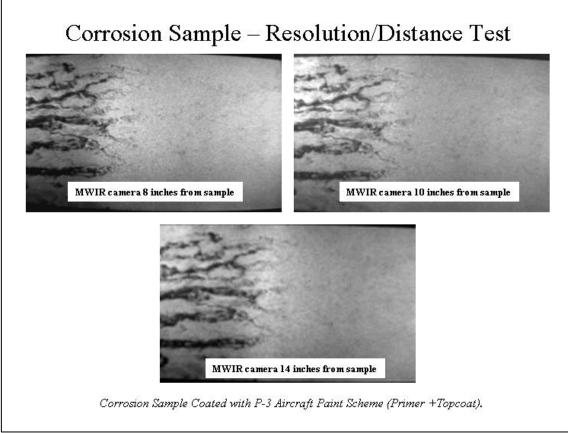
Figure E-29: Corrosion Coupon Resolution-Distance Test

Figure E-29 IR Images of P-3 painted corrosion coupon taken at differing camera to sample distances.

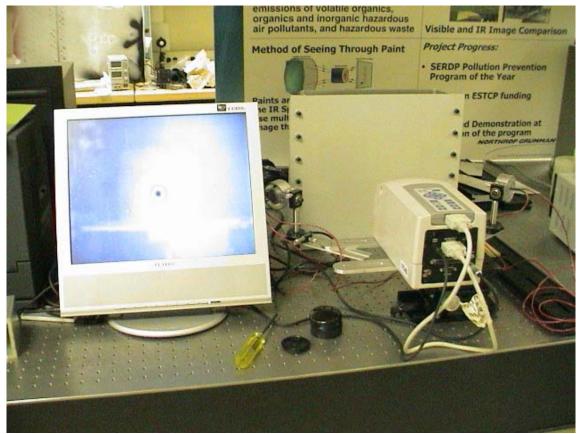
Figure E-30 above illustrates the laboratory set up used to analyze the temperatures that are likely to be anticipated during inspection demonstrations at warm climate areas (e.g., Jacksonville, FL). A water bath was used to control the surface temperature of the epoxy primed (MIL-PRF-85582 Type I) and polyurethane topcoated (MIL-PRF-85285 Type I) corroded panels illustrated in Figure E-30. The monitor to the left of the IR camera was used to continuously monitor the corrosion image real time during the temperature analysis. A number of IR photographs were taken to understand the potential effects of temperature on contrast.

Figure E-30: NGC Laboratory Bench Top Set-Up

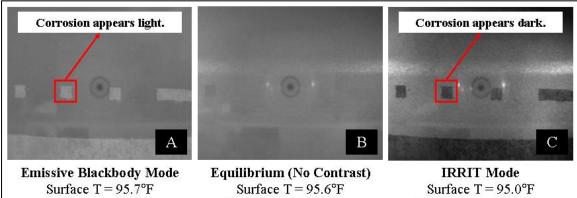
Additional testing was accomplished on a heavily corroded standard panel produced with the aid of ASTM 117 salt fog and Clorox[®] bleach. The following images illustrate the effect of a 95°F substrate temperature that has been primed and painted with a P-3 Orion equivalent finish system. As was illustrated in Figure E-31 (B), the corrosion can not be detected under certain illumination conditions with certain substrate conditions produced by the Blackbody emission for the corrosion when illuminated with IR heaters at 4.35 watts. Figure E-31 (A) illustrates the corrosion, as light in the blackbody mode, as the corrosion in this mode emits more energy than the surrounding non-corroded areas. Note: No illuminators were used for the imaging of Figure E-31 (A).

Heavy corrosion is illustrated by the light squares and the tapering rectangle to the right in Figure E-31 (A). In the blackbody mode corrosion gives off or emits more heat than the surrounding un-corroded aluminum structure. This physical transfer of heat is clearly seen as the corrosion appears white indicating a higher heat flux. Disregard the narcissus effect, which is an optical phenomenon of IR scanning systems which describes how a detector can look back at itself or view a mixture of active scene and itself for certain angles of scan. In Figure E-31 (A-C) the lens reflects off the substrate, as illustrated as a small black dot with a larger black circle surrounding the black dot.

Figure E-31 (B) illustrates the effect of almost zero contrast which is produced when both the corroded surface and the non-corroded surface give off approximately the same heat flux. This occurs when the blackbody heat flux from the corroded area is equal to the IR reflected flux of the non-corroded area. The competing modes of detection cancel out the contrast so the corrosion is not longer apparent, but in fact it is still present under the coating.

Figure E-31 (C) illustrates the effect of the heat flux when the IR reflected heat flux is greater in the non-corroded area of aluminum than from the corroded area, which appears cooler or darker. Note: Corrosion does not reflect IR, as well as the surrounding non-corroded areas. This demonstrates that the 95°F blackbody emission from the corroded area is over whelmed by the 7.7 watt illuminator source. In the example illustrated in Figure E-31, the surface of the aircraft is 95°F. The heat source is required to be at least 7.7 watts as oriented in the test to assure corrosion is detected by the IR illuminator system. Conversely the wattage needs to be less than 4.35 watts and preferably zero watts to observe the corrosion under the coating in the blackbody mode.

IR Source = 0 Watts

IR Source = 4.35 Watts

<u>Conclusion</u>: This study concluded that if the IR heat flux of the corroded areas equals the IR heat flux of the non-corroded areas, the corrosion would not be observable and hence the corrosion would not be detected through the coating. However, this study showed that a solution to this would be to increase the IR heat flux that is emitted from the IR illuminators, thus overpowering the blackbody effect. This solution would then allow the user once again to detect the corrosion via the IRRIT method. In most practical situations, the hanger temperature would not exceed 95° F degrees, and hence IR illuminator wattage of 7.7 watts would totally eliminate this problem.

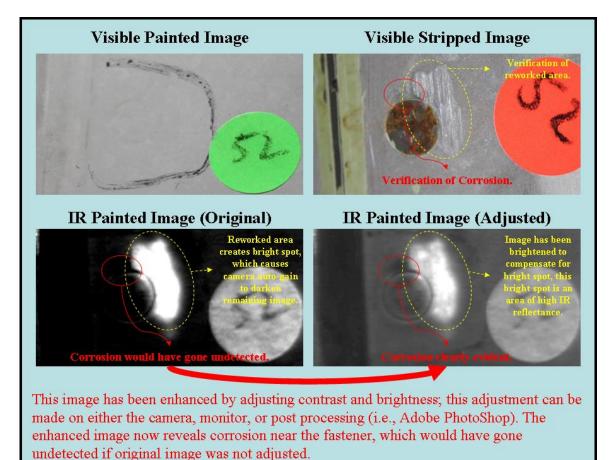
Auto-gain tends to favor bright surfaces (bright surfaces are defined as reworked material, cadmium plated fasteners, and any other highly IR reflective surface), this results in the surrounding area appearing darker. However, if corrosion or other defects are present in this dark area they can be easily missed or go undetected via the IRRIT.

Figure E-32: Auto-Gain Issue

After reviewing video data that was recorded during the 2nd P-3 Dem/Val (Tail #772) it was determined that by adjusting the contrast and brightness on the monitor the dark area becomes bright (the original bright surface also becomes brighter). This results in successfully detecting any corrosion or other defects that might have been missed if no changes were made on the monitor.

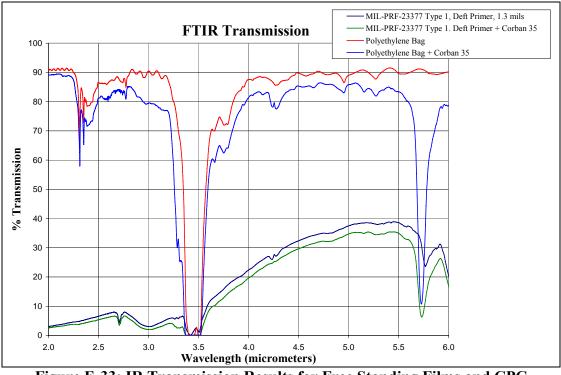
Figure E-33: IR Transmission Results for Free Standing Films and CPC

Two samples (an unsprayed free standing film and a film that was sprayed with Corban 35) were measured via FTIR. There were no additional spectral features introduced in the particular wavelength range ($3-5\mu m$). Overall transmission of the Corban 35-sprayed sample was reduced, most likely due to the additional thickness of the sample.

Corban 35 CPC was sprayed on a 2" x 2" piece of 23377 free standing film. The coating dried under a hood for 2 hours. The primer film thickness is 1.3 mils. The estimated thickness of the Corban 35 is 1-1.5 mils. A reddish discoloration can be visually observed on the surface of the free standing film.

Standard FTIR transmission scans were performed on a Thermo Magna 550 FTIR Spectrometer. The wavelength range of the scans was $1.78-15.3\mu m$. The area of interest for these films is in the range of $3-5\mu m$.

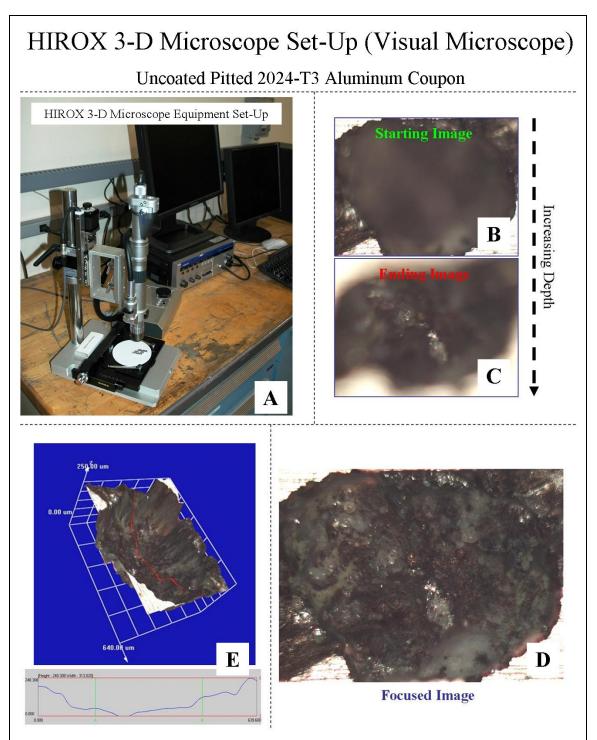
Figure E-34: HIROX 3-D Microscope Set-Up (Visual Microscope)

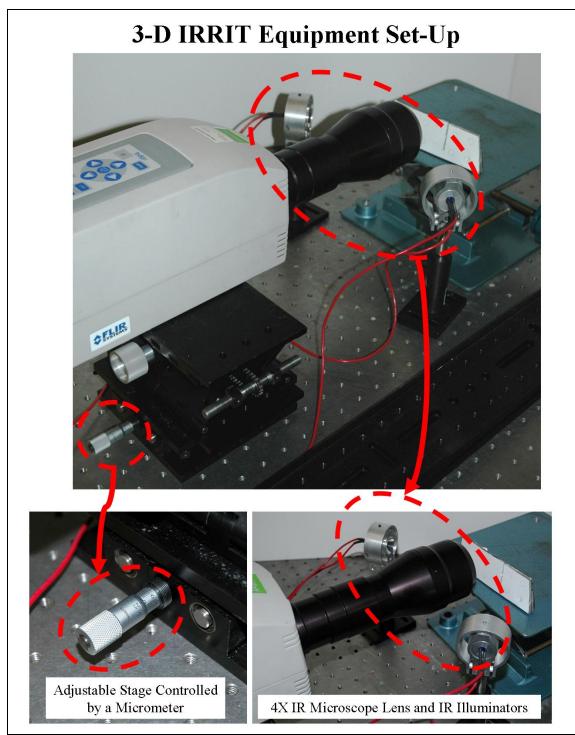
Figure E-35: 3-D IRRIT Equipment Set-Up

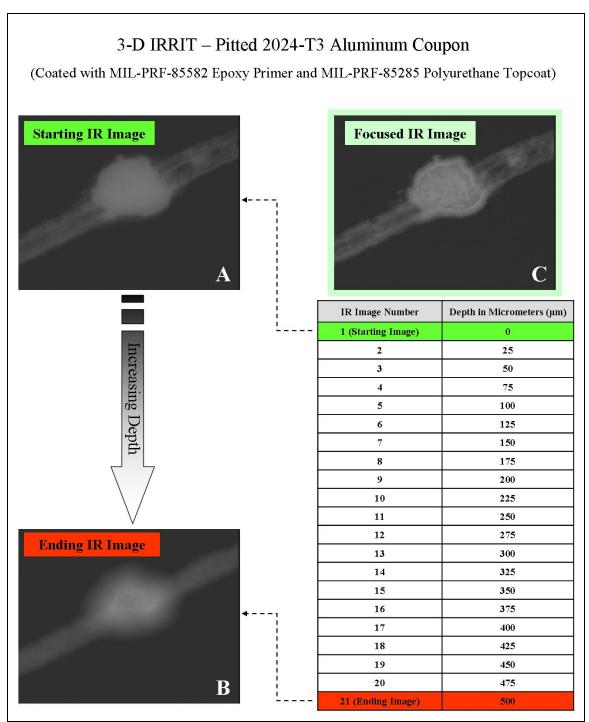
Figure E-36: 3-D IRRIT Images: Pitted Coupon

Using the 3-D IRRIT does allow for improved or enhanced images, as shown in Figures E-36 and E-37. However, the 3-D IRRIT requires additional work to be considered field ready. Specifically, a narrower depth of field IR lens system and a mounting reference system (mounted to aircraft) with a fine micrometer movement in order to accurately acquire the depth data (and for the software to accurately process IR images). The current IR optics (used in this test) have too great a depth of field. The smaller the increment of distance between images (or vertical displacement), assuming the IR optics have the shallower/narrower depth of field, the higher the resolution of the focused image will be. 3-D IRRIT as compared to standard IRRT provides an enhanced image for engineering investigation but does not lend itself as a rapid inspection technique (due to the time required to obtain the quantity of images at one location), thus the 3-D IRRIT is not considered a viable inspection method for depot/production use at this time.

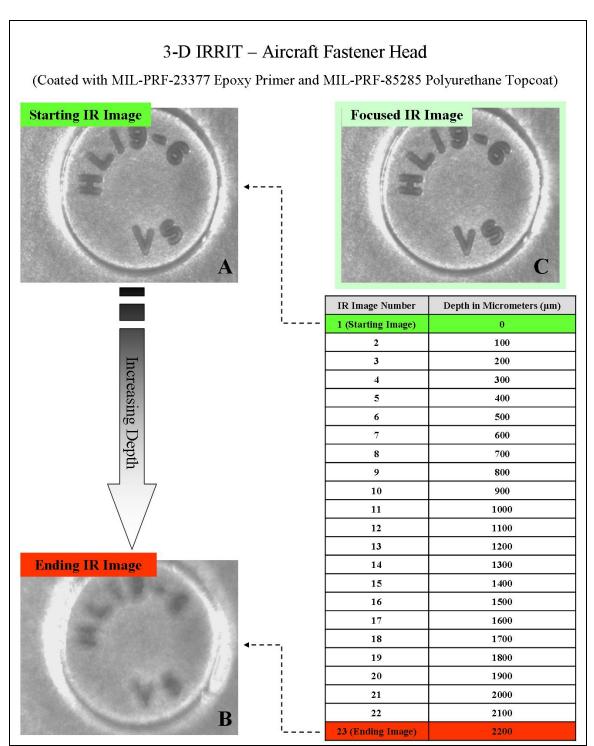
Figure E-37: 3-D IRRIT Images: Fastener Head

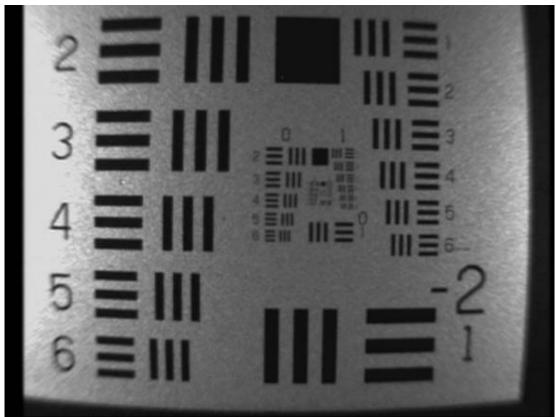
Figure L-2: IRRIT Image of a USAF Glass Resolution Calibration Target.

In Sections L.2.1 through L.2.13, two forms of results are presented: plots of the percentage of IR light transmission through a freestanding film of the specified coating in the range of 3-5 micrometers and, in some cases, IRRIT images were taken of freestanding films suspended partly in front of a standard U.S. Air Force glass resolution target. Such a target is shown without an obscuring coating in Figure L-2.

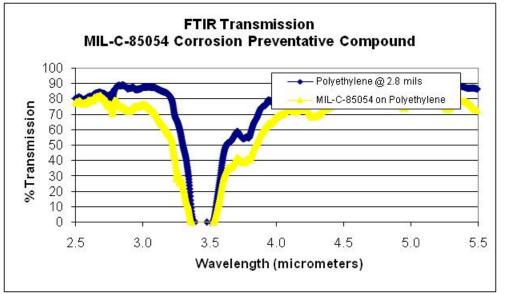
Figure L-3: FTIR Transmission Through SO SURE® MIL-C-85054B Type I Class 134A CPC on 2.8 Mils Polyethylene, and 2.8 Mils Polyethylene Baseline

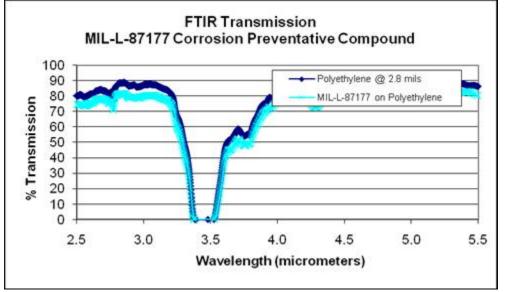
Figure L-4: FTIR Transmission Through LEKTRO-TECH, Inc. MIL-L-87177A Type I Grade B CPC on 2.8 Mils Polyethylene, and 2.8 Mils Polyethylene Baseline

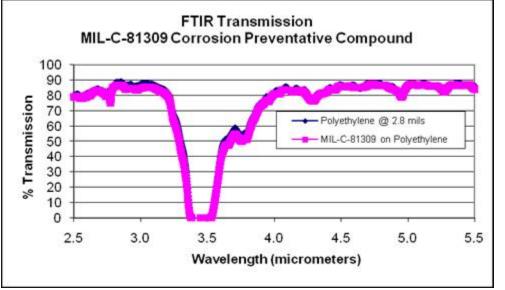
Figure L-5: FTIR Transmission Through SO SURE® MIL-C-81309E Type II Class 2 Grade 134A CPC on 2.8 Mils Polyethylene, and 2.8 Mils Polyethylene Baseline

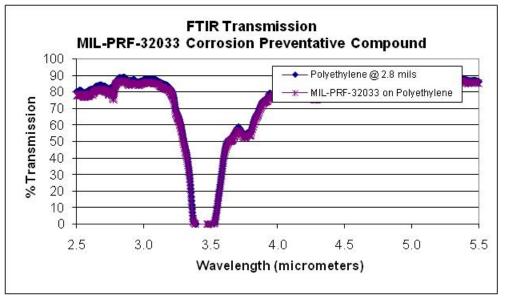
Figure L-6: FTIR Transmission Through LHB Industries MIL-PRF-32033 CPC on 2.8 Mils Polyethylene, and 2.8 Mils Polyethylene Baseline

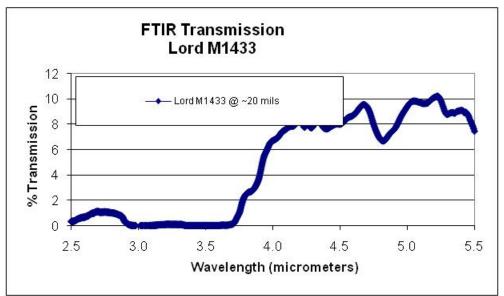
Figure L-7: FTIR Transmission Through LORD Corporation Lord M 1433 (MIL-C-85322) Rain Erosion Coating

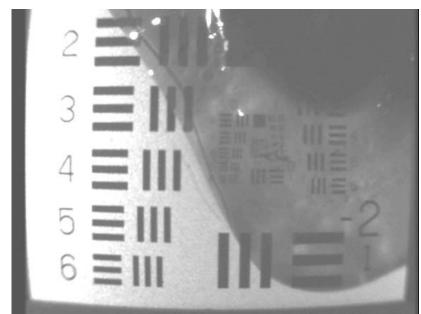
Figure L-8: IRRIT Image of Target Through ~20-mil Lord M 1433 Rain Erosion Coating

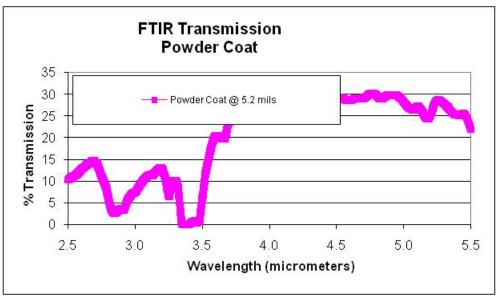
Figure L-9: FTIR Transmission Through 5.2-mil Crosslink Powders, Inc., Powder Coat, Gloss White

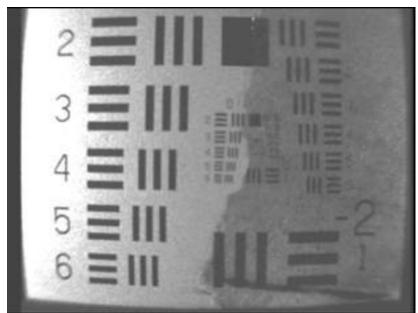
Figure L-10: IRRIT Image of Target Through 5.2-mil Crosslink Powders, Inc., Powder Coat, Gloss White

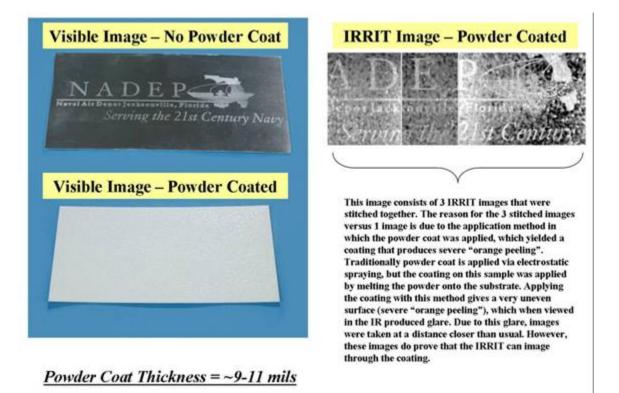
Figure L-11: IRRIT images surface in high detail under thick powder coat

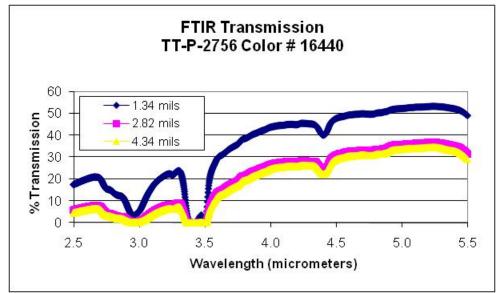
Figure L-12: FTIR Transmission Through Deft TT-P-2756 Type I Self Priming Top Coat, Gloss Gray

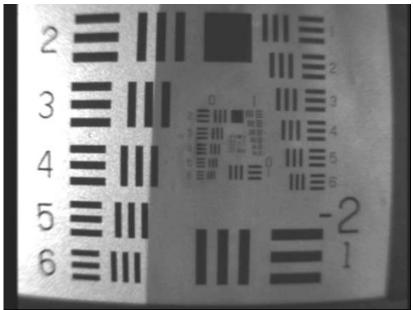
Figure L-13: IRRIT Image of Target Through 1.34-mil Deft Self-Priming Topcoat, Gloss Gray

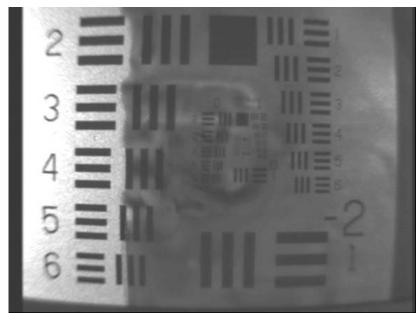
Figure L-14: IRRIT Image of Target Through 2.82-mil Deft Self-Priming Topcoat, Gloss Gray

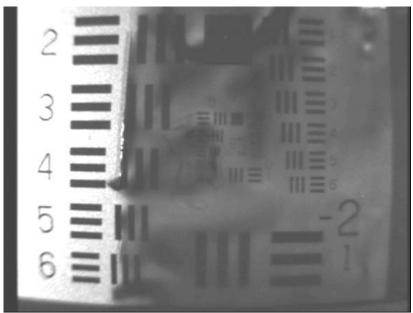
Figure L-15: IRRIT Image of Target Through 4.34-mil Deft Self-Priming Topcoat, Gloss Gray

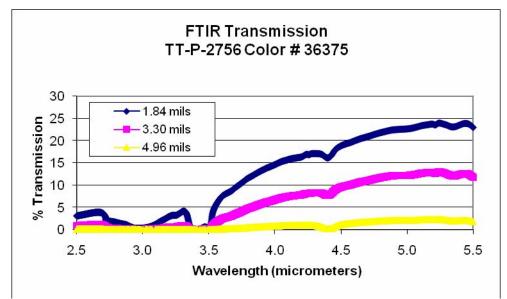
Figure L-16: FTIR Transmission Through Deft TT-P-2756 Type I Self Priming Top Coat, Flat Light Gray 36375

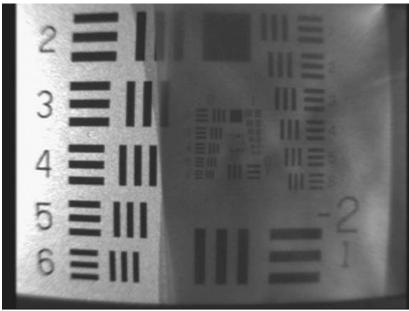
Figure L-17: IRRIT Image of Target Through 1.84-mil Deft Self-Priming Topcoat, Flat Light Gray

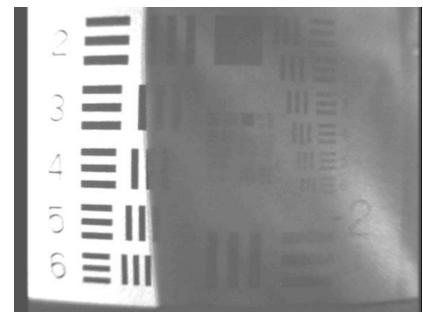
Figure L-18: IRRIT Image of Target Through 3.30-mil Deft Self-Priming Topcoat, Flat Light Gray

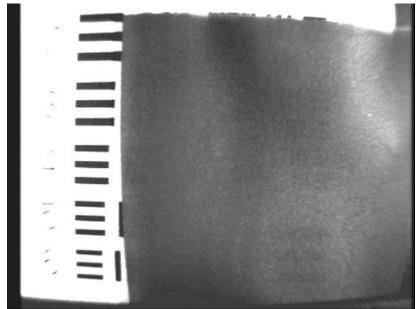
Figure L-19: IRRIT Image of Target Through 4.96-mil Deft Self-Priming Topcoat, Flat Light Gray

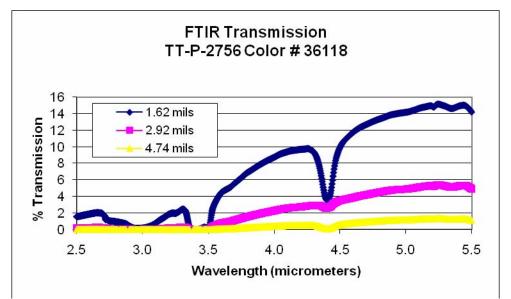
Figure L-20: FTIR Transmission Through Deft TT-P-2756 Type I Self Priming Top Coat, Flat Dark Gray 36118

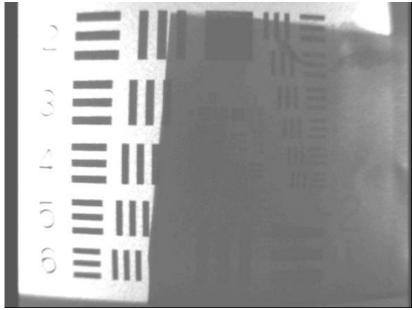
Figure L-21: IRRIT Image of Target Through 1.62-mil Deft APC Topcoat, Flat Dark Gray

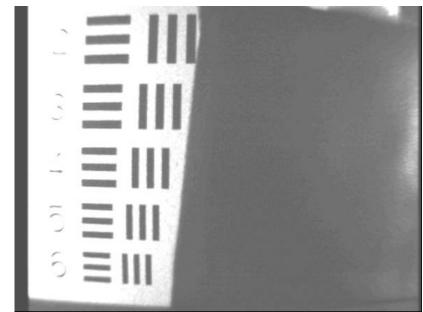
Figure L-22: IRRIT Image of Target Through 2.92-mil Deft APC Topcoat, Flat Dark Gray

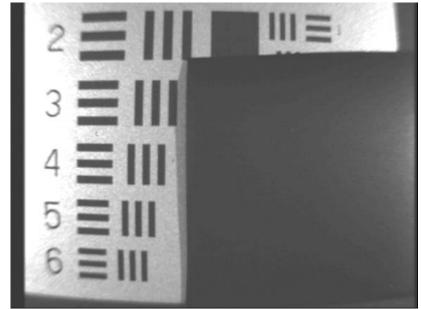
Figure L-23: IRRIT Image of Target Through 4.74-mil Deft APC Topcoat, Flat Dark Gray

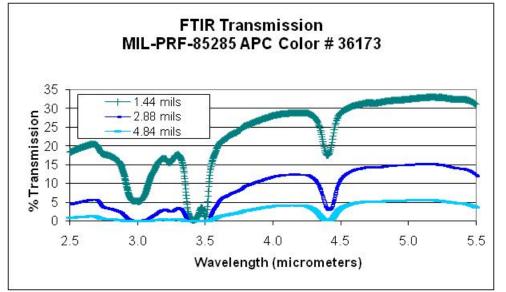
Figure L-24: FTIR Transmission through Deft APC Topcoat, MIL-PRF-85285 Type I, Flat Medium Gray 36173

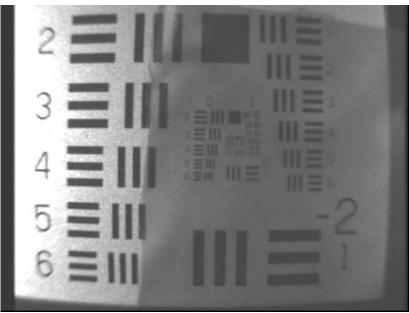
Figure L-25: IRRIT Image of Target Through 1.44-mil Deft APC Topcoat, Flat Medium Gray

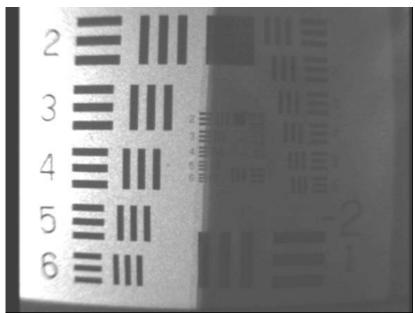
Figure L-26: IRRIT Image of Target Through 2.88-mil Deft APC Topcoat, Flat Medium Gray

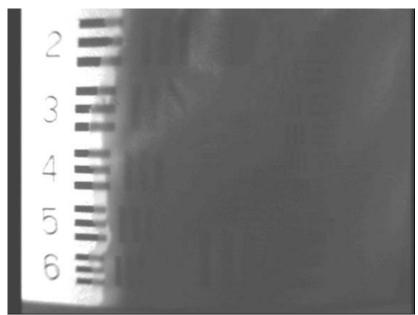
Figure L-27: IRRIT Image of Target Through 4.84-mil Deft APC Topcoat, Flat Medium Gray

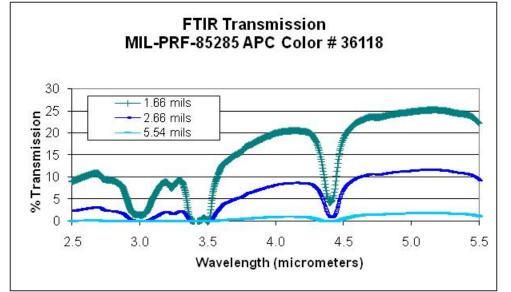
Figure L-28: FTIR Transmission through Deft APC Topcoat, MIL-PRF-85285 Type I, Flat Dark Gray 36118

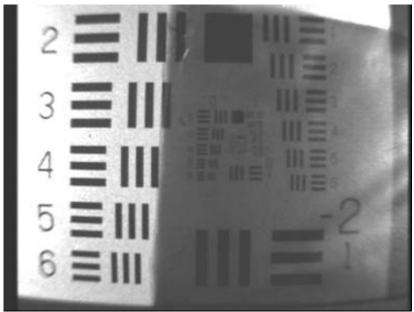
Figure L-29: IRRIT Image of Target Through 1.66-mil Deft APC Topcoat, Flat Dark Gray

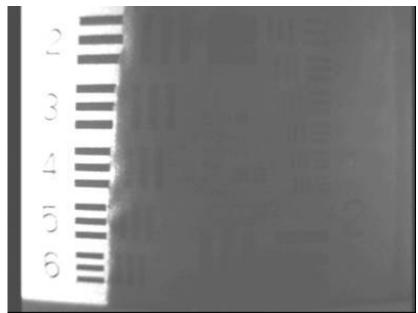
Figure L-30: IRRIT Image of Target Through 2.66-mil Deft APC Topcoat, Flat Dark Gray

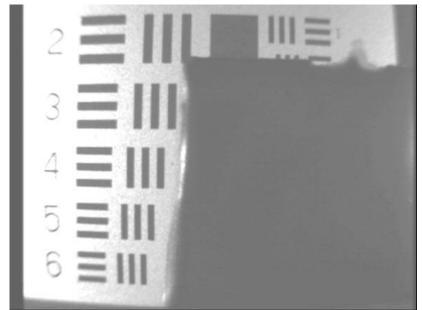
Figure L-31: IRRIT Image of Target Through 1.66-mil Deft APC Topcoat, Flat Dark Gray

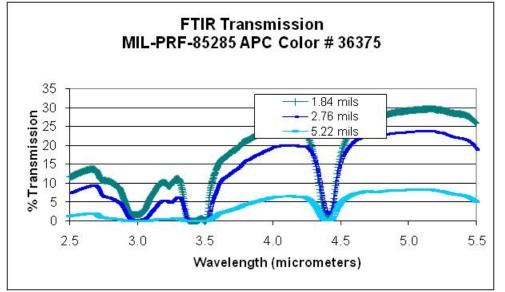
Figure L-32: FTIR Transmission Through Deft APC Topcoat, MIL-PRF-85285 Type I, Flat Gray 36375

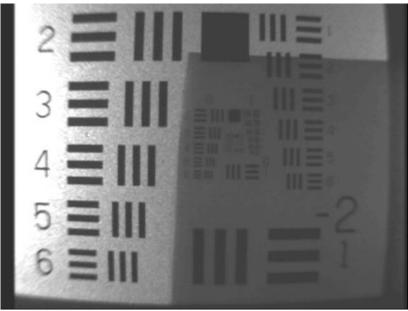
Figure L-33: IRRIT Image of Target Through 1.84-mil Deft APC Topcoat, Flat Light Gray

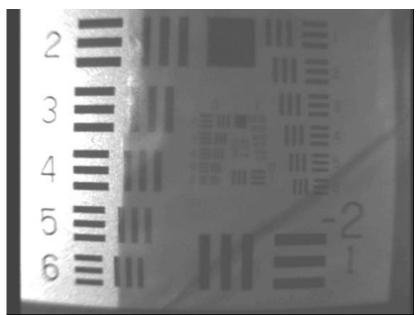
Figure L-34: IRRIT Image of Target Through 2.76-mil Deft APC Topcoat, Flat Light Gray. Note Diagonal Wrinkle in Film.

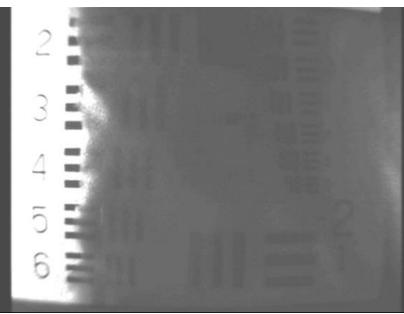
Figure L-35: IRRIT Image of Target Through 5.22-mil Deft APC Topcoat, Flat Light Gray

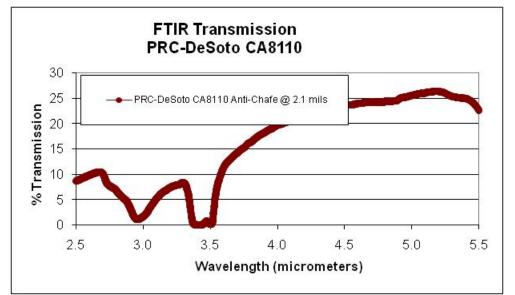
Figure L-36: FTIR Transmission PRC-DeSoto Anti-Chafe Coating, Flat Light Gray

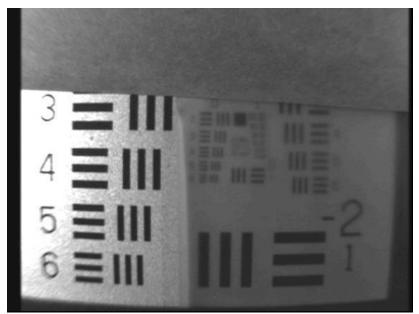
Figure L-37: IRRIT Image of Target Through 1.62-mil PRC-DeSoto Anti-Chafe Coating, Flat Light Gray (Lower Right) and PostItTM Note (Top)

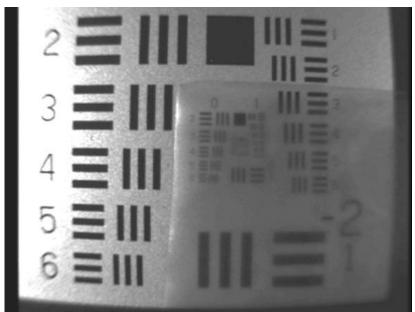
Figure L-38: IRRIT Image of Target Through 2.1-mil PRC-DeSoto Anti-Chafe Coating, Flat Light Gray

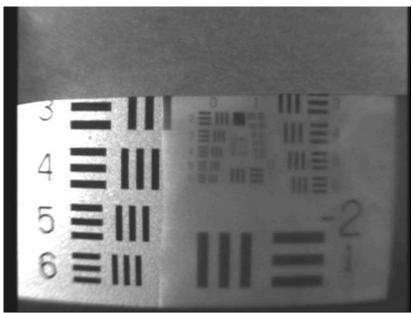
Figure L-39: IRRIT Image of Target Through 2.1-mil PRC-DeSoto Anti-Chafe Coating, Flat Light Gray (Lower Right) and PostItTM (Top)
