## **Component Testing for Modular Pier Replacement at McMurdo Station, Antarctica: Inflatable Pontoons**

Gelbo Flex and Full-Scale Cold Storage/Fold Tests

August 2014

Final Report

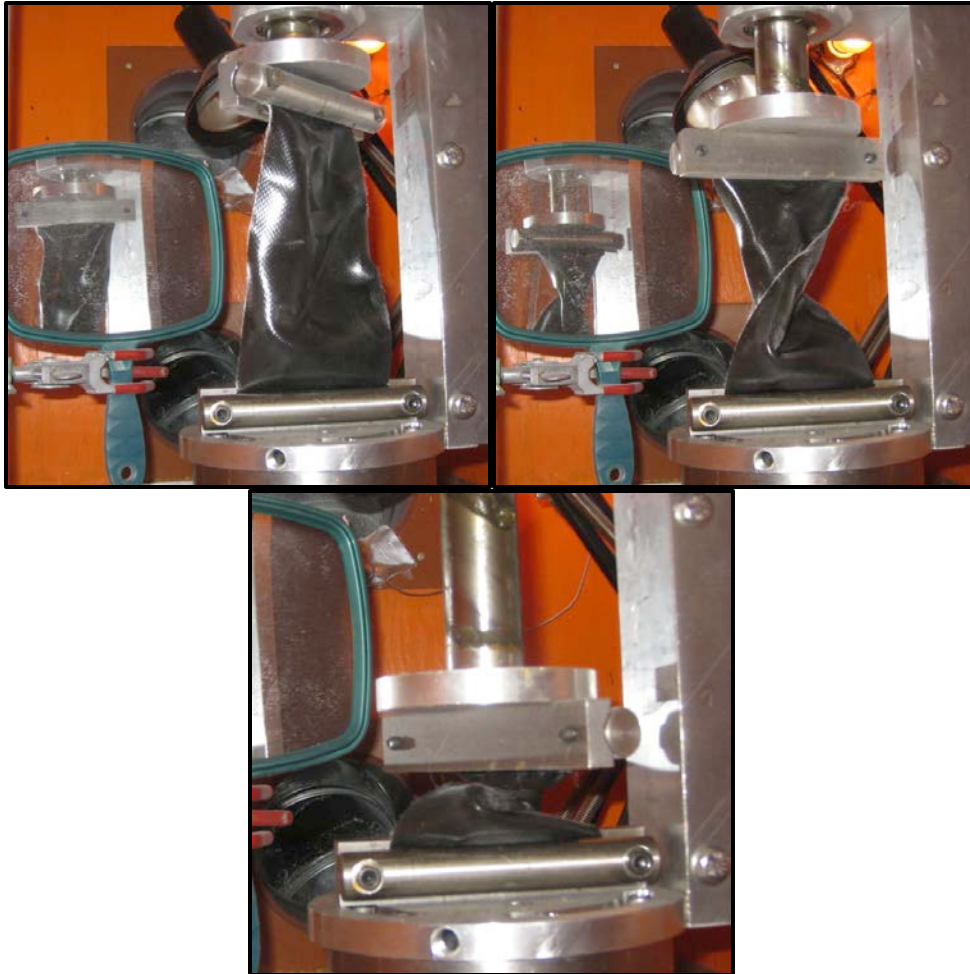
Figure 1. Photo sequence of LMCS pontoon material undergoing Gelbo flex tests at  $-40^{\circ}\text{C}$ . The apparatus imposed a  $440^{\circ}$  rotation during the first 3.5 in. compression, followed by straight compression for 2.0 in. Each cycle took 2 s to compress the specimen and 2 s to reverse the motion (4 s total cycle time). A mirror allowed visual inspection of the back of the specimen without removing it from the apparatus.

The Gelbo test imposed a combined  $440^{\circ}$  rotation and 5.5 in. compression on the fabric specimens to “condition” them. All specimens were 3.5 in. wide with an approximate gage length of 6 in. The resulting flexing and folding was more severe than we expect will be imposed on pontoons during handling, transport, folding, and use as part of the LMCS system at McMurdo Station. We ran up to 1510 cycles (4 s duration per cycle) on the pontoon fabric specimens and assessed them at 500-cycle intervals for cracks, delamination, or other visual evidence of failure (Figure 1).

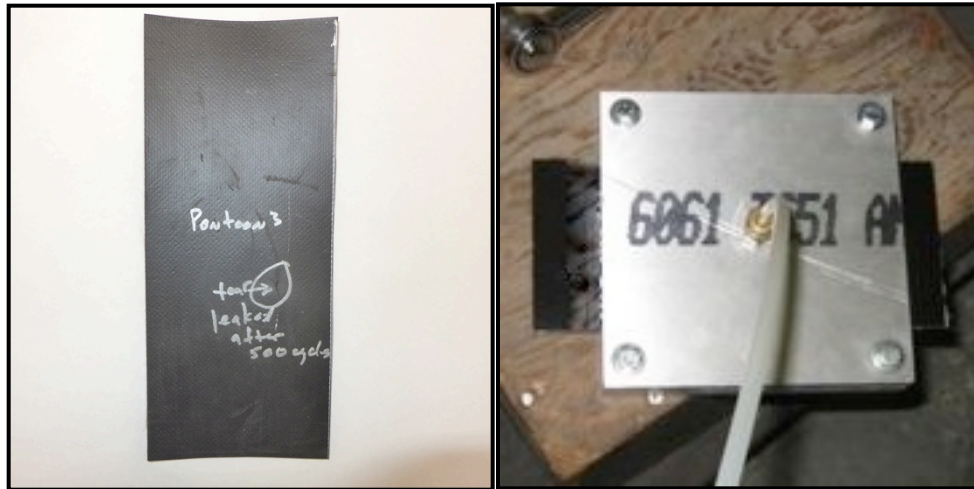
Figure 2. After conditioning material specimens in the Gelbo flex apparatus for a number of cycles, we removed and inspected them for cracks (left) and then clamped over the cracked areas with a leakage-test apparatus to assess failure (right).

ASTM F392 does not specify how to assess the effects of flexing on the specimens. We chose to use visual inspection followed by an air-permeability test to assess relative flex durability. After conditioning, we visually inspected each specimen for signs of cracking or delamination of the coating from the embedded woven fabric. We marked such regions on the specimen and then conducted a check for air leakage at room temperature. The leakage-test apparatus consisted of two aluminum disks with embedded O-rings, with the upper disk connected to an air reservoir. After pressurizing with air, we sealed off the air reservoir and monitored disk pressure over several minutes to assess the leakage rate (Figure 2). The difference in leakage rates between intact and cracked specimens was readily apparent.

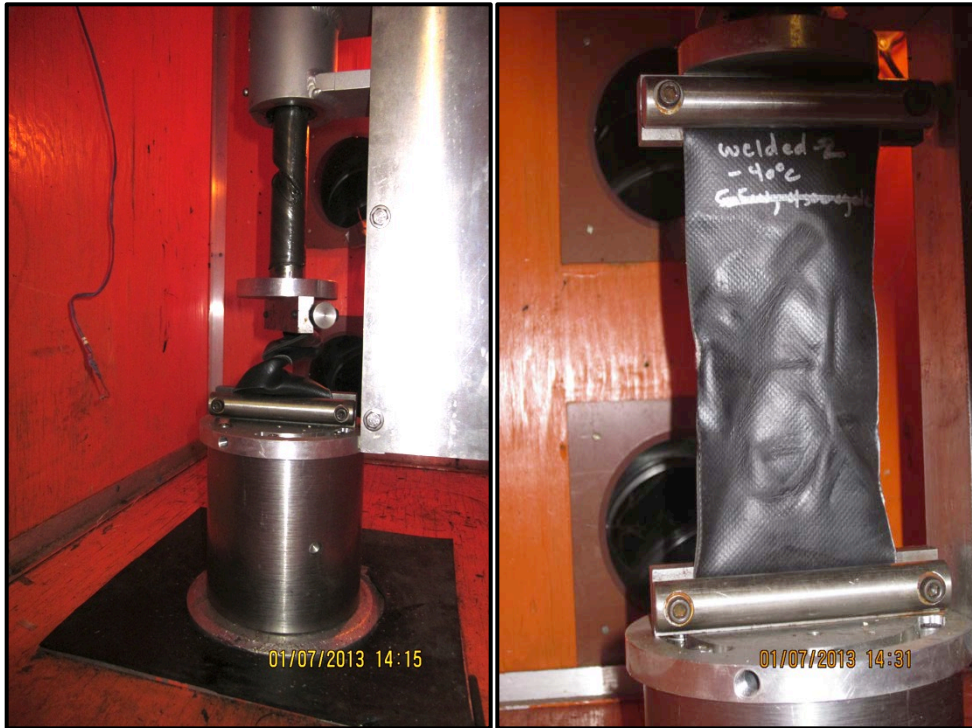
Figure 3. Vulcanized pontoon fabric sample at full compression during Gelbo flex test at  $-40^{\circ}\text{C}$  (left) then at full extension following the test (right). Note folds in the sample following the completion of the tests.

To evaluate the vulcanized samples further and to simulate potential vibration during use and transport, we installed them in the Gelbo apparatus and slowly brought down the crosshead until it had completed its full  $440^\circ$  rotation and 5.5 in. of total stroke (i.e., half a Gelbo cycle) at room temperature. Then we cold-soaked the specimens at  $-40^\circ\text{C}$  and programmed the MTS machine to cyclically execute  $\pm 0.5$  in cycles at 0.5 s periods (4.5–5.5 in. stroke range at 2 Hz) for 10,000 cycles. Table 1 presents the results for all Gelbo-related tests.

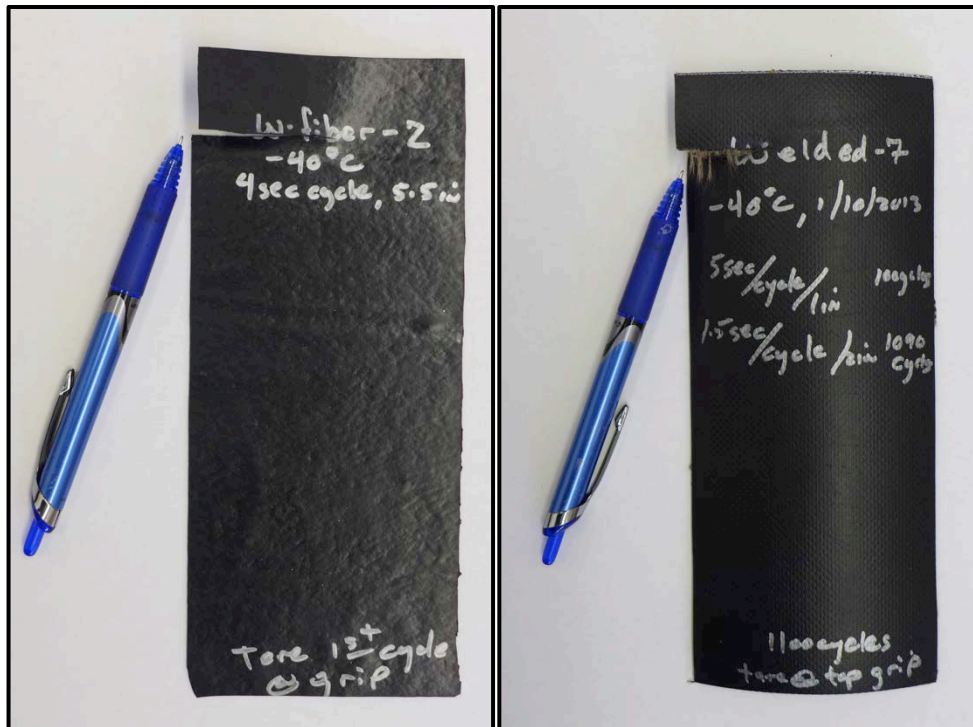
Figure 4. Tears in the gum-sheet (abrasion) material (left) and the vulcanized (welded) compound (right) resulting from a failure at grip location during Gelbo flex tests at  $-40^{\circ}\text{C}$ . Note that these failures were likely due to stress concentrations caused by extreme edge-effect conditions of the test procedure and not from folds imposed by the Gelbo test.

The LMCS pontoon fabric (samples Pontoon-1 to 3) fared well in the extreme Gelbo tests with only the third sample developing a crack, which leaked after 510 cycles. The gum sheets (Fiber-1 and Fiber-2) tore immediately at the grip locations (Figure 4). Two of the vulcanized fabric (gum sheet bonded to pontoon fabric) tore at the sides, likely due to edge-effects from the test apparatus (Figure 4), during the complete Gelbo cycle tests; but none of the specimens developed leaks in the central part of the sample and none of the bonded fabrics developed tears or leaks during the rapid cycling, minimal compressive tests.

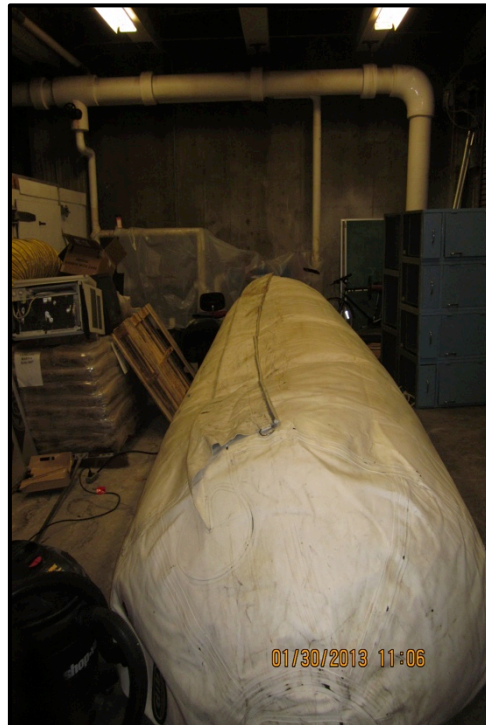
Figure 5. The LMCS pontoon as delivered to CRREL and partially inflated prior to leak identification and patching.

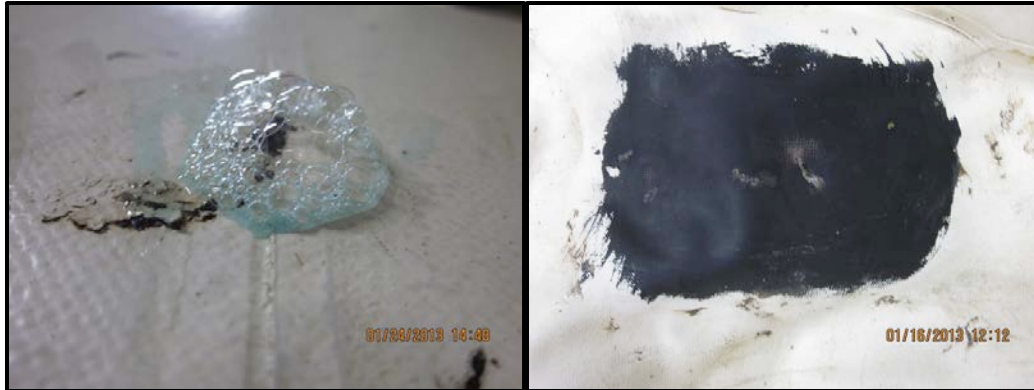
Figure 6. Bubbles forming above a small leak in a thumbnail-sized arc (left), and 2 large gouges at the center of a section prepared for patching (right). The gouges on the right are each approximately the size of a quarter, and the entire prepared area is approximately 8 × 6 in.

CHL and GSL made a full-scale pontoon available to CRREL for testing. The objective of these tests was to determine whether the folding, cold storage, unfolding, and inflation sequence would have the potential to cause cracking or leaks in the fabric or fabric joint welds. Upon receiving the pontoon, we inflated it and determined that there were 5 leaks caused from prior use as the pontoon was taken from a prototype LMCS that had undergone extensive field testing (Figure 5). Once we identified 4 of the 5 locations using a soap-bubble product and, based on leak rates (rate of bubble production), the relative sizes of the damage, we determined that only the fifth site (identified visually and audibly) was large enough to require patching (Figure 6).

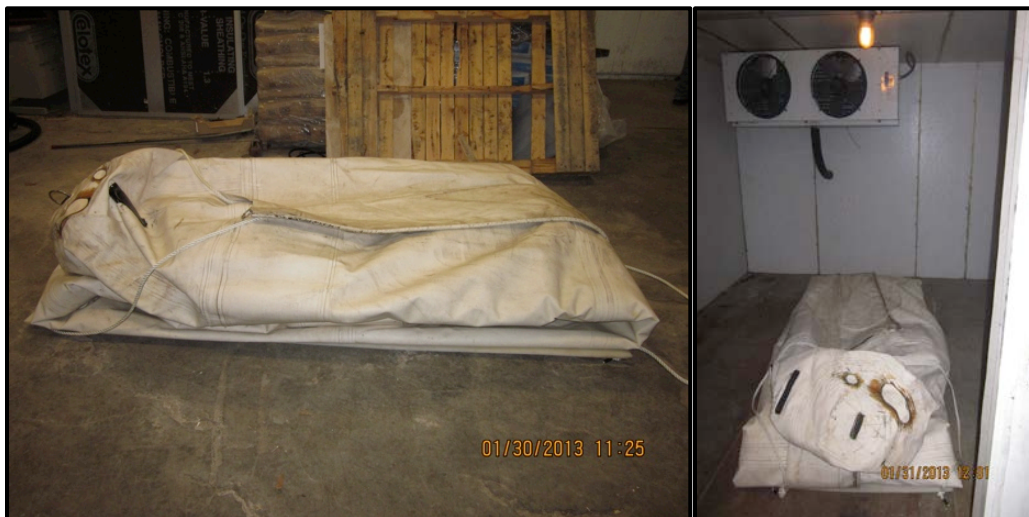
Figure 7. LMCS pontoon tri-folded in 2 directions (left) and ready for cold cycling at  $-40^{\circ}\text{C}$  in CRREL's basement cold room (right).

The test plan called for the 25 ft long × 5 ft diameter pontoon to be tri-folded longitudinally and then tri-folded transversely and stored in a cold room for 24 hr at  $-40^{\circ}\text{C}$  (Figure 7) prior to unfolding and immediate inflation outdoors. We conducted ten folding–cold storage–unfolding–inflation test cycles during the New Hampshire winter (between 25 January and 13 March 2013) to best represent the summer daytime temperatures at McMurdo Station. Our previous material-testing experiences helped determine the recommended timeframes for cold soaking the pontoon and subsequently inflating the pontoon and letting it rest outdoors to equilibrate and to provide sufficient pressure data to determine whether leaks were present. We selected a minimum cold soaking period of 24 hr and a minimum inflation period of at least 2 diurnal cycles.

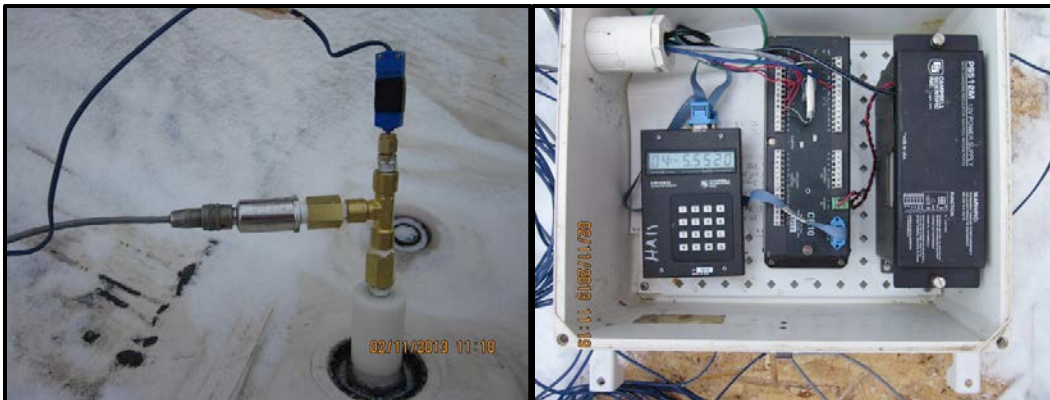
Figure 8. Pressure transducer and thermocouple instruments fitted to the pontoon's pressure relief valve (left) and data monitoring system that measured and recorded the internal pontoon temperature, the external (ambient) air temperature, and the pontoon (gauge) pressure (right).

We calculated and compared the rate of air mass loss over time rather than reporting only the internal air pressure because the pressure reflected temperature swings (particularly the diurnal swings while the pontoon was outside) while potentially masking the volume of air leakage. To calculate air mass loss, we designed and constructed a data monitoring system that measured and recorded the internal pontoon temperature, the external (ambient) air temperature, and the pontoon gauge pressure and fitted the instruments to the pontoon's pressure relief valve (Figure 8). In this test, it was reasonable to assume the ideal gas law applied to a fixed volume of air because the pontoon fabric was not designed to expand or shrink and the relative diurnal temperature swings were expected to be only  $\pm 20^{\circ}\text{C}$ .

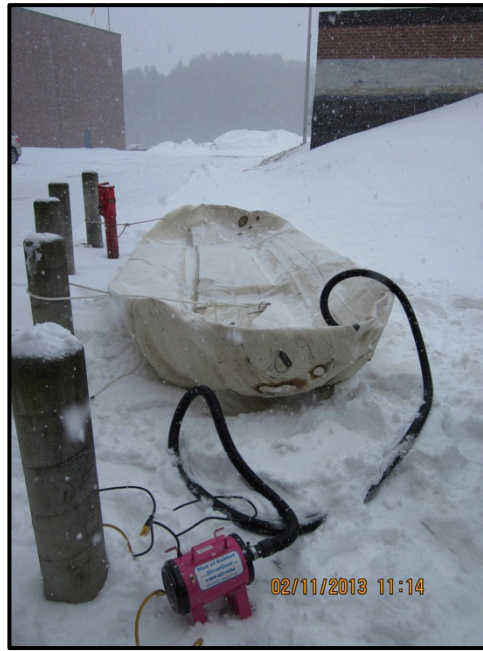
Figure 9. Inflating the LMCS pontoon outdoors during post cold-cycle test 3. Note that instruments are not yet installed in the pressure relief valve at the far end of the pontoon as per Figure 8 above.

We conducted a baseline air mass loss test just outside of the cold room in the basement of CRREL prior to initiating the cold cycling test sequence. We later compared the baseline air mass loss rate with an identical post-test baseline loss rate to determine whether or not the cold cycles and folding and unfolding caused additional damage to the pontoon. We also measured and recorded air temperatures and pressures during the exterior inflations between cold cycles and calculated air mass loss rates during each of those tests (Figure 9).

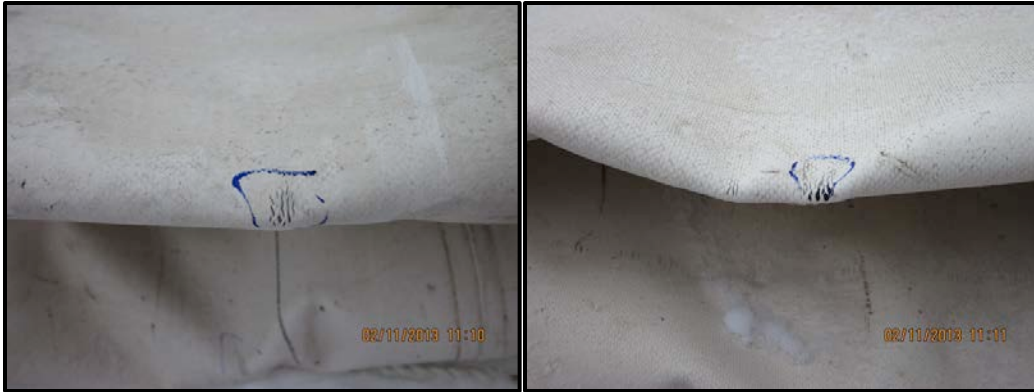
Figure 10. Cracks in the white painted-on coating formed at the “double-fold” points. We identified these cracks while unfolding the pontoon prior to inflation after Cold Cycle #3. Note that cracks in the coating did not affect pontoon performance.

We did find that the white painted-on pontoon coating cracked in fold locations (see Figure 10) during the tests. Note that we attempted to fold the pontoon along the same axes during each cycle to simulate annual cold storage conditions at McMurdo Station. Despite the cracks in the coating, we did not notice any cracks forming in the base pontoon fabric or any increase in size of the existing holes identified prior to the tests.
