*Engineering for Polar Operations, Logistics, and Research (EPOLAR)*

## **Maintenance and Drainage Guidance for the Scott Base Transition, Antarctica**

October 2014

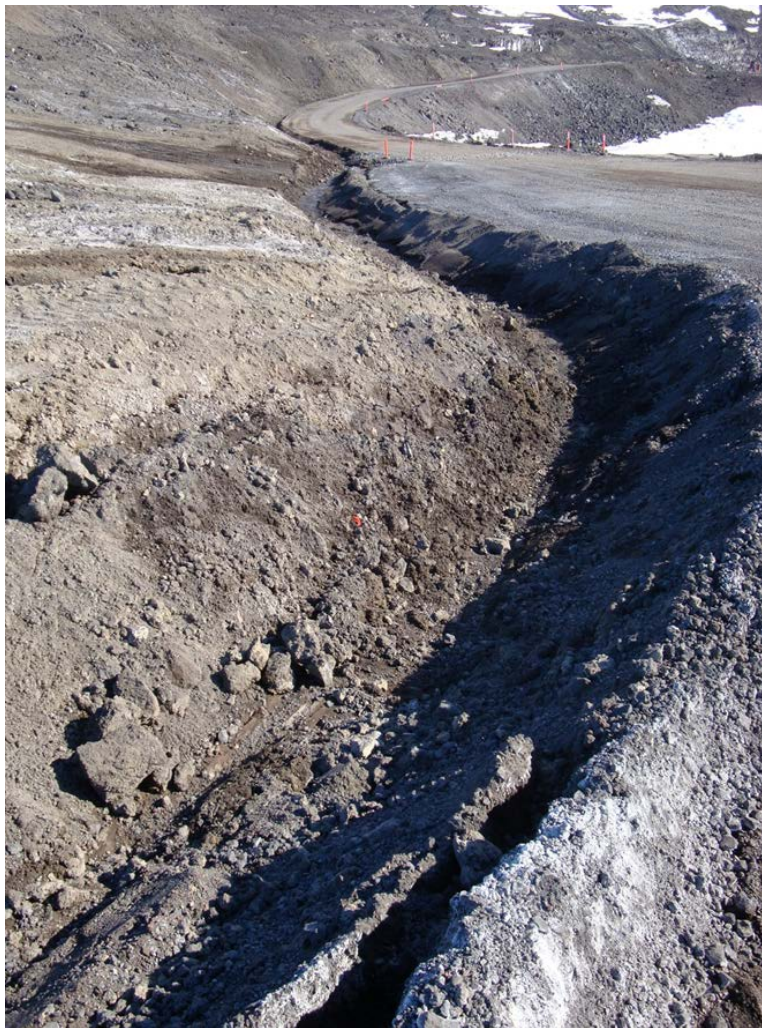
Figure 3. Upslope drainage ditches along the Land Transition of the SBT.

Installing and maintaining drainage structures can mitigate this problem by controlling the flow of water. One type of drainage structure is roadside ditches. Adequately sized and bermed ditches (Figure 3) will prevent water from flowing onto the roadway.

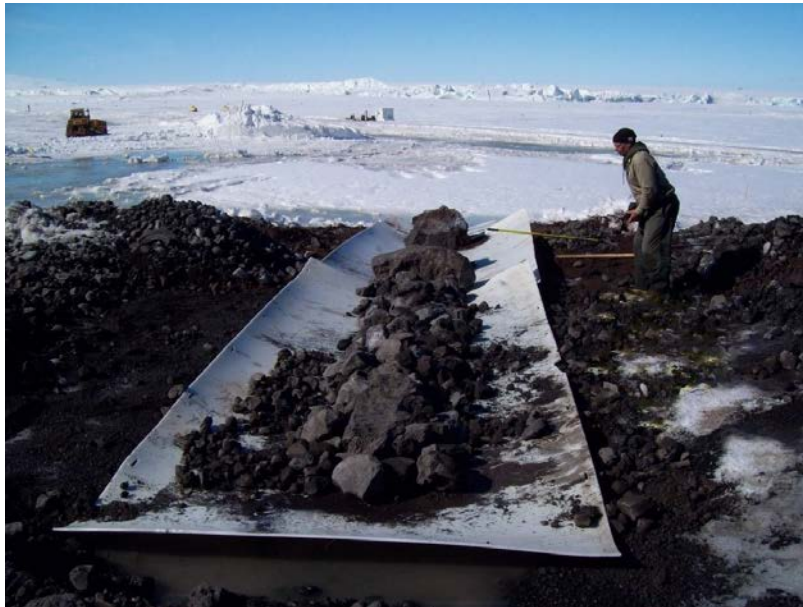
Figure 5. The fines and plastic are installed, and the large rock is placed along the center of the drain.

Figure 5 illustrates how laying 8–12 in. (20.3–30.5 cm) rock on the plastic allows for non-erosive water drainage. The larger rock increases the drain’s lifespan and flow capacity over the 3–4 in. (7.6–10.2 cm) clean-off rock, which easily plugs with silt. Finally, clean-off rock (3–4 in. [7.6–10.2 cm] rock) should cover the plastic and the larger 8–12 in. (20.3–30.5 cm) rock to bring the ditch back to the normal road surface grade.

This AFD successfully drains the water and prevents future subsidence and surface or subterranean erosion that is caused when inferior materials are used. Figures 5 and 6 show the 2010 construction, and Figure 7 shows close-up views of the inflow and outflow sides of a fully constructed, successful AFD.

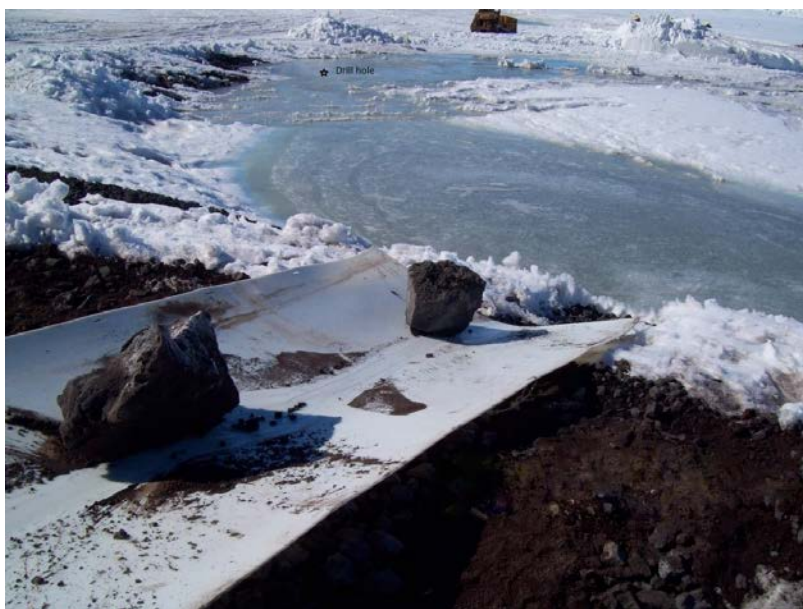
Figure 6. The plastic sheet forms an outlet to protect the Land Transition's side slope from settlement and erosion.

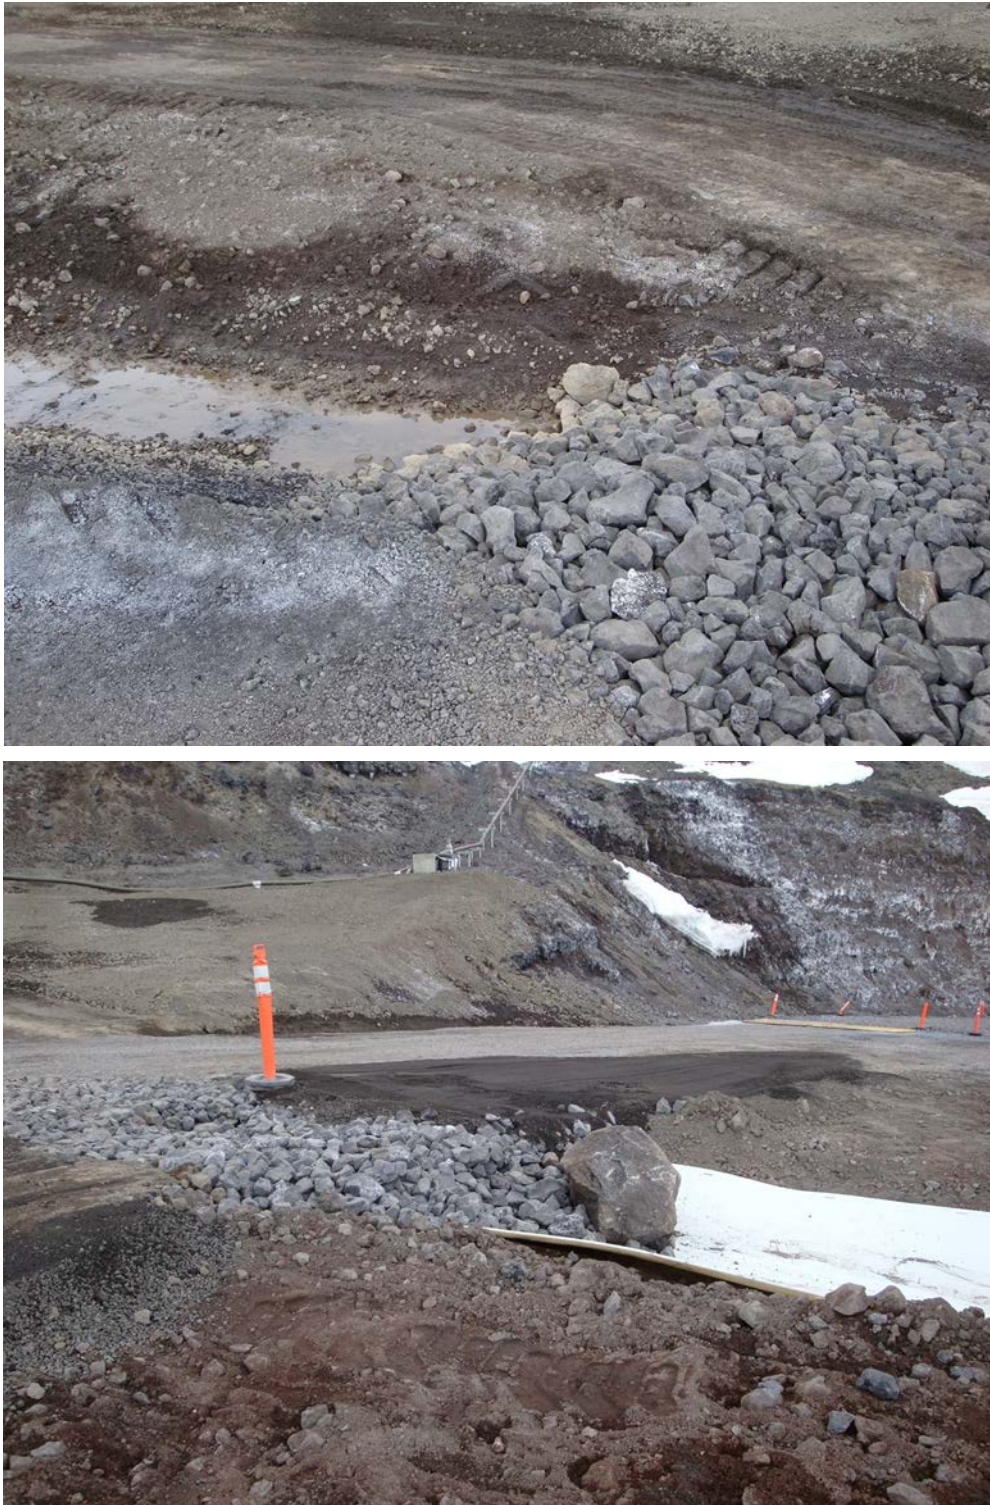
Figure 7. The finished Antarctic drain inflow (top) and outflow (bottom).

The plastic HMW liner should extend beyond the Land Transition road travel lanes on the downslope side to provide erosion protection for the roadside slope at the drain outlet (Figure 7). The side slope tends to crack and settle, and water runoff exacerbates the problem. Whether using a culvert or an AFD, it is imperative to ensure that the outflow is well past the road bed prism or unacceptable erosion and loss of roadway can occur. Two large rocks hold down the plastic for the outlet; the plastic does not need to be covered with smaller rock at the outlet as it is not part of the roadway.

Occasionally, plastic can be used at the roadside slope as a drain outlet to provide erosion control if necessary (as in Figure 7, bottom). In this case, the outlet should be cut deeper than the road trench, sealed with fines, and then laid over with plastic. The fines help prevent it from undercutting. Topping the plastic with large rocks as needed will help keep it in place. The location of these smaller drains should be determined by the location of heaviest flow across the road, which may change from year to year.

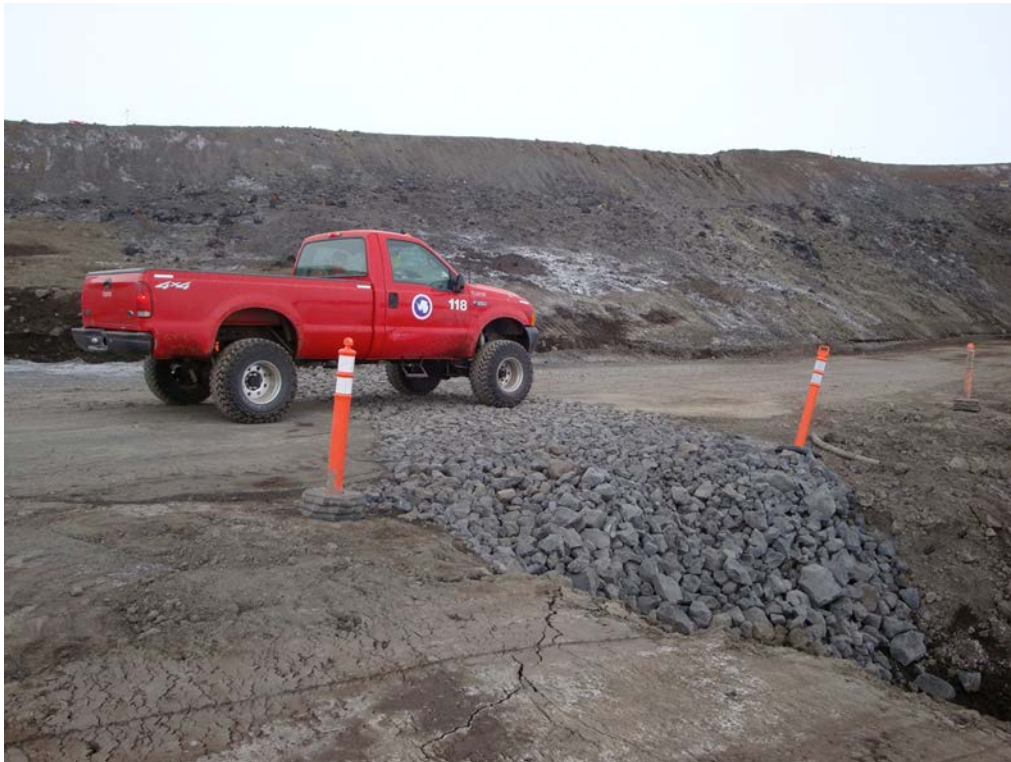
Figure 8. Unlined french drain crossing built with clean-off rock only.

small drainage ditches were cut across the Land Transition road. Traffic crossing these small ditches picked up mud. To fix this problem, transverse trenches 6–8 in. (15.2–20.3 cm) deep and 4 ft (1.2 m) wide were cut with a backhoe and then filled with 3–4 in. (7.6–10.2 cm) clean-off rock (Figures 8 and 9). Fines and HMW plastic are not needed here because the road subbase is solid, impermeable vesicular basalt with no permafrost and is not aggregate and soil over ice as previously discussed with the AFD construction.

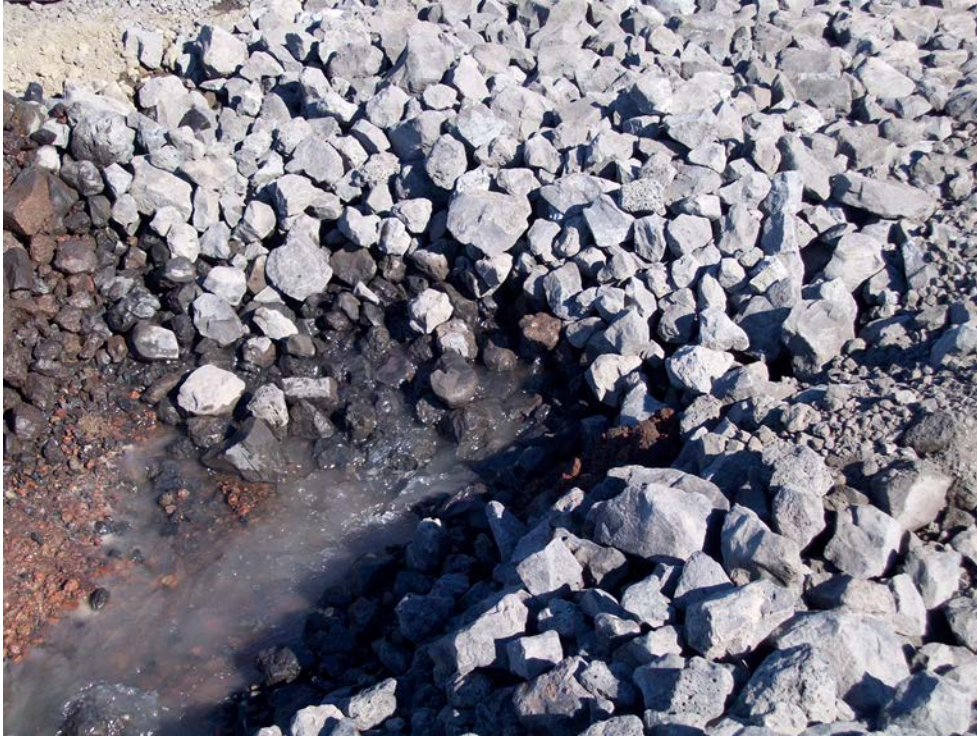
Figure 9. Clean-off rock drain outflow without HWM plastic.

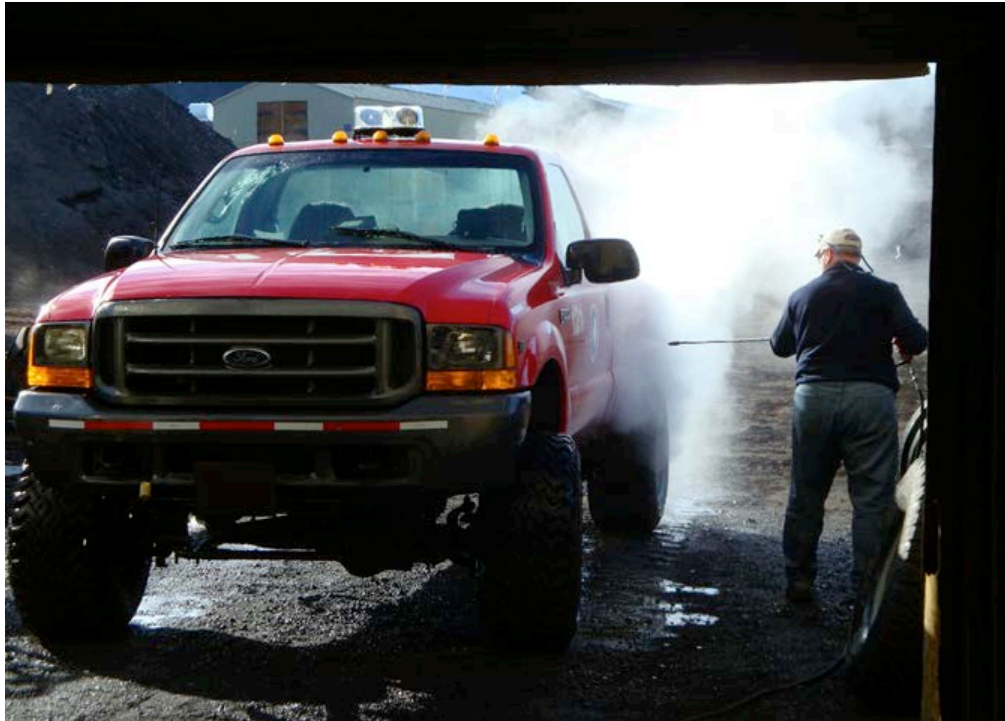
Figure 10. Using a vehicle wash station to keep vehicles clean and well maintained.

1. Any vehicles using the ice shelf should be kept clean at one of the vehicle wash stations in McMurdo (Figure 10). This reduces the wear and tear on the vehicle and keeps dirt off the snow roads.
2. Dust and mud accumulated while driving the McMurdo–SBT Road should be removed at the pull-off vehicle cleaning station before driving onto the ice shelf (Figure 11). Cleaning stations should be maintained and stocked with appropriate tools for vehicle cleaning.

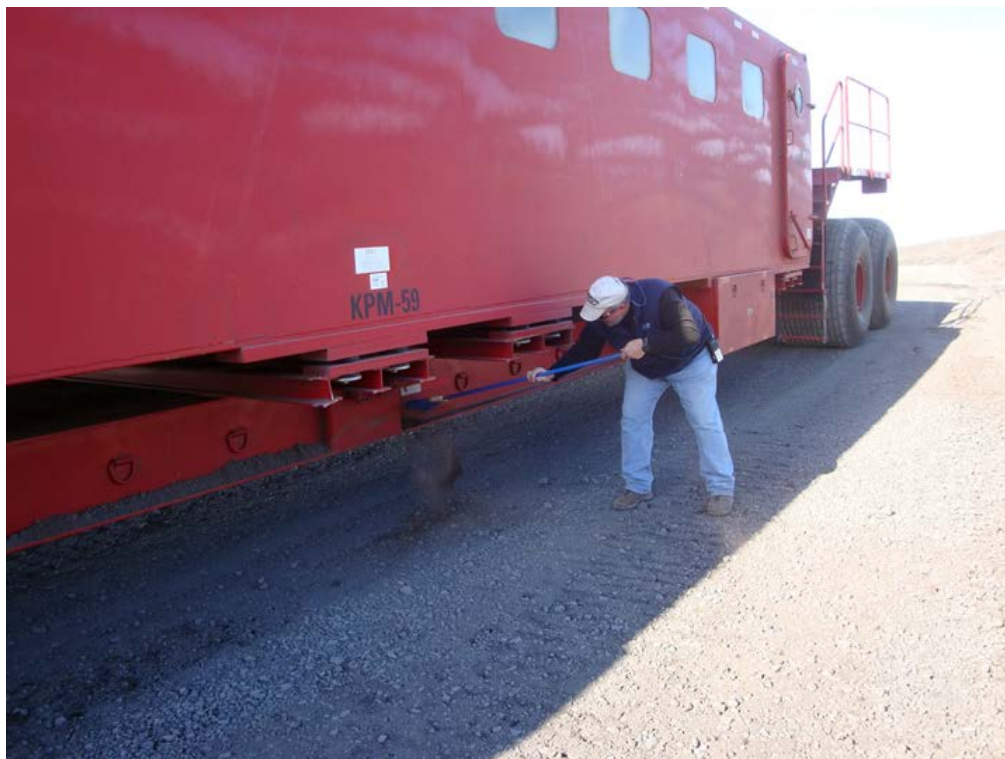
Figure 11. Vehicle cleaning station.

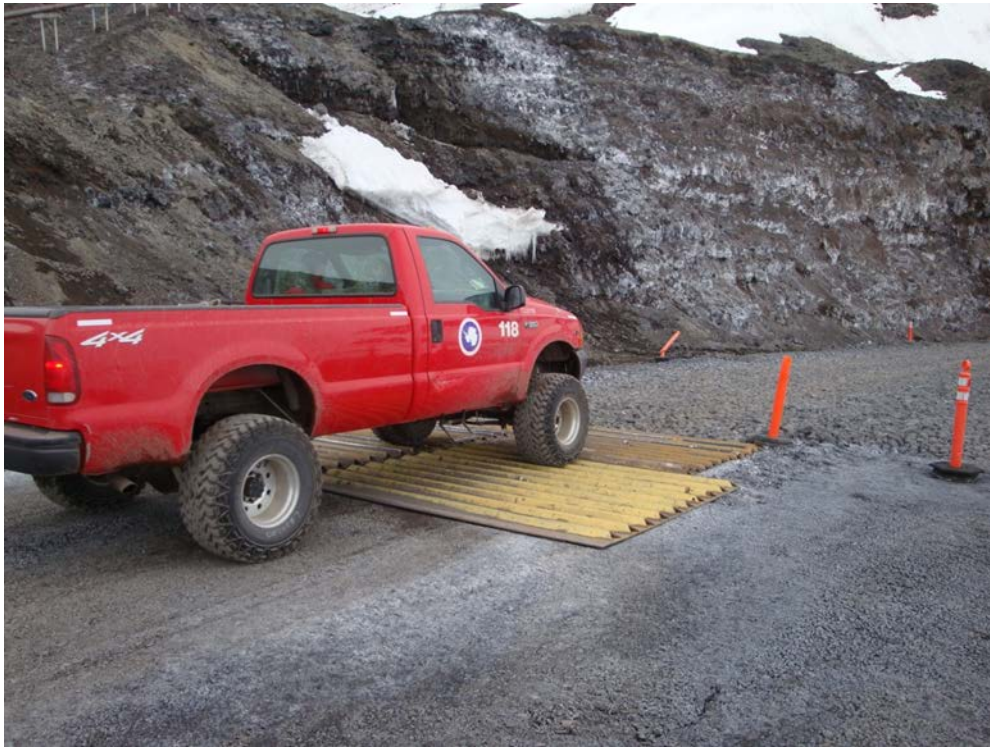
Figure 13. A U.S. Antarctic Program truck crosses the shake plates to clean off debris from the tires and body.

4. Shake plates provide additional vehicle cleaning. We recommend that 40 ft (12.2 m) of shake plate be used along the road (Figures 12 and 13). These plates are 8 ft by 10 ft (2.4 m by 3.0 m) and were originally made of 10 ft by 3 in. (3.0 m by 7.6 cm) angle iron welded in a pleated or corrugated shape. Light wheeled vehicles are required to cross the shake plates before going out onto the ice. Placing the plates near the start of the 100 ft (30.5 m) clean-off rock area but far enough to the right to allow Deltas and tracked vehicles to bypass around the plates (to avoid damage to the tracks or suspension of over-snow vehicles) greatly reduces the amount of dirt tracked onto the Ice Transition.

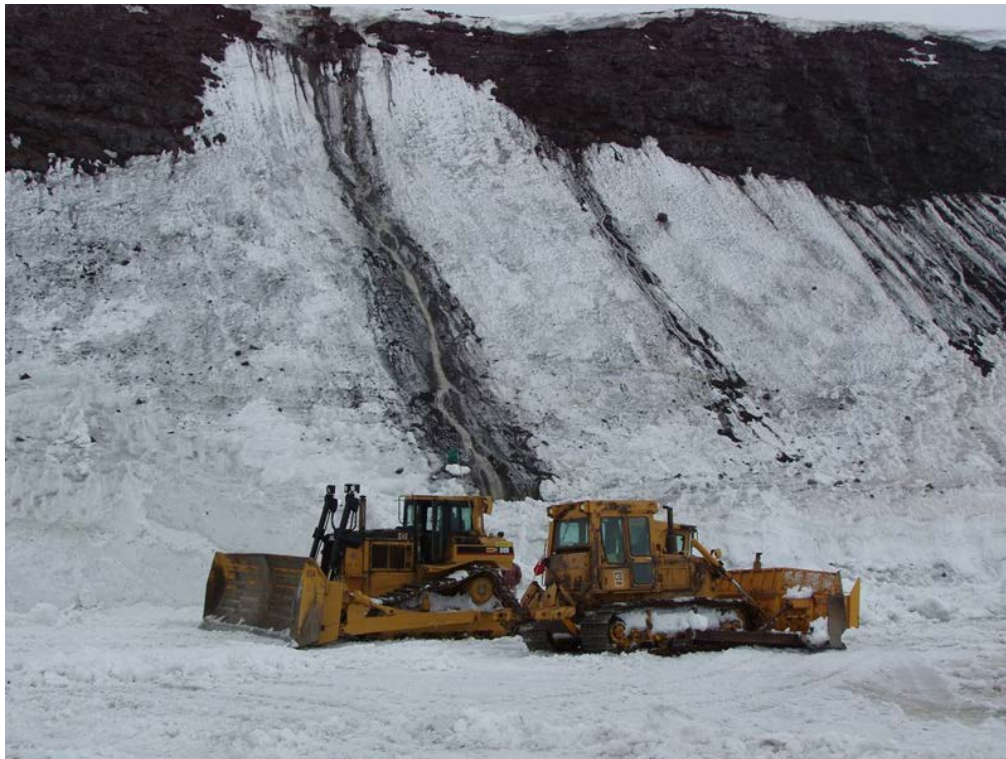
Figure 16. Water runoff down the cliff face.

The water runoff from snow melting on top of the cliff (Figures 15 and 17) is another aspect of water mitigation. In some past seasons, a ditch was cut along the bottom of the cliff; and it flowed to a runoff catch basin or retention pond. This drainage kept water from flowing onto the Ice Transition area. Cutting the ditches deeper may entail digging the catch basin deeper. A laser level or the survey department should determine the slope line and the depth of the ditch's excavation. This ditch could be cut with a D4 (a small bulldozer) or a backhoe. An excavator would be best suited for this project, if available.

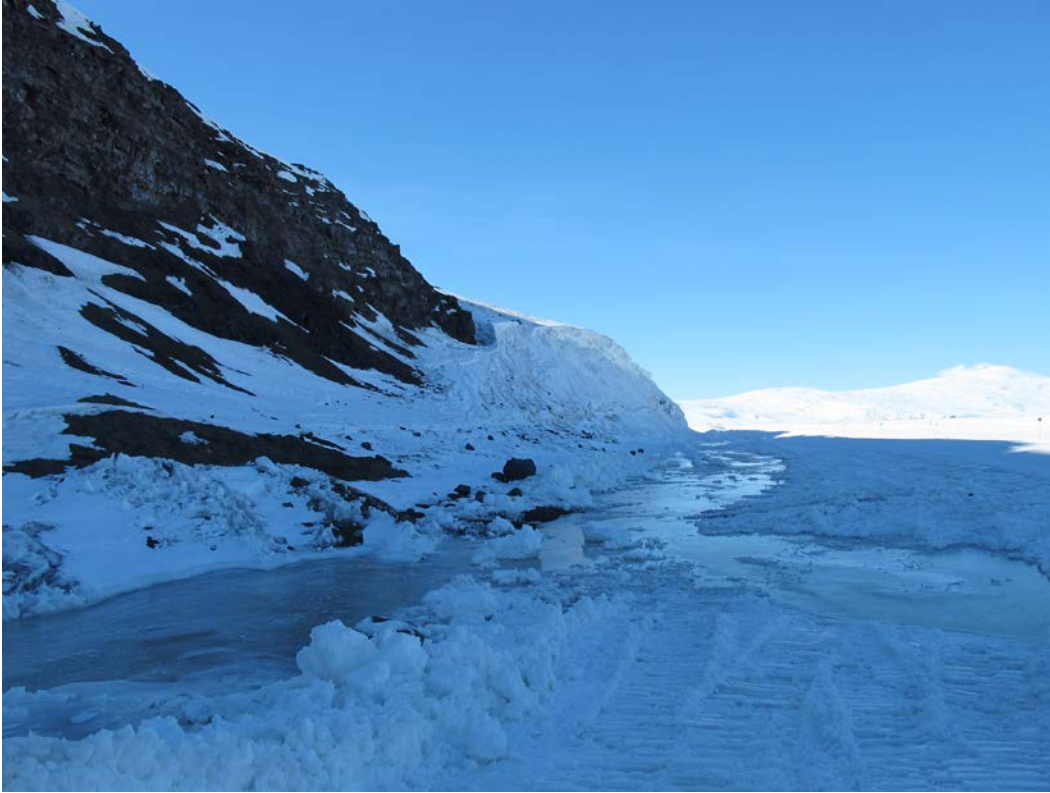
Figure 17. Drainage ditch to catch cliff meltwater.

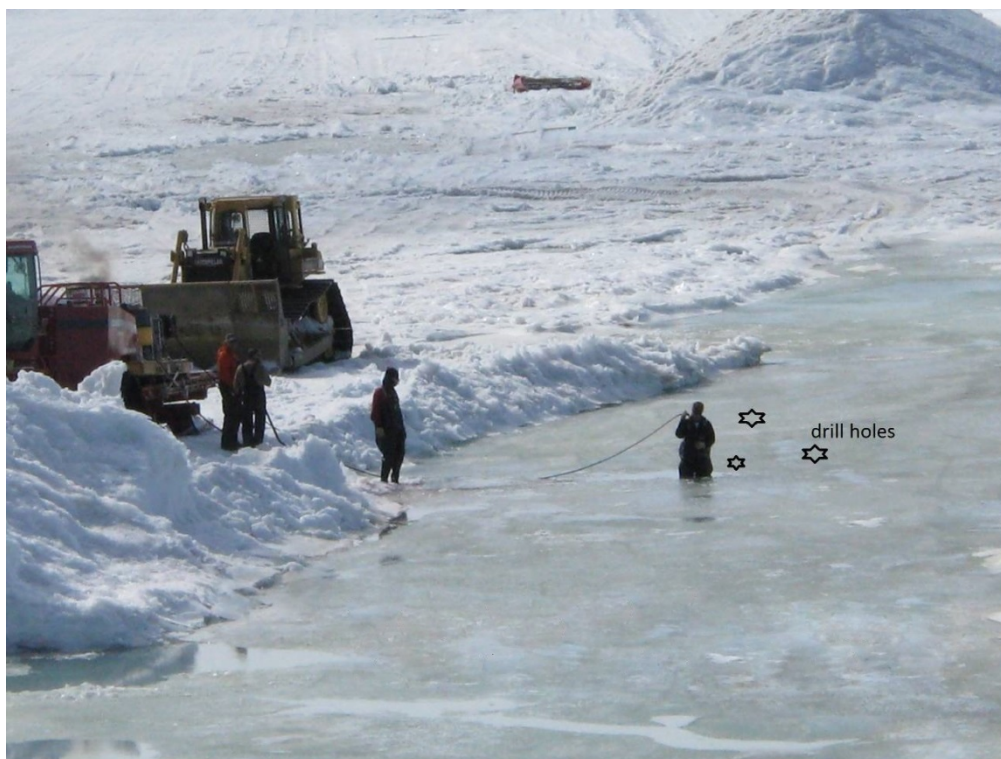
Figure 19. Hot water drilling to drain the retention ponds.

In 2010–2011, two large ponds formed between the Ice Transition and Scott Base. A ditch was trenched from the big ponds to the low area by the Land Transition, forming a single new retention and infiltration pond. During that season, in the new pond that formed at this low point near the fuel line side of the transition, nine holes were drilled 28–30 ft (8.5–9.1 m) deep with a hot water drill (Figure 19). In this case, most of the holes took 15 minutes to drill. After punching through the ice, hitting a crack or void, the water began to drain quickly. It took about a day and a half for the big pond to drain to approximately 20% of its original capacity. Any drill holes and ditches should be located and recorded with GPS and kept on file with the McMurdo survey office. Recording the drill-hole locations and depths over the years provides insight into the structure and behavior of the ice shelf in this area.

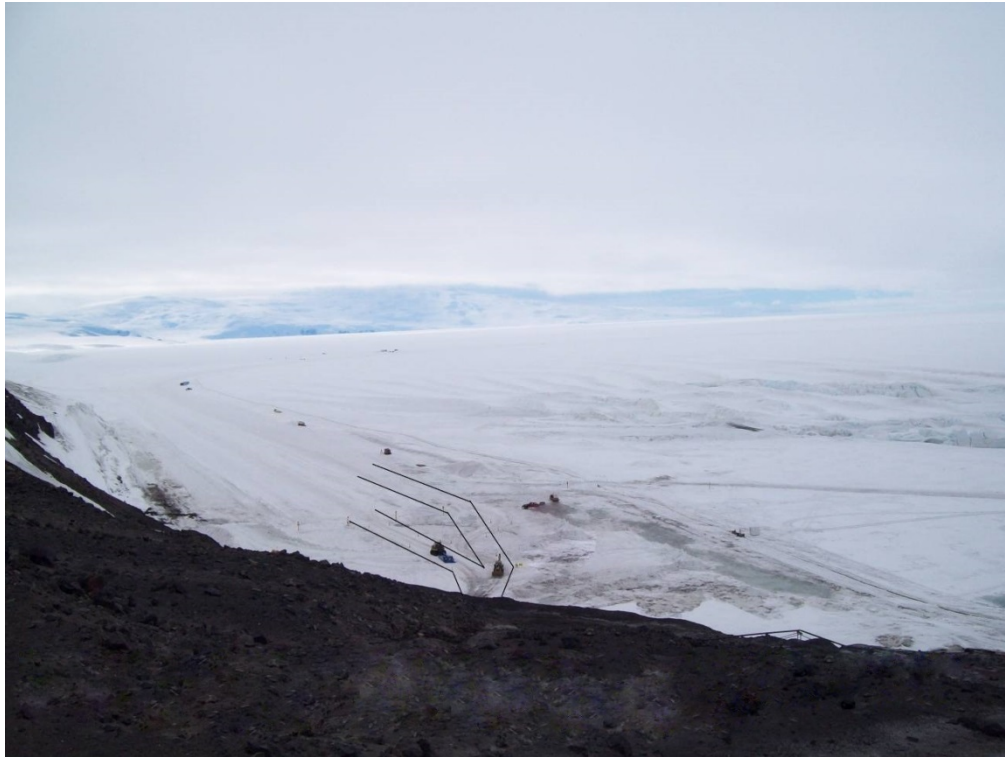
Figure 22. Continued construction during the 2010–2011 season.

Figure 22 shows the reconstruction of the Ice Transition as the first two lanes were worked and the rest of the area was being dewatered. Once these lanes were 100% completed, the rest of the transition was rebuilt.

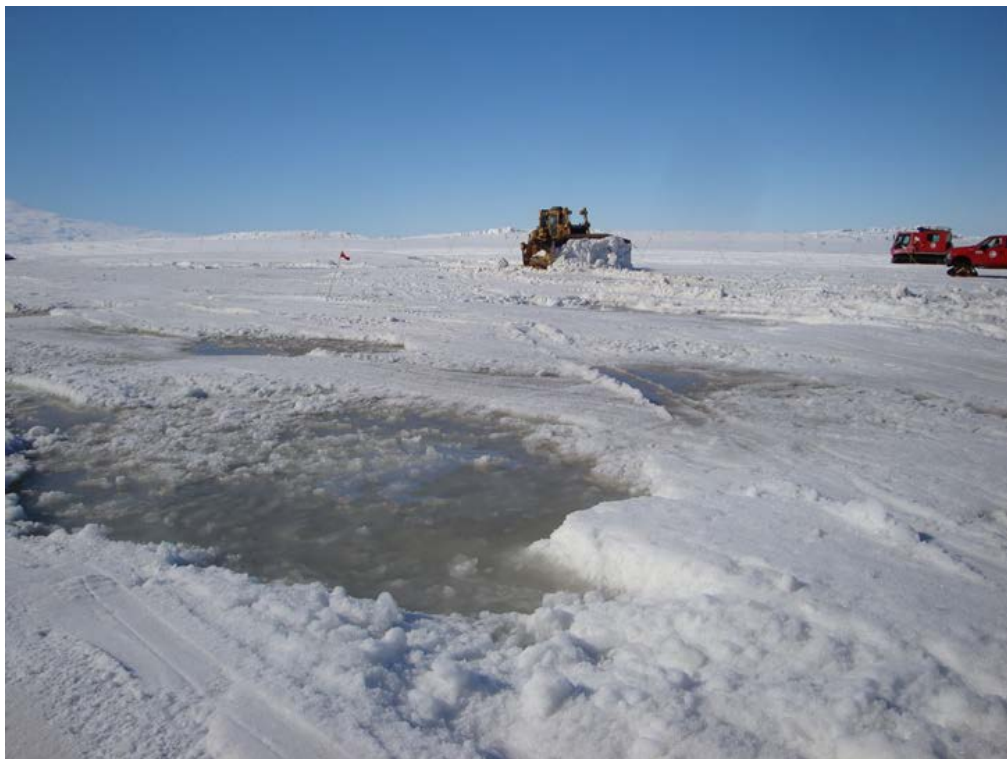
Figure 24. Melt pools requiring maintenance on the Ice Transition.

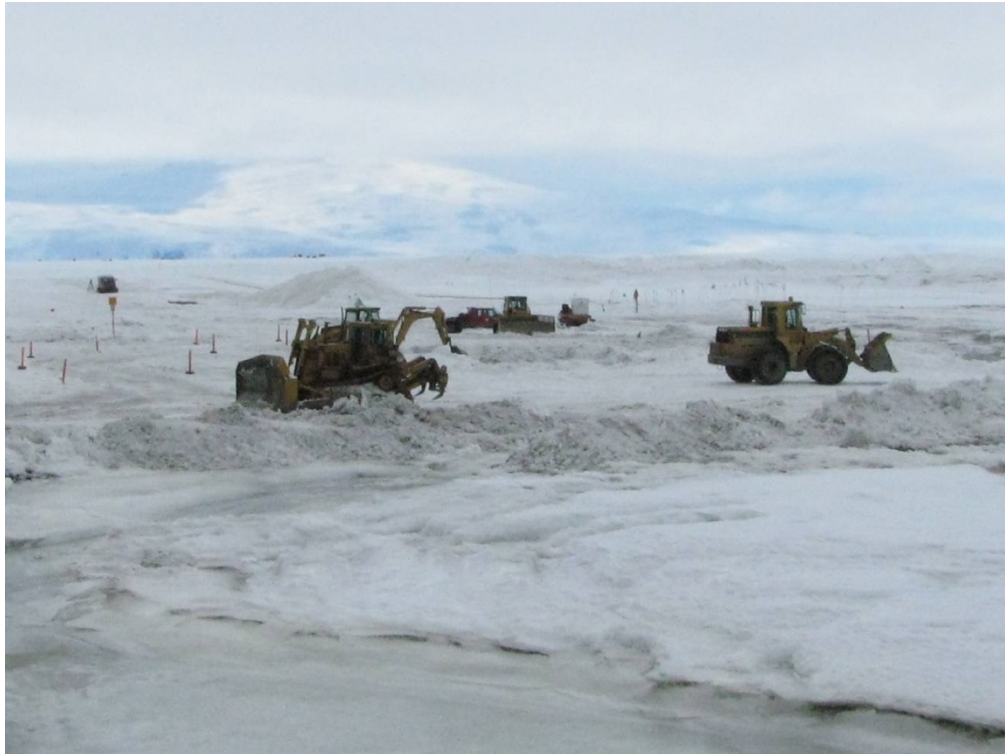
Figure 25. Scraping, ripping, and patching the rest of the Ice Transition after stabilizing the primary lanes.

During this time of clearing and filling melt pools, a ripper helps to break up any ice layers that have formed below the road bed as a result of repeated freeze–thaw (Figure 25). This layer is particularly common on the track vehicle lane where the heavy cargo vehicles compact the snow. These ice layers block the melting snow from percolating downward into the firm. Once the ice layer is broken, mixed, and compacted, additional clean, stockpiled snow can be used to increase the height of the patch. It is ideal to create a patch that is a mix of the colder ice from below and the warmer surface snow, with the patch being above grade by 1–2 ft (0.3–0.6 m). The patch will solidify during the Antarctic summer “nights” when the temperatures drop slightly, and it can be graded level after a couple of days.

Any new holes that appear may require digging out, ripping, and patching with the snow and slush slurry mixture as needed (Figure 25). The new lanes and patched areas can be covered and rolled with new or stockpiled clean snow as available. As discussed by Shoop et al. (2013, 2014), in 2011 and 2012, the clean snow was laid down on the lanes by a Challenger pulling a snow milling machine (the Keweenaw Research Center SnowPaver), which mixed and compacted the road (Figure 26).

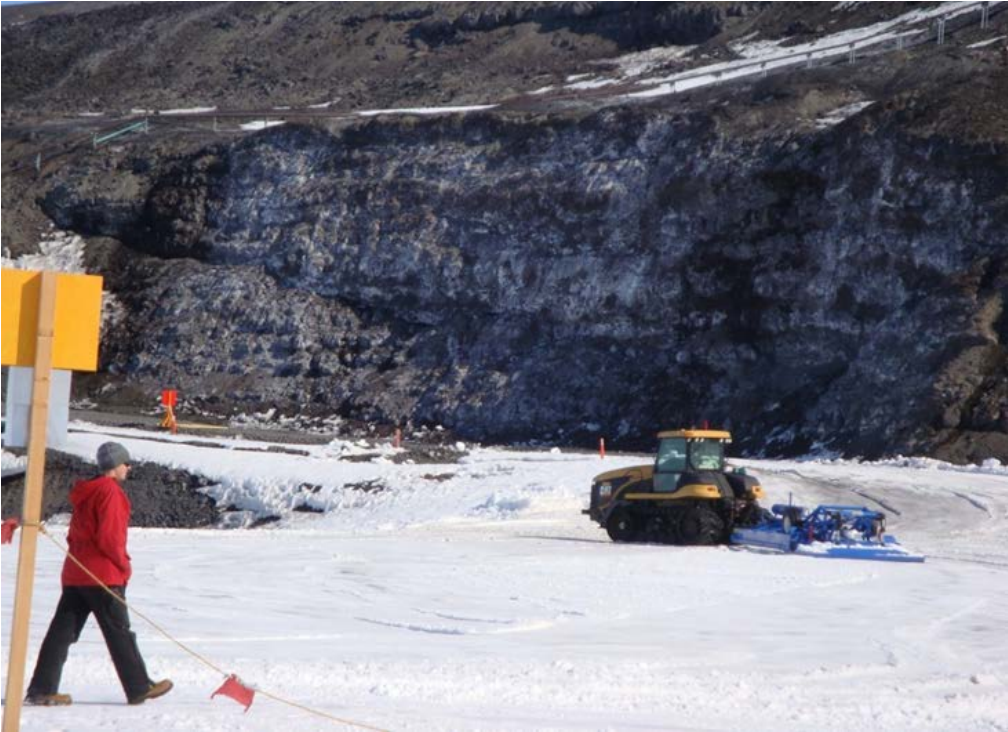
Figure 26. The Keweenaw Research Center SnowPaver mixes and compacts the wet snow at the SBT (January 2012).

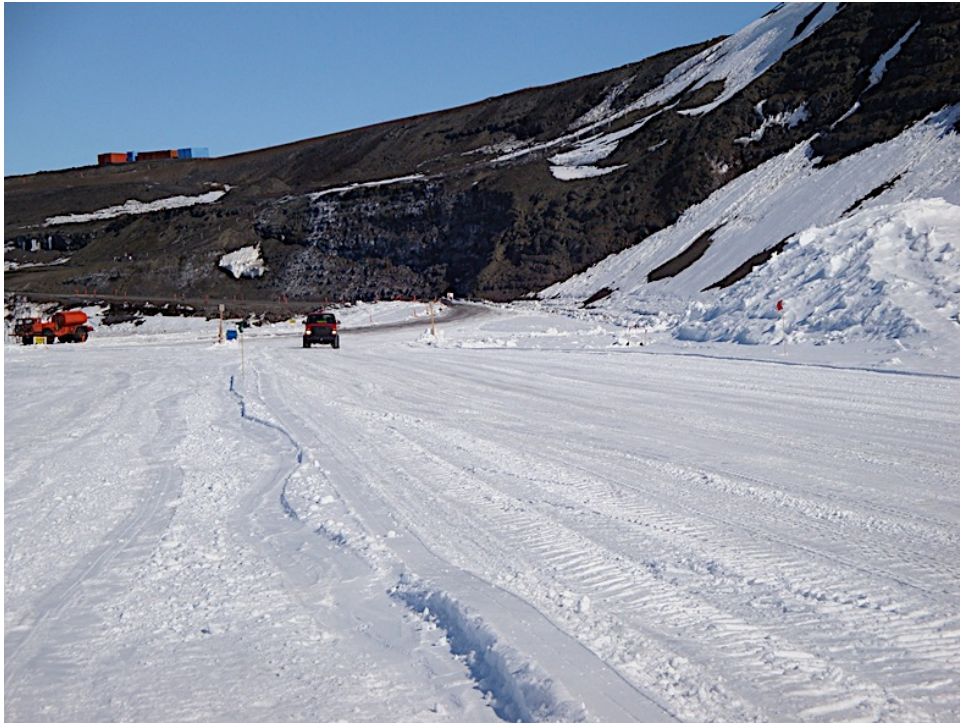
Figure 30. Final results—a nice dry and passable Ice Transition.

Keeping the dirt and debris off the ice is essential for having a solid, well-built Ice Transition roadway section. A properly maintained Land Transition is key to ensuring a clean ice shelf to minimize melting. The final result is a well maintained SBT area that is passable through the melt season (Figures 27 through 30). The melt pools are under control and lanes are open.
