Preliminary Guidelines and Standard Operating Procedure for Drainage and Erosion Control at McMurdo Station

Rosa Affleck and Meredith Carr

December 2014

Under Engineering for Polar Operations, Logistics, and Research (EPOLAR)
EP-ANT-13-04, "McMurdo Drainage Design Solutions"

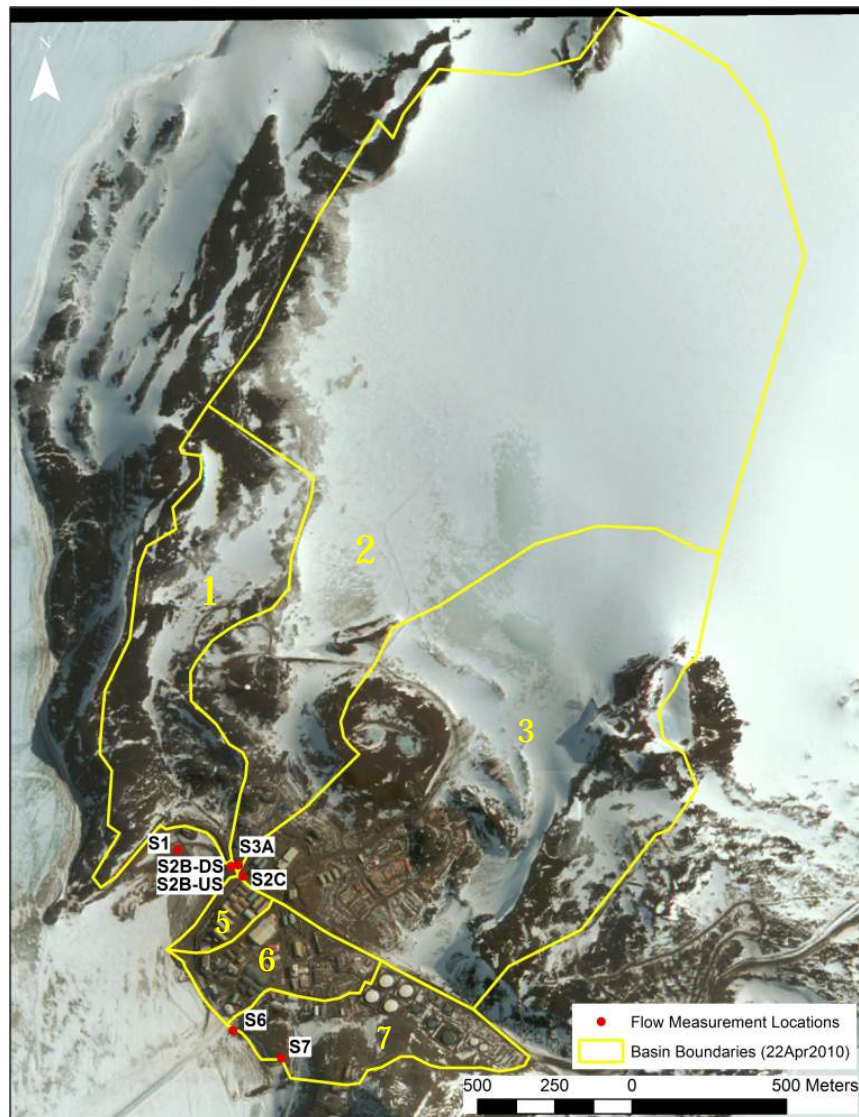
Figure 1. McMurdo Station watershed and sub-basin boundaries (after Affleck et al. 2012a).

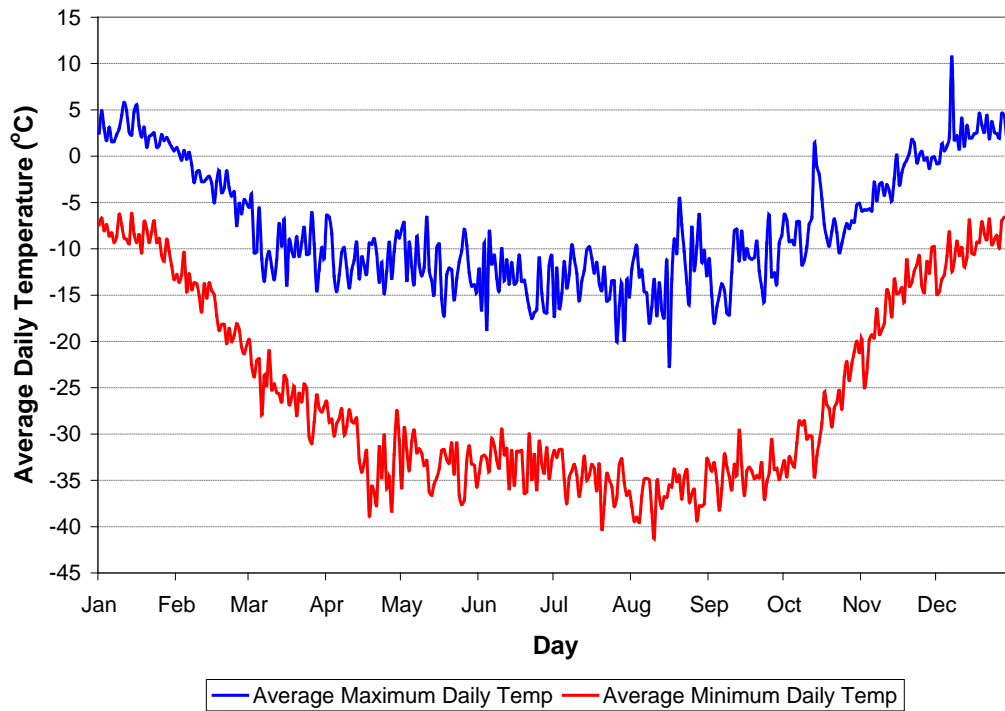
Figure 2. Average maximum and minimum daily temperatures, 1973–2008 (after Affleck et al. 2012a).

The daily air-temperature fluctuations at McMurdo depict several warming events occurring during the summer months (Figure 2). The warming and cooling trends observed in the 2009–2010 and 2010–2011 austral summers reflected these historical trends in temperature variations (Figure 3 shows maximum daily temperature). Warming events can occur as early as the first week of November (see summer 2010–2011) but are most common and have the most significant impact on flow in December and January.

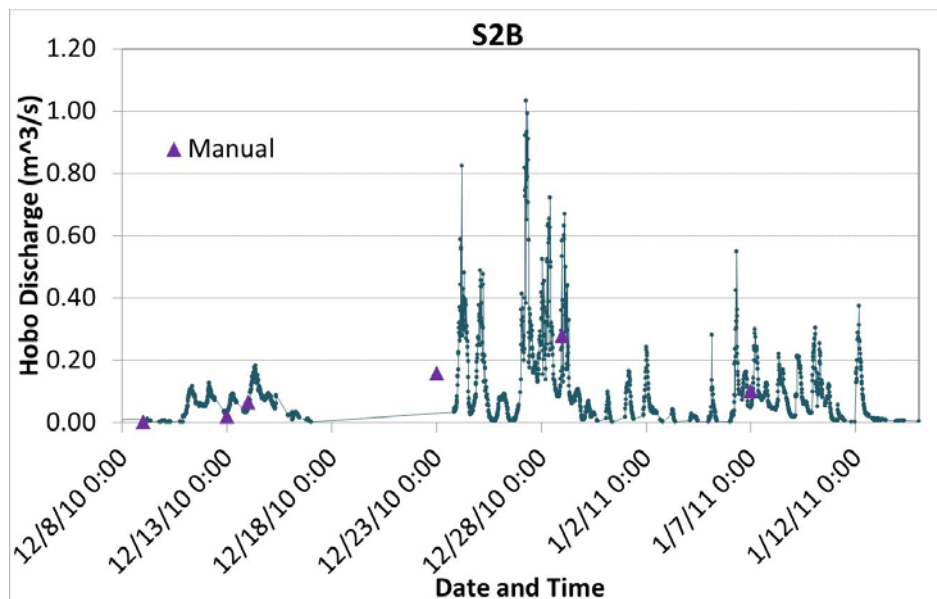
Figure 6. Flow recorded during the 2010–2011 season at location S2B in channel 2BU from Fig. 5 (after Affleck et al. 2014a).

Snowmelt runoff has been observed as it starts to seep out of the surface and appear in the lower channels as early as the third week of November. Flow measurements were conducted during two austral summers: 2009–2010 (Affleck et al. 2012a) and 2010–2011 (Affleck et al. 2014). In general, the continuous flow rate in these critical channels depicted large diurnal variations. Based on the continuous runoff data during the summer of 2010–2011, the measurable runoff data started on 11 December; and then it fluctuated and subsided for days (Figure 6). These patterns continued with varying flow peaks throughout the season. The maximum flow rate at S2C (along Gasoline Alley, channel 2CD in Figure 5) of $0.44 \text{ m}^3/\text{s}$ occurred on 22 December 2010. The estimated maximum flow at S2B (in channel 2BU in Figure 5) of $1.03 \text{ m}^3/\text{s}$ occurred on 27 December 2010 (Figure 6).

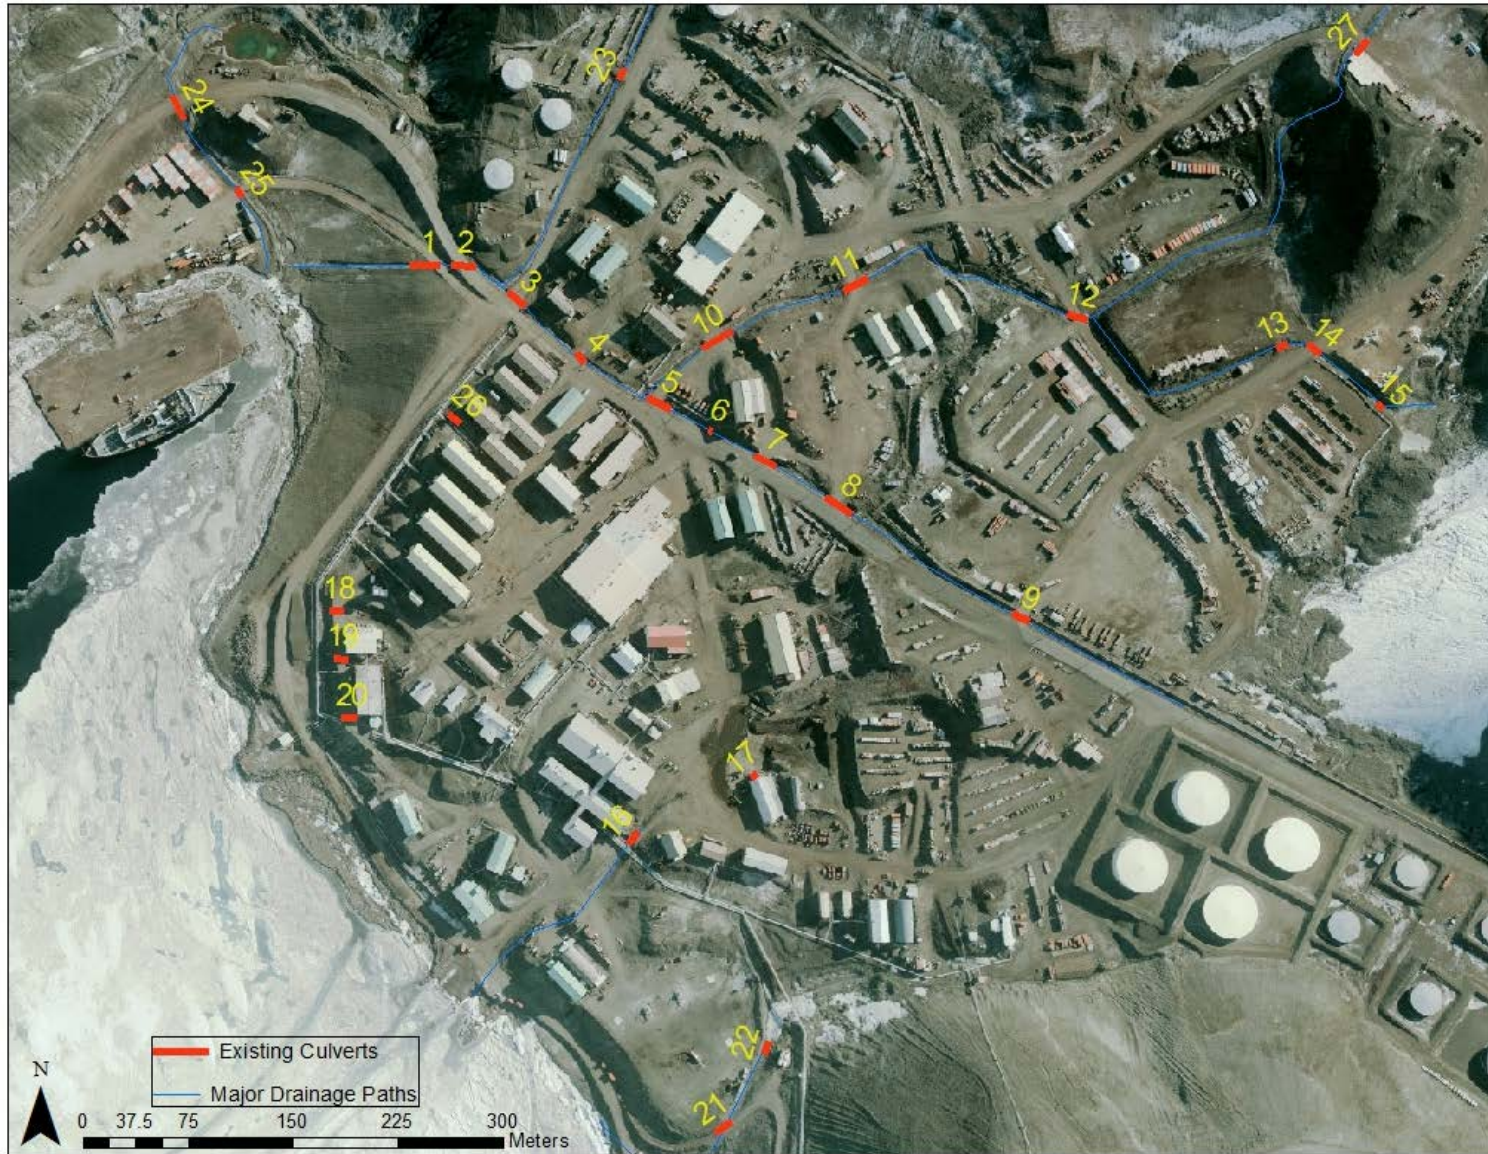
Figure 9. Existing culvert locations.

Table 3 details the Affleck et al. (2014b) study on culvert recommendations specific for particular locations (Figure 9), indicating the size, and information on its conditional capacity as of 2010–2011 information. Further work needs to determine the appropriate culvert replacement type (e.g., metal or plastic or concrete, etc.) and to try to standardize culverts around the Station.

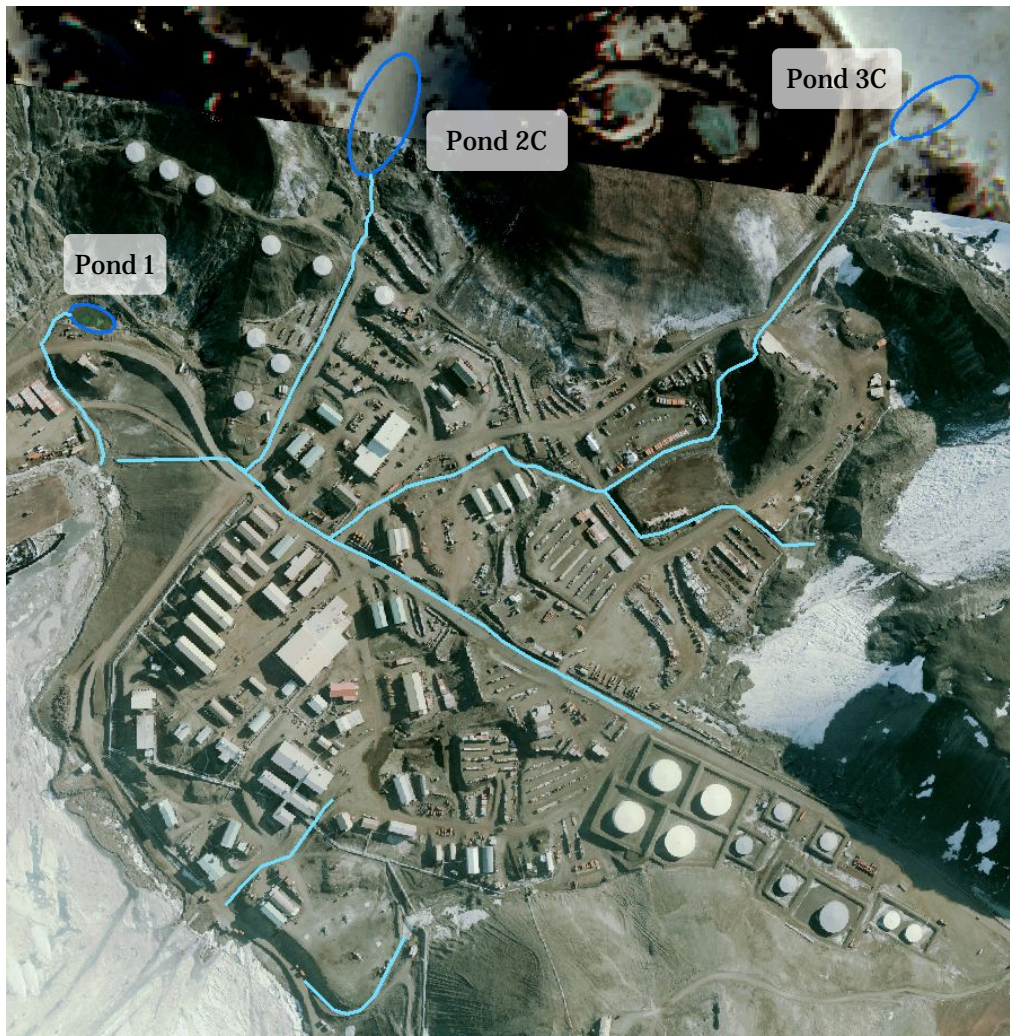
Figure 10. Proposed sediment basin locations.

We highly recommend implementing and constructing sediment ponds (Figure 10) to contain the snowmelt and to slow down the flow in drainage channels. The sediment ponds for sub-basins 1, 2, and 3 were designed as oversized water collection basins with a surface overflow outlet. We recommend investigating the ability to excavate out a larger sediment pond at site 1 and reviewing methods to maintain a pond at that site. Potential sites near 3C should be further explored through borings or small excavations. Table 4 summarizes the recommended dimension ranges for the sediment ponds, and orientation in Figure 9 may vary depending on the topographic and surface information discovered at each location.
