Acoustic Nondestructive Testing And Measurement of Tension for Steel Reinforcing Members

Part 2 – Field Testing

by Michael K. McInerney

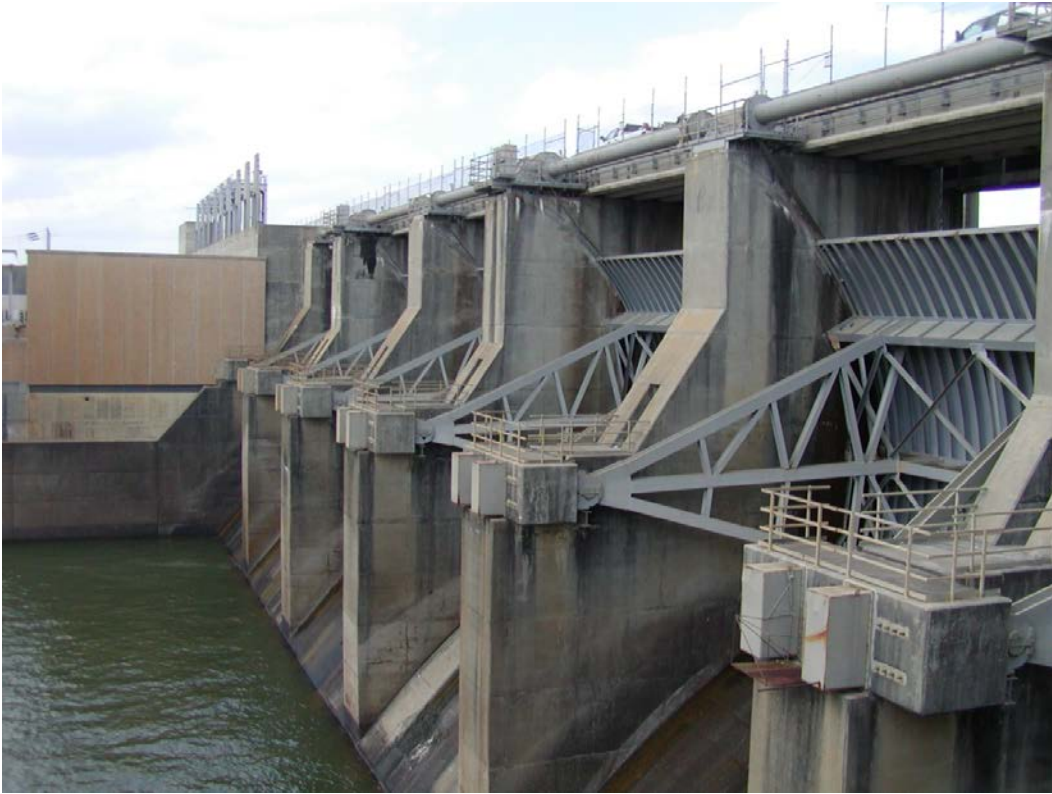
Figure 2 is a photograph of tainter gates and trunnions at one of the test locations. In this picture, the anchor rods are located behind the pairs of vertical rectangular steel enclosures about halfway up from the water line.

Figure 2. Typical tainter gates and trunnions.

Over the past few years, several tendon (rod) failures have been noted. Figure 5 (left) shows several failed rods—one that has penetrated the cover and two that have dimpled it from the inside upon fracturing. These covers are one barrier to inspecting the rods. They are large and made of heavy gauge steel, and are secured with many bolts or sometimes even peripherally welded to the anchorage. There are no designed inspection hatches, although some have been retrofitted during recent maintenance. As can be seen in Figure 2, these covers are located where access is difficult.

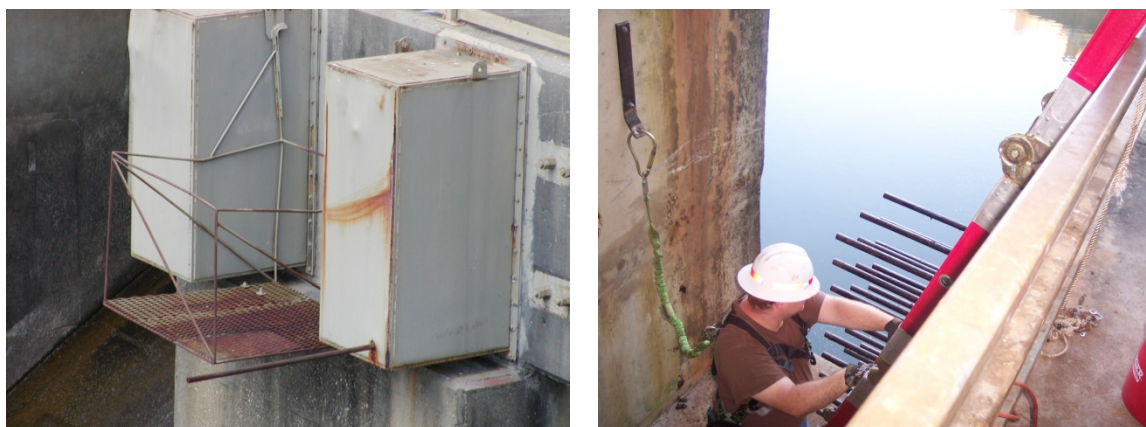
Figure 5. Failed anchor rod penetrating cover, showing one dimple in each cover indicating failed rods that did not penetrate (left); cover removed exposing anchor rods prior to testing (right).

The ends of the rods are visible in Figure 5 (right) where the cover has been removed for anchor rod maintenance and testing.

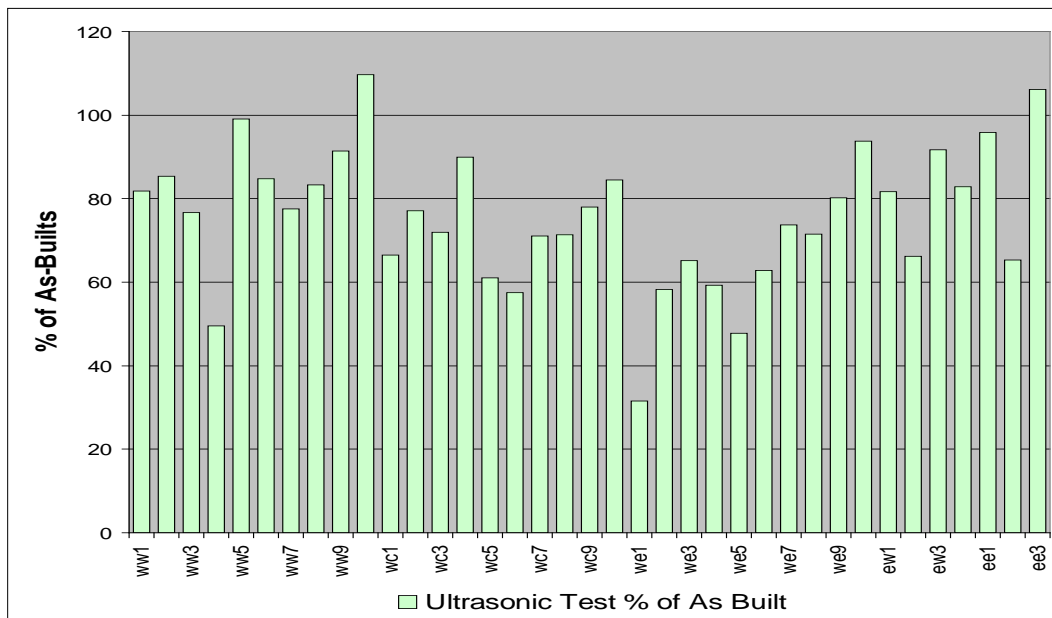
The second field test was conducted at West Point Dam in Georgia (see Figure 2 and Figure 5). On one pier, 37 rods measuring 38 – 48 ft were tested. (One rod, ee4 by our nomenclature, was broken and therefore not tested.) The filler material was grease. Both longitudinal and shear ultrasonic signals were obtained for all rods. Results of these measurements are shown in Figure 6 as a percentage of the design-specified rod tension.

Figure 6. Measured rod tension as percentage of design specification tension for West Point Dam.

There is quite a variance in the tension measurements. The average measured value was 85,038 lb. The average as-built value is 112,543 lb. The standard deviation of the measured values is 17,839 lb, while the standard deviation of the as-built values is 2,263 lb. One would expect the rods to change tension uniformly and without such extreme variance. We have high confidence in our measurements. Unlike the Keystone (Oklahoma) test, the acoustic signals were easily detectable. The difficulties in the Oklahoma test were because of shear wave attenuation. (The attenuation of the shear wave was four to ten times greater than that of the longitudinal wave.) We were able to obtain longitudinal and shear wave measurements on all 37 tested rods, but obtaining a shear measurement was difficult for a few of the 48 ft rods. This led us to conclude that our current instrumentation and transducers are suitable for use on rods up to 45 ft.

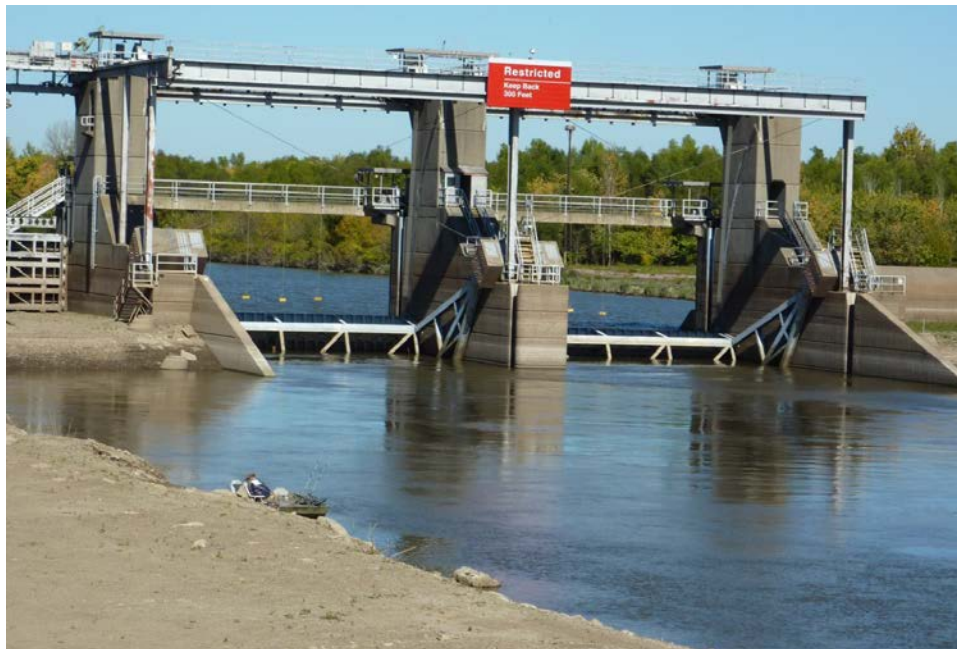
The third field test was conducted at Kaskaskia Lock and Dam in Illinois (Figure 7). Rod ends are shown in Figure 8. Of the 112 rods in the sample, 42 measured 42 ft long, 42 were 46 ft, and 28 were 50 ft. All rods were 1.25 in. diameter, and the filler material was grout.

Figure 7. Site of third field test, Kaskaskia Lock and Dam, Illinois.

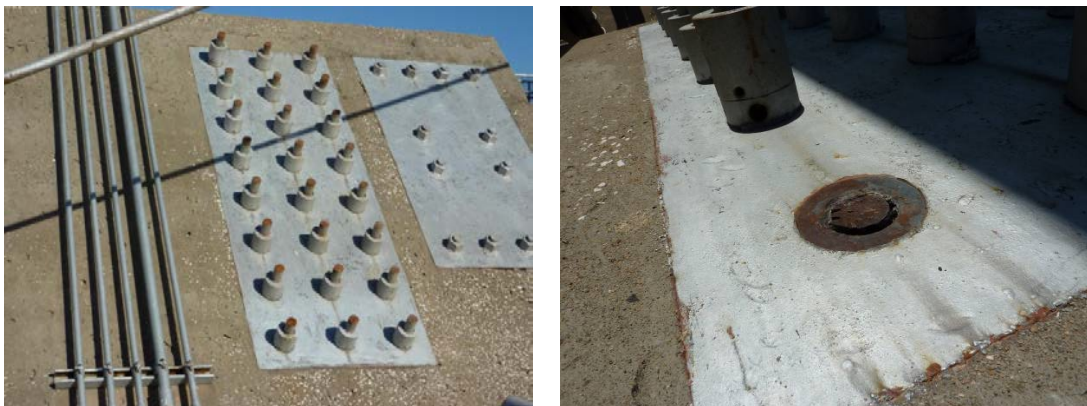
Figure 8. Rod ends at Kaskaskia Lock and Dam (left); broken rod (right).

Ultrasonic data were obtained for 111 of the 112 tendon rods (rod P3W-A3 was broken). Unfortunately, the increased wave attenuation due to absorption by grout prevented shear wave measurements for all rod lengths. Tension could not be calculated due to the lack of shear wave data. However, longitudinal wave measurements indicated that no rods were broken internally. All length measurements using the longitudinal wave agreed very closely with as-built lengths. We can also infer that rod tension when the grout set has remained the same. The rods are being held firmly in place by the grout, as indicated by the broken rod that remains and cannot be extracted.

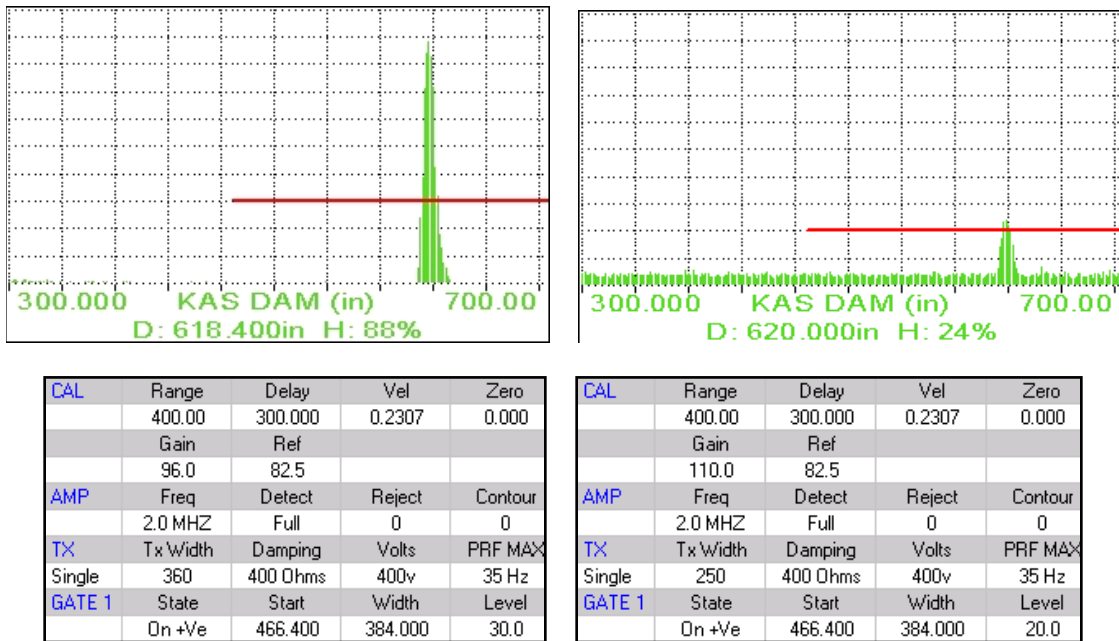
There was also a large variation of longitudinal wave attenuation among the rods. For example, a longitudinal measurement was obtained from rod P1E-D3 using a 2.25 MHz sensor driven at 400 V, which had 24% echo height using 110 dB of receiver gain. On another rod (P1E-D2, which was right next to P1E-D3), the same sensor, again driven at 400 V, gave an 88% echo height using 96 dB of receiver gain (see Figure 9).

The screen capture and table on the left in both Figure 9 and Figure 10 were produced by a normal echo from a “normally” behaving 50 ft rod (P1E-D2) using a 0.75 in. diameter 2.25 MHz sensor. (This sensor was used for all longitudinal mode testing.) Receiver gain is 96 dB. Note that the height of the echo is 88% of full screen height and the bottom axis is not noisy. The red line is the gate¹, with a level of 30% of screen height. The distance the wave traveled to the end of the rod is 618.400 in. (51.5 ft).

Figure 9. “Normal” rod with 2.25 MHz sensor (left); “abnormal” rod with 2.25 MHz sensor (right).

Figure 9 and Figure 10 (next page) each illustrate both the simplicity and difficulty of making field measurements. These figures contain screen captures from the ultrasonic detector instruments during data collection at the Illinois location.

An echo from an “abnormally” responding 50 ft rod (P1E-D3) using the standard 0.75 in. diameter 2.25 MHz sensor with a higher gain of 110 dB is shown on the right in Figure 9. The change in decibels from the normal situation is -25.3 dB, or just 5.4% the strength of the normal signal from the standard sensor on a normal rod. There is noise along the bottom axis due to the high gain. The red line is the gate level, set to 20% of screen height. The level was reduced to measure the lower echo height. The specific reason for the high ultrasonic wave attenuation in this rod is not known. However, it may indicate that a larger surface area of the rod, compared to the other rods, is in direct contact with the grout. Snell’s Law predicts that a large percentage of the wave (63.4% for concrete, which has a base composition similar to grout) is refracted into the grout and absorbed due to the grout’s higher attenuation coefficient. The more of the rod’s surface is in direct contact with the grout, the more of the waves are refracted into the grout and absorbed, leading to the appearance of increased wave attenuation in the rod. Therefore, the attenuation in the rod is most probably directly related to the amount of grout in direct contact with the rod. The increased attenuation of the waves is another indication that the rods are firmly held in the grout.
