Report No. CG-D-13-15

# Evaluation of Rutter Sigma S6 Ice Navigation Radar on USCGC Healy during Arctic Shield 20

March 2015

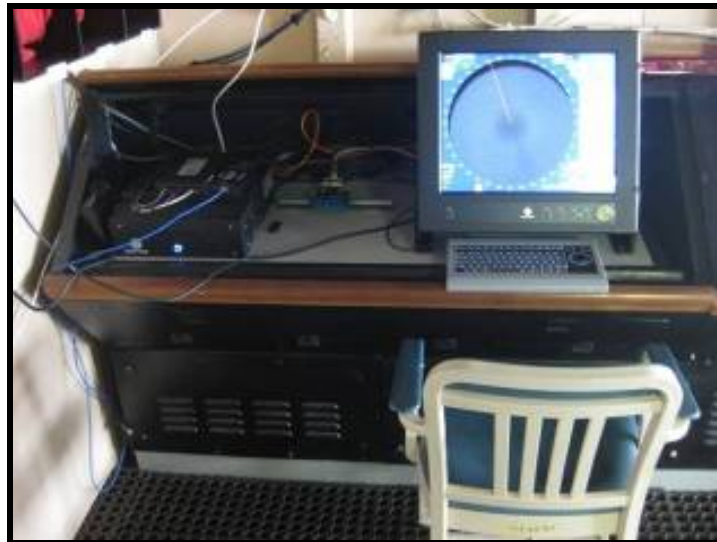
Figure 2. Setup of Rutter computer and radar display in the Chart Planning Station onboard the USCGC Healy.

The Chart Planning Station was the primary location on the bridge where the computer and radar display were established (See Figure 2). This setting was used during navigation when the OOD was comfortable with the amount of ice in the water, when the weather was clear enough, or when the ship remained stationary. However, one downside to this setup was that the crew found it cumbersome to check on the Ice Navigation radar on the bridge because the Chart Planning Station is located behind a bulkhead. This meant the OOD would need to leave his/her station for several seconds to check the Ice Navigation radar display for information about the upcoming ice configuration. Also, if the radar display was in another location (such as the ALOFTCON or the main console on the bridge), two people would be needed to be on the radio in different locations. They would have to communicate to each other what should be done to adjust the controls since one person would have eyes on the radar display and the other would control the keyboard and mouse.

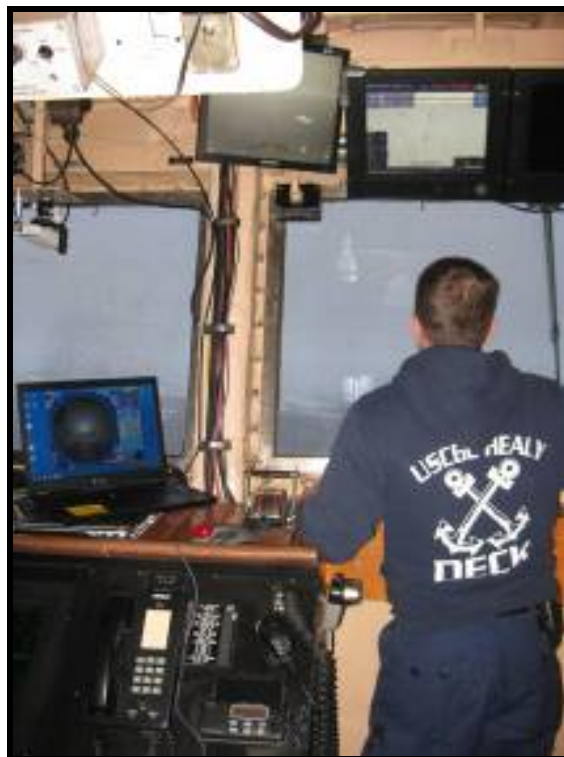
Figure 3. Setup of Rutter-configured laptop in the ALOFTCON with OOD navigating.

If the weather deteriorated or thick fog appeared while navigating, the OOD transferred ship controls to the ALOFTCON to gain better visibility of the surrounding environment. When this occurred, a laptop configured with Rutter software was used to show the Ice Navigation radar display. This was made possible with an Ethernet cable that ran from the Chart Planning Station, where it was plugged into the Rutter computer, to the ALOFTCON where the other end was plugged into the laptop. This made for a very comfortable setup for the OOD as the Ice Navigation radar display was situated directly next to him/her while navigating (See Figure 3).

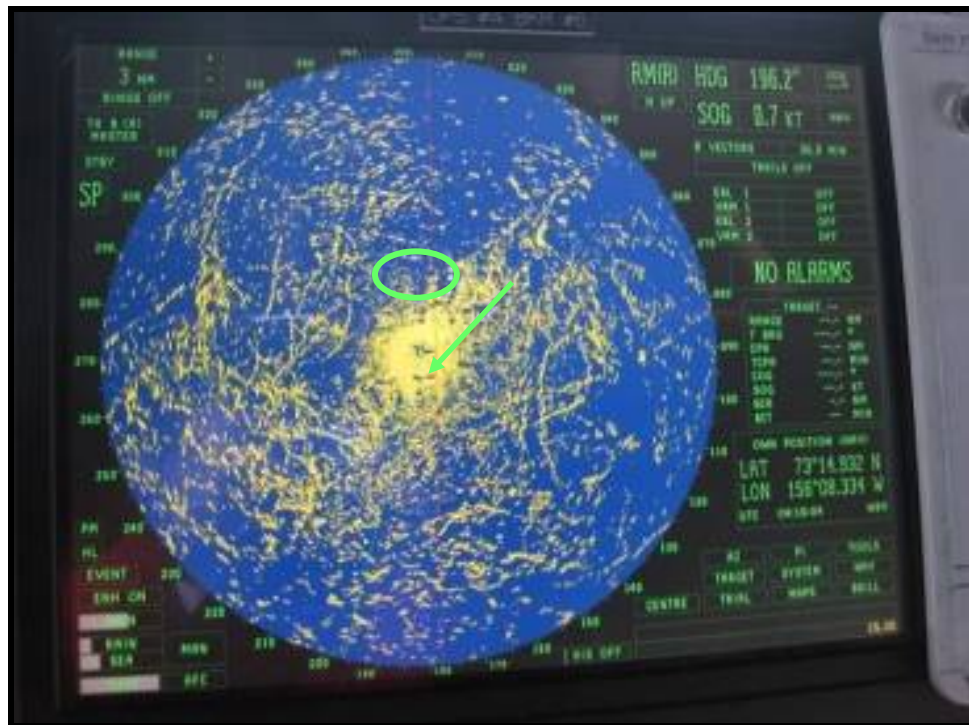
Figure 5. Photograph of Coast Guard radar display during Stationary Procedure (3 nm range scale; arrow indicates the patch of open water, which is difficult to discern on this display; circle suggests open water).

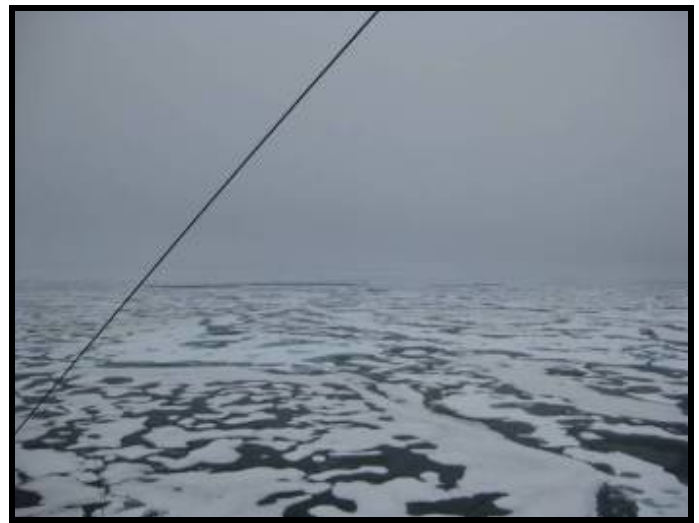
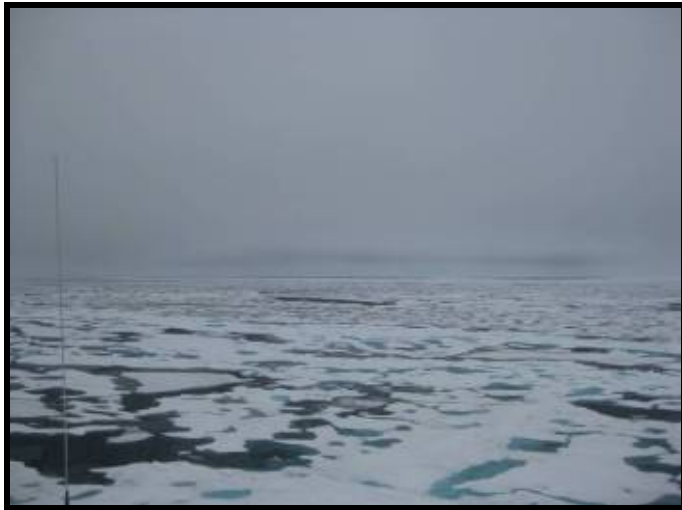
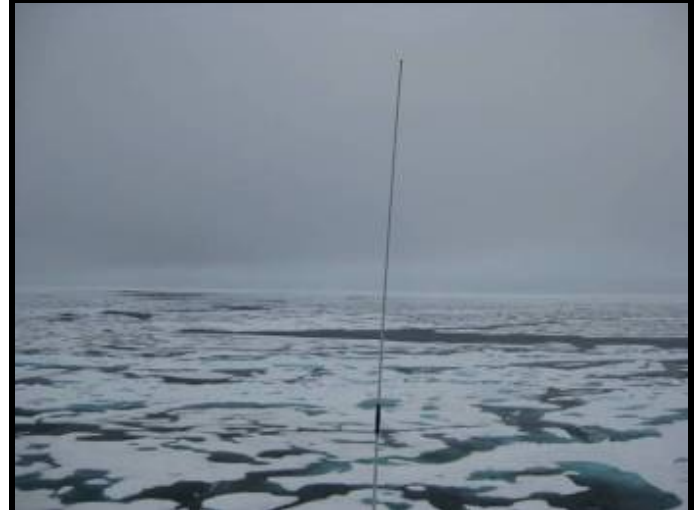
Figure 7. 180 – 315 degree relative bearing views of ice infested field.

The ice and sea surface features were more clearly identifiable on the Rutter radar display out to a range of approximately 3 nm. At this same range, the CG radar system becomes unreliable as the ice conditions are not clearly visible. On the Ice Navigation radar, when the range increases, the resolution decreases slightly but it still provides more details when compared with the CG radar at the same range. The differences between the two are shown more clearly in Figures 8 and 9. This side-by-side comparison is one of the many examples that prove that the Rutter radar display provided significantly superior surface texture information, both in near and far range. In Figure 8 and the subsequent 360-degree view photographs in Figures 10 and 11, it is evident that the ship is facing a body of open water. However, the CG radar display (Figure 9) does not show the full extent of the open water directly in front of the ship. Additionally, there is very little information about the ice field after approximately 1.5 nm in the CG radar display.

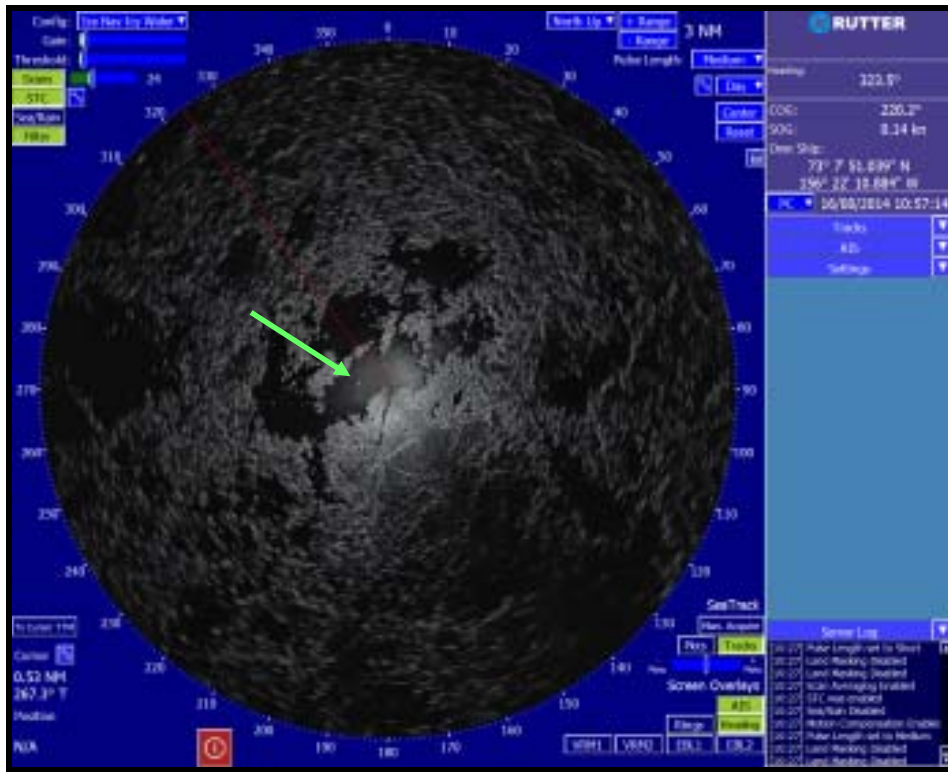
Figure 8. Ice Navigation radar screen capture during Stationary Procedure (3 nm range scale; arrow indicates location of a small ice chunk in an area of open water).

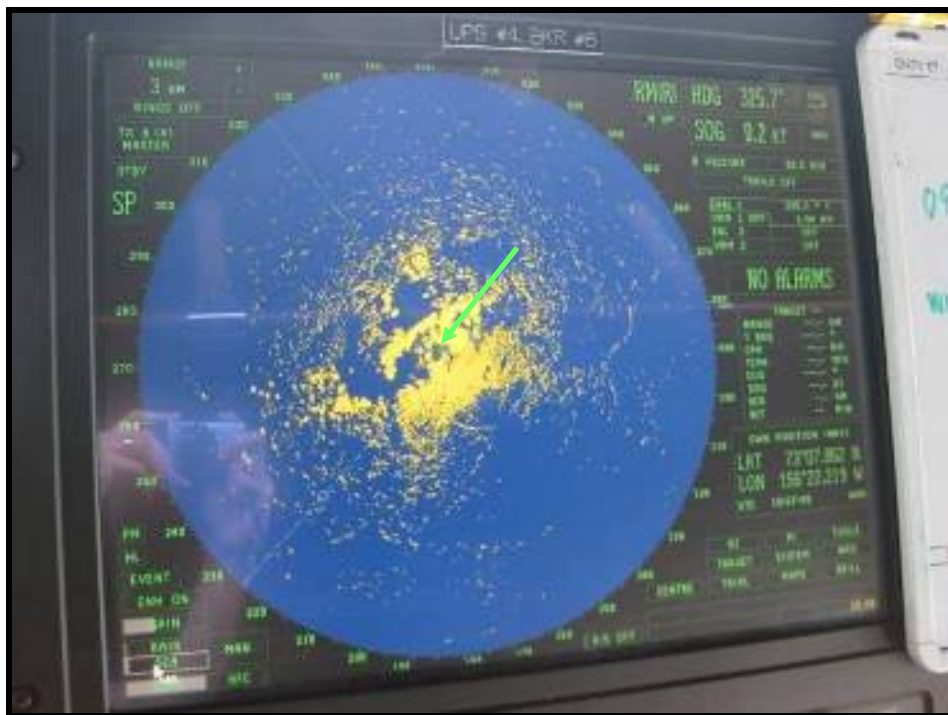
Figure 9. Photograph of Coast Guard radar display during Stationary Procedure (3 nm range scale; arrow shows how that particular region on the radar screen shows less resolution than that of Figure 8).

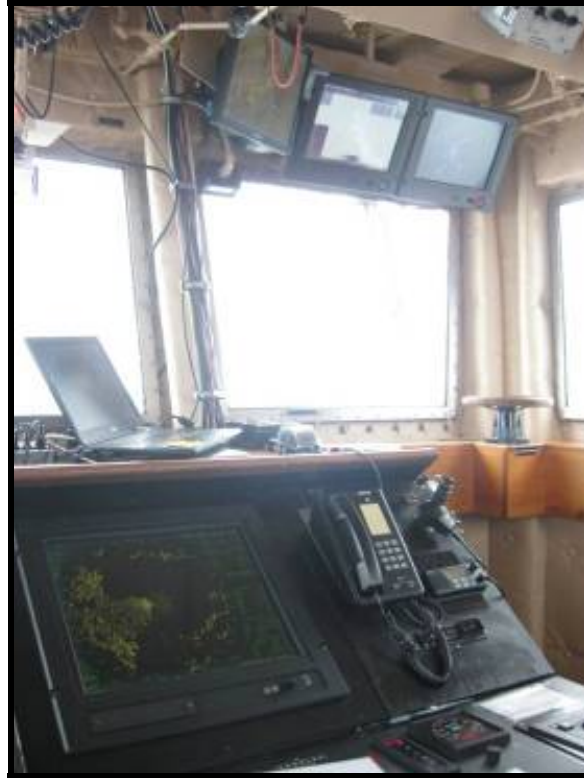
Figure 12. Rutter-configured laptop setup in the ALOFTCON.

The ALOFTCON with a Rutter-configured laptop was found to be the more ideal location for the Ice Navigation radar display as compared to the Chart Planning Station on the bridge. The laptop display could be set directly to the left where the OOD stands and in front of the window (See Figure 12). This vantage from the ALOFTCON

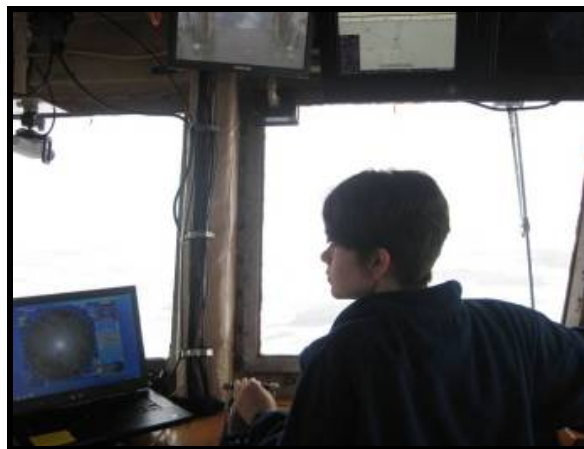
Figure 13. OOD utilizing the Rutter-configured laptop during navigation during poor weather in the ALOFTCON.

allowed the OOD to see out the window and simultaneously observe the Ice Navigation radar display with ease (See Figure 13). When this setup was engaged, the current CG radar display in the ALOFTCON was not used since the laptop radar display provided a superior picture in a better location.

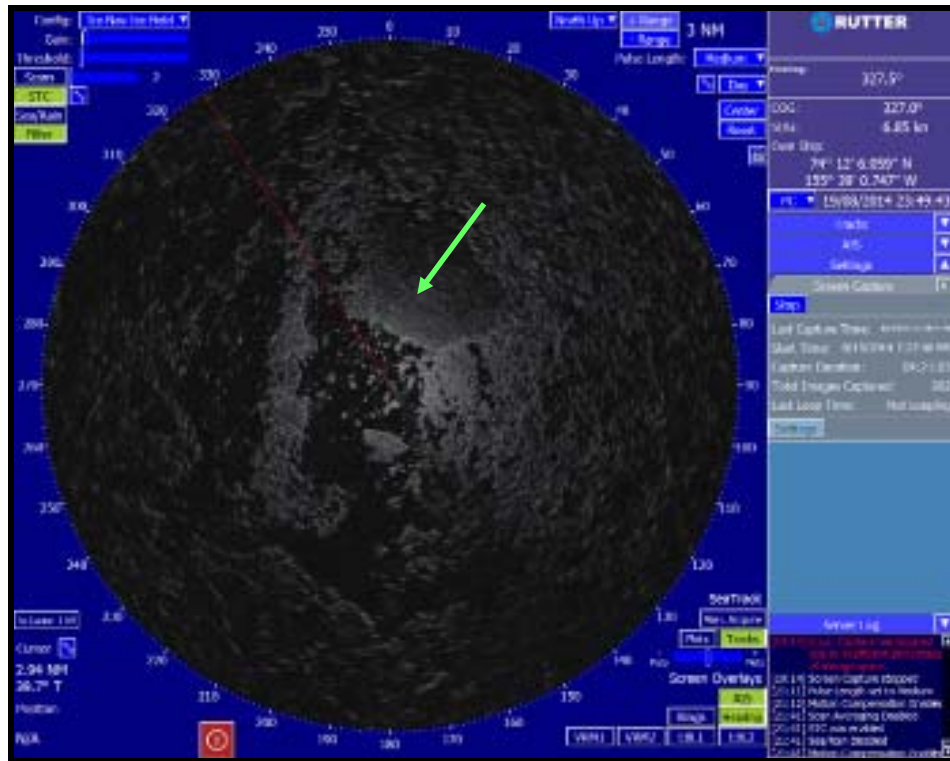
Figure 14. Arrow indicates thin ice field shown on Ice Navigation radar 30 degrees east of the ship's heading and 0.5 nm away (3 nm range scale).

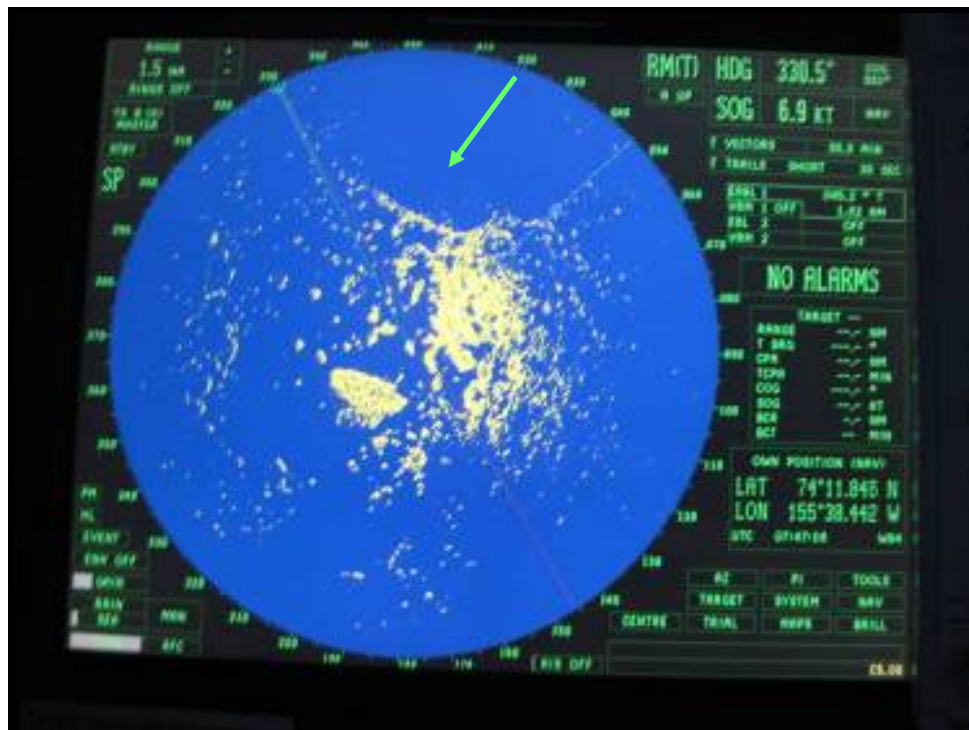
Figure 15. Arrow indicates lack of distinguishable ice field shown on CG radar 30 degrees east of the ship's heading and 0.5 nm away (1.5 nm range scale).

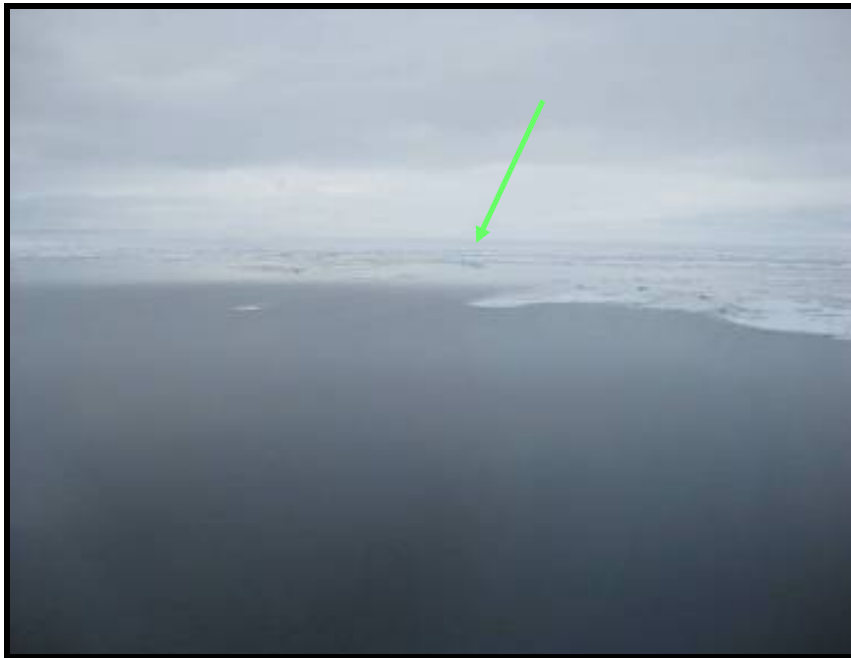
Figure 16. Ice field shown in the distance.

The ice encountered during Arctic Shield 2014 did not pose serious navigation challenges for the ship. Most of the time, the ship's crew would establish a destination and arrive there in a straight line. It would deviate from its course occasionally to avoid large ice floes or change the ship's heading to cross over a pressure ridge rather than run parallel to it. Still, the Ice Navigation radar was useful for the navigators in their awareness of upcoming ice conditions. Data collection during navigation showed that there were some ice features that the Ice Navigation processor captured that the CG processor did not. For example, on August 19 at 11:49 PM, the Ice Navigation radar system registered a thin ice sheet approximately 30 degrees to starboard of the ship's heading and 0.5 nm away (See Figure 14) while the CG radar system showed an empty space in the same region (See Figure 15). It can be interpreted to be a patch of open water but a photograph of the environment showed ice in the distance, not open water (See Figure 16).

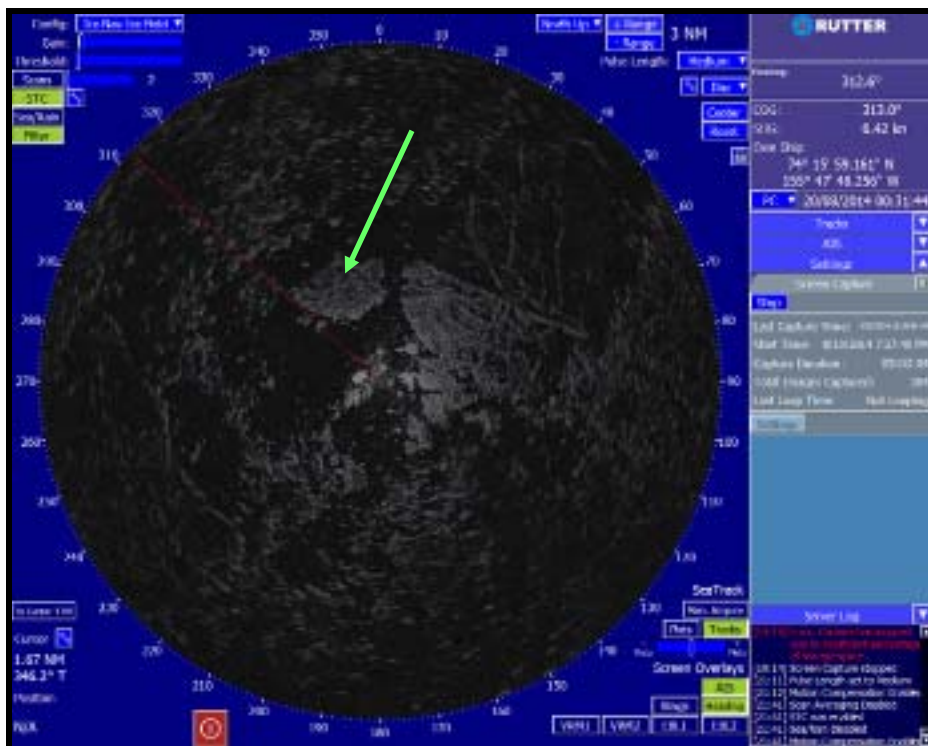
Figure 18. Avoiding the ice floe (3 nm range scale).

During one watch early in the morning on August 20, the OOD relied heavily on the Ice Navigation radar in the Chart Planning station and identified a large ice floe ahead that he took into account while navigating. Figures 17 to 20 show the path that the ship took to avoid breaking through the ice floe and maintain the ship's momentum. This particular ice floe was undetected through the window due to light fog (See Figure 21) but as the ship got closer, it became visible (See Figure 22). After the ship safely maneuvered around the ice floe, a photograph of the CG radar display (See Figure 23) was taken to compare the clarity of the ice floe in question to the Ice Navigation radar display as shown in Figure 20. The comparison between Figure 20 and Figure 23 of the ice floe south of the ship shows clearly that the extent of the ice floe is easily identified by the Ice Navigation radar but is not clearly defined by the CG radar. The ability to clearly define ice edges and identify the differences between ice and open water has large implications in choosing safer and more efficient shipping routes for the OOD.

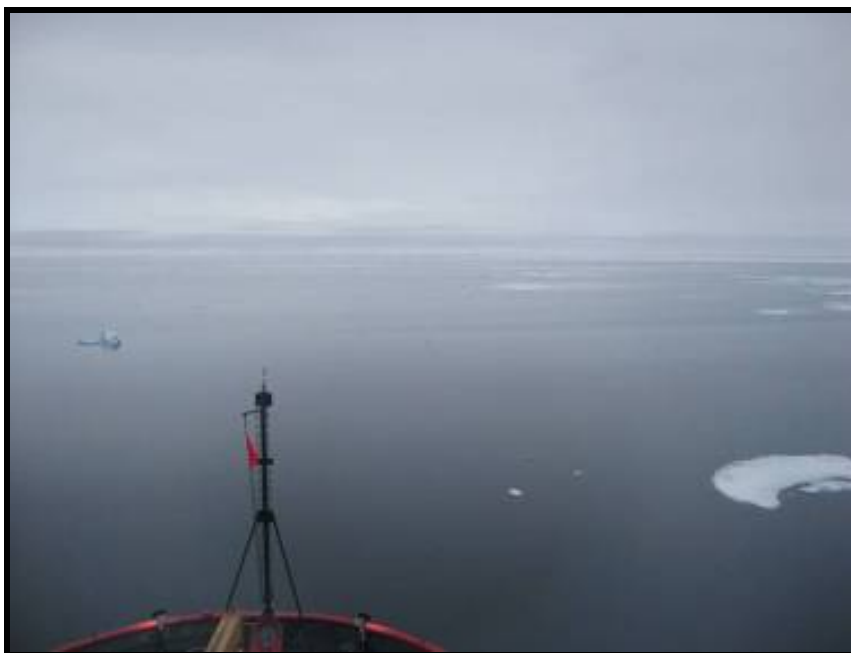
Figure 21. USCGC Healy is approximately 0.5 nm away from ice floe to avoid but it is difficult to see.

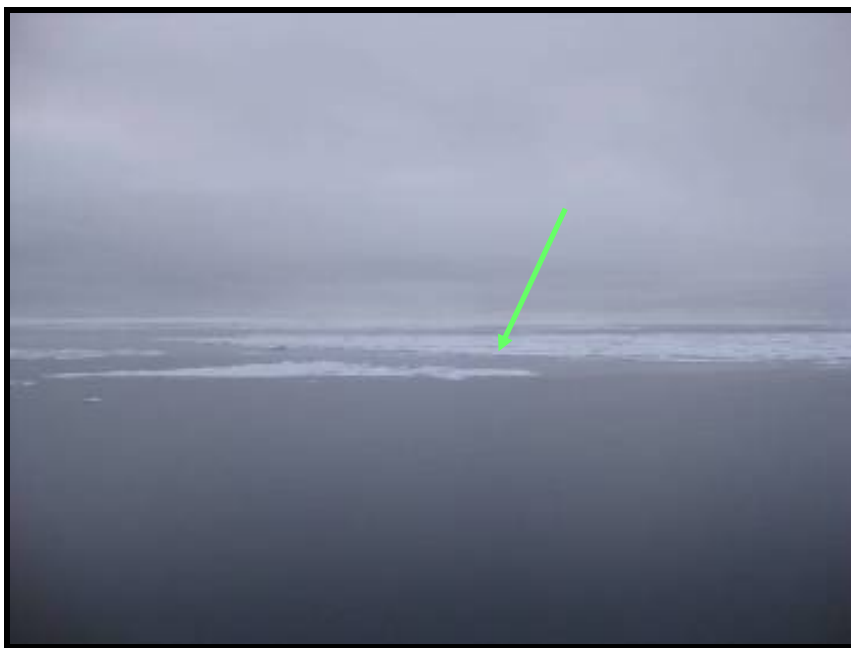
Figure 22. Ice floe becomes visible as ship nears it.

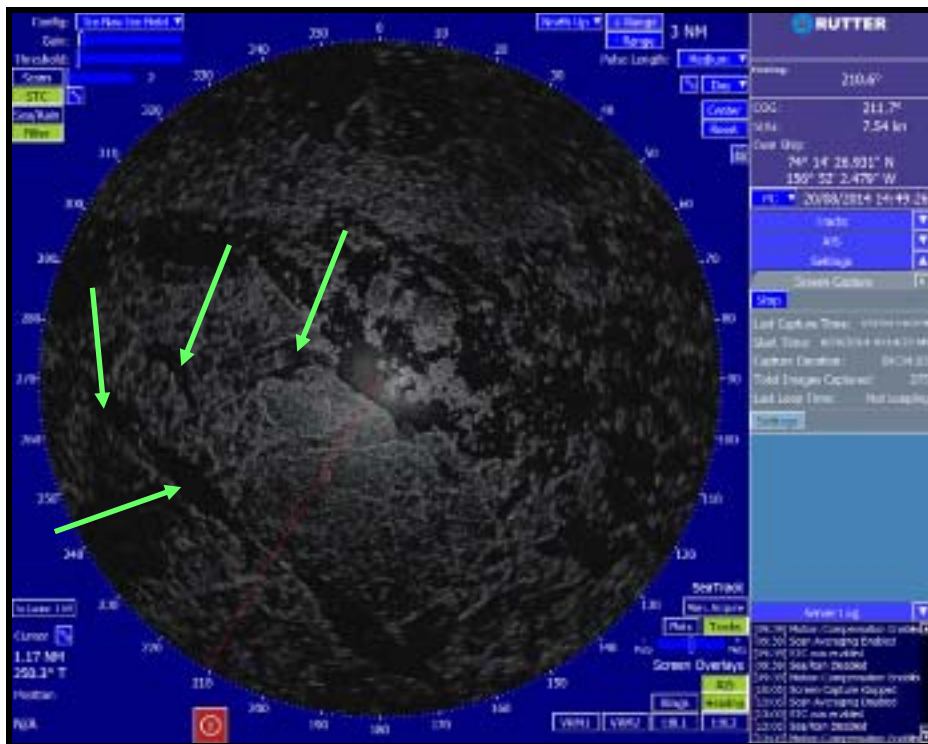
Figure 24. Upcoming ice floe that ship was stuck in; green arrows indicate the possible route ship could have taken; red line is ship's heading (3 nm range scale).

At approximately 2:55 PM on August 20, the ship found itself stuck in an ice floe. The OOD at the time was on the main bridge and chose not to use the Ice Navigation radar since it was inconveniently located in the Chart Planning Station. He relied on the CG radar and the vantage from his standing position on the bridge. Figure 24 shows what the Ice Navigation radar display captured prior to the ship becoming stuck in ice. It was clearly evident that the radar display showed a large ice floe and it was possible to avoid it by heading to the right where a channel of open water existed with loose ice ahead of it (See green arrows in Figure 24). Figure 25 shows the ship stuck in the ice floe.

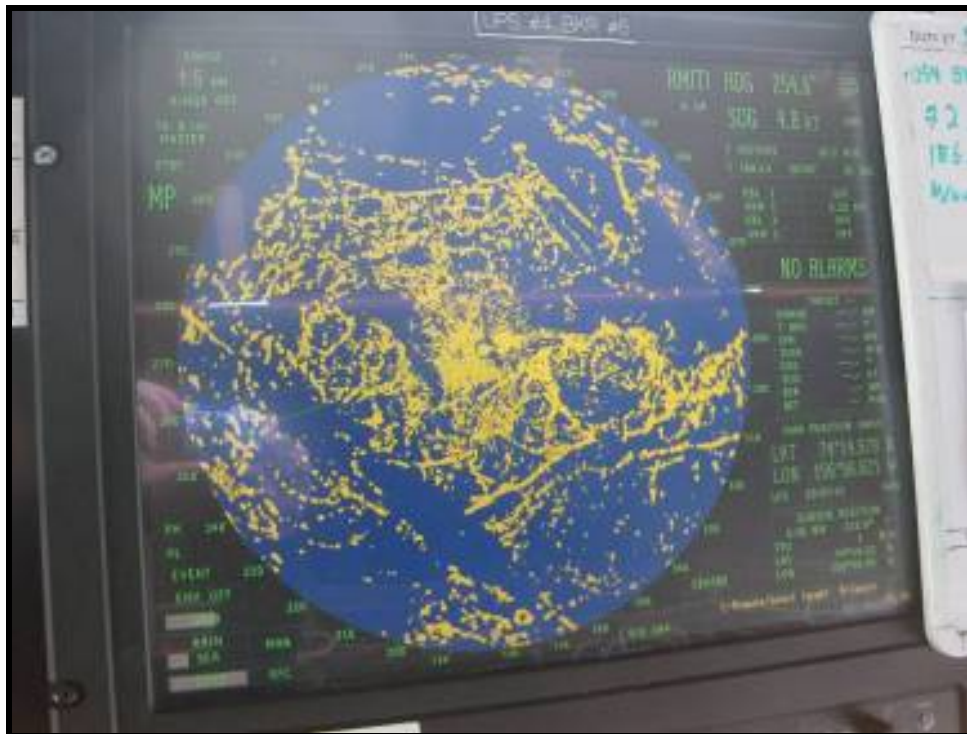
Figure 29. CG radar display while ship is stuck in an ice floe (1.5 nm range scale).

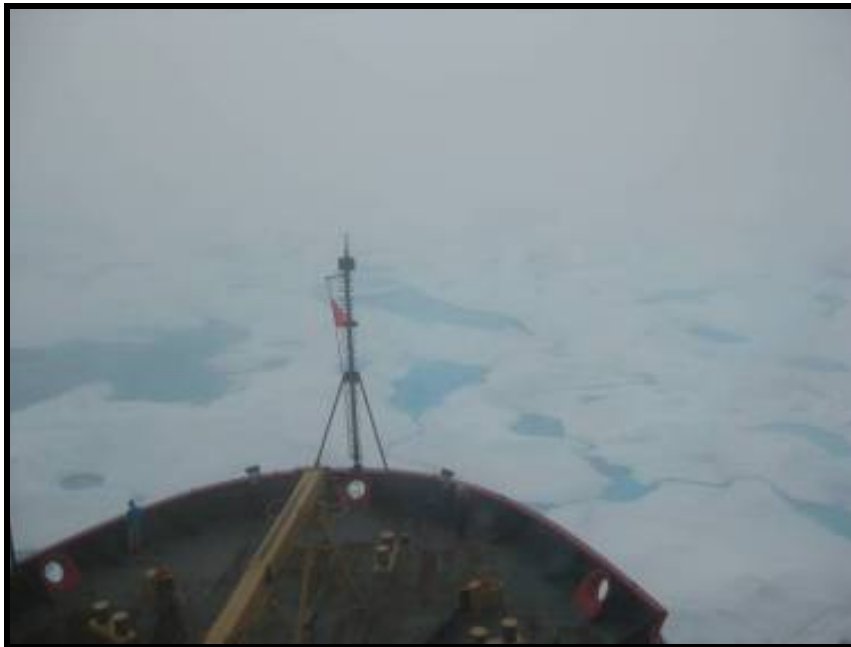
Figure 30. Ship is stuck in large ice floe and the effort to extricate the vessel from the floe was hampered by heavy fog.

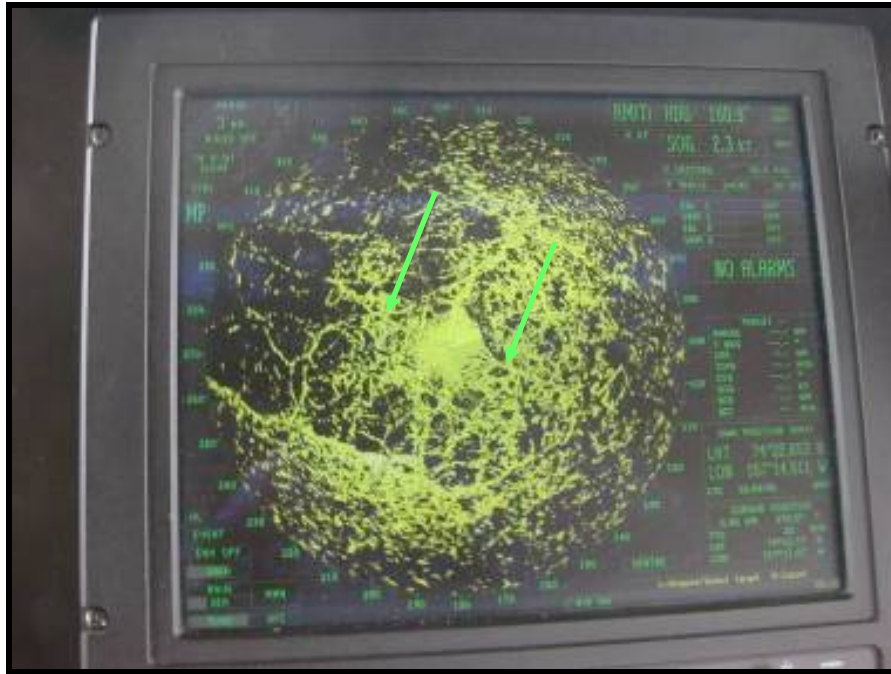
Figure 33. CG radar display of pressure ridge (3 nm range scale).

Pressure ridges are important features in ice fields that navigators should be aware of. They are a result of two ice floes coming together to create thick strips of ice that become potential barriers for icebreakers. It is more effective, if there is no option to avoid them completely, to run into them perpendicularly while the ship has momentum. It is important to spot them on radar displays ahead of time so navigators may be prepared to either run into them perpendicularly or to avoid them completely. On August 20 at 6:42 PM, a large pressure ridge was detected on both the Ice Navigation and CG radar displays and this particular ice feature can be clearly discerned in Figures 31 to 32 (see green arrows). It takes more effort to notice this pressure ridge on the CG radar (See Figure 33).

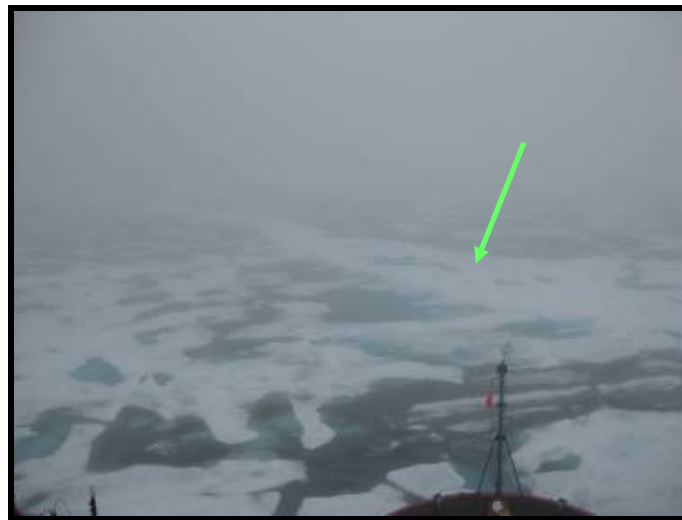
Figure 34. Pressure ridge as seen through the window on the bridge.

In heavy fog, it is difficult to make out pressure ridges with the naked eye but as the ship gets closer, they become easier to see (See Figure 34). The radar is useful in making decisions about the pressure ridges ahead of time instead of making an immediate decision.

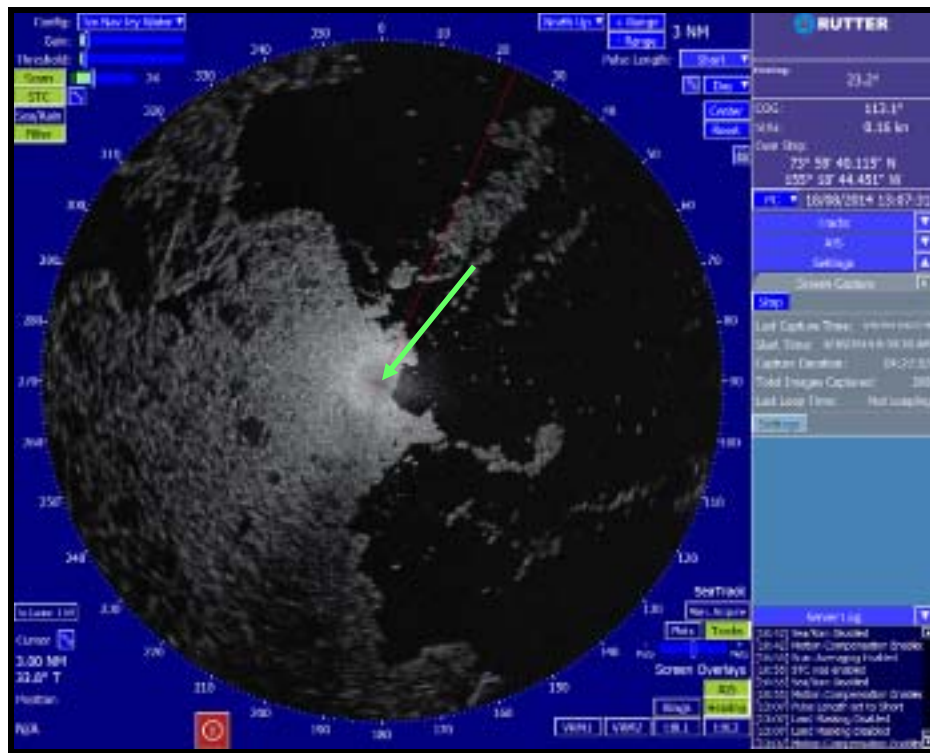
Figure 36. ASB clearing a path to open water (3 nm range scale; arrow indicates location of vessel heading roughly east).

During a technology demonstration on August 18, USCGC Healy drifted inside an ice field characterized with loose ice after arriving at a body of open water. Instead of powering up the ship's propellers and moving back into the open water for release of the Arctic Small Boat (ASB), the ASB was deployed into a small opening in the ice field and pushed its way back into the open water. It acted as a snowplow and pushed one piece of ice floe at a slow but steady clip until it reached open water. The ice-clearing path was captured by the Ice Navigation radar with clarity (See Figures 35 to 38), which impressed the ship's crewmembers.

The capture of the ASB clearing a path for itself demonstrates an added utility for the Ice Navigation radar. Not only does it detect the ice edge and type of ice with high resolution images but it can also provide improved situational awareness of polar operations that the USCGC Healy routinely performs. The radar can be extremely useful in assessing the safety of the crew, particularly in poor weather conditions when visibility is near zero.

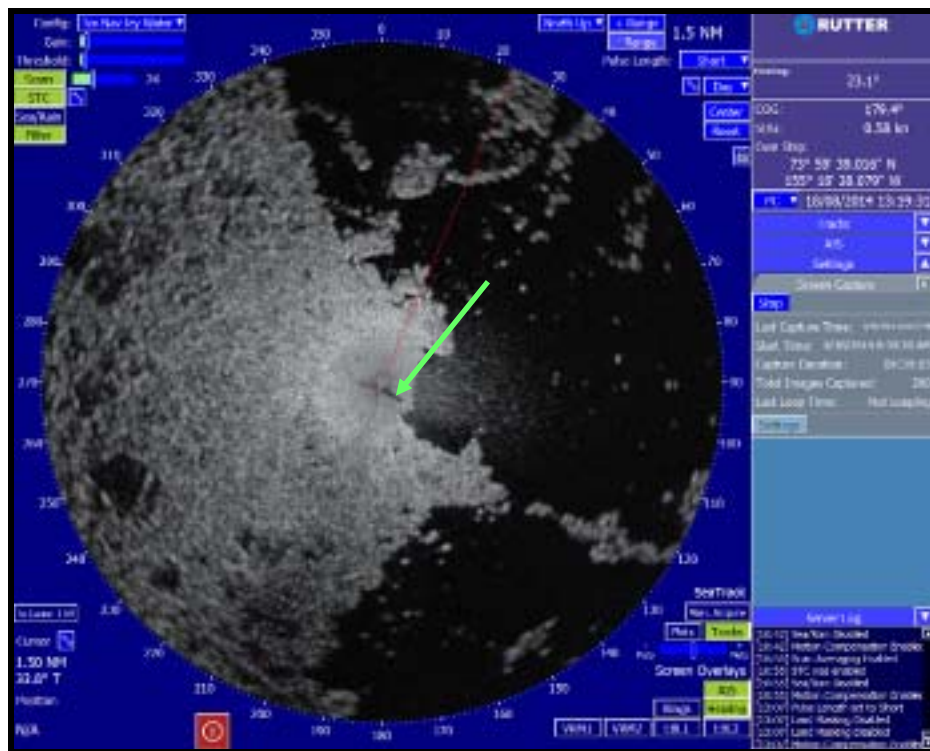
Figure 37. ASB reaching the open water (1.5 nm range scale).

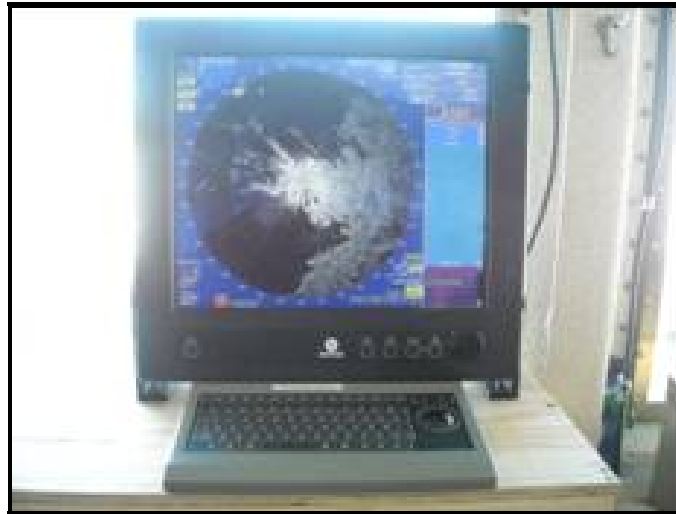
Figure A-1. Rutter Ice Navigation radar display with radar display turned on.

The key to this processor is that it processes a full dynamic range of data (12-bit video) versus the 2-4 bit intensity in standard navigation radar that are more than adequate to identify other vessels, buoys and points of land. This processor then is able to produce a higher-quality image for better ice definition (see Figure A-1). The processor uses the standard X-band out (Analog) usually set on a short pulse for better resolution. Figure A-2 shows setup of the processor and monitor in the Chart Planning Station on the USCGC Healy.

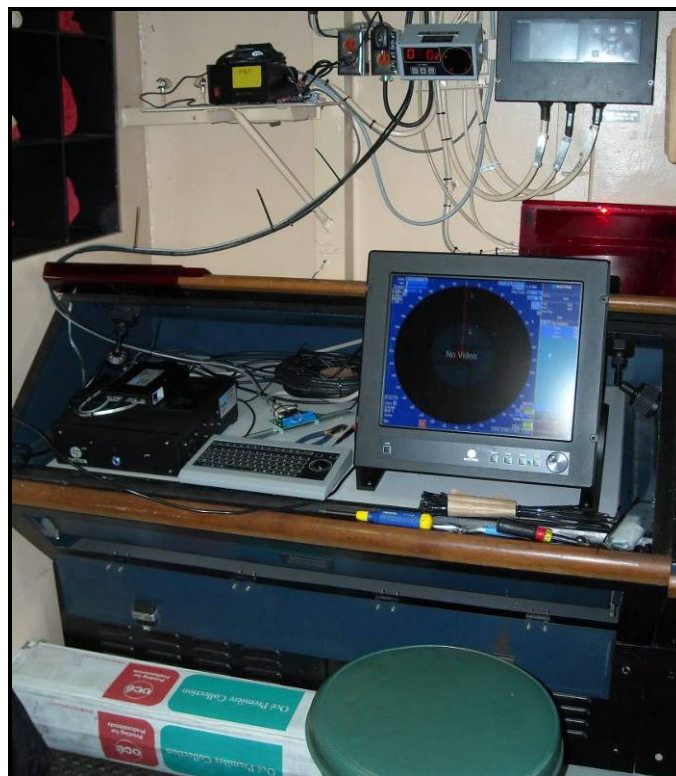
Figure A-2. Rutter Ice Navigation radar setup in the Chart Planning Station on the USCGC Healy.
