Detection of Microcracks in Trunnion Rods Using Ultrasonic Guided Waves

James A. Evans and Richard W. Haskins

July 2015

Final report

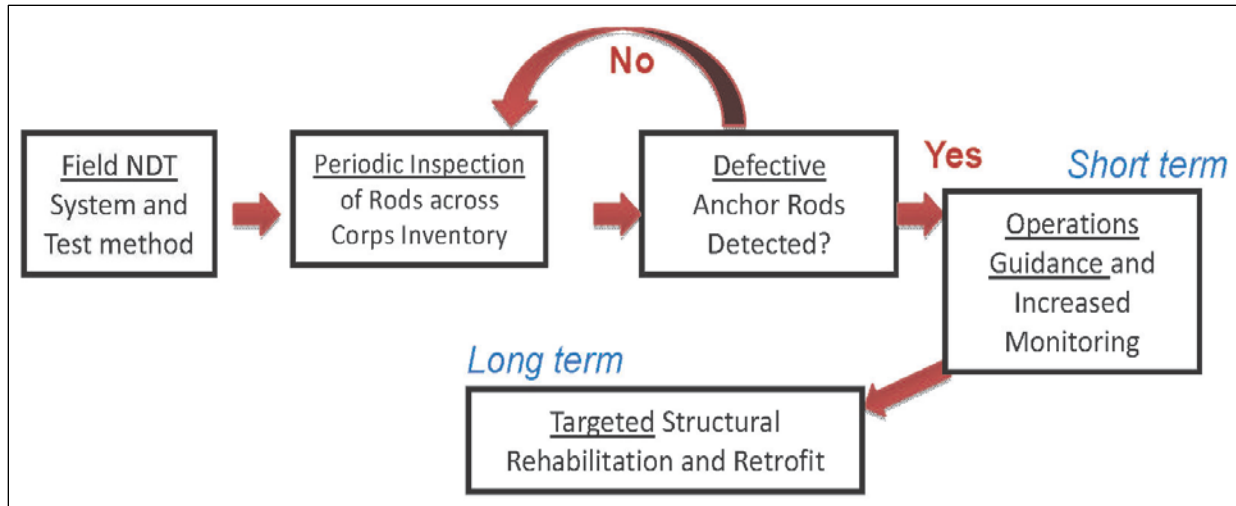
Figure 2. Utilization of anchor rod NDT.

Research statements of need (SON) were submitted by the USACE Research Area Review Group (RARG) to the Navigation Systems Research Program. In response to these SON, a work unit (WU) was established to develop procedures and specifications to assess posttensioned anchorage capacity deterioration by means of microcrack detection using nondestructive testing/nondestructive evaluation (NDT/NDE) types of field techniques. The purpose of this research is to develop a field inspection capability for the purpose of detecting and quantifying slowly propagating cross-section loss due to microcracks in trunnion anchor rods. This inspection method would integrate into a scheme as shown in Figure 2.

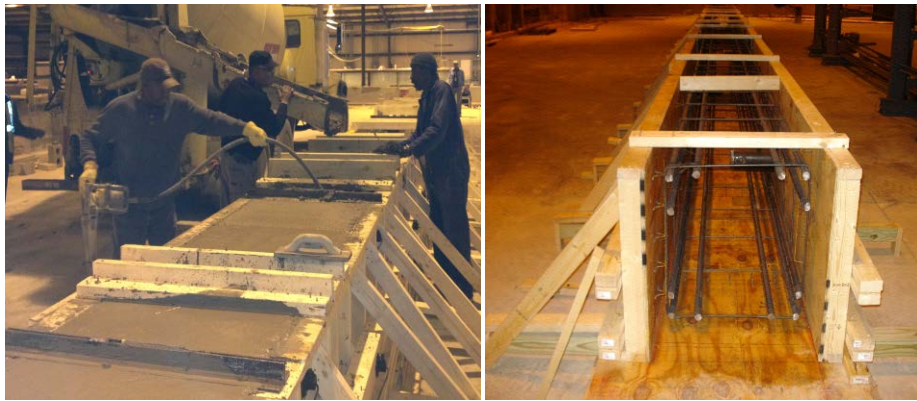
Figure 4. Full-scale 4-rod test bed during construction and concrete placement.

The posttensioned, trunnion-anchor-rod test bed was designed to allow for controlled laboratory testing under full-scale field representative conditions (Figure 4). The test bed allows for the tensioning of four rods across a length of 56 ft. Sleeve material consists of 2 in. schedule-40 pipe, as used commonly in the field, or oversized PVC, to avoid sleeve contact and allow larger immersion layers. Features include injection and access ports and internal embedded acoustical sensors.

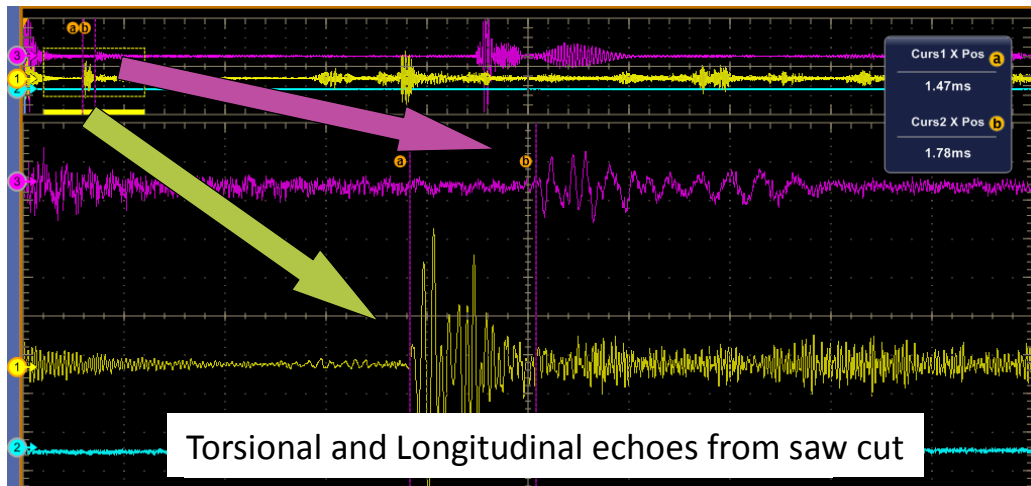
Figure 6. Torsional and longitudinal reflections from a shallow, 9 mm saw cut.

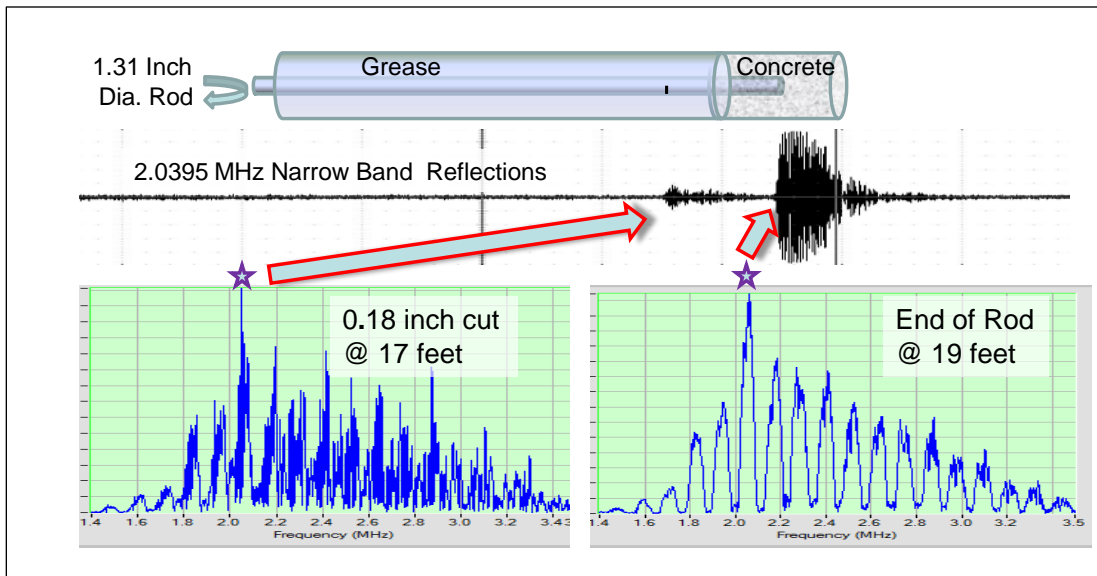
Figure 10. Narrow-band spectral reflections at a 0.18 in. deep cut and the rod end of a 1.31 in. diameter grease-embedded trunnion anchor rod with concrete termination.

To evaluate the capabilities of shallow, near-surface defect detection, an experiment was performed where a progressively deepening cut was made while monitoring the expected reflection region in the ultrasonic A-scan. This cut notch was detected with an approximate signal to noise ratio of 2 using the low-loss, narrow-band inspection frequency at a depth of 0.1 in. at a distance 23 ft away from the free end of a grease-embedded 1.2 in.

diameter rod (Figure 10). As the cut was increased, the echo amplitude grew as expected at a very high rate due to both the increased rate of material removed from the rod's cross-section and the reflection of the higher energy concentrations as the cut moves towards the rod's center. The spectral signature of the cut (i.e., open crack) can serve as a signature for monitoring purposes.

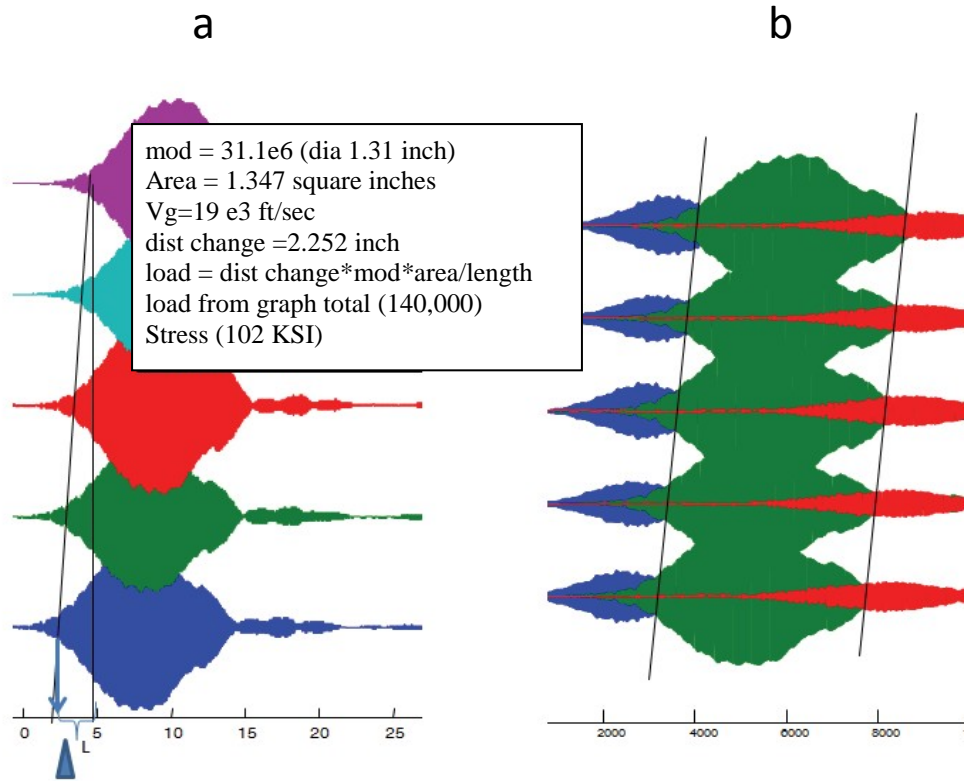
Figure 11. Variation in load and the resulting influence on propagation delay.

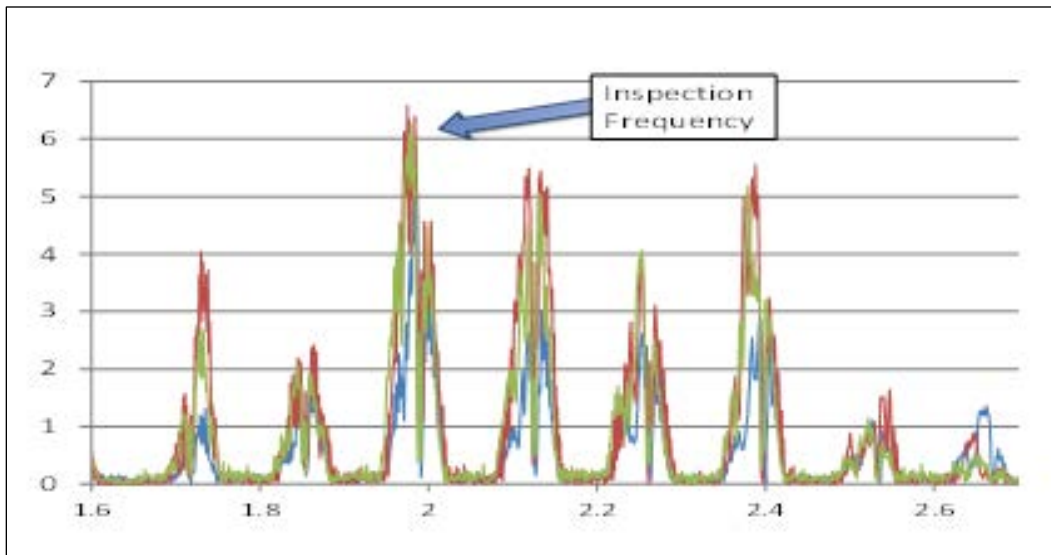
Figure 13. Three frequency scans at Greenup Lock and Dam and the selected low-loss inspection mode.

Prior to narrow-band testing, numerous frequency scans were performed on randomly selected rods in each bank to determine the ideal guided-wave inspection parameters and to verify their consistency from rod to rod. Three of these frequency scans are shown in Figure 13. For the majority of tested

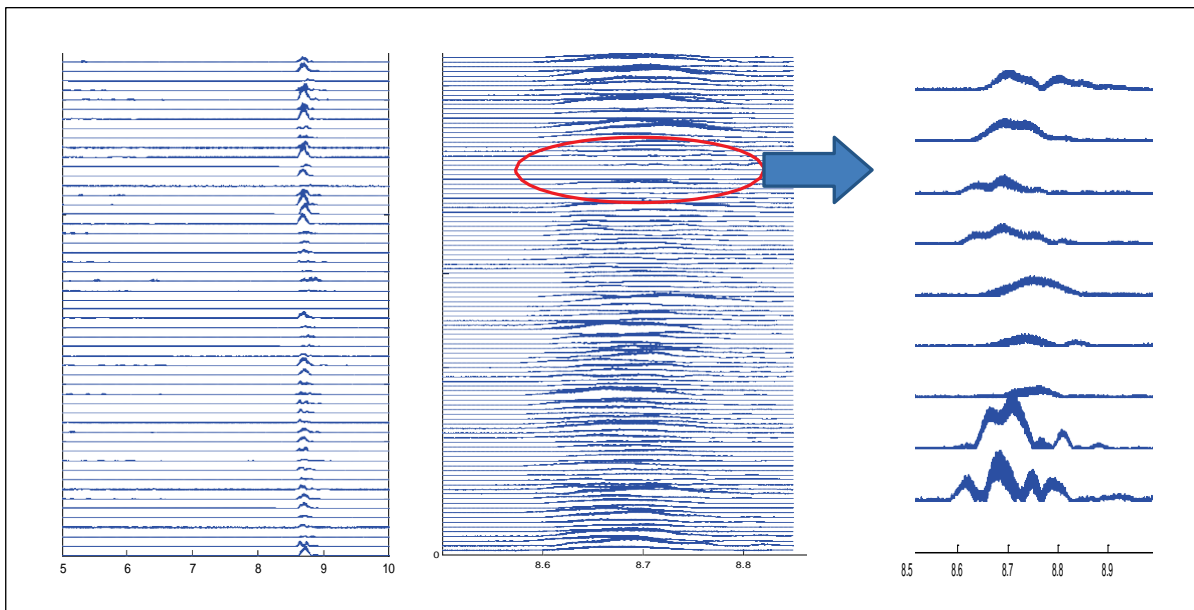
Figure 15. Various representations of some of the Greenup Lock and Dam test data. The x-axis is time in milliseconds (msec).

Figure 15 shows various representations of some of the signals collected at Greenup Lock and Dam. The center image in Figure 15 shows zoomed-in, phase-detected signals from the east-most pier. The circled region in the center panel shows rods that had weak backwall reflections and were rescanned and retested with a slightly higher inspection frequency. The figure on the right in Figure 15 shows the retested data zoomed in to the backwall.

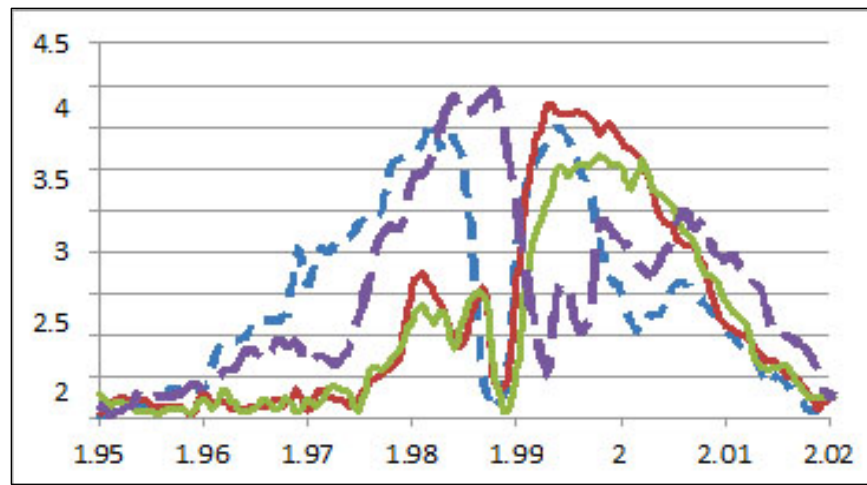
Figure 16. Shift in ideal inspection frequency as observed for a group of rods (pier 2, east bank).

The shift in ideal inspection frequency seen in the lower section of the far-east bank of rods corresponded to a migration of the dominant peak from the left to the right of the null point in the low-loss frequency mode. This null point consistently appears in low-loss propagation modes and has been commented on by other guided-wave researchers (Beard 2003). Figure 16 shows this low-loss mode frequency migration in the spectral domain. The solid lines correspond to rods where the ideal inspection frequency shifted to the right of the null point. The new low-loss mode for this small subset of rods is approximately 1.995 MHz. This change observed in this small group of rods is suspected to be due to either material property variations or curvature in the rod axis due to sleeve contact. Research (Beard 2003) indicates that curvature as small as 800 times the rod diameter can be detected in guided-wave responses.

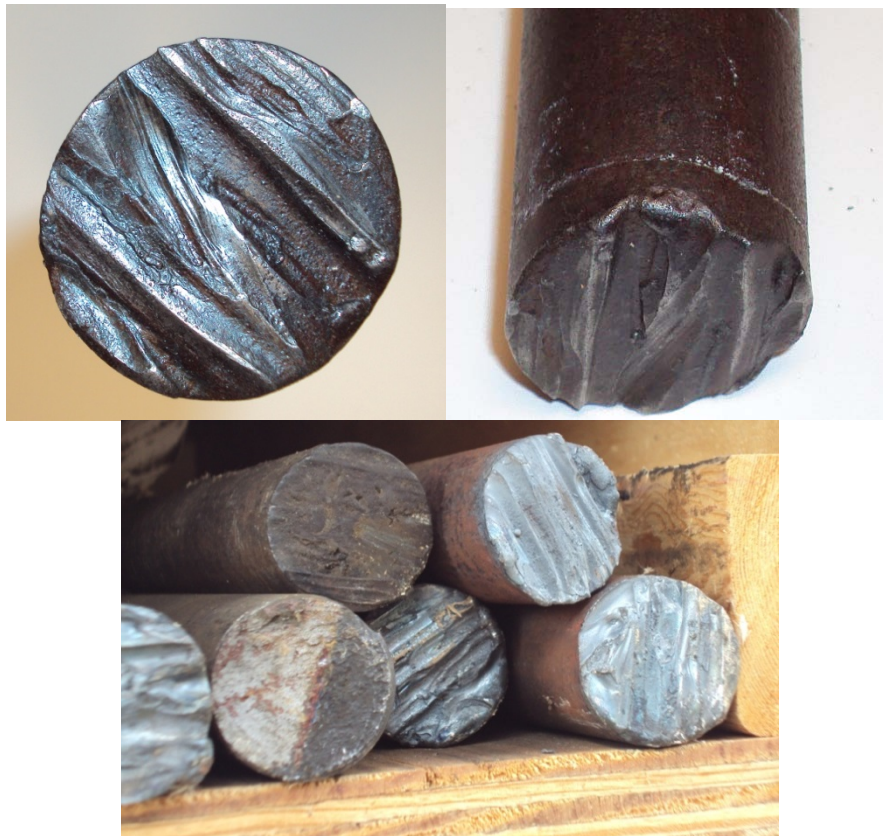
Figure 21. Torch-cut rod ends.

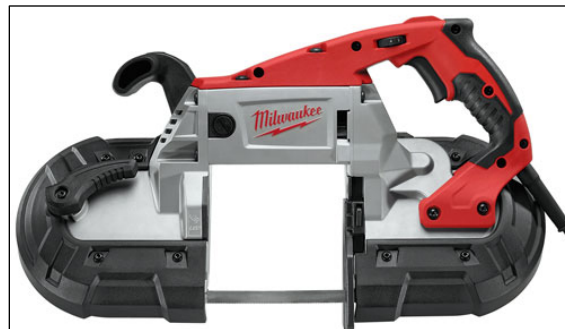
Figure 22. A portable band saw used to cut ends of rods.

With the portable bandsaw, some slight scalloping in the direction of the blade's cut direction has been observed. Increasing blade tension and decreasing feed rate should help minimize occurrence of this effect. It is difficult to put a definitive number on the time required to perform a cut, as faster cuts can be made at the cost of cut quality and blade life. Approximately 5 minutes is a nominal time to cut with reasonable quality a 1.25 in. diameter rod.

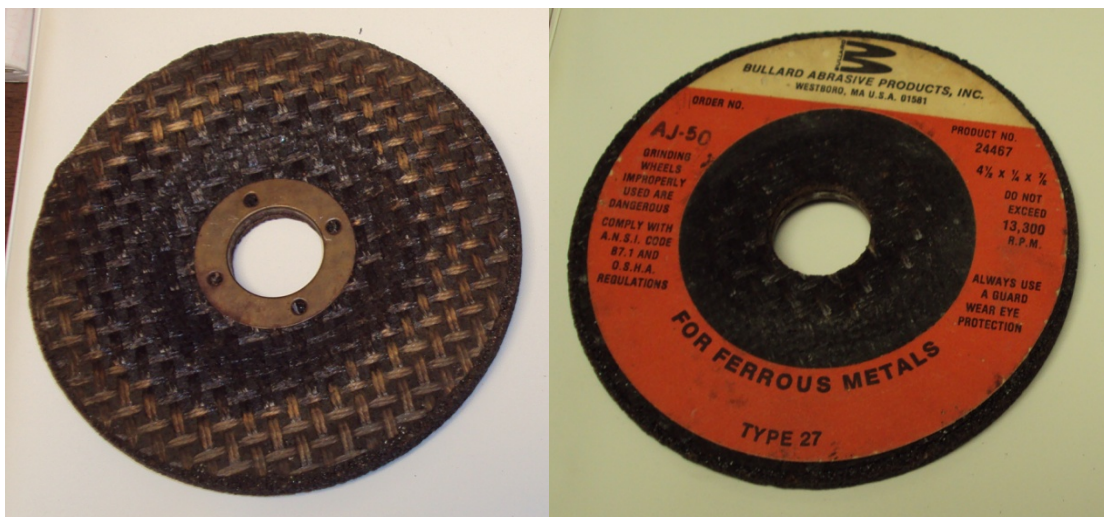
Figure 23. Angle grinder disc producing best results for rod finishing.

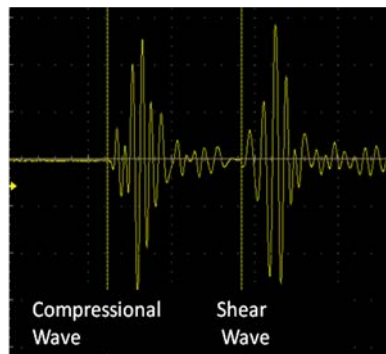
Figure 24. Waveforms of Fields metal through-transmissions.

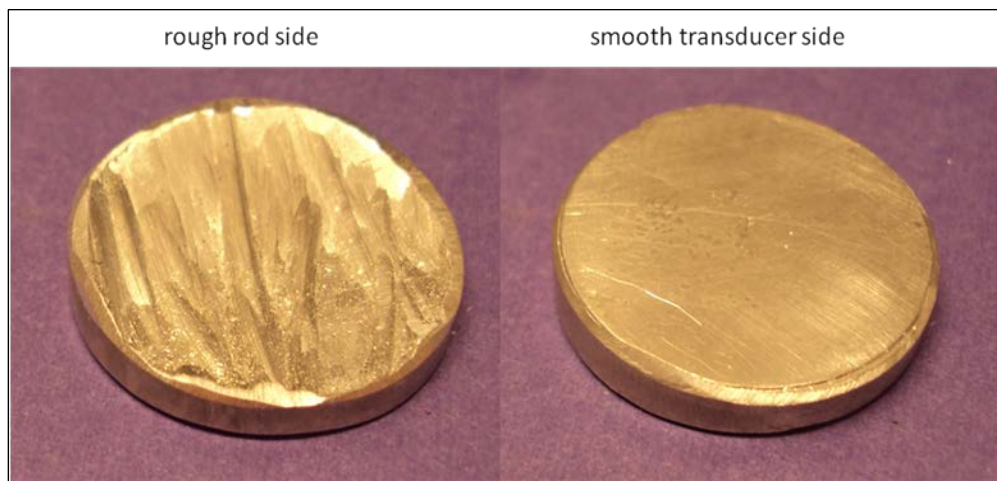
Figure 26. Rod end castings.

Typically, in 1 to 2 minutes, the Field's metal has set, and the casting apparatus can be removed. This prototype design allows casting on horizontal or inclined bars and variability in casting thickness. Portable propane stoves such as those used in backpacking can be utilized as an easy field system for heating the Field's metal to its 140 °F melting point. An example of cast ingots is shown in Figure 26. These castings do not form an

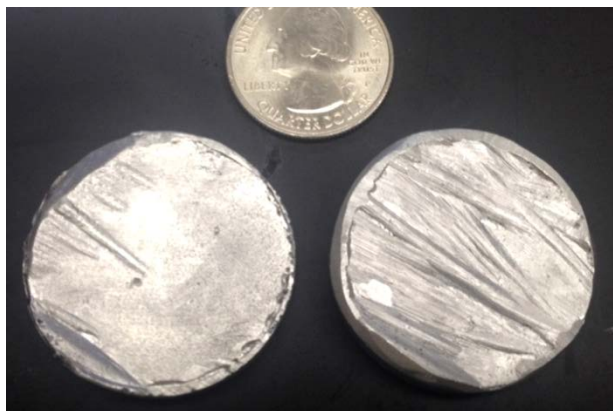
Five surface conditions were investigated. These represented two rough conditions, including two rough-cut rod ends, one with an overall angle and one relatively orthogonal, and two medium conditions where a short grinding operation of several minutes was used to flatten the high spots on the rod, and last, a flat condition from cutting with a portable band saw. Figure 28 shows two cast ingots from the medium and rough condition.

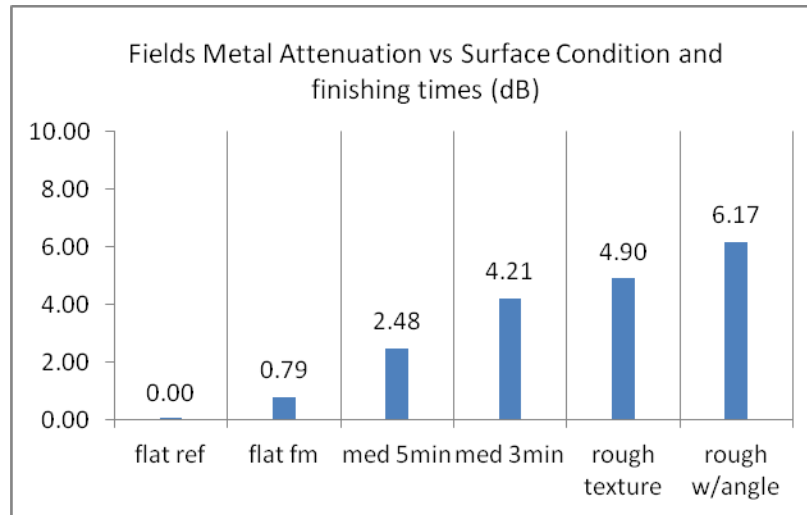
Figures 29 and 30 show the attenuation results from various surface condition comparisons in decibels and percentages. These results are normalized with respect to the transducer coupled on a flat rod end. This process removes the material attenuation and provides a frame of reference with respect to an ideal condition.

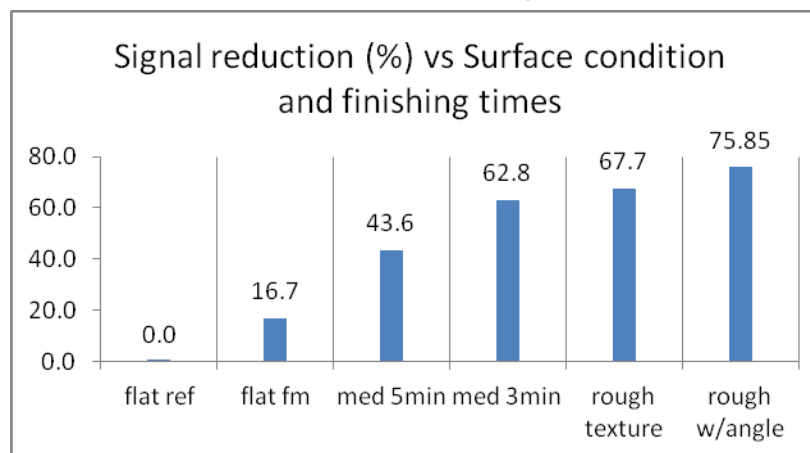
Figure 30. Field's metal coupling performance to various surface conditions in percentages.

These findings indicate, as expected, that the Field's metal coupling performance degrades with surface roughness due to destructive phase interactions at the Field's metal/rod interface. Based on these numbers, it is still possible to receive backwall reflections on most rough-cut rod surfaces. Using a system dynamic range of 108 dB and the .2 and .6 dB loss rates for 1.25 and 1.125 in. diameter rods, respectively, Table 4 was

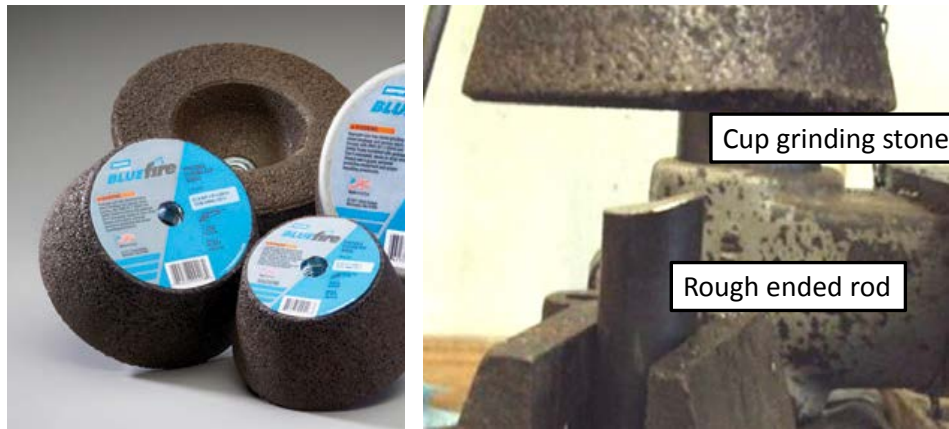
Example pictures of grinding cups are shown in Figure 35 (left), and Figure 35 (right) shows the grinding cup used in this investigation prior to grinding a rough ended rod. The mechanism in this experiment was swung in a rotational arch instead of a linear path.

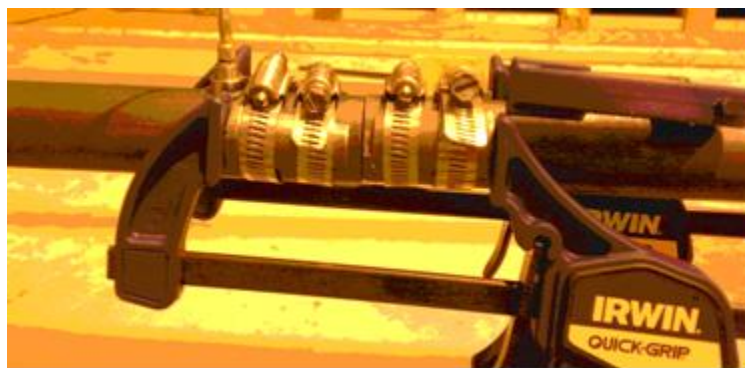
The tested trunnion rod has a diameter of 31.75 mm. The crack imitation was presented by contact of two rods having lengths of 6.07 m and 9.2 m. Both rods were connected together using clamps as shown in Figure 46.

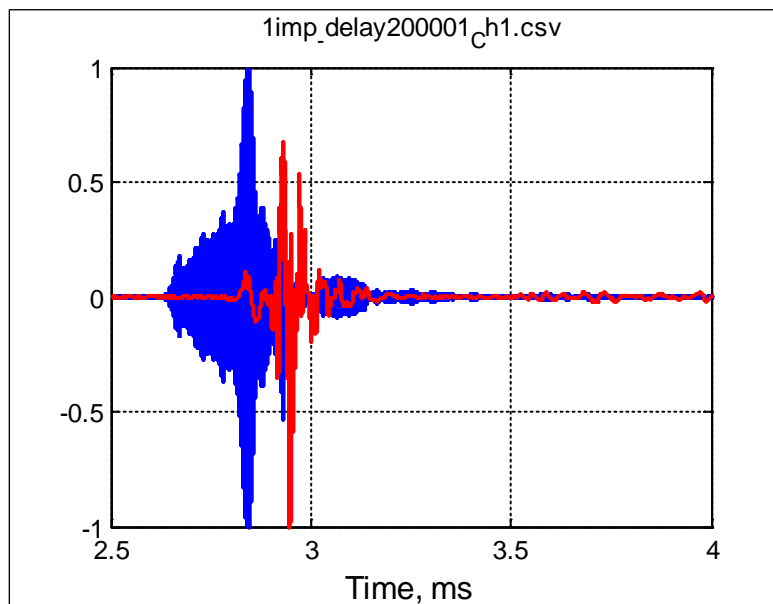
Figure 49 shows the signals received by the Panametrics sensor on the right side. It indicates that the beginning of the HF pulse had less amplitude than the second part of the pulse. This means that the interaction of the HF pulse with the LF mechanical pulse led to the increasing of the HF pulse amplitude while that portion of the pulse that does not interact remains unchanged.

The increasing of the HF signal reflected from a simulated crack in the time of interaction with the LF mechanical wave can be explained by increasing the average contact area under the action of the mechanical pulse. The increasing of contact area led to increasing of the energy of the wave passing through the crack and decreasing of the wave reflected from the crack.
