SIO Shipyard Representative Bi-Weekly Progress Report

Project: AGOR 28	Contract No.: N00014-12-C-0305	Shipyard: Dakota Creek Industries
Prepared by: Paul D. Bueren Scripps Institution of Oceanography (SIO) 297 Rosecrans St. San Diego, CA 98106	Date: 26 May 2015	Program Officer: Robert (Tim) Schnoor Office of Naval Research 875 Randolph St ONR 321 Arlington, VA 22203-1995
Distribution Statement A: Approved for public release; distribution unlimited.		Report No. A002.079

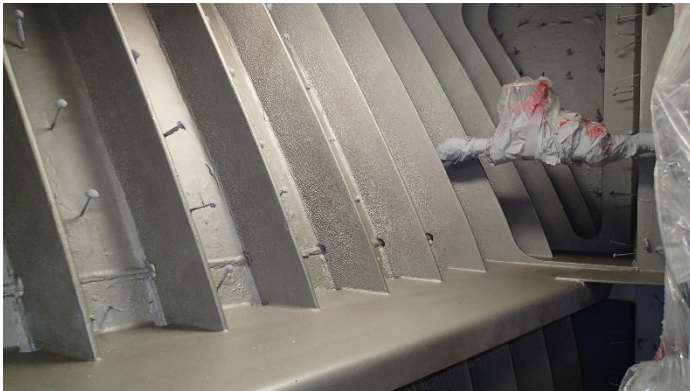
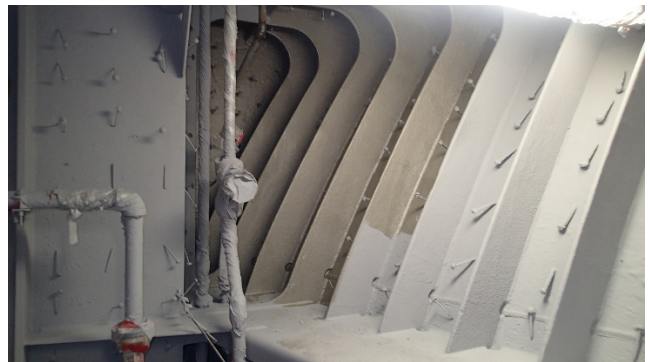
Bow Thruster Room – Port and Starboard

- **Tuff-Mass MLV and Acoustic Tiles** – The application of Delta-db in the BT room is complete and the treated surfaces are being painted. Tiles have been removed from the Tunnel Thruster space. To date, these and the area below the anti-roll tank are the only locations where the yard has removed tile.

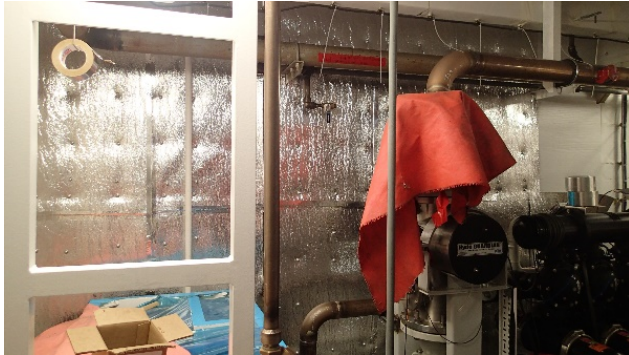
- **Sally Ride Quad-Zero MLV** – The yard continues to install the Quad-Zero in location with no sound dampening tiles. This includes the Main Engine Space overhead and aft bulkhead. The insulators switched to a 4-inch wide foil tape vice the 2-inch tape used previously, as they were having trouble getting the narrower tape to adhere to the insulation panels that are sheathed in Mylar.

Upper Machinery Space, Aft Starboard Bulkhead with Quad-Zero

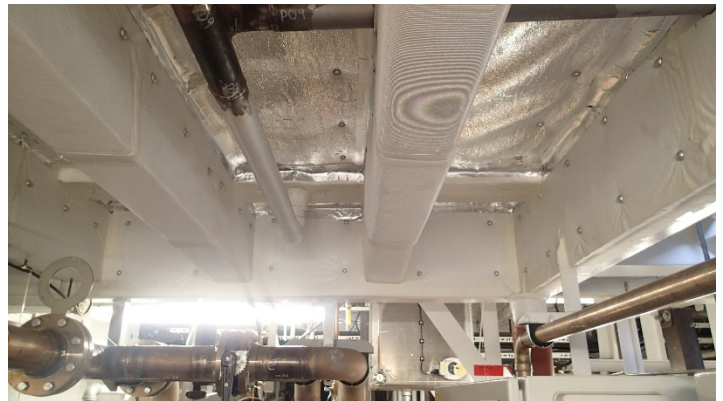
Engine Room Overhead Aft – Quad-Zero and Mylar Sheathing

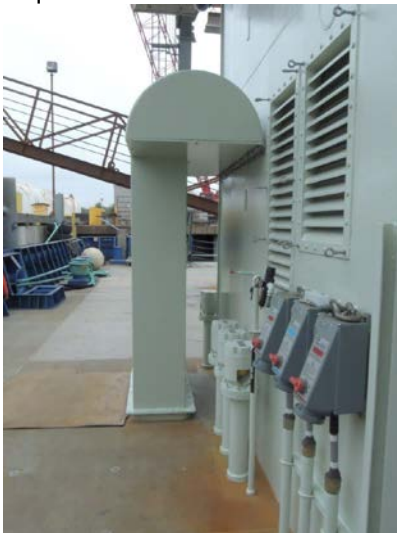
- **Main Deck Vent Closures** – DCI has installed a traction winch exhaust ventilation gooseneck on the main deck of Armstrong. The vent is fitted with a hinged closure and will meet reg body requirements. Functional but not pleasing to look at.

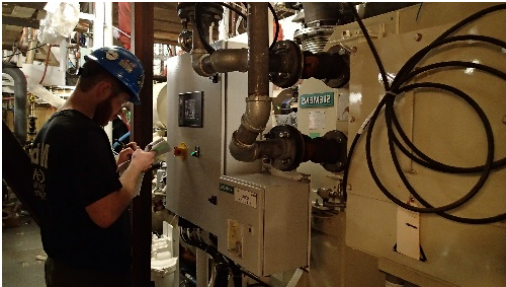
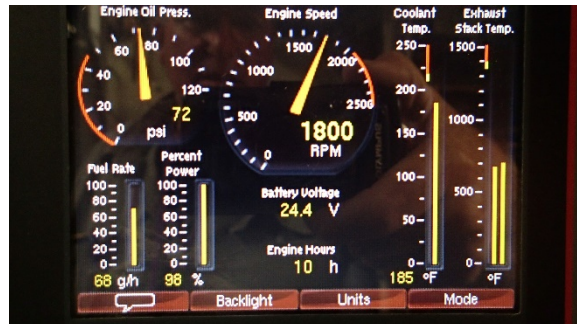
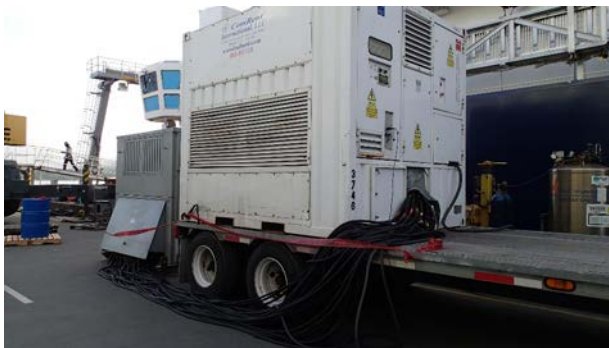
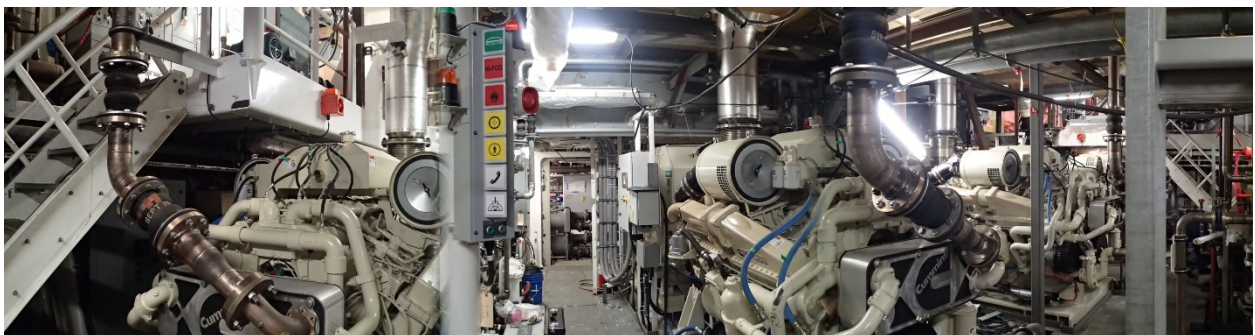
- Load Bank Testing - The Emergency Genset was tested at 100% load for 4-hours. The SSDG's were tested two at a time while in parallel for a total of 4-hours each at 100% load. Prior to load banking all engine alarms and shutdowns were demonstrated and found to be functioning. Siemens is now grooming their systems to the engines. Testing of various AC plant configurations and loads will continue this week.

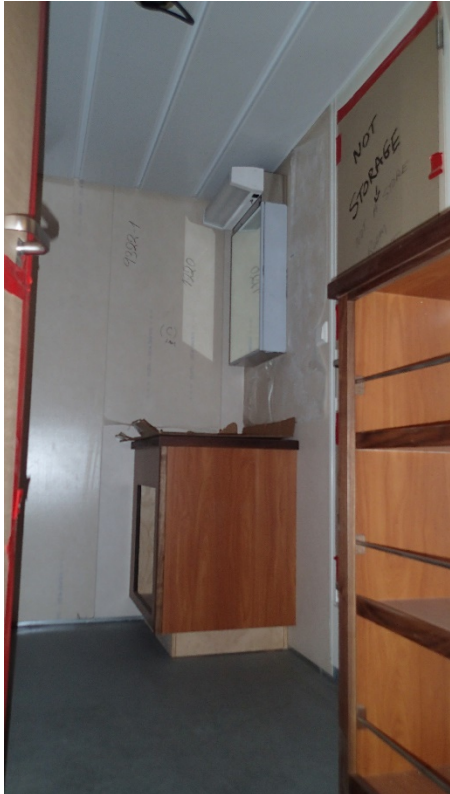
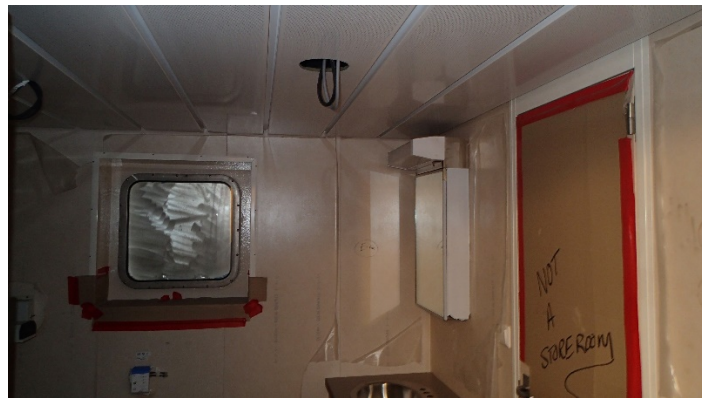
- Engine Exhaust – Work continues on completing the exhaust system insulation. During load bank testing, each exhaust joint was inspected for leaks while the engine was at 100% load.
- Central Fresh Water Cooling – Heat runs were performed on both pump sets, with cold and hot resistance readings. Current, voltage, flow and pressure readings were taken at 15-minute intervals for one hour.
- Sea Water Cooling – Heat runs were performed as described above.
- Deck Machinery Hydraulic Piping – Hard pipe is installed and leak testing has been started.
- Accommodations – Ceiling panels are up in several Foc'sle deck staterooms. Furniture and fixtures are being installed.
