# Mount St. Helens Ecosystem Restoration General Reevaluation Study Reconnaissance Report

Sediment Retention Structure on the North Fork Toutle River

July 2007

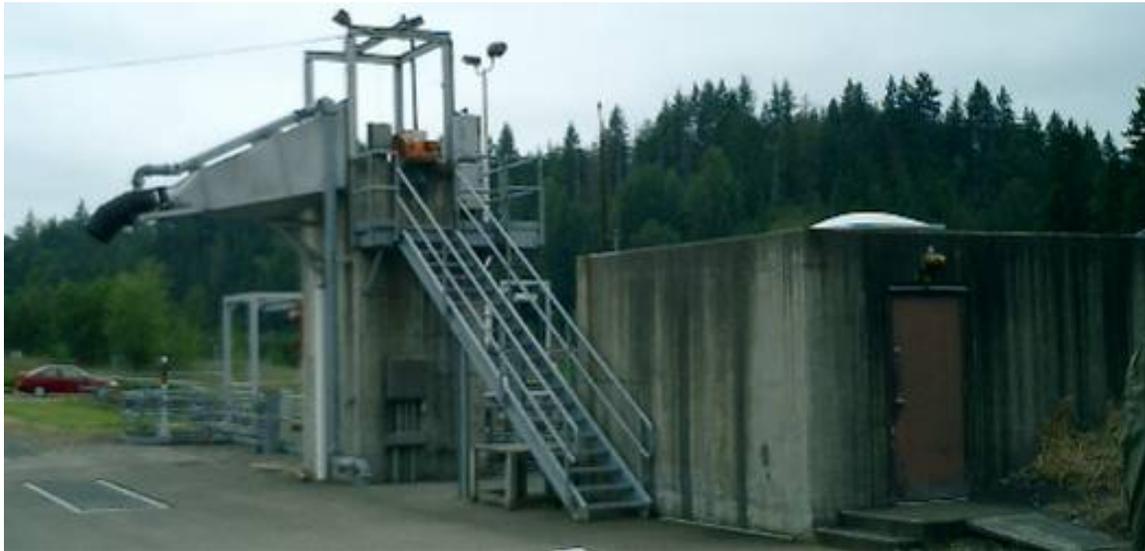
*Figure 3. Fish Collection Facility Downstream from the SRS*

As mitigation for the SRS, a trap-and-haul FCF was funded and constructed by the Corps on the North Fork Toutle River 1.3 miles downstream from the SRS to facilitate fish passage (Figure 3). The FCF was turned over to the State of Washington to operate and maintain. Adult steelhead trout (*Oncorhynchus mykiss*) and coho salmon (*Oncorhynchus kisutch*), both threatened species under the ESA, are collected at the FCF. Fish are collected by diverting a portion of the river above the FCF into a fish ladder. Fish are attracted by this flow into the ladder and move up into a collection pond. Fish are then moved into transport tanks on trucks and taken to two upstream release locations (Hoffstadt and Alder creeks). Transported fish are released randomly in each stream without knowledge of their stream of origin. Large sediment volumes in the North Fork Toutle River have contributed and continue to contribute to FCF operational problems.

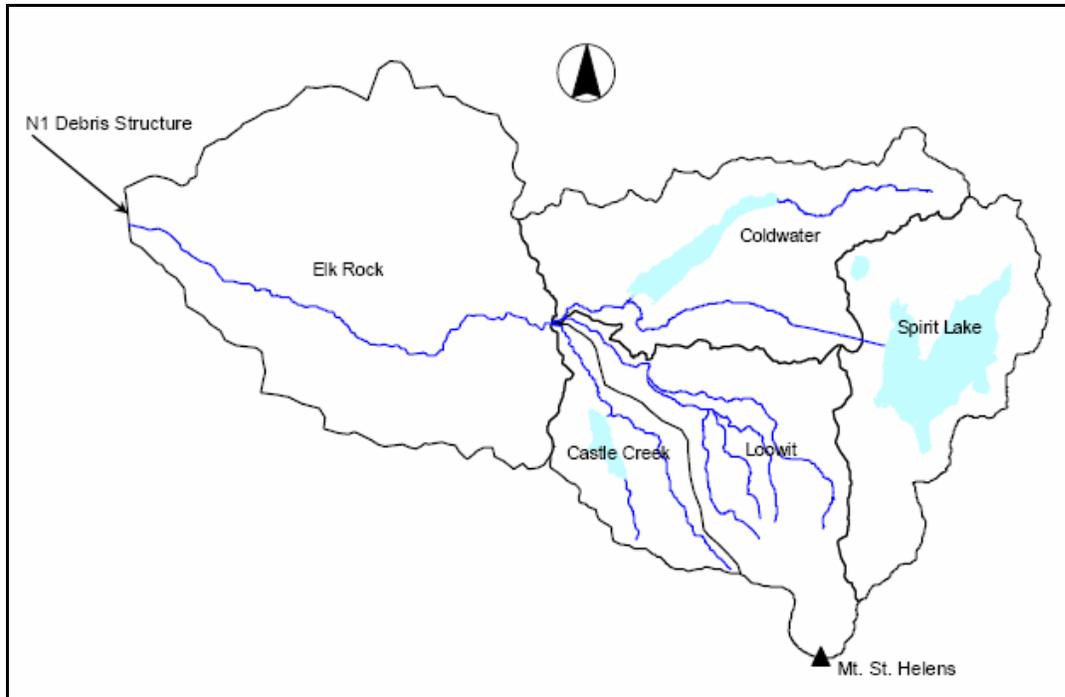
Figure 6. Primary Sediment Source Sub-areas above N-1 Debris Retention Structure

Figure 6 shows the primary sediment sub-areas in the Toutle River watershed. Digital Elevation Models (DEMs) were developed from aerial photography for 1987 (pre-SRS) and 1999 in the form of Triangulated Irregular Networks (TINs) as part of the Corps' 2002 Mount St. Helens Engineering Reanalysis study. The DEMs were used to estimate the total erosion on the debris avalanche upstream of the SRS and the total deposition behind the SRS from 1987-1999 (Figure 7 and Table 2).

Erosion estimates were defined for each of the primary sediment sub-area on the debris avalanche. These sub-areas include Elk Rock, Coldwater, Castle, and Loowit creeks. Deposition estimates were developed for the North Fork Toutle River between the SRS and N-1 debris retention structure. The Elk Rock and Loowit sub-areas accounted for the majority of sediment yield to the SRS and North Fork Toutle below SRS; when combined, these two sub-areas account for 78% of total debris avalanche erosion from 1987 to 1999.

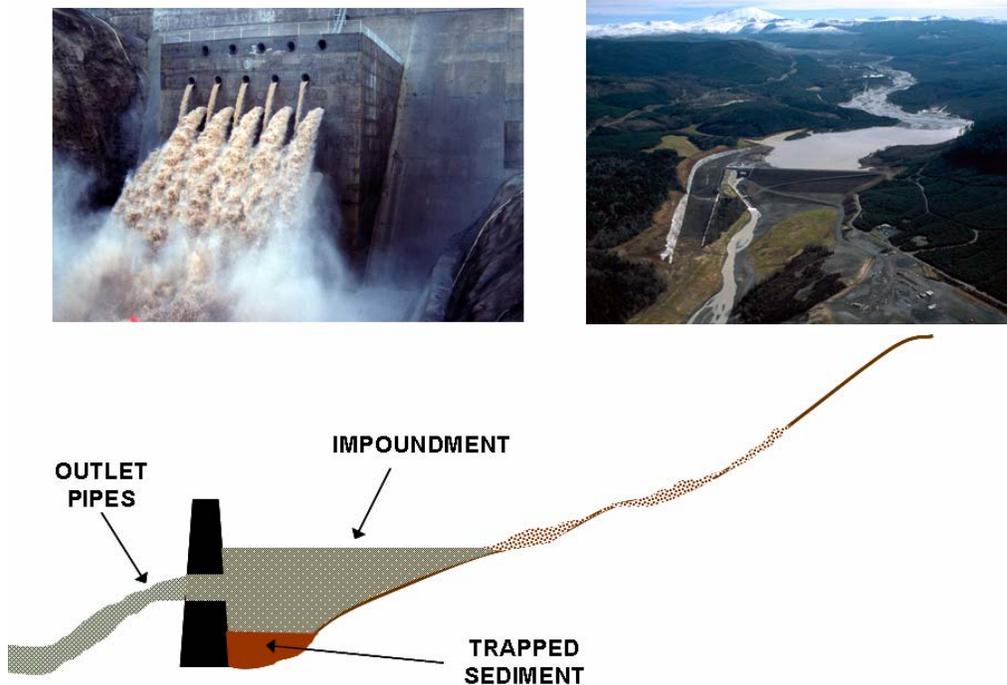
Figure 9. Phase I Operation, Photographs of Outlet Pipes and View Showing SRS

For phase I operation, an impoundment was created by the dam and water was discharged through a series of outlet pipes (Figure 9). During phase I the majority of sediment moving through the system was deposited behind the SRS. Only silts, clays, and some very fine sand passed through the SRS via the outlet pipes. As sediments filled the impoundment, water was discharged through rows of outlet pipes at a higher elevation. Table 3 shows the dates when each row of outlet pipes were closed. By April 1998 the last row of outlet pipes was closed and nearly 90 million cubic yards (mcy) of sediment had filled behind the SRS. The upper row of pipes may be reopened, if necessary.

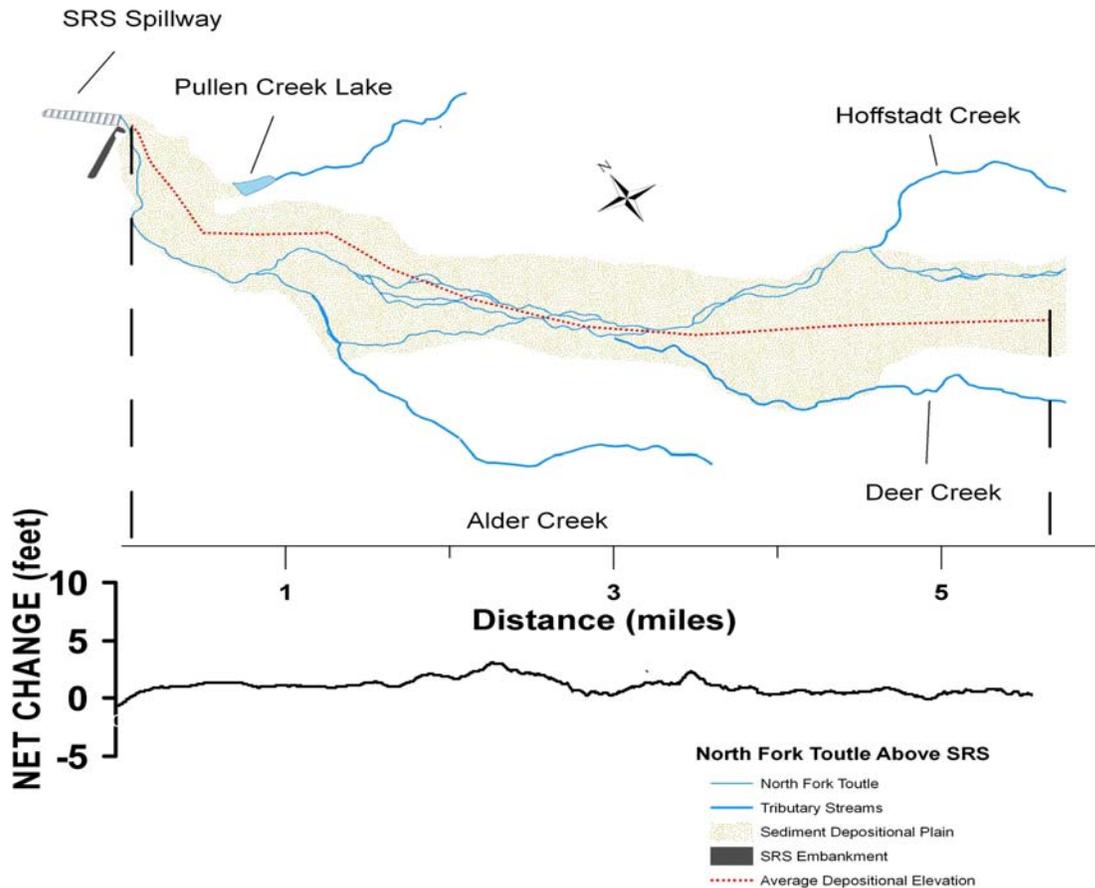
Figure 11. Tributaries to North Fork Toutle above SRS, Net Elevation Change 2005-2006

Figure 11 shows a general schematic of the tributary streams draining the North Fork Toutle through the sediment plain and a relative change in ground elevation (2005-2006) throughout this reach.

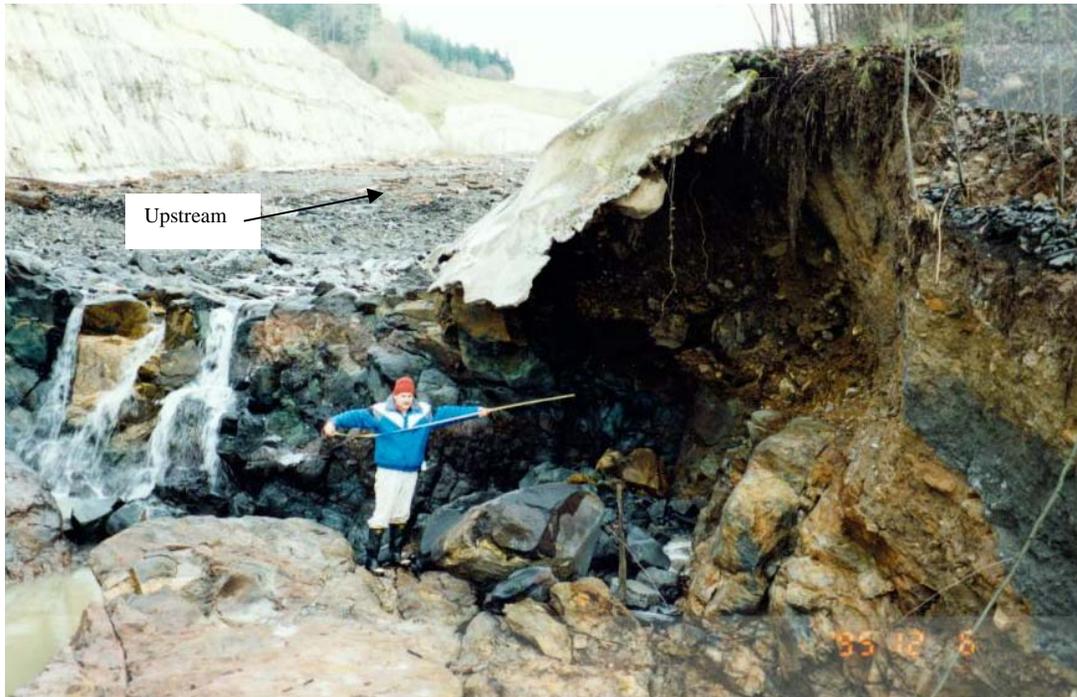
*Figure 12. 1995 Erosion Creating the Falls*

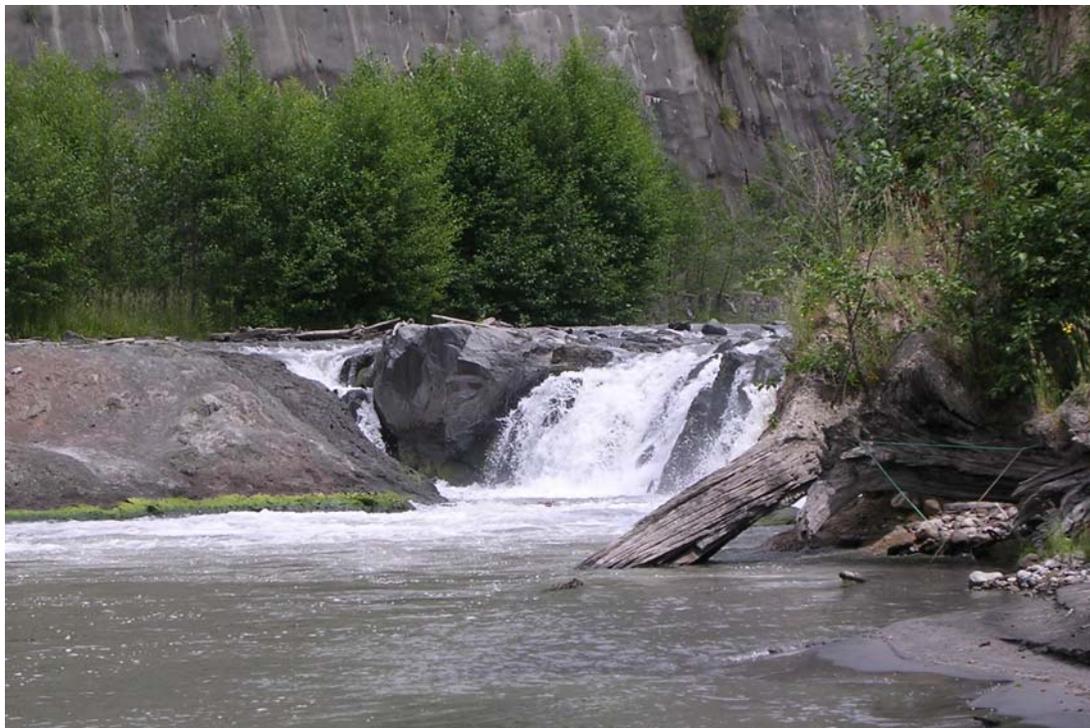
*Figure 13. The Falls Today*
