Award Number: W81XWH-10-1-0933

TITLE: Ready to Use Tissue Construct for Military Bone & Cartilage Trauma

TYPE OF REPORT: Final

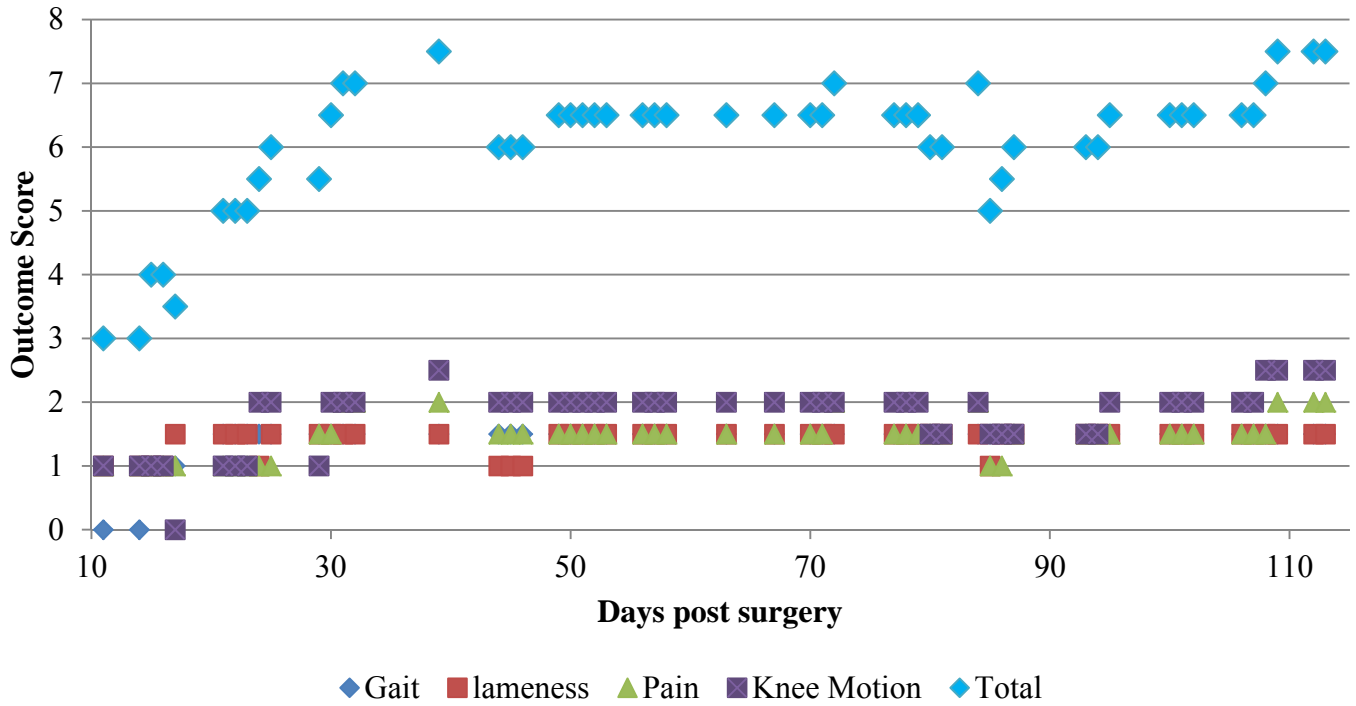
Figure 4: Outcome measurement for Osteochondral Defect Dog 1.

Outcome measures of gait, lameness, pain, knee motion and an aggregate of these measures were recorded for Osteochondral Defect Dogs 1, 2 and 3 every weekday, excluding Saturdays and Sundays and reported below in Figures 3, 4, and 5, respectively. The criteria used to determine the outcome measures are provided in Table 1. However, because sling walking was prescribed immediately following surgery, no outcome measures were obtained until Day 10 for all three dogs. Figure 4 shows that Dog 1 had a steady improvement in its aggregate outcome score until approximately 40 days post-surgery. After that point, the aggregate outcome score leveled off and remained somewhat constant until sacrifice. Figure 5 shows that Dog 2 started out with a relatively high total outcome score, but then the score degraded at about day 30 post-op and remained low until sacrifice. Figure 6 shows that Dog 3 had a steady improvement in its total outcome score until approximately day 30 post-op, after which the score plateaued and remained relatively high until sacrifice.

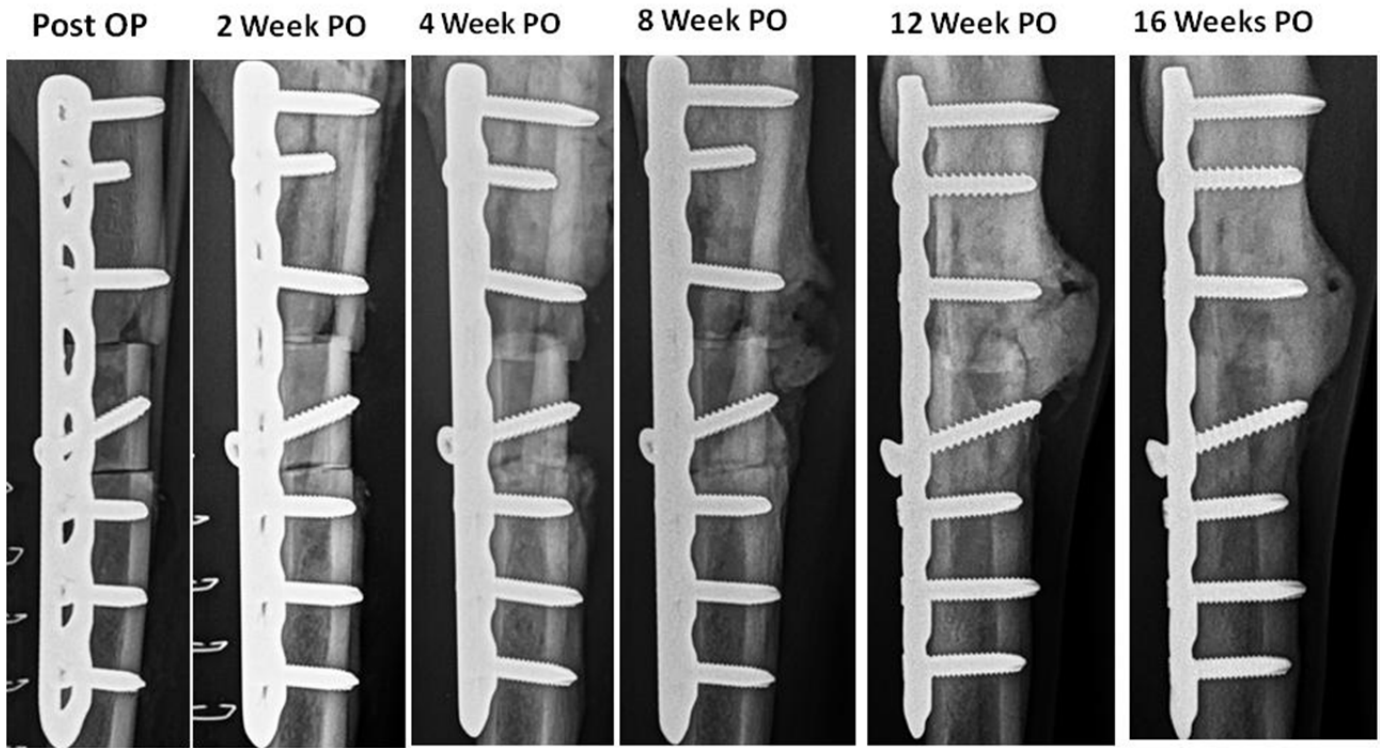
Figure 28: Radiograph of lateral view for Segmental Defect Dog 6 (allograft) as a function of time showing progress of callus formation in the vicinity of the allograft (the area between the two cuts with an oblique screw). As for Dog 5, by post-op week 8 the gaps between both superior and inferior ends of the allograft was clearly narrowing

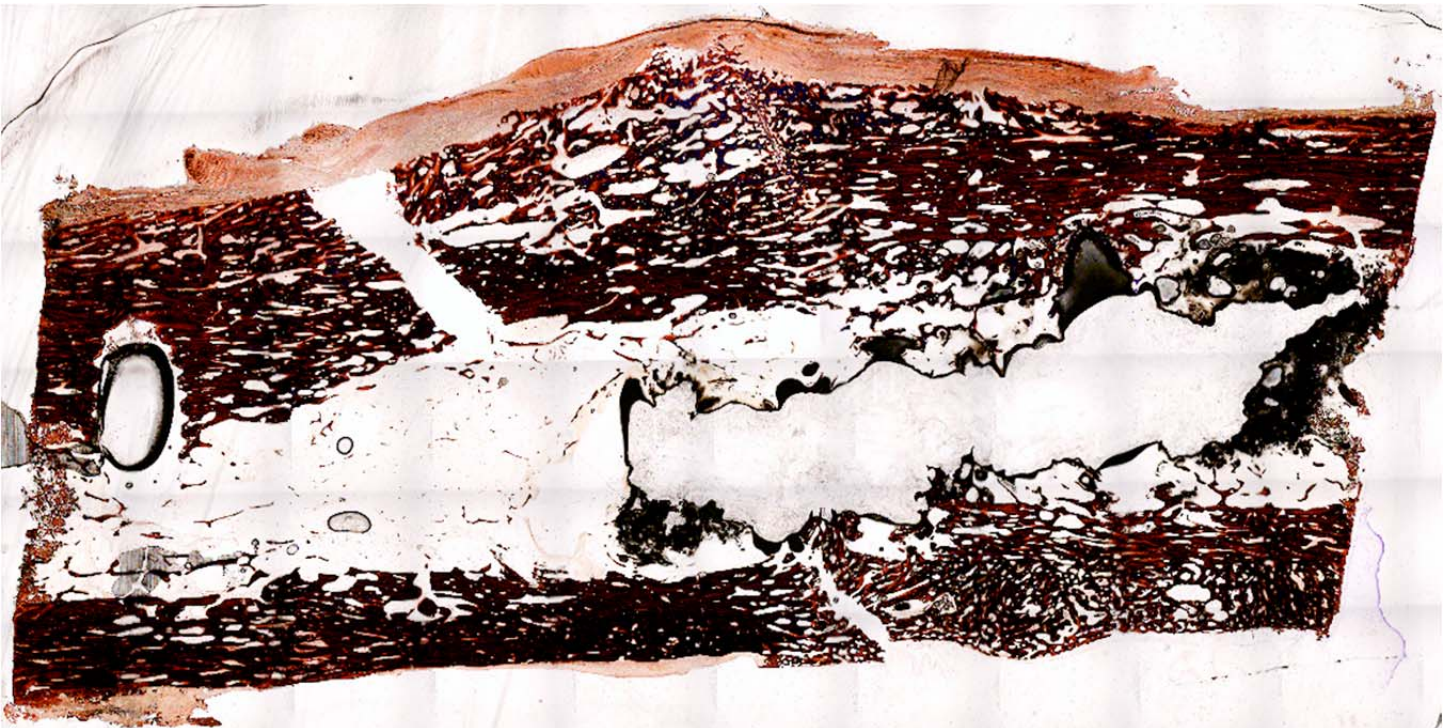
Figure 92: Hard sectioning histology image of Segmental Defect Dog 5 implanted with canine cadaveric allograft, stained by Masson's Trichrome method. Overview of mid-diaphysis of right tibia with canine cadaveric allograft. The black tissues in the middle level at right half are the bone marrow soft tissues. The oblique crack was the fracture generated by biomechanical testing.

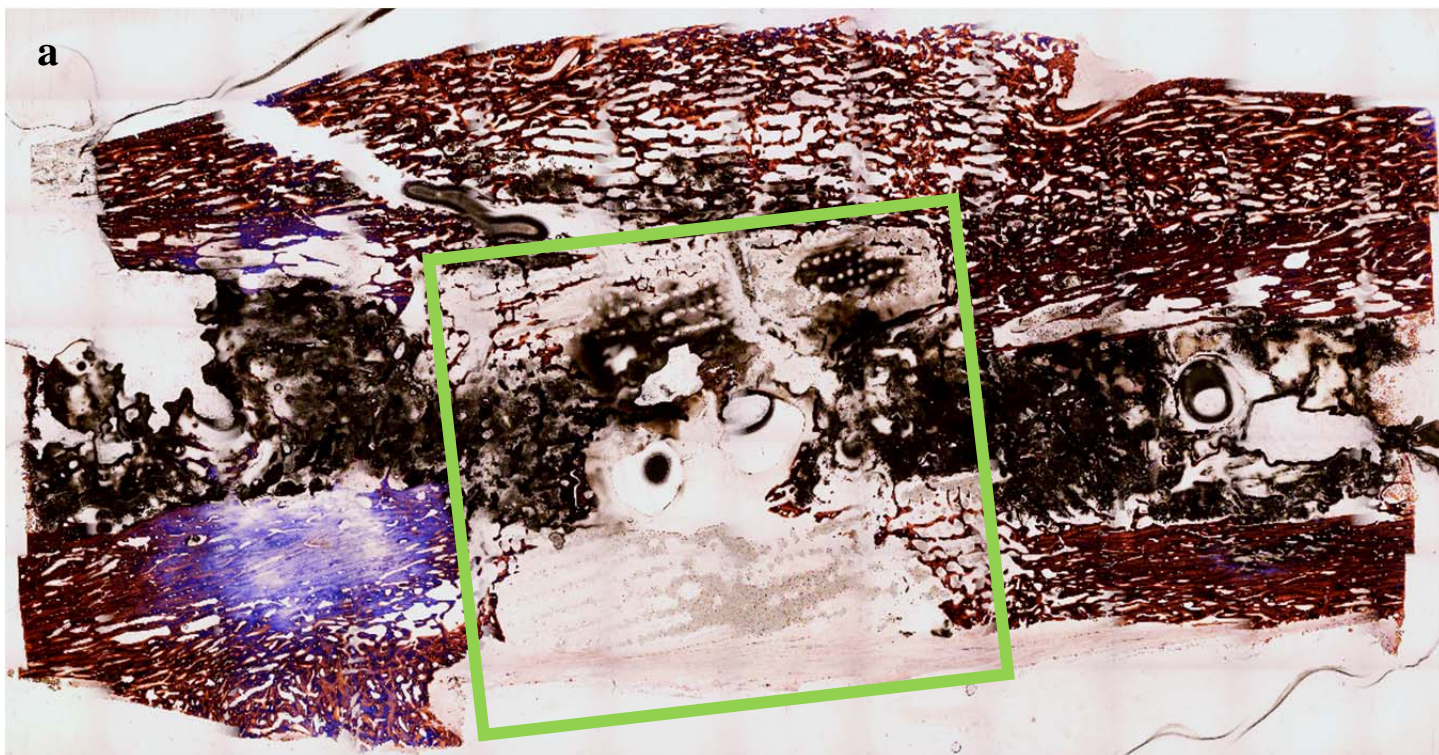
Figure 94: Hard sectioning histology image of Segmental Defect Dog 4 implanted with unseeded scaffold, stained by Masson's Trichrome method. (a) Overview of mid-diaphysis of right tibia with unseeded scaffold, (b) close-up of green rectangular region coming from another Trichrome-stained slice, (c) close-up of red rectangular region. The oblique crack was the fracture generated by biomechanical testing.
