Final Environmental Assessment

13th Street Bridge Emergency Repair and Retrofit

Vandenberg Air Force Base California

23 June 2003

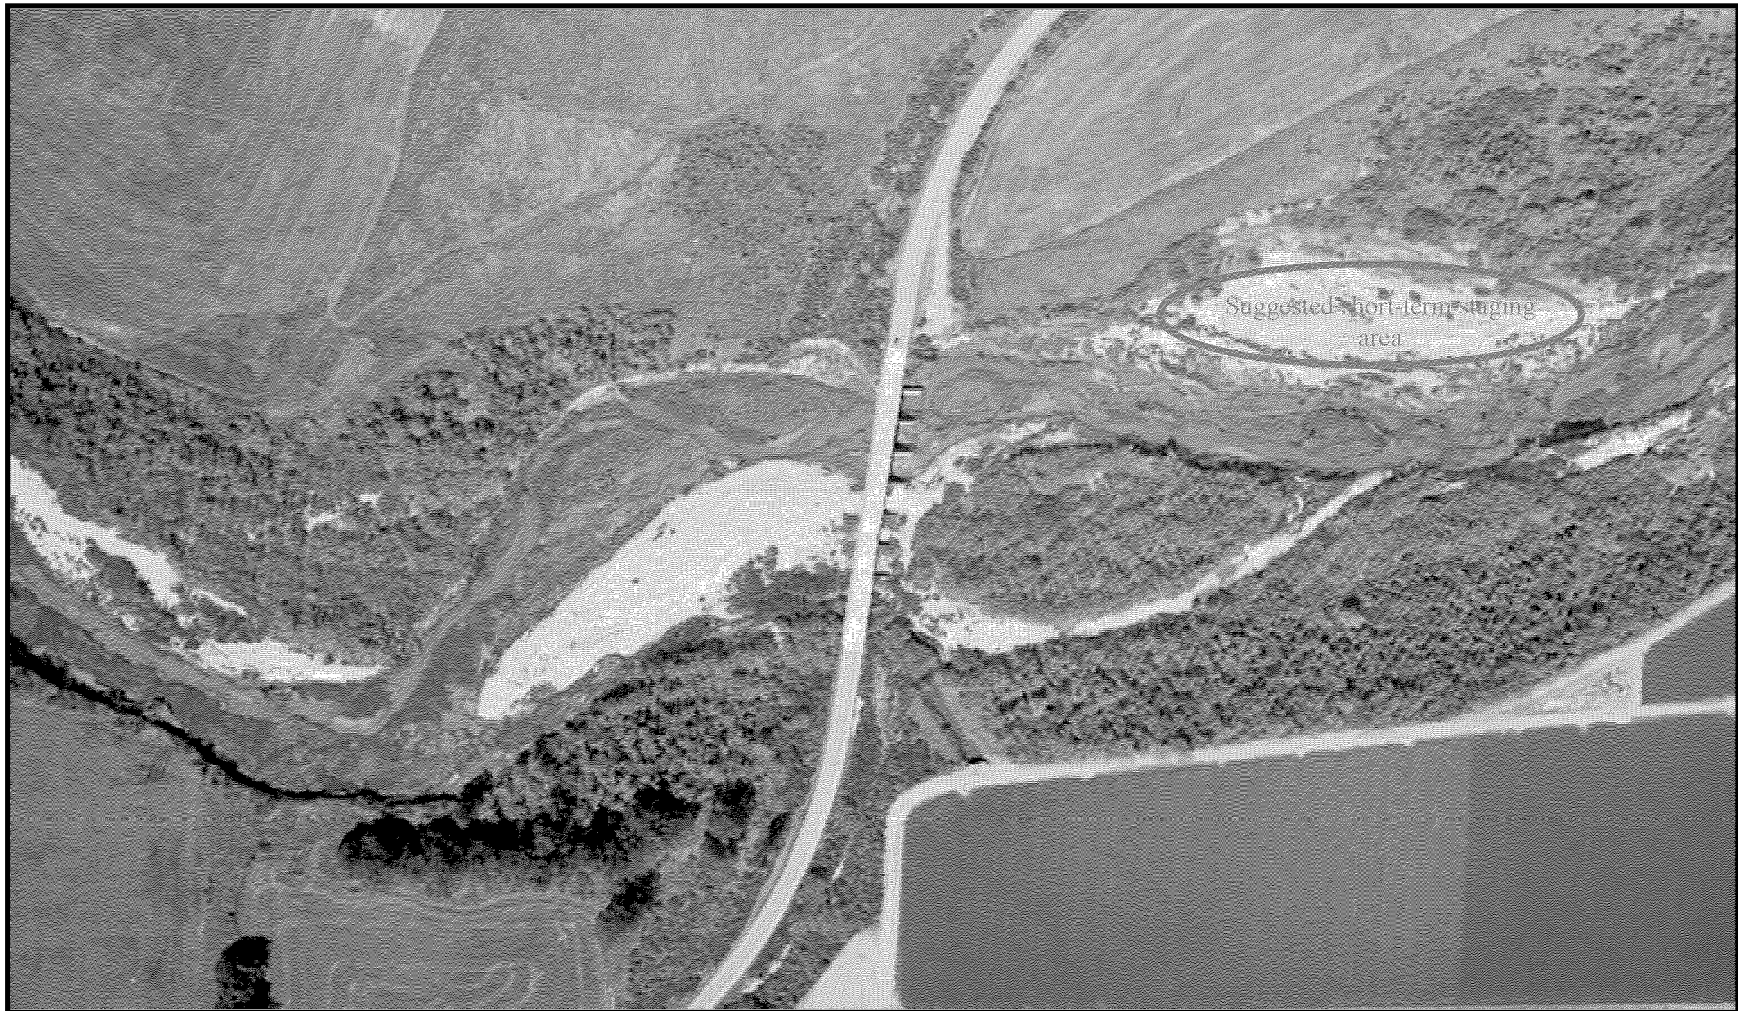
Figure 2-6. Aerial view of 13th Street Bridge vicinity and suggested short-term staging area in upstream unvegetated sandbar for proposed retrofit project.
