SERDP / ESTCP Workshop
Surface Finishing & Repair Issues for
Sustaining New Military Aircraft

Cadmium Alternatives for High-Strength Steel
JTP – Phase II

Fiesta Resort and Conference Center
Tempe, AZ
27 February 2008

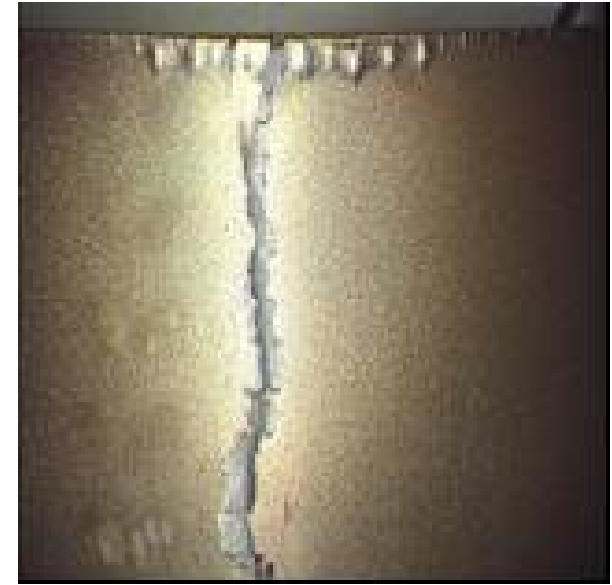
- All primary coatings passed appearance testing
- Mixed stripability results
 - LHE Zinc-Ni failed due to change in bend adhesion in 1-2 bend cycles
- Mixed Bend Adhesion Results
 - All Primary Coatings passed using both 4130 steel & 17-4 stainless
 - LHE Zinc-Ni and electroplated Al failed bend adhesion for Ti-6-4 due to spalling and edge buckling respectively

Electroplated
Aluminum on Ti-6-4

Coating	Bend Adhesion Results		
	4130 steel substrate	17-4 PH stainless substrate	Ti-6-4 substrate
LHE Cadmium (Baseline) – Hill AFB	Not required	Pass	Pass
IVD Aluminum (Baseline) – Hill AFB	Not required	Not required	Not required
LHE Zinc-Nickel (Dipsol IZ-C17)	Pass – cracking of coating up to 3/8”	Pass – no cracking or defect	Fail – during 1 st bend cycle; spalling beyond 3/8”
Electroplated Aluminum	Pass	Pass - no cracking or defect	Fail – edge buckling to 1/2”
Sputtered Aluminum	Pass- no cracking or defect	Pass - no cracking or defect	Pass - no cracking or defect

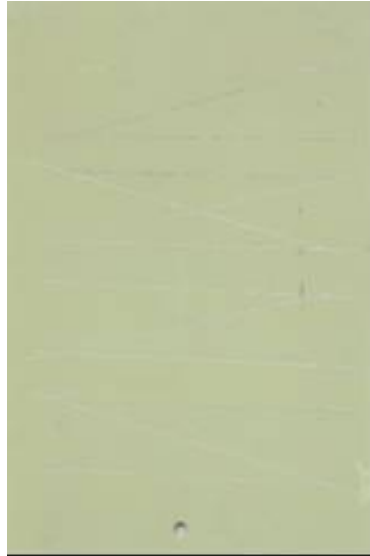
**IVD Al with MIL-PRF-85582 C1,
after 4 days**

Primer Application →	MIL-PRF-23377, Class C2			MIL-PRF-85582, Class C1			MIL-PRF-85582, Class N		
	1 day	4 days	7 days	1 day	4 days	7 days	1 day	4 days	7 days
Coating	Test Results (average of 12 measurements)								
IVD Aluminum (Hill AFB)	5B	5B	5B	5B	5B	5B	5B	5B	5B
LHE Zinc-Nickel (Dipsol IZ-C17)	5B	4B	4B	5B	1B	1B	5B	5B	5B
Electroplated Aluminum	5B	5B	5B	5B	5B	5B	5B	5B	5B
Sputtered Aluminum	5B	5B	5B	5B	5B	5B	5B	5B	5B

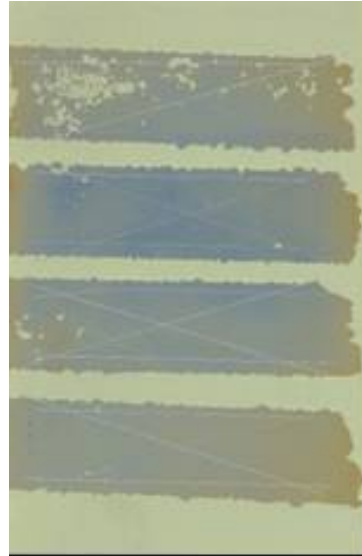
**LHE Zn-Ni with MIL-PRF-85582
C1, after 4 days**

- **Primary Coatings Passed Paint Adhesion Testing with one exception (LHE Zinc-Ni failed for 85582 Class C1 after 4 and 7 days)**
- **Run On/Breakaway torque test results:**
 - Passed for 3/8" fastener
 - 5/8" fastener need to be discussed

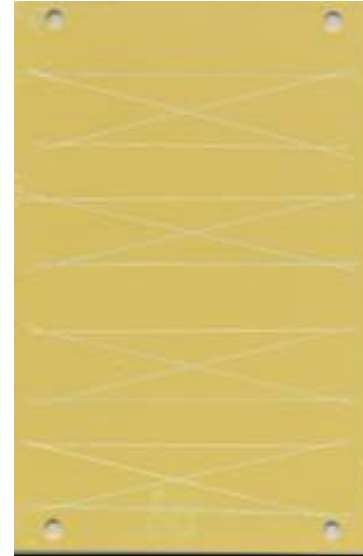
**Electroplated Al
with MIL-PRF-
23377, after 7 days**

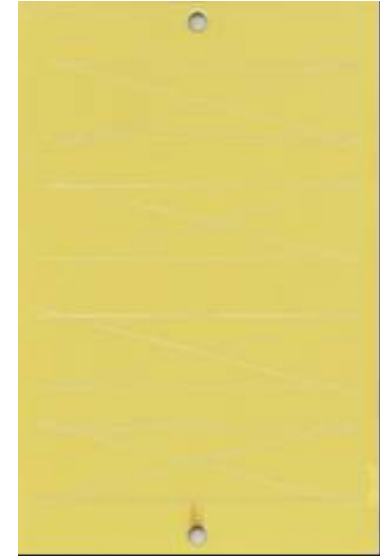
**Sputtered Al with MIL-PRF-23377,
after 4 days**
