VACUUM INSULATOR FAILURE MEASUREMENTS AND IMPROVEMENT*

G. E. VOGTLIN, J. E. VERNAZZA
LAWRENCE LIVERMORE NATIONAL LABORATORY
UNIVERSITY OF CALIFORNIA
LIVERMORE, CA 94550

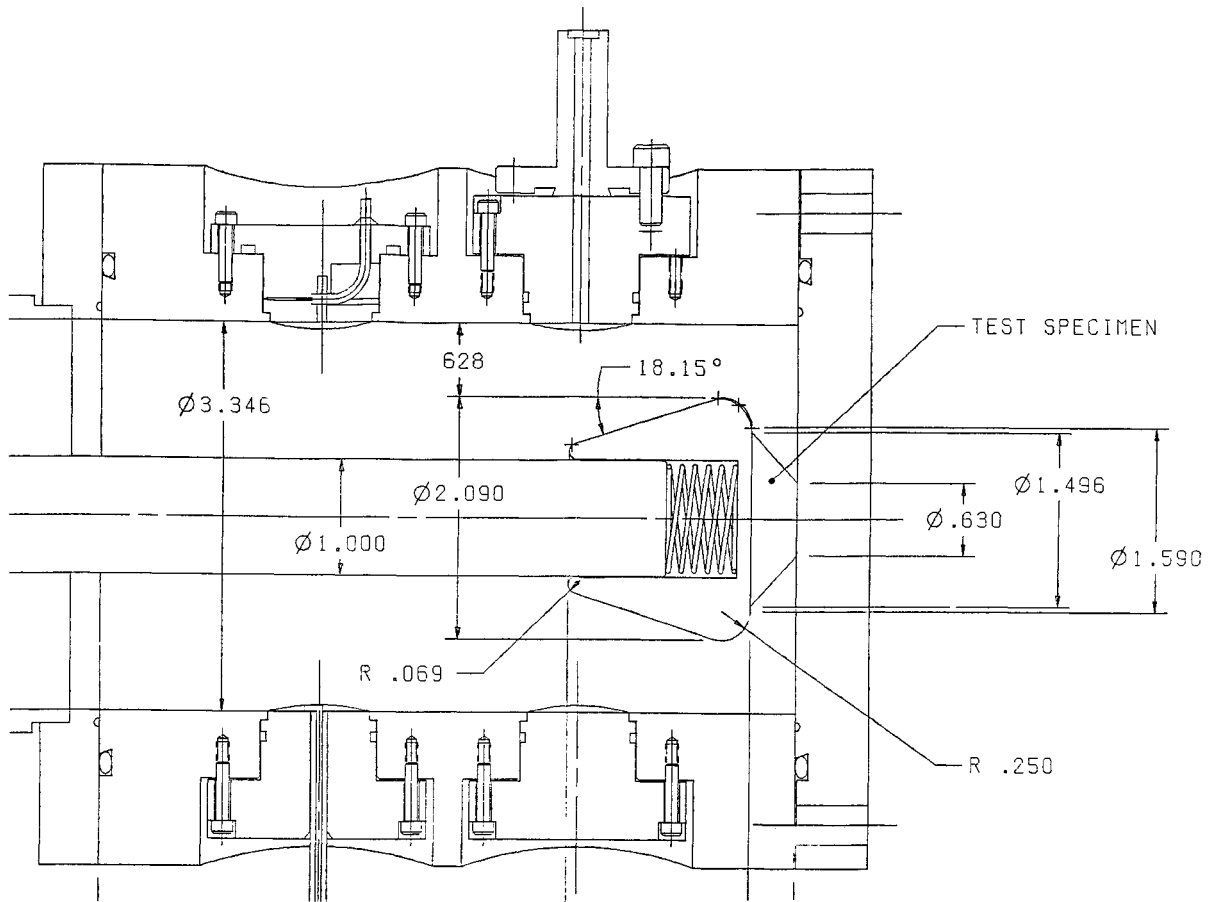
Fig. 1. TEST SETUP

The 3-ns pulse used was constructed by Scarpetti and described in Ref. [6]. The electrode and insulator arrangement is shown in Figure 1.

Specimens were cleaned with isopropyl alcohol and dusted with a micro duster before sealing and pumpdown. In all cases a single shot was fired with each specimen. Cathodes were either refinished or were not reused. Anodes were not always refinished or replaced. The surface smoothness of the insulators did not seem to be a factor; however, all specimens included in the data were polished with a light abrasive. The surface condition can influence breakdown with longer pulses. A particular problem is with microscopic chips stuck at one end in their machining groove. These chips can only be seen by blowing on the specimen in the dark while illuminated by flash light. They appear to be as long as 0.5 cm.

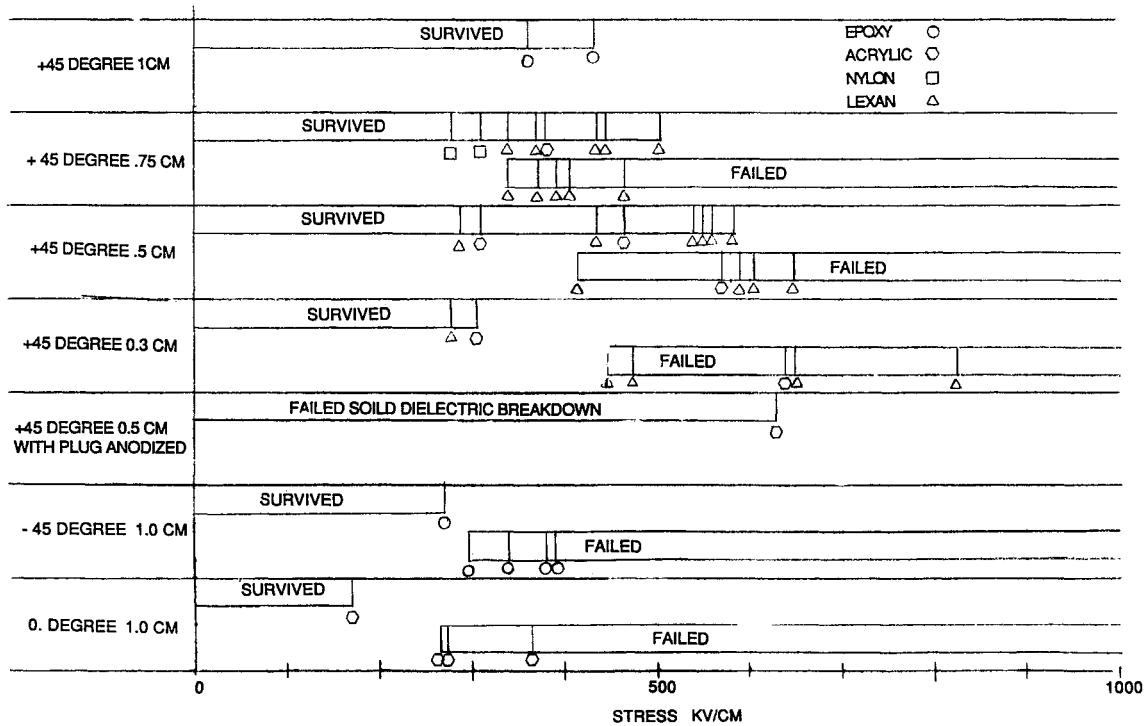
Fig. 2. INSULATOR FAILURE-SURVIVAL CHART

Specimens tested either held the 3 nanosecond pulse or failed during the pulse. Figure 2 shows results of this testing. The first bar on the top shows 3 specimens 1 cm high and a +45° angle. They survived 360 kV/cm and 430 kV/cm. No specimens failed since this was close to the voltage limit of the pulser. The second bar is for +45° 0.75 cm specimens, 7 specimens survived and 5 specimens failed. The highest survival was 505 kV/cm with a Lexan specimen and the lowest failure was 310 kV/cm with a nylon specimen. Data is presented for an angle of +45° with .5 cm and .3 gaps. Other angles are -45° and 0° with 1 cm specimen. The highest level was achieved with a 0.5 cm acrylic specimen with an anode plug to relieve the anode stress and an anodized aluminum cathode surface. The failure was at 620kV/cm. This failure, however, was through the solid dielectric from the plug to the cathode. A description of this specimen is given in Ref. [5].

The 3 nanosecond pulse testing of insulators was similar to previous work with longer pulses. It was found that a positive 45° angle cone held the highest stress. Failure of these cones was associated in most cases with surface tracking which we believe to be indicative of anode induced breakdown. The introduction of an anode plug to reduce the anode stress caused failures that were a higher level and did not involve tracking. We believe these are cathode induced. The use of an anodized cathode and a plug relieved anode resulted in the highest stress before failure, 630 kV/cm, and failed due to solid dielectric breakdown.

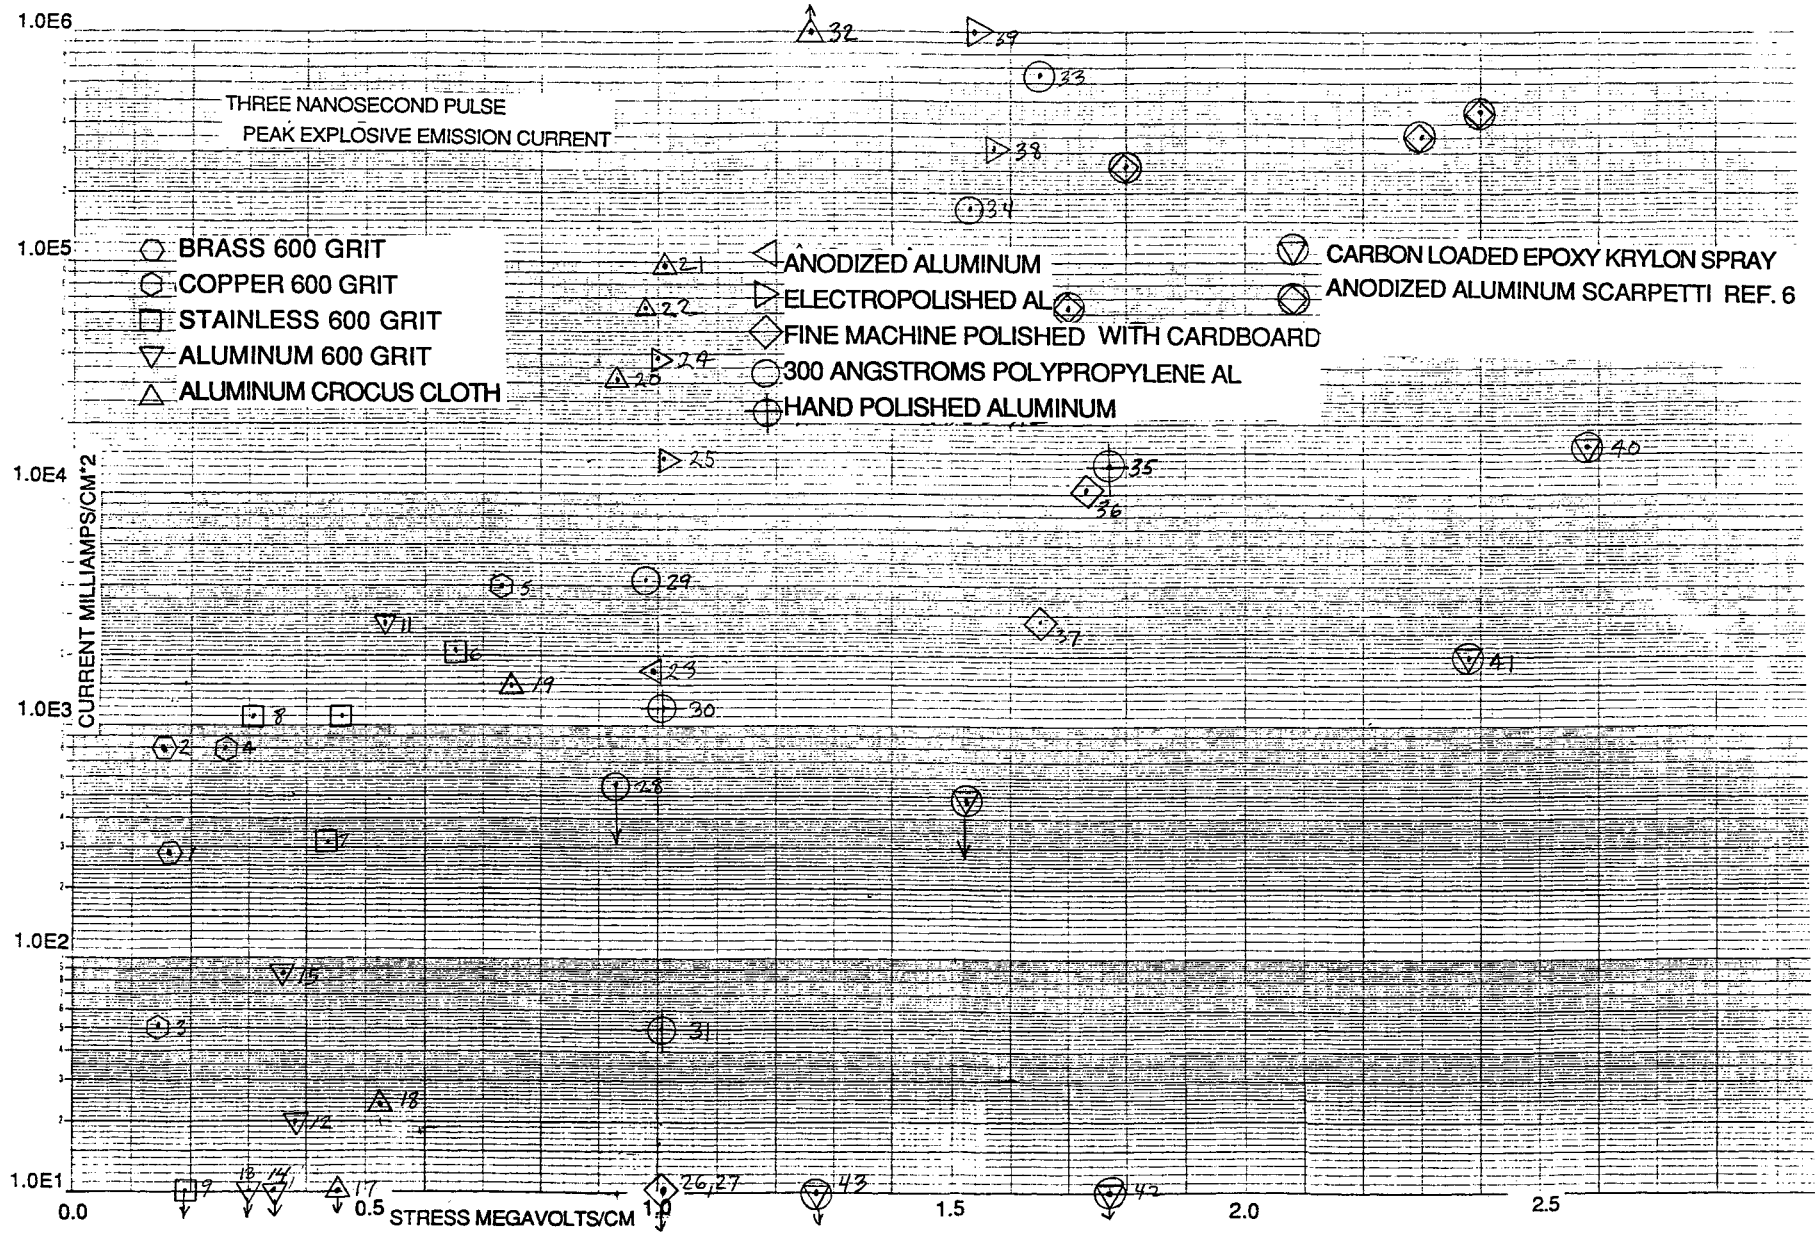
Fig. 3. PEAK EXPLOSIVE EMISSION CURRENT VS STRESS

Field emission was measured with the same apparatus as described in Reference [5]. Figure 3 (current vs stress) shows the results for various metal surfaces. The surfaces tested from 100kV to 800 kV/cm were finished with 600 grit or crocus cloth. Brass with a 600 grit finish gave a peak current of 800 milliamps with a peak stress of 180 V/cm. If we assume an emission per point of 100 ma, then there would be 10 emission points. This is in an area of .785 cm² or 12 points/cm².

Figure 3 from 800 kV to 1.8 meV/cm shows materials such as anodized aluminum and electron polished stainless steel. One specimen held 1mV/cm without measurable current. This specimen was fine machined stainless steel, polished on a lathe with a piece of cardboard. The next best was an aluminum specimen coated with 300 angstroms of polypropylene, which emitted 50 ma at 1 mV/cm.

Another surface tested was aluminum coated with a carbon filled epoxy. The epoxy coating was approximately 0.1 millimeters thick with a surface resistivity of 200-800 KΩ per square. This surface was polished with paper and sprayed with krylon spray, matte finish. Figure 3 shows this surface did not have any measurable emission at 1.7 megavolts/cm. It emitted 3 amps at 2.3 megavolts/cm. This current probably represents no more than two explosive emission points.

It would seem unlikely that an emission point would fall on the cathode triple point; however, the probability always exists even if there is only a single emission point. The plasma expansion from an explosive emission point is on the order of 2.5 cm/μs. This would imply a hemisphere of plasma 1.5 millimeters in diameter at 3 ns. Later at 1 microsecond, this hemisphere would be 5 cm in diameter. The longer the pulse, the more likely that plasma will reach the cathode triple point. The higher the stress without measurable emission, the better the performance of the cathode surface. Other surfaces such as crocus cloth finished aluminum reached 460 kV/cm with less than 10 ma of current.
