REPORT NO. 327/2

RIFLE BARREL STEEL - SPRINGFIELD ARMORY

WATERTOWN ARSENAL
WATERTOWN, MASS.

SUMMARY OF INVESTIGATION OF RIFLE BARREL STEEL

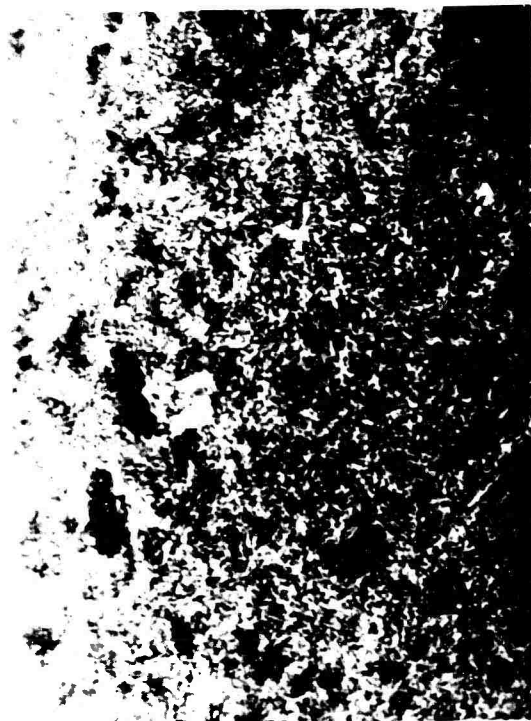
Figs. 5 & 6, X1000, Same as Figs. 3 & 4. The structure was in a hot worked condition.
MG-269 & 270
Plate WA639-702

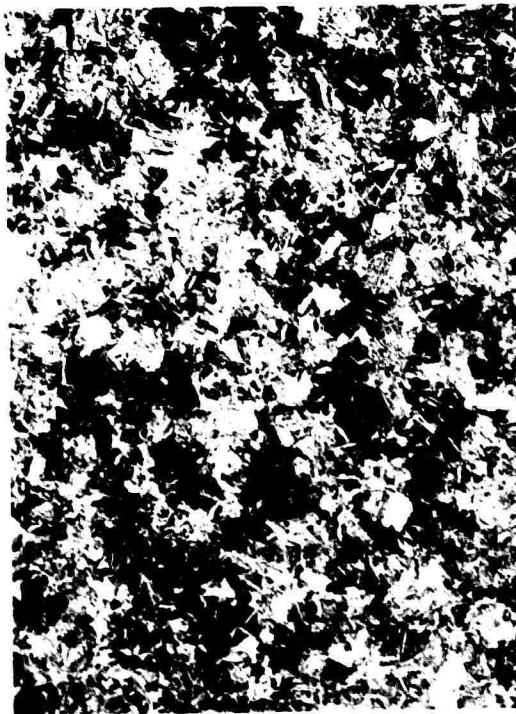
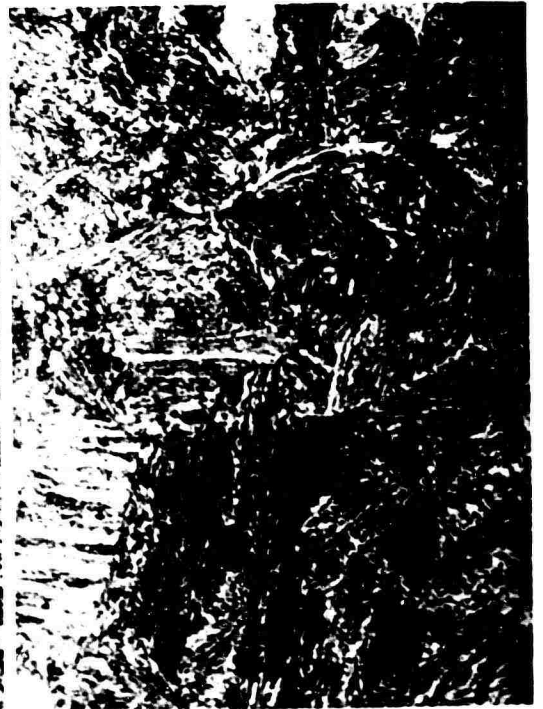
Figs. 13 & 14, X100 & X1000 1% Nital etched. MIA. Somewhat segregated, grain size #6, Hot worked condition.

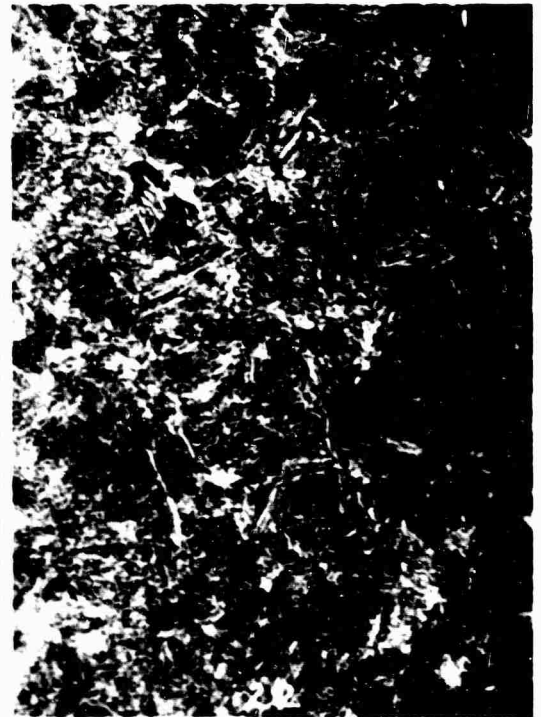
Figs. 21 & 22, X100 & X1000, 1% Nital etched, C2A.
Slightly segregated fine grained
troostite sorbite with some free
ferrite.

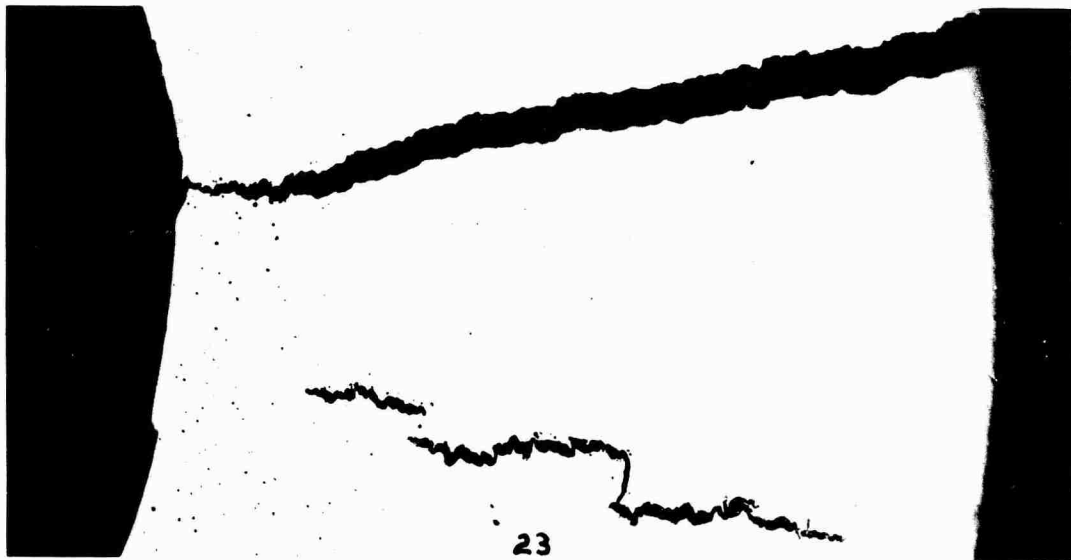
Fig. 23, X25, Unetched AVA. Trans. showing rupture
cracks. MG-257

6. Cal. .30 M1903 Rifle #286901, Mfg. by Avis - This steel was dirty. The inclusions were small, fairly short with a tendency to form chains. The structure was banded, segregated #6 grain size and showed that the steel had been BURNT during the heating for hot forming. The rupture was undoubtedly due to fatigue of burnt steel. No heat treatment short of remelting would have made this barrel safe.

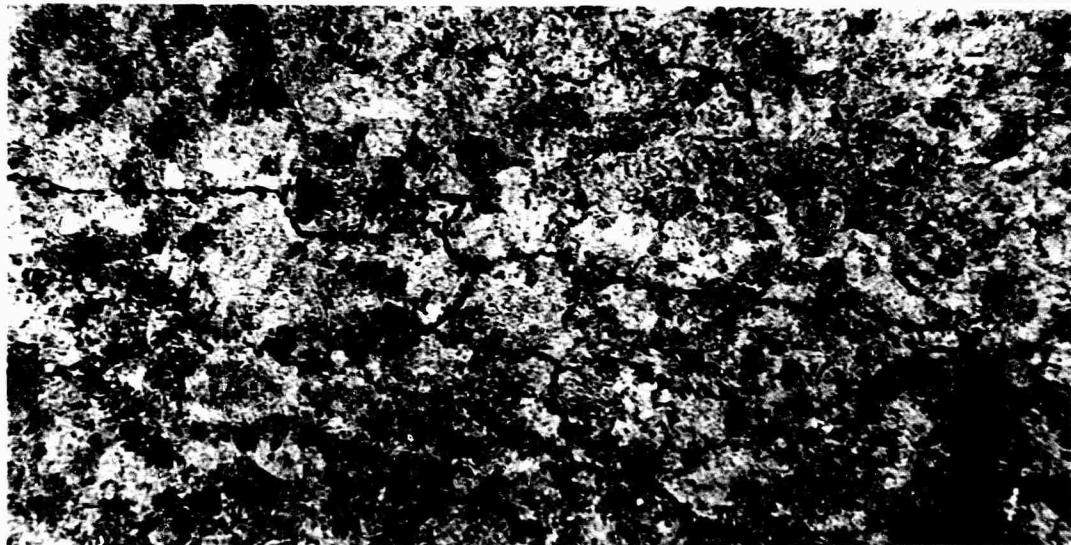
Figs. 24 & 25, X100 & X1000, AVA. Trans. near crack.
Segregations due to burnt condition.
MG-265 & 275

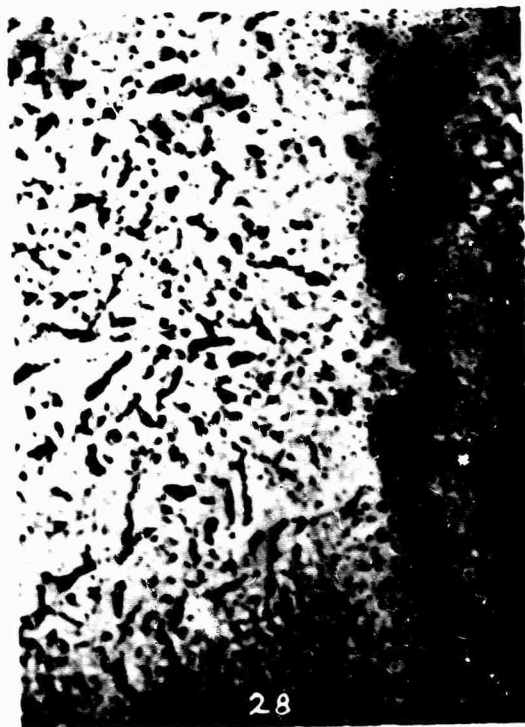
27

Fig. 27, X3, CuCl_2 etched, AVA. Steel is banded.
MG-287

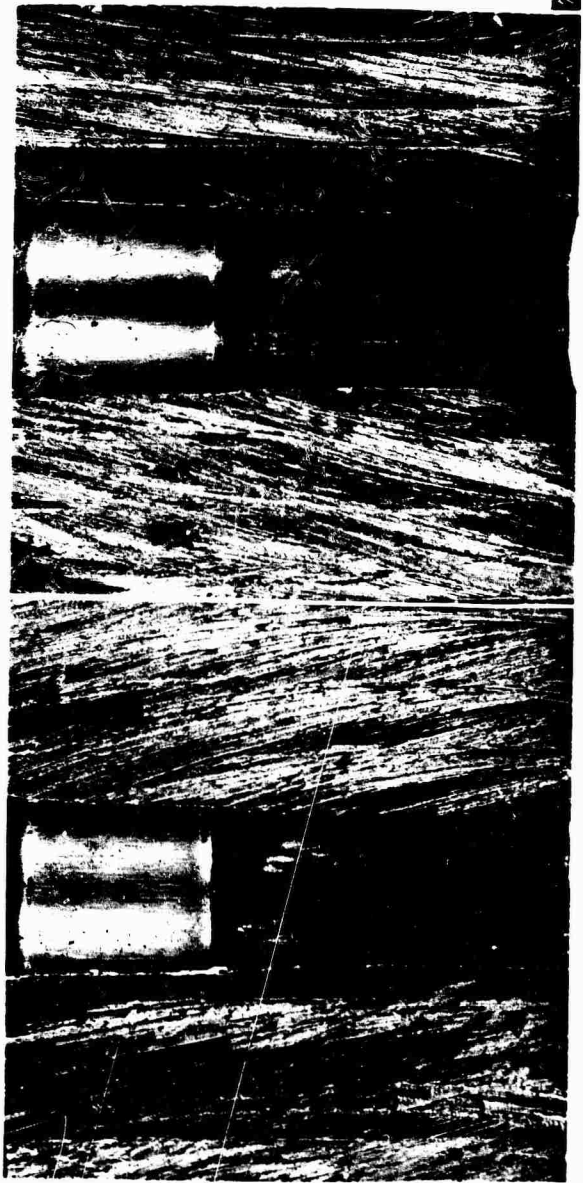
Fig. 1

The condition of the bore is shown in Figure 1. The lands were eroded smooth with grooves; checking and spalling were noticeable. Figure 2 shows the extent of cracking at a cross-section of the bore. Figures 3 and 4 show the intersections of radial cracks with non-metallics strung out normal to them.

Both Halves of Colt Machine Gun Barrel A
(X.O. 47-A19) X3.

Section at origin of rifling.

Fired 10,000 rounds.

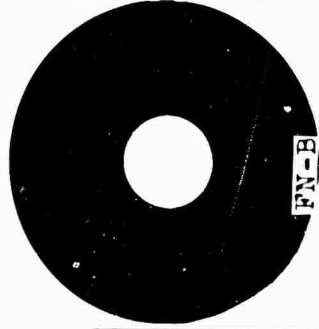
RIFLE BARREL STEEL 6-15-37
740-8

Longitudinal Section Stamped FN-C - The metal shows very fine longitudinal streaks at the outer portion gradually changing to a slightly more prominent similar structure near the bore. The partially finished smooth bore shows no defects.

Transverse Section Stamped A-B - The metal shows a very well worked dendritic structure with slightly more prominent interdendritic material than the FN Steel. Very short radial cracks extend from the bore surface (after firing) for one, two hundredths of an inch.

Longitudinal Section Stamped A-C - The longitudinal streaking is fairly prominent, some of the sulphide and phosphide segregations extending for 1/4". The heat checking in the bore is only found on the lands.

Transverse Section Stamped M1-B - The steel has been well forged and heat treated. The material at the outer portion of the disc shows a very homogeneous and fine macrostructure. The amount of segregation in the center is greater than any of the other steels.

Longitudinal Section Stamped M1-C - As noted in the transverse disc the structure at the outside is clean and uniform but it changes quite suddenly to a heavier streaked section (sulphide and phosphide streak) that is very prominent at the extreme center. Some of the elongated sulphides appear to be about 1" long.

Transverse Section Stamped M2-B - This disc was taken from part 3 of the lot described above and shows practically the same macrostructure. It does, however, show a slight amount of decarburization at the extreme outside.

Longitudinal Section Stamped C2-C - This section shows a very fine and very uniform macrostructure at the outside gradually changing to a somewhat streaky formation with dark areas but fairly high in sulphur and phosphorus.
