REPORT NO. P316/21-2

HYDROGEN WELDED 18/8 SHEET.

WATERTOWN ARSENAL
WATERTOWN, MASS.

Report on Hydrogen Welded 18/8

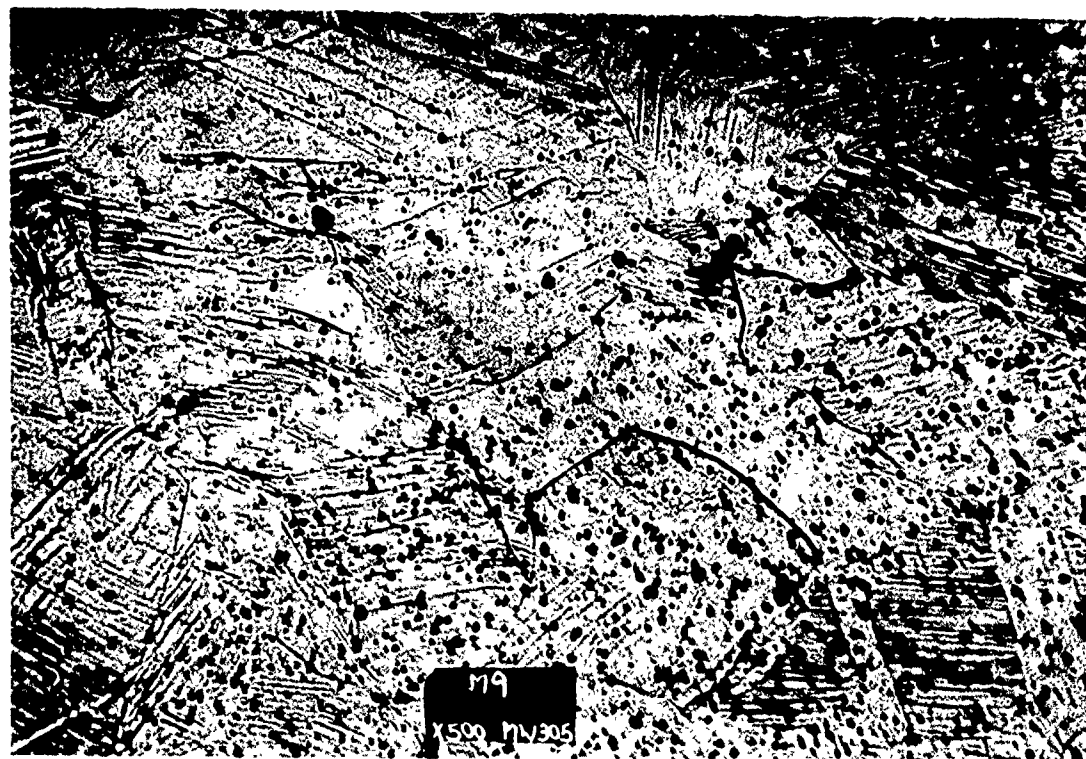
Fig. 3. Junction of sheet with weld metal after water quench from 2950°F. Stress left in sheet from shearing while preparing specimen apparent. Weld metal located with difficulty.

The weld was found to be sound. The weld metal was fine grained. Carbides were precipitated along and within grain boundaries in a zone some $3\frac{1}{2}$ mm away from the edge of the weld. Heat treatment at 1850°F and at 1950°F removed the precipitated carbides and also removed all but traces of the cast structure in the welded joint. Microphotographs are shown on Figures 1 to 3. Etching difficulties resulted in pitting of the specimen.
