REPORT NO. 710/409

BALLISTIC AND METALLURGICAL PROPERTIES
OF HIGH ALLOY FACE HARDENED ARMOR PLATE
MADE BY THE PLURIMELT PROCESS

February 11, 1942

WATERTOWN ARSENAL
WATERTOWN, MASS.

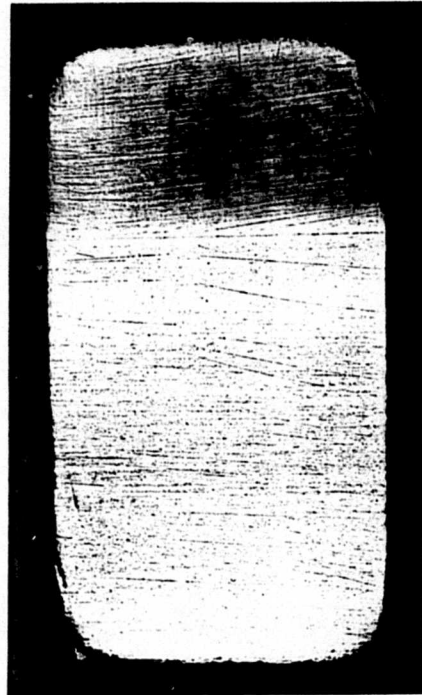
Figure 4

Figure 4MacrostructureOberhoffer's EtchPlate AR30 - Section B

The hard surface layer had a uniform structure. The steel base only showed a trace of banding. A sharp line of demarcation is observed between the hard surface and the steel base.

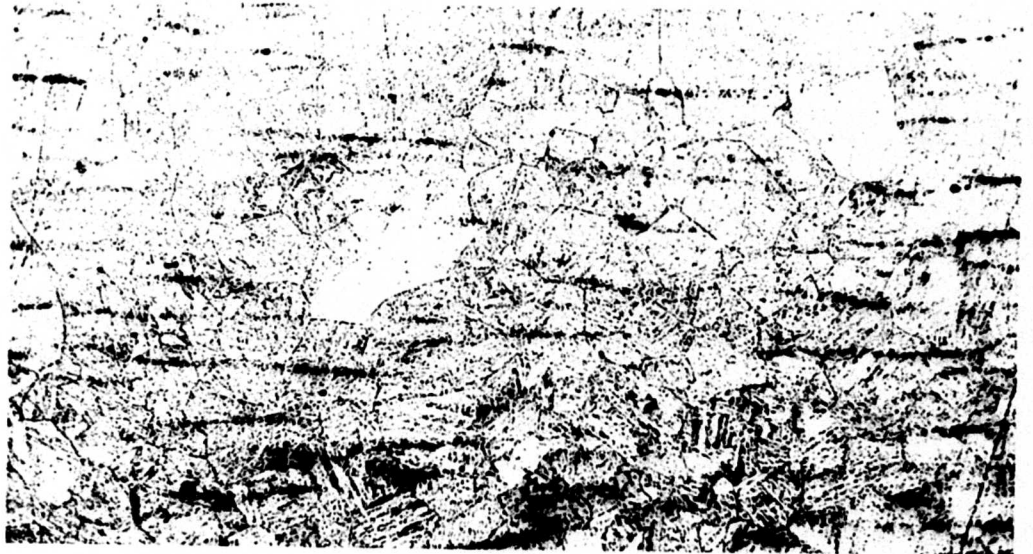
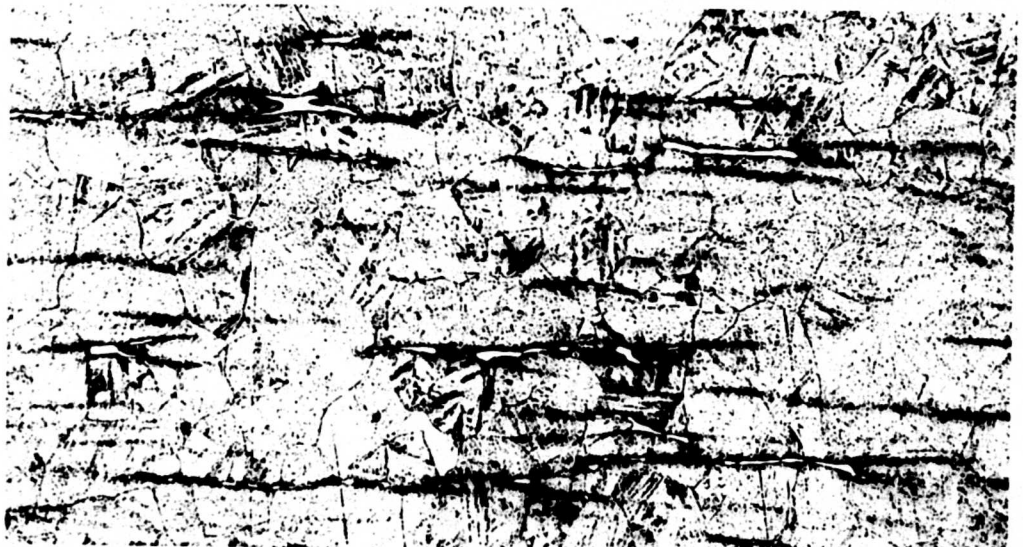
Figure 9

Figure 9Microstructure

- a. Typical microstructure of hard surface layer of plate AR30.
Etched in Vilella's Reagent X100 MA-3163
- b. Typical structure of base metal side of junction between base metal and top layer of plate AR30.
Etched In Vilella's Reagent X100 MA-3161
- c. Typical microstructure of low carbon steel base of plate AR30.
Etched in Vilella's Reagent X100 MA-3162

In most of the samples there is a gradual transition in the microstructure of the relatively high carbon surface to the low carbon rear face. (See Figures 9, 12, 14, and 15.) In the case of one section of plate AR30 this was not true. A sharp line of demarcation between the hard surface and soft back was detected. (See Figure 10.)

The high carbon layers of the plates consist of banded carbides in a martensitic matrix, while the microstructure of the steel bases of the plates consisted of chromium ferrite pools in a low carbon martensite matrix. (See Figures 9 - 16 inclusive.)

In the high carbon face of plates AR30, AR35, AR36, and AR39 considerable carbide banding was evident. (See Figures 9a, 11a, b, c, 12a, 13a, 15a, and 16c.) This banding was less noticeable in plates AR37, and AR38. (See Figure 14a.) In plate AR35, evidence of a wedge shaped ferrite streak is present in the hard surface layer. (See Figure 13b.) A prominent band of carbide is evident in the hard surface layer of plates AR36 and AR39. This band runs in the center of the layer, parallel to the surface of the sheet. (See Figure 18a.)

In the low carbon backs of the plates AR30, AR35, AR36, AR37, AR38, and AR39 the ferrite pools occur in distinct bands, an example of which is shown in Figure 9b. There is evidence of some decarburization on the hard surface of the plates examined as noted below:

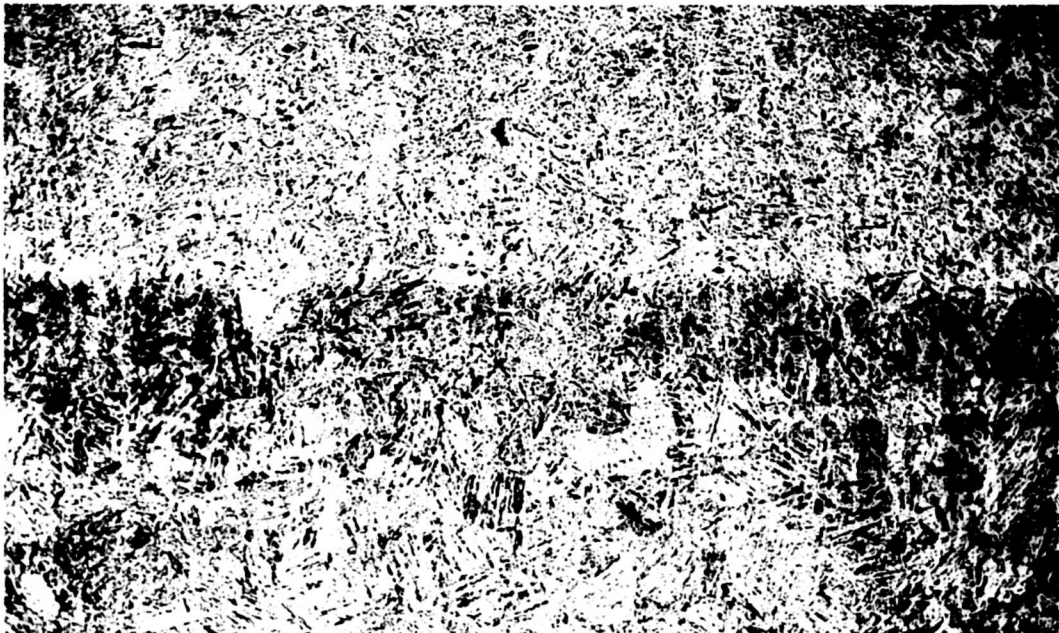
Figure 10

Figure 10Microstructure

a. Microstructure of junction of hard case and soft back
of another section in Plate AR30.

Etched in Marble's Reagent X100 MA-3178

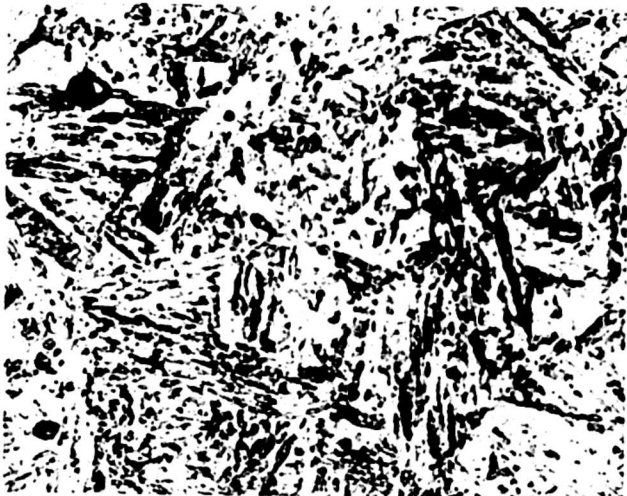
Figure 11

Figure 11Microstructure

- a. Microstructure of hard surface of Plate AR30, 0.7 mm. below surface.
Etched in Marble's Reagent X1000 MA-3172
- b. Same as above, 1.7 mm. below surface.
Etched in Marble's Reagent X1000 MA-3176
- c. Same as above, 5.4 mm. below surface.
Etched in Marble's Reagent X1000 MA-3174
- d. Same as above, 7.8 mm. below surface. Upper layer side of junction.
Etched in Marble's Reagent X1000 MA-3173
- e. Same as above. Microstructure of steel base.
Etched in Marble's Reagent X1000 MA-3175

a. Pronounced bands of carbides and some grain boundary carbides in the hard surface layer. (See Figures 11a, b, 16a, b, and 17a, and 18e.)

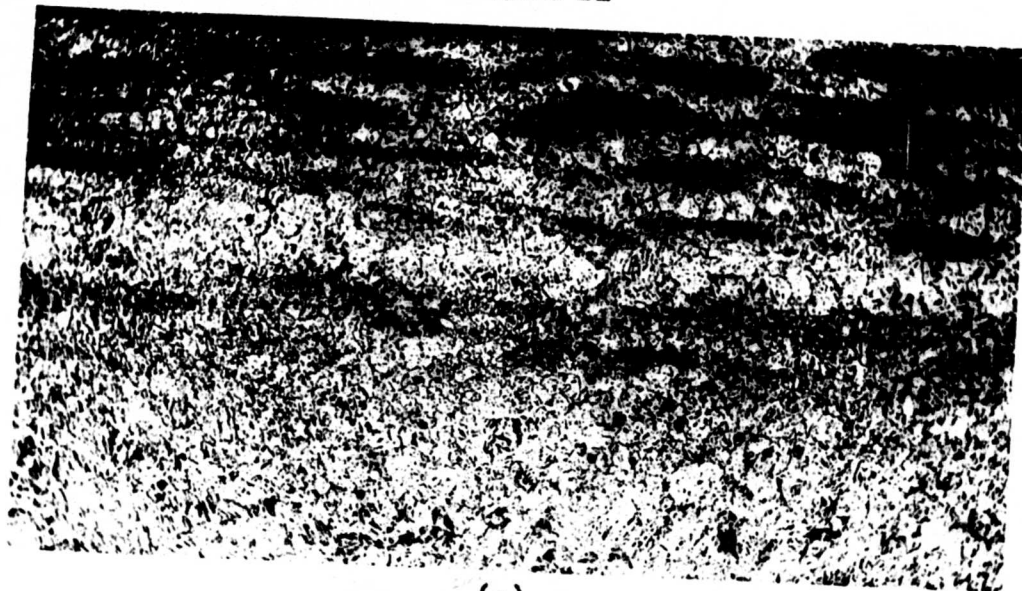
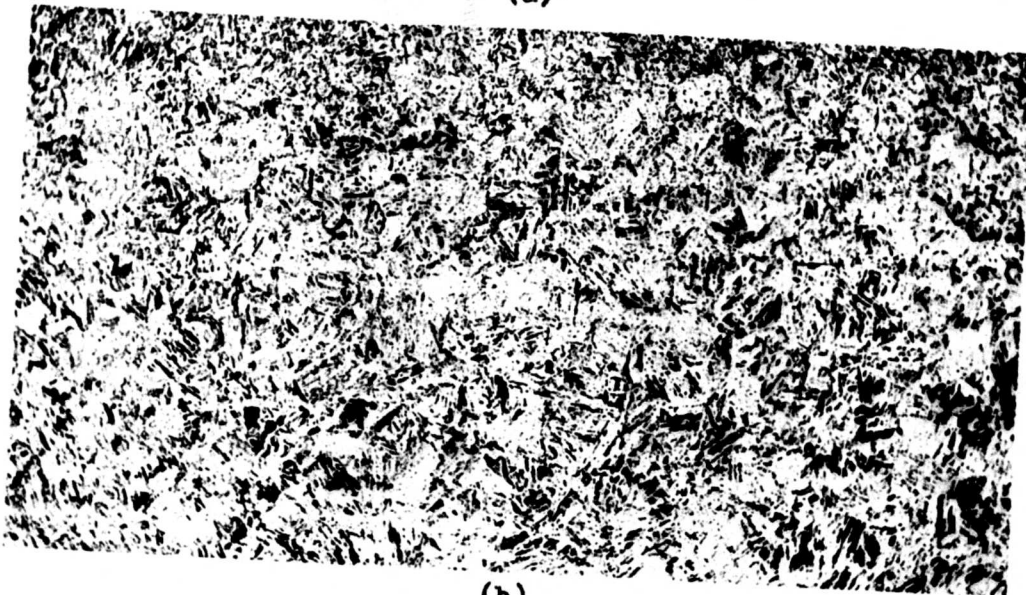
Figure 12

a. Microstructure of junction between hard and soft layers at approximately the center of the junction zone.

Etched in Vilella's Reagent X100 MA-3433

3. Metallurgical examination indicated that the steel base was relatively free from nonmetallics and that with one exception, a gradual transition in microstructure was evident from the hard surface layer to the steel base. (See Figures 7a, 12, 14, 15, and 10b.)

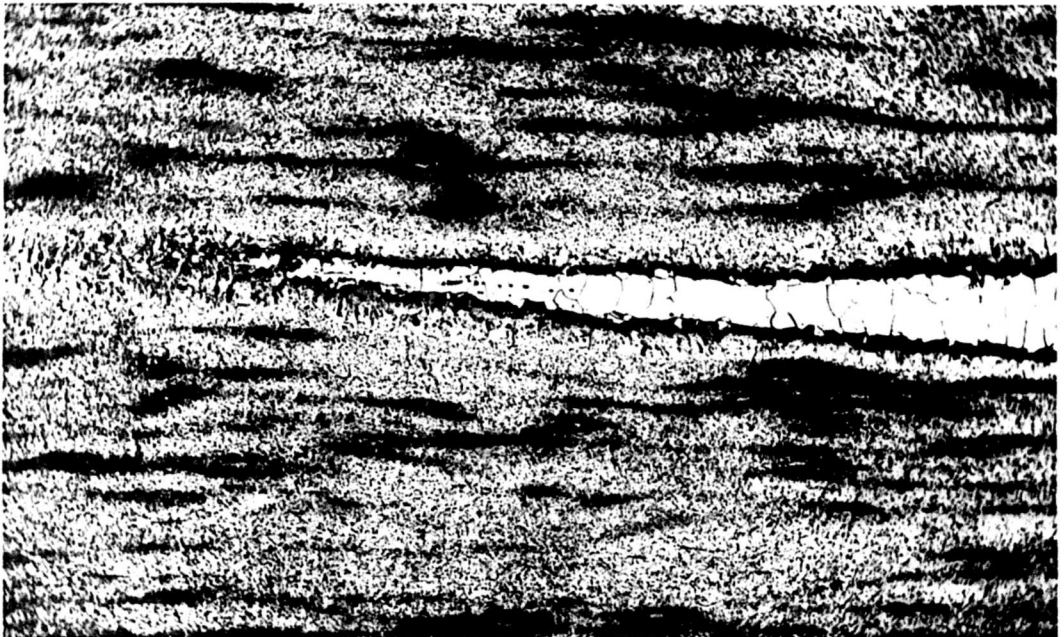
Figure 13

a. Typical banded structure found in hard surface layer.

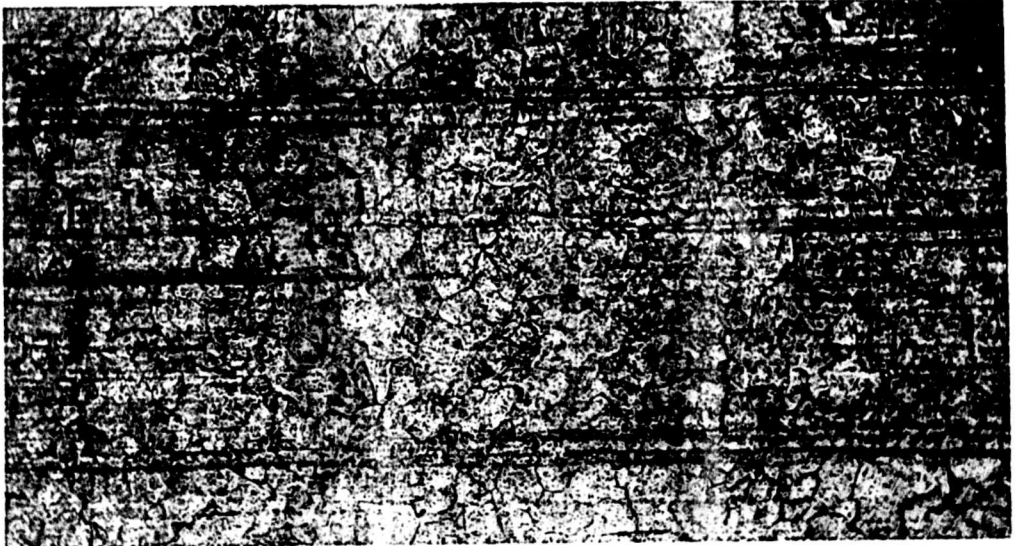
Figure 14

a. Typical microstructure of hard surface layer of plates AR37 and AR38. Note banding and grain boundaries.

b. Typical microstructure of junction zone between hard surface and steel base of plates AR37 and AR38.

c. Typical microstructure of steel base of plates AR37 and AR38.

Etched in Vilella's Reagent X100 MA-3427

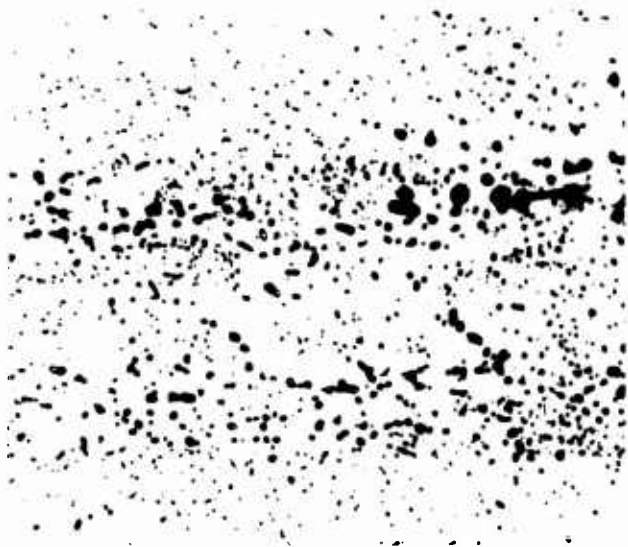
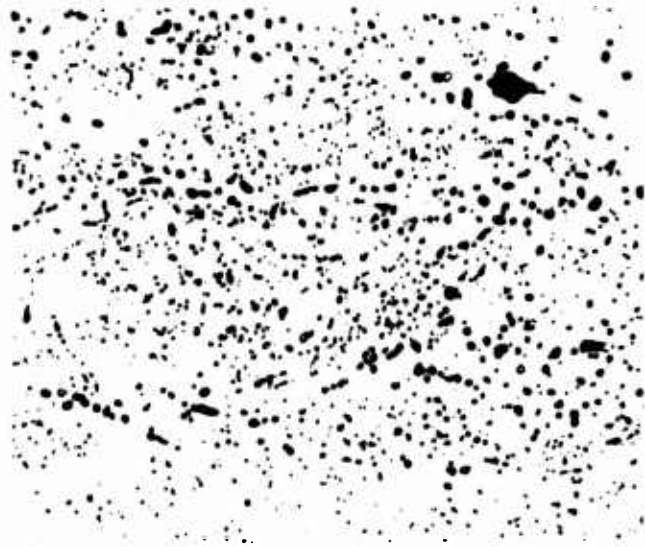
Figure 16

- c. Bands of carbide in hard surface layer.
Etched in Murakami's Reagent X250 MA-3416
- d. Bands of carbides in soft steel base of plate. The dark globules are etched delta ferrite.
Etched in Murakami's Reagent X250 MA-3417

d. Occasionally some grain boundary carbide was found in the steel base. (See Figures 16d, 17c, and 18d.)

AR30, AR35, AR36, and AR39. (See Figures 16a, c, and 16a.) The Murakami etch shows that there is a more complete solution of carbide in the surface layer of plates AR37 and AR38 than in the other samples. Some evidence of bands of carbide are present in the steel base of plate AR35. (See Figure 16d.)

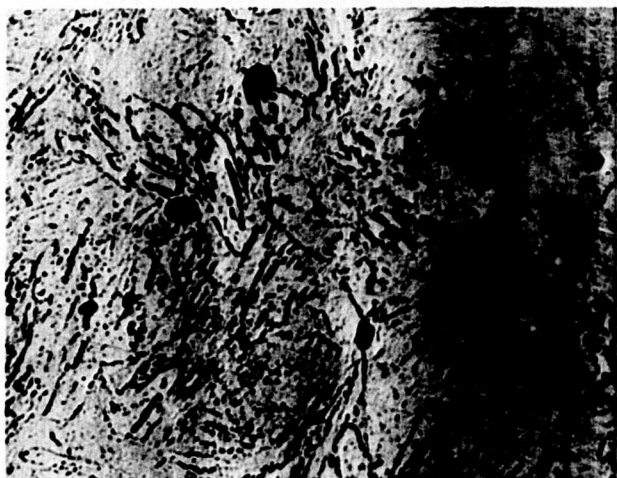
Figure 18

Figure 18Carbide Distribution

- a. Typical bands of carbides in the hard surface layer of AR39, including the prominent band which runs parallel to the plate surface, midway between the plate surface and center of the junction zone. The inclusion stringer which begins the inclusion-crack system occurs in the band. (The stringer has been attacked by the etch.) The carbide distribution in the hard surface layer of Plate AR36 is the same as illustrated by the photomicrograph.

- c. Typical grain boundary carbide found in the center of junction zone of hard surface and soft back of Plates AR36, AR37, AR38, and AR39.

- d. Typical microstructure of soft steel bases of Plates AR36, AR37, AR38, and AR39. Black globules are etched delta ferrite.

- e. Typical grain boundary carbide found in the hard surface layers of Plates AR37 and AR38.

Etched in Murakami's Reagent X1000 MA-3415

c. Some grain boundary carbide in the junction of the hard surface layer and the steel base. (See Figures 17b, and 18c.)

Fine grain boundary carbides are present in the low carbon layers of most of the plates as revealed by the Murakami reagent. (See Figures 17c and 18d.) Some prominent grain boundary carbide chains occur in the junction of the high and low carbon layers in plates AR35, AR36, AR37, AR38, and AR39. (See Figures 17b, and 18c.) Some medium size grain boundary carbides are present in this area in plate AR30. There are fine grain boundary carbides present in the hard surface layers of plates AR37, and AR38. Pronounced carbide bands are present in the high carbon face of plates

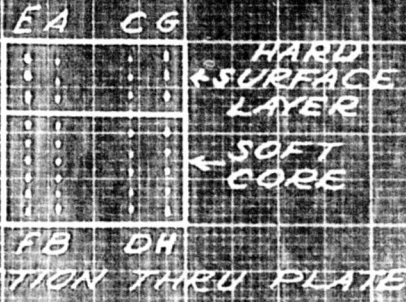
VARIATION IN HARDNESS FROM SURFACE TO BACK 1" DUPLEX ARMOR PLATE No. AR-35

Vickers Brinell hardness surveys were made on sections cut from the plates to show the variation in hardness from the surface to the rear face.
