REPORT NO. 710/407

METALLURGICAL EXAMINATION OF TWO DISSECTION 1-1/2"
ROLLED HOMOGENEOUS ARMOR PLATES

Metallurgical Examination of Two Disston 1-1/2"
Rolled Homogeneous Armor Plates

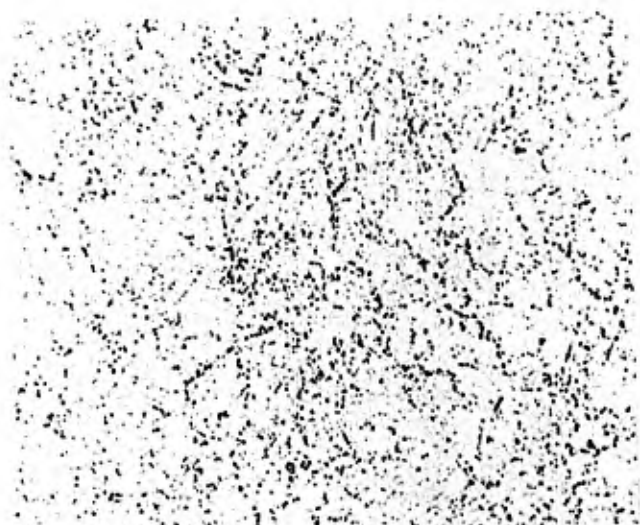
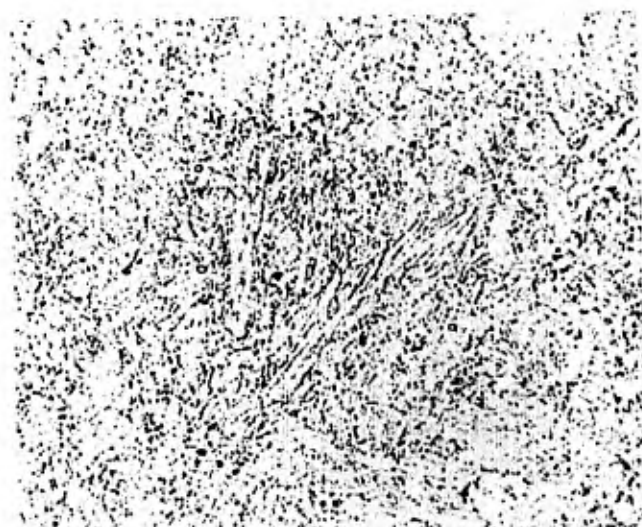
Figure 7

Carbide Distribution

a. Good Quality Plate 1E30 (D_h)

Carbide condition as revealed by the Murchani Etch.

b. Same as a carbide condition as revealed by the 10% chromic acid electrolytic etch.

c. Same as a carbide condition as revealed by the alkaline sodium picrate etch.

d. Same plate as a showing the high carbon bonded area in the central layers of the plate after etching in 10% chromic acid electrolytic etch.

e. Same high carbon area shown in d after etching in alkaline sodium picrate.

Figures 4a, 5a, b, and c. The grain boundary carbides as revealed by the Murakami reagent, 10% chromic acid (electrolytic etch) and alkaline sodium picrate are shown in Figures 7a, b, c, d, e, and 8a, and b. Figure 9 illustrates the segregation in the central layers of heat 1830 and the absence of such segregation in heat 1843 as revealed by the alkaline sodium picrate etch. This segregation is not all carbides as shown by the 10% chromic acid electrolytic etch. (See Figures 7d, and e.)

Recent investigations on the use of various reagents for revealing grain boundary carbides indicate that a 10% chromic acid electrolytic etch is superior to the Murakami reagent, and alkaline sodium picrate. Alkaline sodium picrate attacks other constituents, such as manganese segregations, ferrite rich in silicon, etc. (See "Metallographers' Handbook of Etching" by Berglund, and "Use of Sodium Picrate in Revealing Dendritic Segregation in Iron Alloys" by Sauvour & Krivobok, A.I.M.M.E. Transactions, Vol. LXX, 1924, Pages 239-253).

Figure 7d, e, illustrates the etching of the banded area in heat 1830 (D⁴) in 10% chromic acid (electrolytic) and also in alkaline sodium picrate. It is to be noticed that alkaline sodium picrate tends to etch or discolor areas in the relatively high carbon band other than carbides.
