EVALUATION OF SHOCK PROPERTIES OF WELDED ARMOR JOINTS AT SUBNORMAL TEMPERATURES

Examination of Samples from 31 Commercially Welded "H" Plates
Ballistically Shock Tested as Part of the
1942 - 1943 Canadian Cold Test Program

DATE 9 August 1944

Watertown Arsenal Laboratory
Report No. WAL 648/6
Problem No. D-1.1

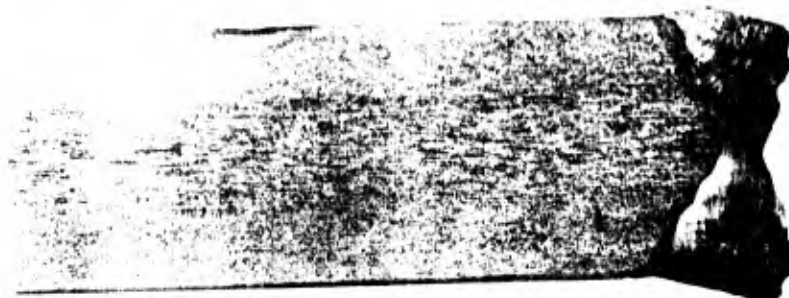
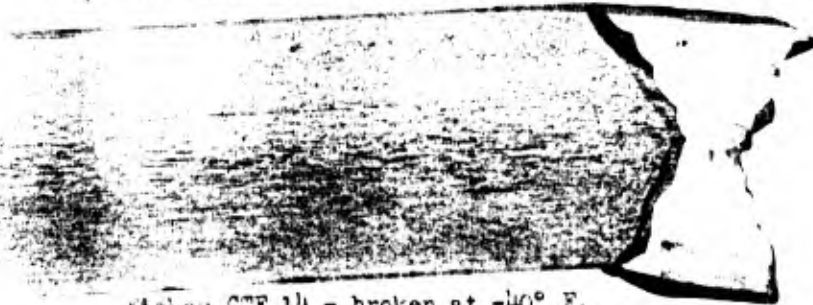
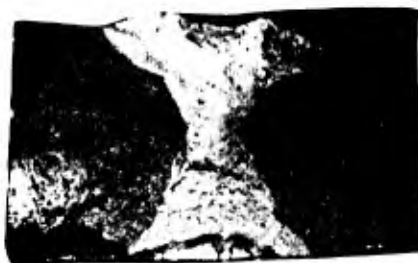
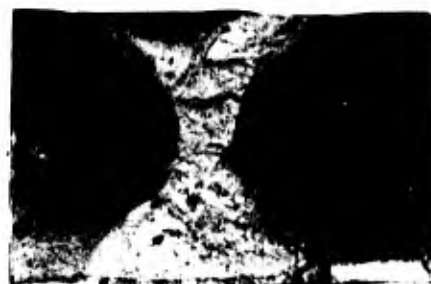
1 1/2 inch thick austenitic hand welded rolled plate Fisher CTF 14 - broken at room temperature

Fisher CTF 14 - broken at -40° F.

1 1/2 inch thick austenitic hand welded rolled plate Fisher CTF 21 - broken at room temperature

Fisher CTF 21 - broken at -40° F.

Plate Fisher CTF 14

Plate Fisher CTF 21

Nick-break test results for the six samples from these plates (Table II) reveal no tendency for low impact energy failure of weld metal, weld heat-affected zone, or unaffected plate. The path of failure in the bend fracture tests (Table III) is predominantly in the fusion zone. Typical fractured specimens are shown in Figure 3.

The type of failure observed in the bend fracture of the austenitic hand welded 1-1/2 inch rolled plates (Table III and Figure 3) is similar to that observed in the reheated bend bars. While the cold test H plates were not tempered after welding, the interpass temperature was permitted on a number of the plates to exceed by several hundred degrees the present specification limit of 100° F. above the initial plate temperature (see welding data, Appendix A). The upper right and center left photomicrographs of Figure 5 show that the interpass heat has been sufficient to cause carbide precipitation with adjacent base metal decarburization in cold test plates. The center right photomicrograph shows the carbides etched with Murakami reagent. The lower left photomicrograph shows a typical section of the fractured edge of a bend bar from a cold test plate.

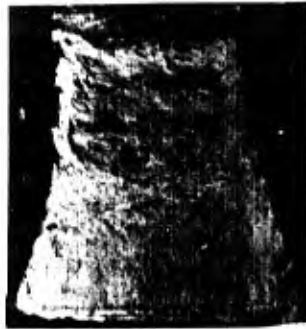
-A-

Fusion zone failure in bend bar from as-welded joint in Carnegie-Illinois armor.

Examples of the latter two types of fracture are shown in Figure 4. The upper left photograph shows the fractured surface of a bend bar from a butt weld made in 1-1/2 inch thick Carnegie-Illinois armor plate with a typical austenitic electrode welding procedure. The characteristic scaled appearance of the fracture surface is representative of the majority of the failures observed in austenitic hand welded plates previously examined⁽¹⁰⁾. The center left photomicrograph is a typical view of an unbroken section of the plate-weld junction showing the precipitation of nonmetallic inclusions lined up parallel to the fusion line. The lower left photomicrograph is a section through a nickel-plated fracture edge showing the path of failure in the bend fracture bar. The type of fracture represented by these three pictures is predominantly through the weld metal at a distance from the fusion line which coincides with the usual location of the inclusions.

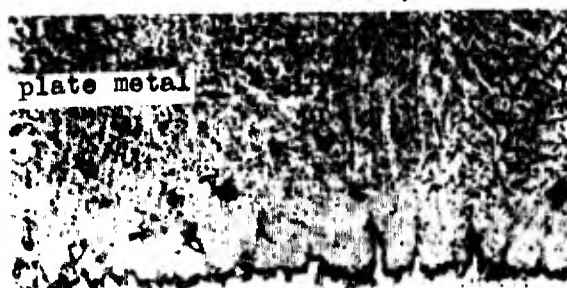
Figure 5

X500 Picral
Failure through slack quenched struc-
ture near fusion line in 1/2 inch
thick austenitic hand welded plate
Gen. Motors Truck C 11.

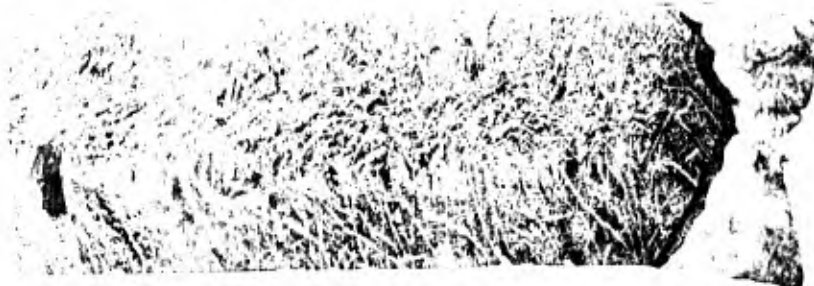
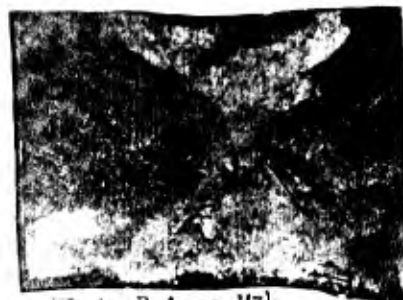
Figure 6

1 1/2 inch thick austenitic hand welded cast plate Briggs M34 - broken at room temperature

Plate Briggs M34 - broken at -100° F.

1 1/2 inch thick austenitic hand welded cast plate Chrysler CP 51 - broken at room temperature

Plate Chrysler CP 51 - broken at -100° F.

Nick-break test results (Table 11) reveal crystallinity in unaffected plate for all of the eight cast armor samples. Table IX (Appendix B) indicates that about 28% of the ballistic fracture was in unaffected base metal and 46% in fusion zone. Bend fracture tests of the eight samples showed similar tendencies except for plates CTF22 and CTF28 which broke brittly through center of weld metal. Figures 6 and 7 show typical nick-break and bend fractures including the two plates which developed brittle failure in the weld metal.

Nick-break test results (Table II) reveal crystalline heat-affected zone fracture for all samples. Bend fracture tests (Table III and Figure 6) show preponderance of failure to be in heat-affected base metal. As discussed in a previous report(12), this condition is brought about by the high heat input of the Unionmelt process. The base metal adjacent to the weld is heated to a high temperature and slowly cooled. The result is a slack-quenched heat-affected zone which can be avoided only by use of very high alloy armor plate or by use of a procedure involving much lower weld heat input.

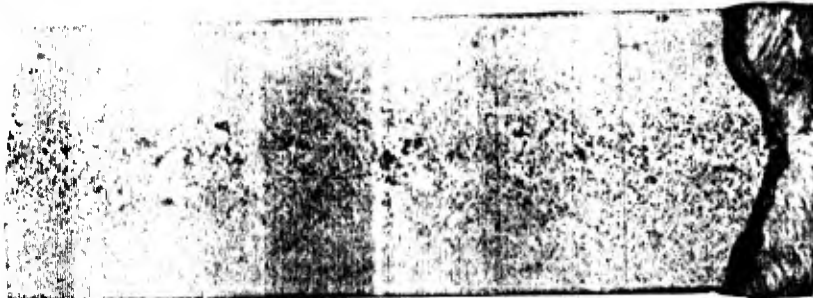
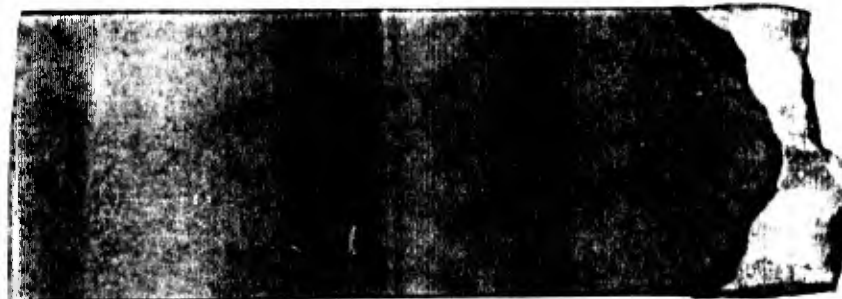
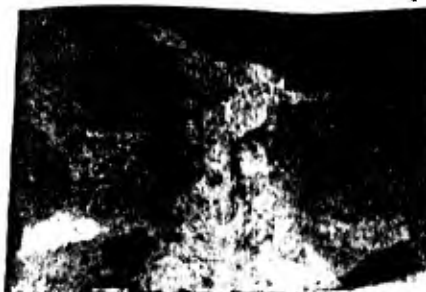
1 1/2 inch thick austenitic hand welded cast plate Fisher CTF 22 - broken at room temperature

Plate Fisher CTF 22 - broken at -40° F.

1 1/2 inch thick austenitic hand welded cast plate Fisher CTF 28 - broken at room temperature

Plate Fisher CTF 28 - broken at -40° F.

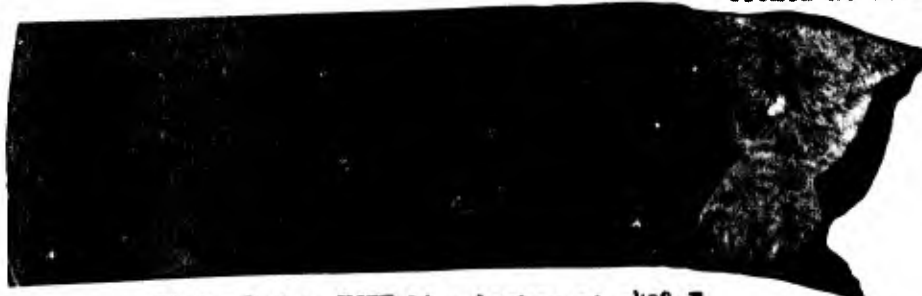
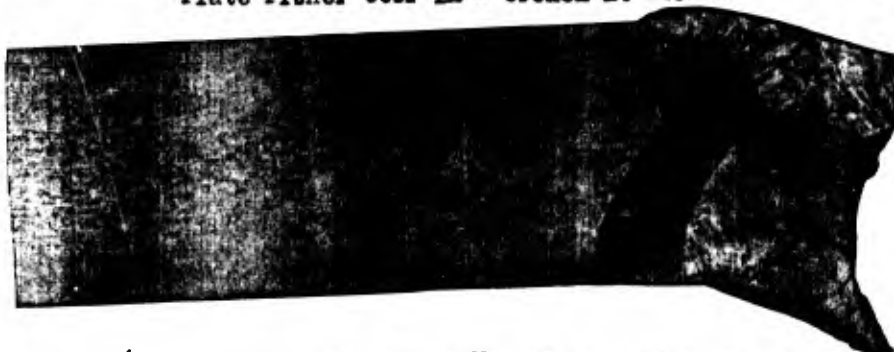
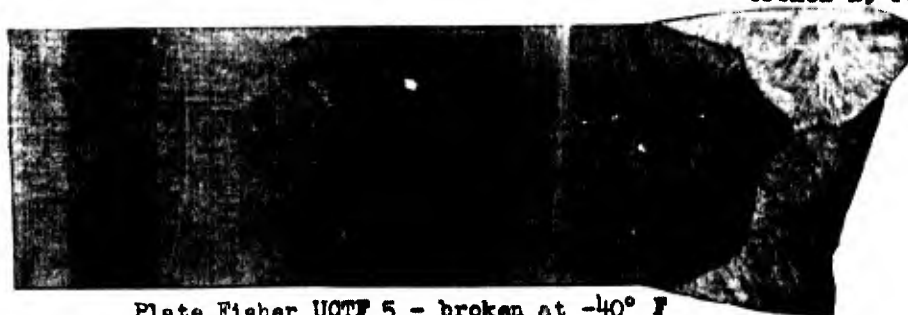
Figure 9

1 1/2 inch thick austenitic Unionmelt welded rolled plate Fisher UCTF 1A -
broken at room temperature

Plate Fisher UCTF 1A - broken at -40° F

1 1/2 inch thick austenitic Unionmelt welded rolled plate Fisher UCTF 5 -
broken at room temperature

Plate Fisher UCTF 5 - broken at -40° F
BEND BAR FRACTURES

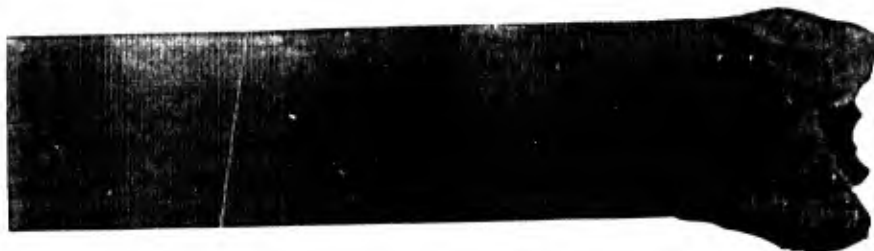
Figure 10

1 inch thick austenitic hand welded rolled plate Cadillac 94 - broken at room temperature

Plate Cadillac 94 - broken at -40° F

1 inch thick austenitic hand welded rolled plate Cadillac 96 - broken at room temperature

Plate Cadillac 96 - broken at -40° F

Nick-break tests (Table II) revealed fibrous fractures, but three of the four samples are severely laminated. Bend tests (Table III and Figures 10 and 11) showed fractures through weld metal (associated with weld metal cracks and incomplete fusion - Plate TH68), fusion zone, heat-affected and unaffected base metal. The poor steel quality of plates 94, 96, and 97 lead to the belief that the plate and heat-affected zone ballistic cracking of these plates might be associated with directional properties in the fairly dirty steels. V-notch Charpy impact bars, therefore, were taken in unaffected plate metal midwall and perpendicular to weld. Impact values were as follows:

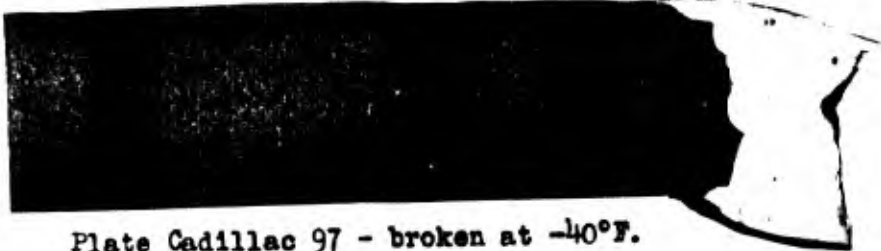
Figure 11

1 inch thick austenitic hand welded rolled plate Cadillac 97 - broken at room temperature

Plate Cadillac 97 - broken at -40°F .

1 inch thick austenitic hand welded rolled plate Ternstedt TH 68 - broken at room temperature

Plate Ternstedt TH 68 - broken at -40°F .

The bond zone failure of plate 97 and the weld metal failure of plate TH68 (Figure 11) probably are caused by precipitation of carbides at bond zone (see section on 1-1/2 inch Thick Austenitic Hand Welded Rolled Plates) and weld defects (root bead cracking and incomplete fusion) respectively.

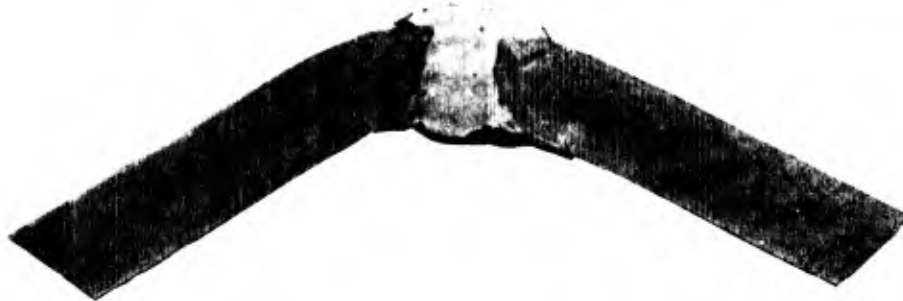
1/2 inch thick austenitic hand welded rolled plate
General Motors Truck C 11 - tested at room temperature

Nick-break tests (Table II) indicate fibrous fractures, but two of the four samples (C17 and C21) were severely laminated. Bend tests (Table III and Figure 12) show a high proportion of fusion zone failure in plates C17 and C21 which were very poor ballistically. There was less of this type failure in plates C11 and C14 probably because of a more favorable weld geometry (see section from plate C11 - Figure 12 - which did not break in the room temperature drop weight test).

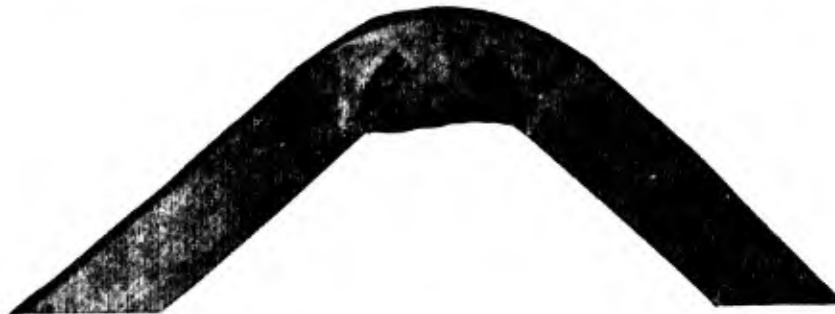
1/2 inch thick ferritic Unionmelt welded rolled plate
General Motors Truck C 3 - tested at room temperature

Nick-break tests of the two samples (Table II) reveal crystalline, slack-quenched, fracture of heat-affected base metal. Weld metal fracture of plate C3 of the low alloy Unionmelt ferritic type previously found to have Charpy impact values of approximately 15 ft.lbs. at room temperature and 7 ft.lbs. at 0° F. showed large crystalline patches. Nick-break weld fracture of plate D5-45-22 (Figure 13), of a higher alloy analyses, showed only slight amount of crystallinity.

In the absence of notches or weld defects it is not usually possible to fracture 1/2 inch thick bend bars with the drop weight test. When bend fracture tests were made on four bars from these two plates (Table III and Figure 13) with the face of the weld, which had been ground flush, on the tension side of the bend bar, only one failure through the slack-quenched heat-affected zone was obtained. However, when additional bars were tested with the unground face down, they all fractured brittly through the slack-quenched heat-affected zone.
