5 October 1943
WATERLOO ARSENAL
WATERLOO, MASS.

Watertown Arsenal Laboratory
Report Number WAL 710/413
Problem Number B-33

A Preliminary Study of the Effects of the Conchoidal Fracture
Upon the Physical and Metallurgical Characteristics of
Cast Armor

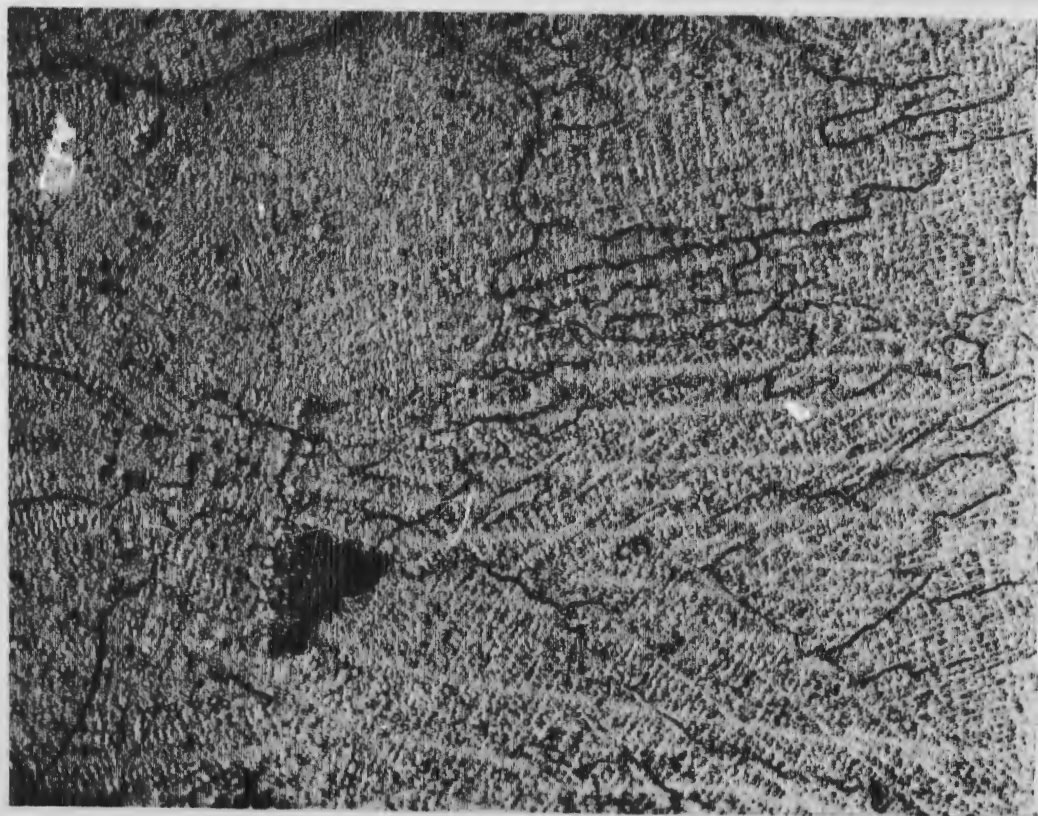
FIGURE 4

Hot Acid Etch. Sample B X2
Hair-line boundary attack in steel
having spheroidal fracture.

Hot Acid Etch. Lower right hand corner of above photo. X5
Heavy etching attack at dendrite boundaries.

A small piece of sample B was polished through No. 000 paper and etched in hot 50% hydrochloric acid. The structure revealed by etching is shown in Figure 4. It is apparent that some material segregated along the boundaries of the primary austenite grains has been dissolved by the acid. The network is frequently discontinuous and at times extends around groups of primary austenite grains rather than around individual grains.

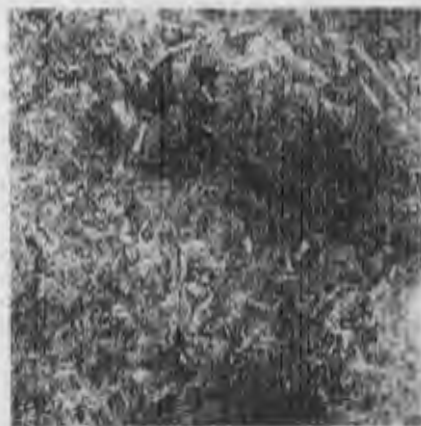
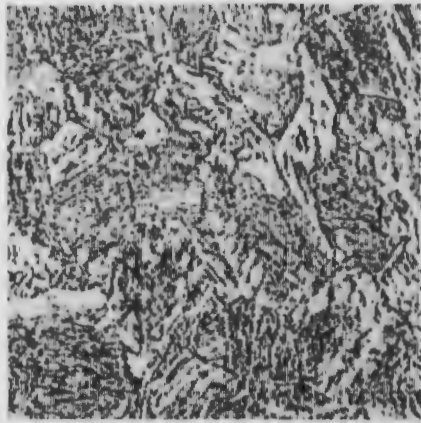
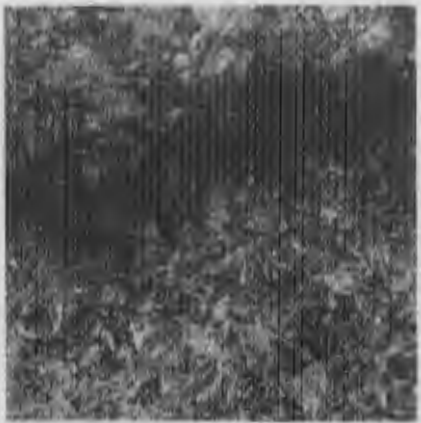
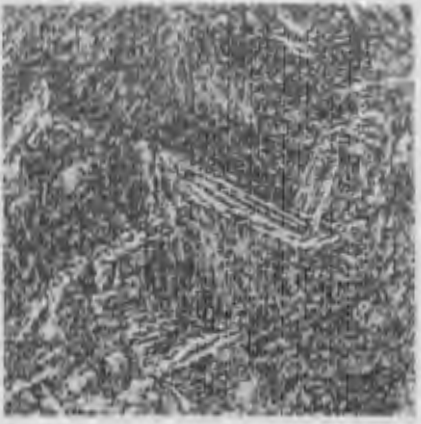
#A -A- X1000
Unetched
Small disconnections
inclusions occasionally
found at grain boundaries.

#B -B- X200
As received.
Dendritic segregation.

#C -C- X1000
Incompletely quenched
hardened. Rejected ferrite
and grain boundary carbides.

#D -D- X1000
Reheat-treated.
Tempered martensite.

#B2 -B- X1000
Reheat-treated.
Tempered martensite.

#B3 -F- X1000
Reheat-treated.
Tempered martensite.

#C -G- X200
As received.

#H -H- X1000
Incompletely quenched
hardened. Rejected
ferrite and carbides in
matrix of tempered
martensite.

Section A, heat 3594 as-received, has a microstructure consisting of high temperature transformation products resulting from incomplete quench hardening. Dendritic segregation, with greater amounts of ferrite rejected in the dendritic axes occurs throughout the cross-section, see Figures 6b and c. Reheat treatments of sections cut from sample A, namely specimens B1, B2, and B3, produced tempered martensitic microstructures, Figures 6d, e, and f.

The microstructure of steel C (heat 3135 as-received) contains some ferrite and pearlite in a matrix of tempered martensite, see Figures 6g and h. The microstructure of steel C does indicate, however, more satisfactory quench hardening than detected in steel A.

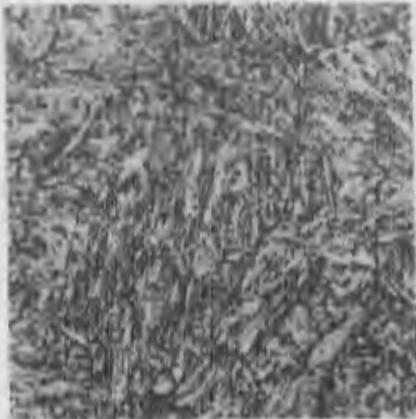
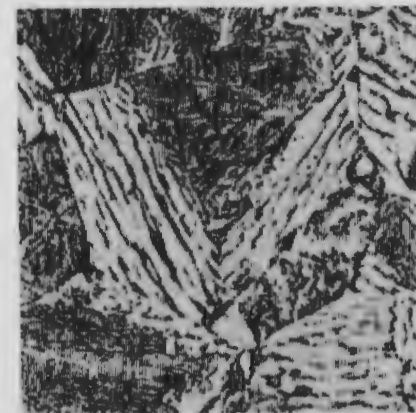
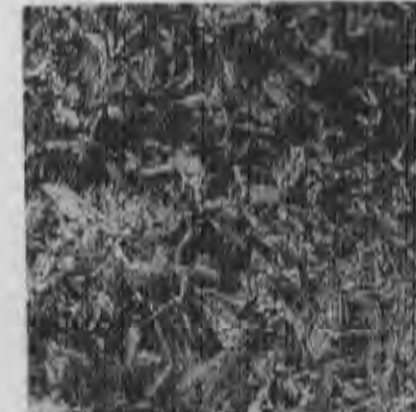
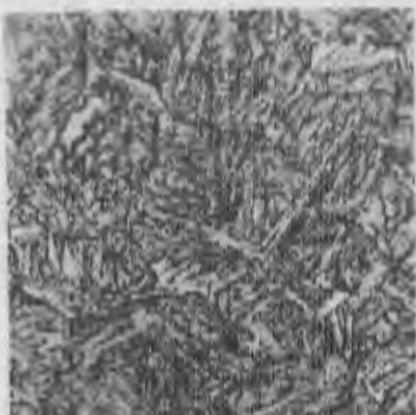
#E X200
As received. Coarse, segregated structure.

#F X200
Reheat-treated. Homogeneous structure.

#E X1000
Incompletely quench hardened. Rejected ferrite and pearlite.

#G X200
As received. Dendritic segregation.

#H X1000
Reheat-treated. Small amount of rejected ferrite and pearlite in tempered martensite.

#H X200
Reheat-treated. Relatively homogeneous structure.

#G X1000
Incompletely quench hardened. Rejected ferrite and carbides.

Steel E (heat 3261 as-received) contains large amounts of rejected ferrite and coarse pearlite resulting from high temperature transformation, see Figures 7a and b. Reheat treatment of a portion of the same steel produced a tempered martensitic microstructure, Figures 7c and d. Steel G (heat 3267 as-received) has an unsatisfactory microstructure consisting of large amounts of rejected ferrite and grain boundary carbides, see Figures 7e and f. After reheat treatment, small amounts of ferrite and pearlite occur in a tempered martensitic matrix, indicating a slight degree of transformation occurring at elevated temperatures, Figure 7g and h.
