WELDING LABORATORY
WATERTOWN ARSENAL

EVALUATION OF SHOCK PROPERTIES OF WELDED ARMOR JOINTS

Examination of Samples from 33 Commercially Welded,
Ballistically Shock Tested "H" Plates

UNCLASSIFIED DATE 10 June 1944

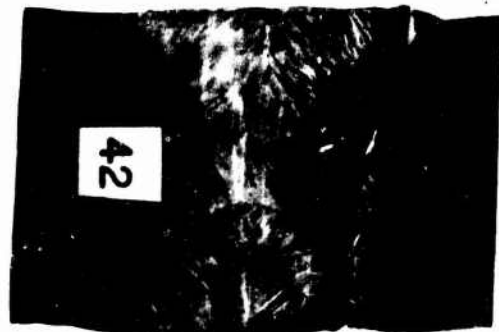
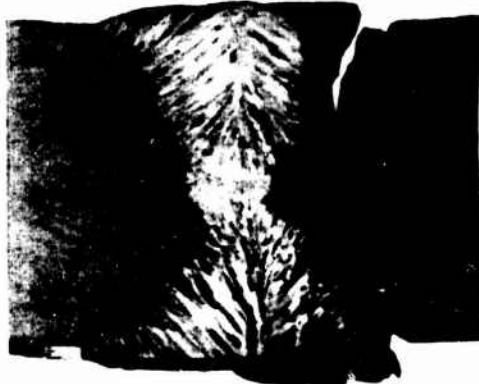
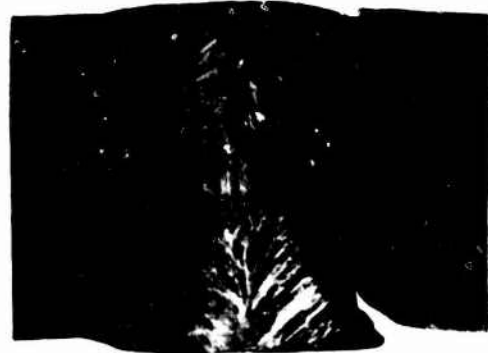
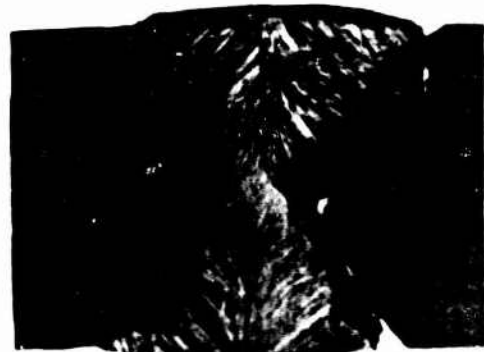
Figure 10. Aberdeen Proving Ground Photomicrographs of Sections through Ballistic Fractures.

New York 42

New York 44

New York 45

New York 46

New York 47

New York 48

At Aberdeen Proving Ground sections through ballistic fracture of some H plates are taken, macroetched and photographed. This was done on seven of the 1-1/2 inch thick Austenitic Unionmelt plates included in this report (Figure 10). It would be very desirable to have the path of ballistic fracture of a certain proportion of plates from each thickness and welding procedure group determined and reported.

1-1/2 inch thick plate - All plates with completely crystalline fracture of weld heat-affected zone showed excessive cracking during ballistic shock test. Figure 10, which is a reproduction of Aberdeen Proving Ground photomicrographs of sections through ballistic fracture, shows that the path of ballistic fracture of these plates was through the weld heat-affected zone. New York plate 46 in this Unionmelt welded group had a fibrous heat-affected zone in the fracture test (see Figure 8), and showed better ballistic performance with ballistic fracture principally through weld metal and fusion zone (see Figure 10).

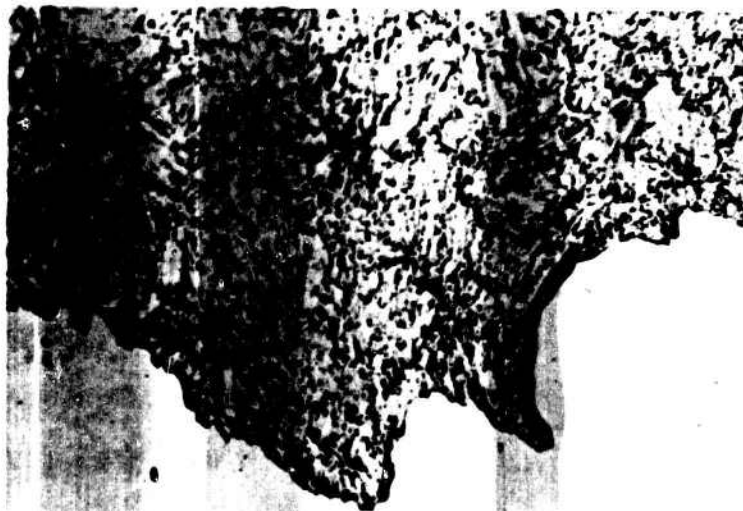
Figure 14. Fracture Edges of 0.25 Carbon Mn-Mo Armor Plate Heat-Treated by Two Different Methods to Equivalent Tensile Strength and Hardness Levels.

X750

Picral

Water quenched and drawn.
Hardness: 30 Rc
Charpy Value: 49 ft. lbs.
Fracture: Fibrous

a. Weld heat-affected zones - In general a steel which has been quenched to martensite and tempered and has a microstructure consisting of very fine uniformly distributed carbide particles has relatively high impact energy. A steel with a heterogeneous microstructure consisting of high transformation temperature lamellar carbides has very low impact energy under severe conditions of testing. This is illustrated in Figure 14 showing photomicrographs of specimens of a .25 C Mn-Mo armor plate heat treated by two different procedures to equivalent tensile strength and hardness levels.

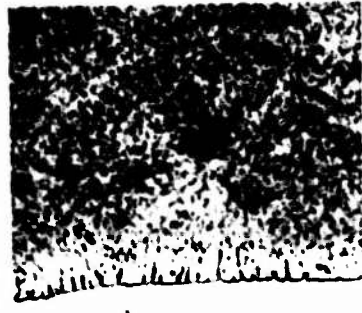
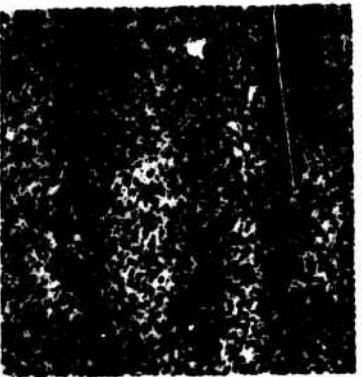
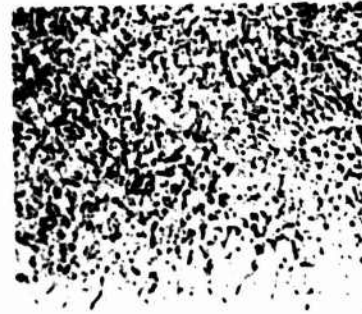
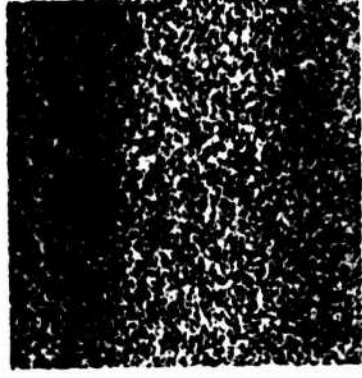
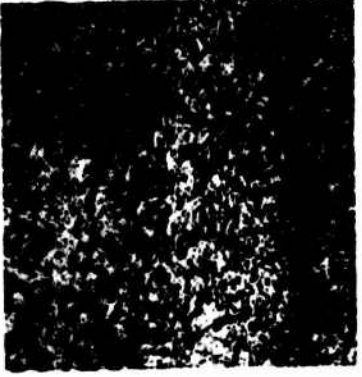
Figure 16. Microstructure of Heat-Affected Zones of Typical 1 1/2 Inch Thick Austenitic Hand Welded Test Plates (4% Picral etch - X250).

1/8 inch from fusion line

1/4 inch from fusion line

3/8 inch from fusion line

Plate Midland MM 113 (Republic Armor)

Plate Midland CR 45 (Carnegie - Illinois Armor)

Hand welded 1-1/2 inch thick plates generally have relatively high impact values through the heat-affected zone associated with a microstructure of very fine uniformly distributed carbides resulting from formation of martensite in one welding pass and tempering by subsequent welding passes. Heat-affected zone impact values of the two hand welded plates (Figure 16 and Table VI) are considerably higher than for the two Unionmelt plates. A few areas of high transformation temperature carbides were present in these two plates as a result of the use of 1/2 inch diameter electrodes (see discussion of fracture test). The difference in impact energy level for these two plates appears to be largely due to directional properties. Both plates are very dirty and rolling direction is parallel to leg weld in Midland plate RE-113 and transverse to leg weld (not in accordance with specification) for Midland plate CR-45 as is apparent from distribution of inclusions in photomicrographs.

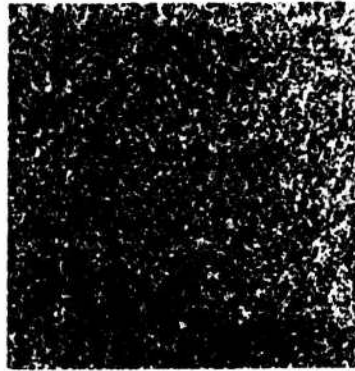
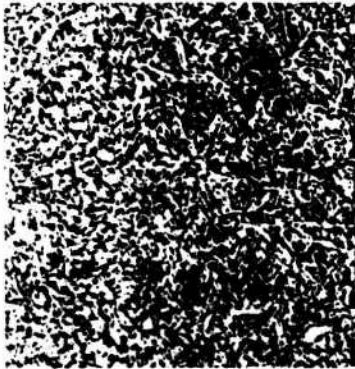
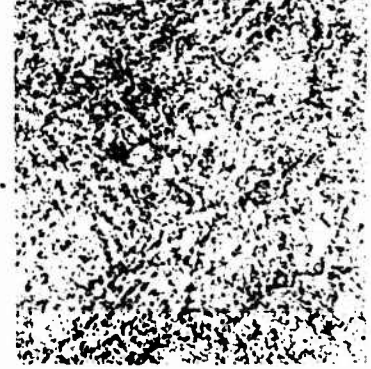
1/8 in. from fusion line

5/16 in. from fusion line

Plate Fisher H 115 (Jones and Laughlin Armor)

Plate Fisher H 116 (Great Lakes Armor)

Microstructure of Heat-Affected Zones of Typical 1/2 Inch Thick Ferritic Hand Welded Test Plates (4% Picral etch - X250).

The microstructure of the heat-affected zones of two ferritic hand welded 1/2 inch thick plates (Figure 17) showed some areas of high transformation temperature carbides, but most of the zone was of tempered martensite. Charpy impact values (Table VI) are higher for weld heat-affected zone than for unaffected plate, the former having been tempered by the heat of welding to a considerably lower hardness than the base metals (see Table III and Figure 5).

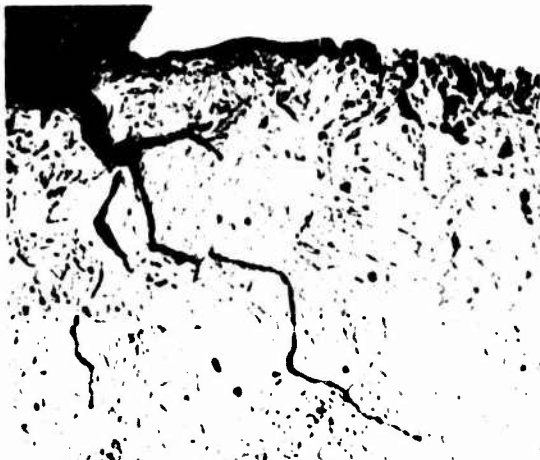
X250 Hydrochloric and Picric Acids Fusion zone and heat-affected zone cracks from area of incomplete fusion in Plate Ford W-235.

b. Fusion Zones - There is a pronounced tendency for austenitic hand welded plates to fail through the bond zone and this tendency is an indication of inferior ballistic performance as discussed in connection with the bend test. Careful examination of ballistic and bend test fractures disclosed three separate conditions which may lead to fusion zone failures: (1) Lack of fusion and fusion zone cracks. Lack of fusion at the root of New York Air Brake Unionmelt plates was disclosed in several tests and failure usually proceeded through this defect in bend tests. No extensive crack systems were observed.* A few small cracks observed on macroexamination appear to be local defects which did not influence bend or tension test results to an appreciable extent. Photomicrographs in Figure 17 illustrate types of cracking observed. (2) Precipitation of carbides at weld-plate interface. Failure right at the bond line has been observed to a limited extent in a few plates. A characteristic very fine grained crystalline fracture is observed. Microexamination indicates that this condition is caused by a heavy precipitation of carbides at the weld-plate interface on reheating by subsequent welding passes as illustrated in the upper two photomicrographs of Figure 18. Heating a hand welded austenitic bend bar at 1150° F. for one hour produced a heavy carbide precipitation and caused the bar to break without deformation and almost entirely along the tempered interface. Very limited carbide precipitation occurs in hand welded plates, but the condition tends to be more serious when large electrodes are used and in Unionmelt welded plates. The presence of a very low impact energy heat-affected zone in most of the Unionmelt plates afforded an easier path of failure. Preheating or stress relieving of austenitic welds would probably favor precipitation of carbides and interface failures. (3) Linear precipitation of nonmetallics in weld metal adjacent to fusion line. The majority of fusion zone failures proceed through the weld metal a few thousandths of an inch from the true fusion line. The fracture has the characteristic scaled appearance of plate Midland RE-104 in Figure 11. Microscopic examination of a number of austenitic welds reveals a fine precipitation of nonmetallic inclusions lined up parallel to the fusion line. This condition is illustrated in the two center photomicrographs of Figure 18. The lining up is in contrast to the random distribution of nonmetallics throughout the remainder of the weld metal. An attempt is being made to connect this phenomenon to the observed tendency for greater fusion zone cracking in austenitic welds made with certain armor compositions, and photomicrographs are now available which clearly indicate that a majority of fusion zone failures proceed through the area of lined-up inclusions.

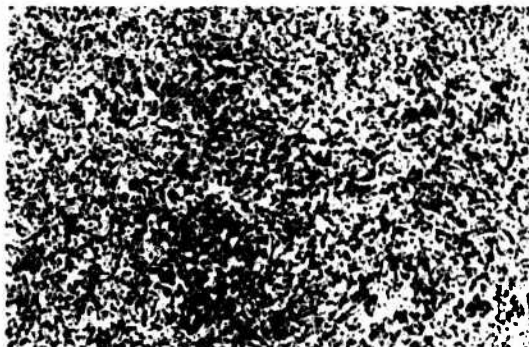
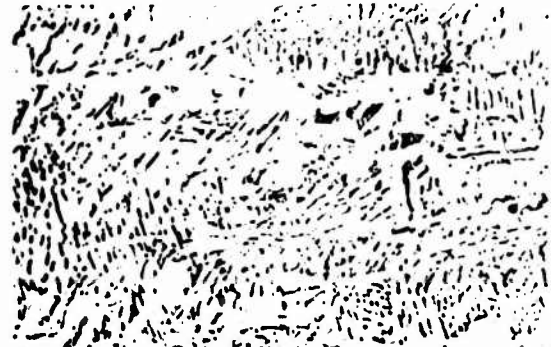
X250 Picral

X1000 Picral
Typical weld metal microstructure of 1/2 inch thick ferritic hand welded plates.

X1000 Picral
Typical weld metal microstructure of 1/2 inch thick ferritic Unionmelt welded plates.

c. Weld Metals - Fractures of all austenitic welds were fibrous and had high impact energies (see Table VI); therefore were not studied microscopically. The manually deposited Mn-Mo ferritic weld metal was comparatively good and the Unionmelt ferritic very poor in impact energy (Table VI). Photomicrographs of both weld metals are shown in Figure 18. The finer more uniform distribution of carbides in the hand weld indicates better properties than could be expected of the Unionmelt weld metal, but the presence of high temperature transformation carbides in both welds indicate poor impact properties under very severe testing conditions as confirmed by the Charpy values at subnormal testing temperatures.
